Initiation of sub-surface micro-cracks and white etching areas from debonding at non-metallic inclusions in wind turbine gearbox bearing

H.A. Al-Tameemi, H. Long, R.S. Dwyer-Joyce

Department of Mechanical Engineering, The University of Sheffield, Sheffield, S1 3JD, UK

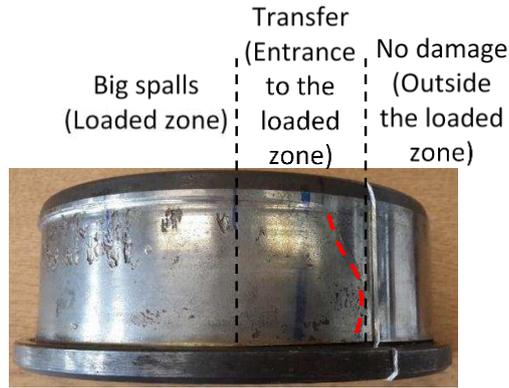
The dimensions of the examined inner raceway were 65mm in inner radius, 47 mm in raceway width, and 12.5 mm in thickness. Only half of the inner raceway of the failed bearing was available for examination in this study, and the results obtained refer only to this half of this bearing, while the other half was used for another study [11]. Three regions of damage can be identified on the surface of the bearing, as shown in Figure 2. The first region consisted of big spalls, bigger than 3 mm as the maximum dimension, spreading on the downwind side of the raceway. The width of this region was about 20 mm. At the entrance to the loaded zone, less spalling damage was observed with the largest spalls in this region located on the flange side. The red dotted line in Figure 2 shows the wear trace line which was not parallel to the axial axis of the raceway. This could be due to skewing of the rollers when entering to the loaded zone. Outside these two regions, no visual damage was observed however an optical microscopic examination of the surface showed some micro-indentations.

Fig 2: Inner raceway of the examined failed bearing

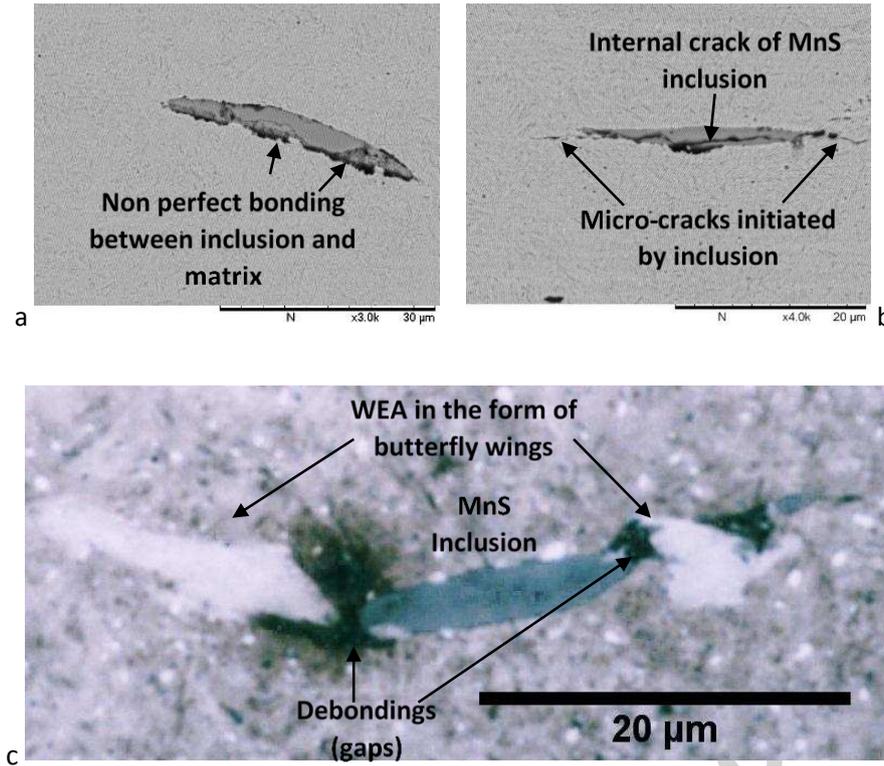
of damage observed during the examination of the failed bearing are presented in Table 1. It should be noted that more than one type of damage could be observed at the same time such as debonding and cracked inclusions. Figure 4 shows examples of different types of damage defined in Table 1. A database of the damage was created by recording the length, angle and depth for cracks, inclusions and WEA in the axial and circumferential sections. Figure 5 depicts the procedure adopted to measure the angle of inclusion and the butterfly wings. This figure shows the right and left wings of the butterfly, which are defined relatively to the Over Rolling Direction (ORD). The same definition for the angle was applied to the right and left cracks initiated from an inclusion. The length of the inclusion represented the distance between the two pointed tips, or the radius for globular inclusions, and the width was the maximum dimension normal to the length. The depth was measured from the surface to the centre of the inclusion.

Fig 4: Examples for the damage defined in Table 1 (a) Debonded inclusion (b) Cracked inclusion with micro-cracks (c) Butterfly with WEAs debonded from matrix

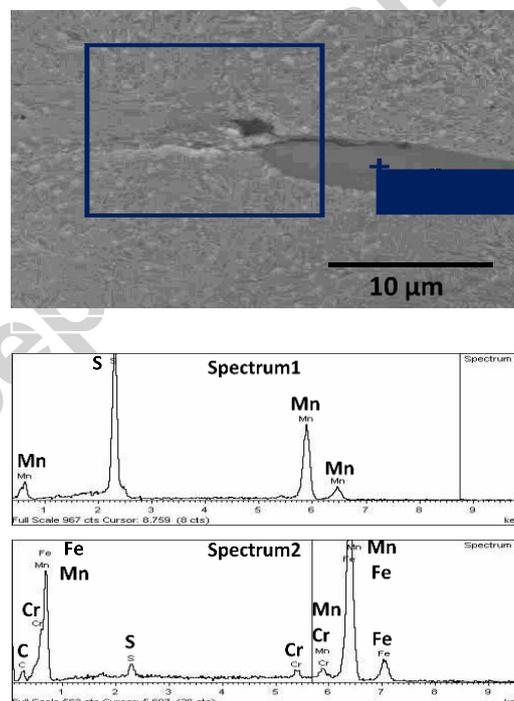
structure changes (WEA) were analysed. The most common inclusions found in this bearing were light grey elongated inclusions. Inclusions with these features are classified as Type A-Sulfide which could be manganese sulphides [24] or aluminates embedded in manganese sulphide according to the standards ASTM-E45-13 and ISO-4967 [25]. Determining the exact components of these inclusions was performed using energy dispersive x-ray (EDX) which revealed the presence of Manganese (Mn) and Sulphur (S) as shown in Figure 6.

Fig 6: EDX analysis (spectrum 1) point identification of a MnS inclusion and (spectrum 2) area identification of a WEA and inclusion

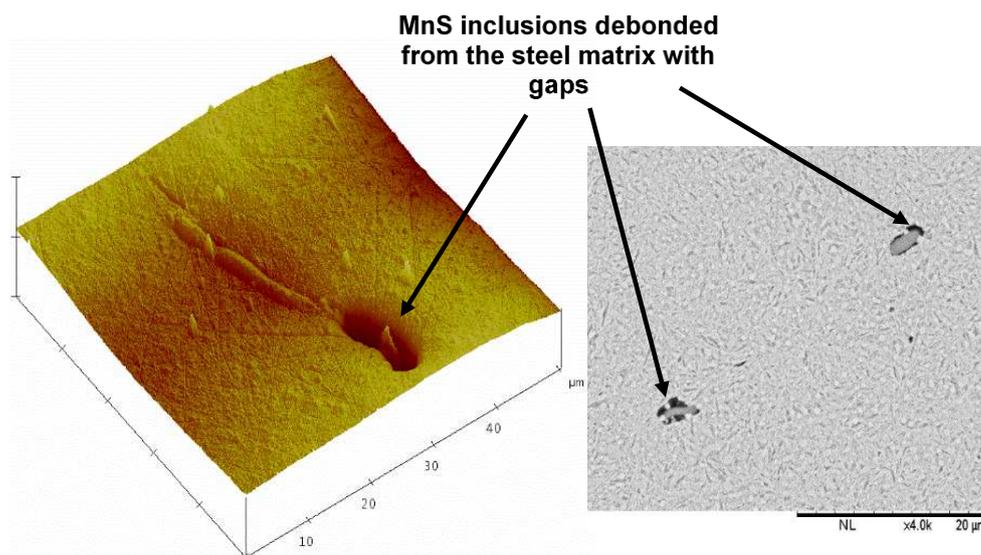
The dark tips of some of the inclusions, which could be mistaken for encapsulated oxide, were identified using AFM and SEM as shown in Figure 7, and they were found to be discontinuities between the inclusion and the steel matrix as debondings (gaps). The debondings may have been manufacturing defects and evidence of this has been reported in manufacturing studies ([26][27][28]). In this study, debondings were observed at different depths from the surface, greater than 1 mm as shown in the right image in Figure 7. Sometime these debonded inclusions were found far from the zone of high sub-surface stress, which was calculated using the Hertzian contact theory. Accordingly, these debondings were mostly material defects rather than results of loading in operation. These deep inclusions were not included in the database of the catalogued inclusions which was used to identify the characters of inclusions initiated damage.

Fig 7: (Left) AFM 3D image and (Right) SEM image of debonded inclusions at 1300 μm depth

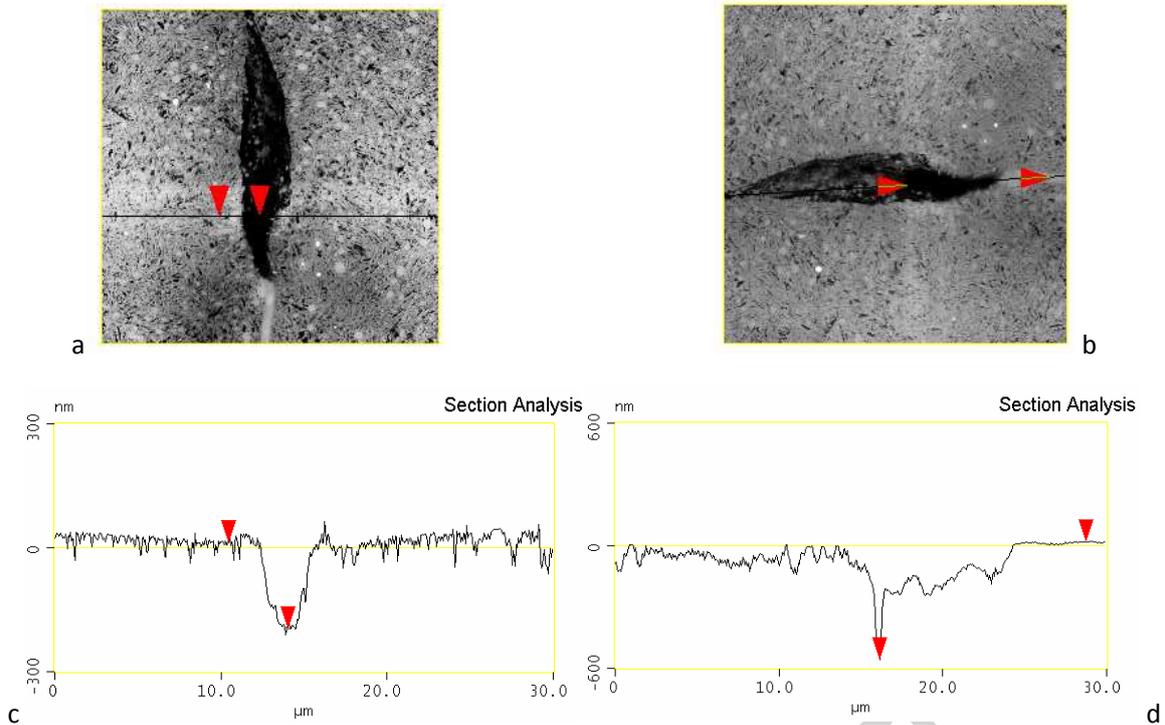
It was observed that WEAs in butterfly wings, were mostly attached to the debonding gaps at inclusion tips rather than the inclusions directly. This could be due to the higher stress concentration factor at debondings around the inclusion tips [29][30]. Debondings were found with different shapes around inclusions. To gain an insight on the size of the inclusion as well as examining the topography of the WEA, AFM analysis was conducted. The single wing butterfly shown in Figure 3 was examined using AFM. This butterfly was at 207 μm under the surface and it showed a MnS inclusion with a debonding gap at one of its tips, and a single butterfly wing was found to be attached to the debonding. After an AFM scan, the depth along two lines crossing the debonding was characterised as shown in Figure 8. The WEA was found to be lower than the steel matrix, and the discontinuity between the inclusion and the WEA was clearly shown by the relative depth. The maximum dimensions for this debonding were found to be 2.3 μm in depth, 9.6 μm in length and 3.3 μm in width. This analysis shows the extent of damage in the form of a material discontinuity starting from the debonding gap of the inclusion into the steel matrix in the form of WEA that has a degree of discontinuity and damaged material. The WEA is shown to be a microstructural change accompanied by damage to the material.

Fig 8: AFM analysis showing the debonding between a MnS inclusion and WEA (butterfly wing)

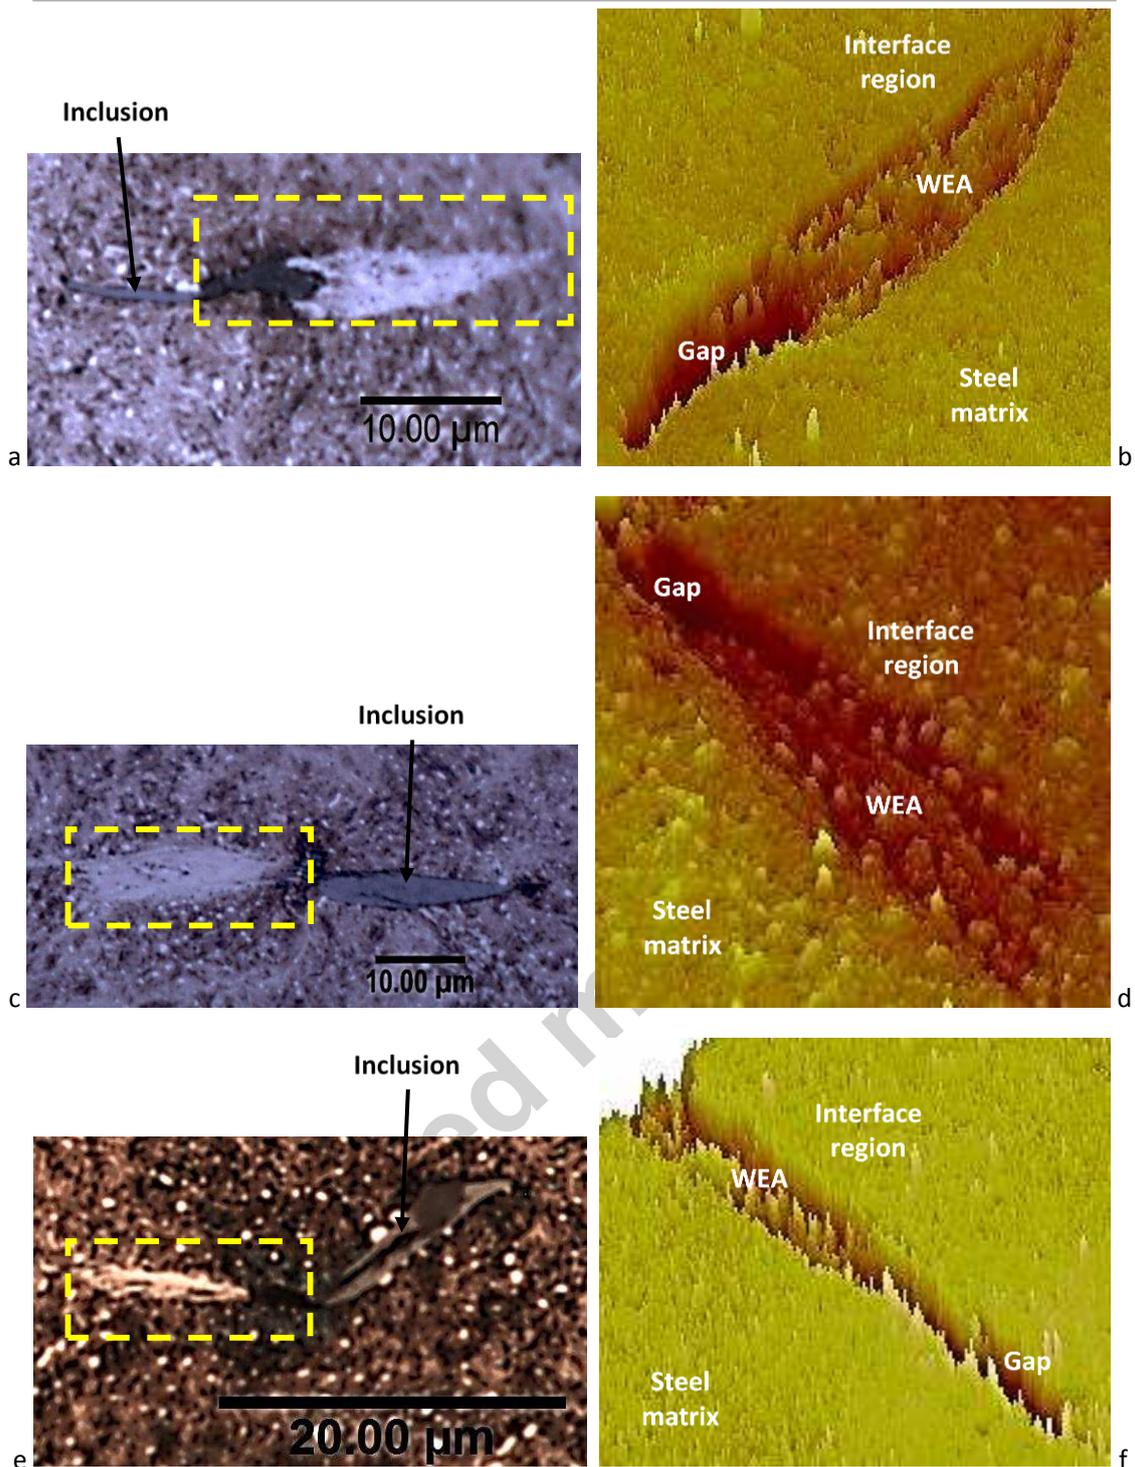
The AFM imaging measurements also showed that the WEA was not a dense material, and it resembled a damaged material extending from the debonding at the inclusion tip. Figure 9 shows three butterfly wings observed in the axial and circumferential sections with 3D AFM images for the WEAs. These images show clearly the features of the WEAs that are not available by 2D optical or SEM images. The borders of the WEA show a sudden transition from the dense steel matrix to the discontinuous material inside the WEA. This could be due to a local stress concentration that pulls or shears the edges of the WEA (i.e. the interface with the steel matrix). The hardness of the WEA was reported to be higher than the steel matrix [1], and this was confirmed in this investigation and results to be discussed in Section 4.3. This could be an indication of material hardening after the bearing steel yield limit had been exceeded due to stress concentration around the debonding of inclusion.

Fig 9: (Left) Optical images of debonded MnS inclusions attached to WEA. The highlighted parts are the 3D AFM images to show the discontinuity of the WEA, and the debonding at the boundaries between the WEA and the steel matrix. The images in (a) to (d) are from axial sections; and (e) and (f) are from circumferential section with ORD from left to right

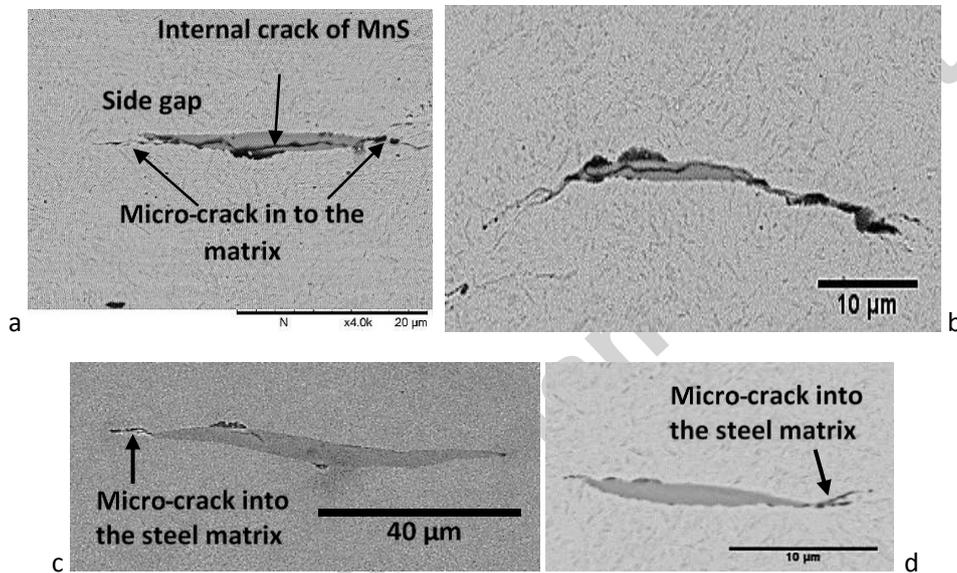
Some of the observed micro-cracks and WEA (butterfly wings) were initiated by inclusions with internal cracking as shown in Figure 10 (a) and (b). It was more likely that the micro-cracks started from the interface between the inclusion and the steel matrix, since no cracked inclusion was found where the internal crack does not interact with this interface. It was also observed that some micro-cracks propagated into the steel matrix or formed butterfly wings could initiate from the debonding between the inclusion and the steel matrix where the inclusions were not cracked themselves. An example of this was the non-cracked inclusion with debonding which formed a butterfly as shown in Figure 9 (a). In other cases, micro-cracks into the steel matrix were initiated from inclusions tips without debonding or inclusion internal cracking as shown in Figure 10 (c) and (d). Accordingly, no specific order for the damage initiation can be confirmed in this study.

Fig 10: Micro-cracks initiated by inclusions (a) and (b) cracked inclusions with cracks propagated into the steel matrix (c) and (d) Micro-cracks initiated from non-cracked inclusions

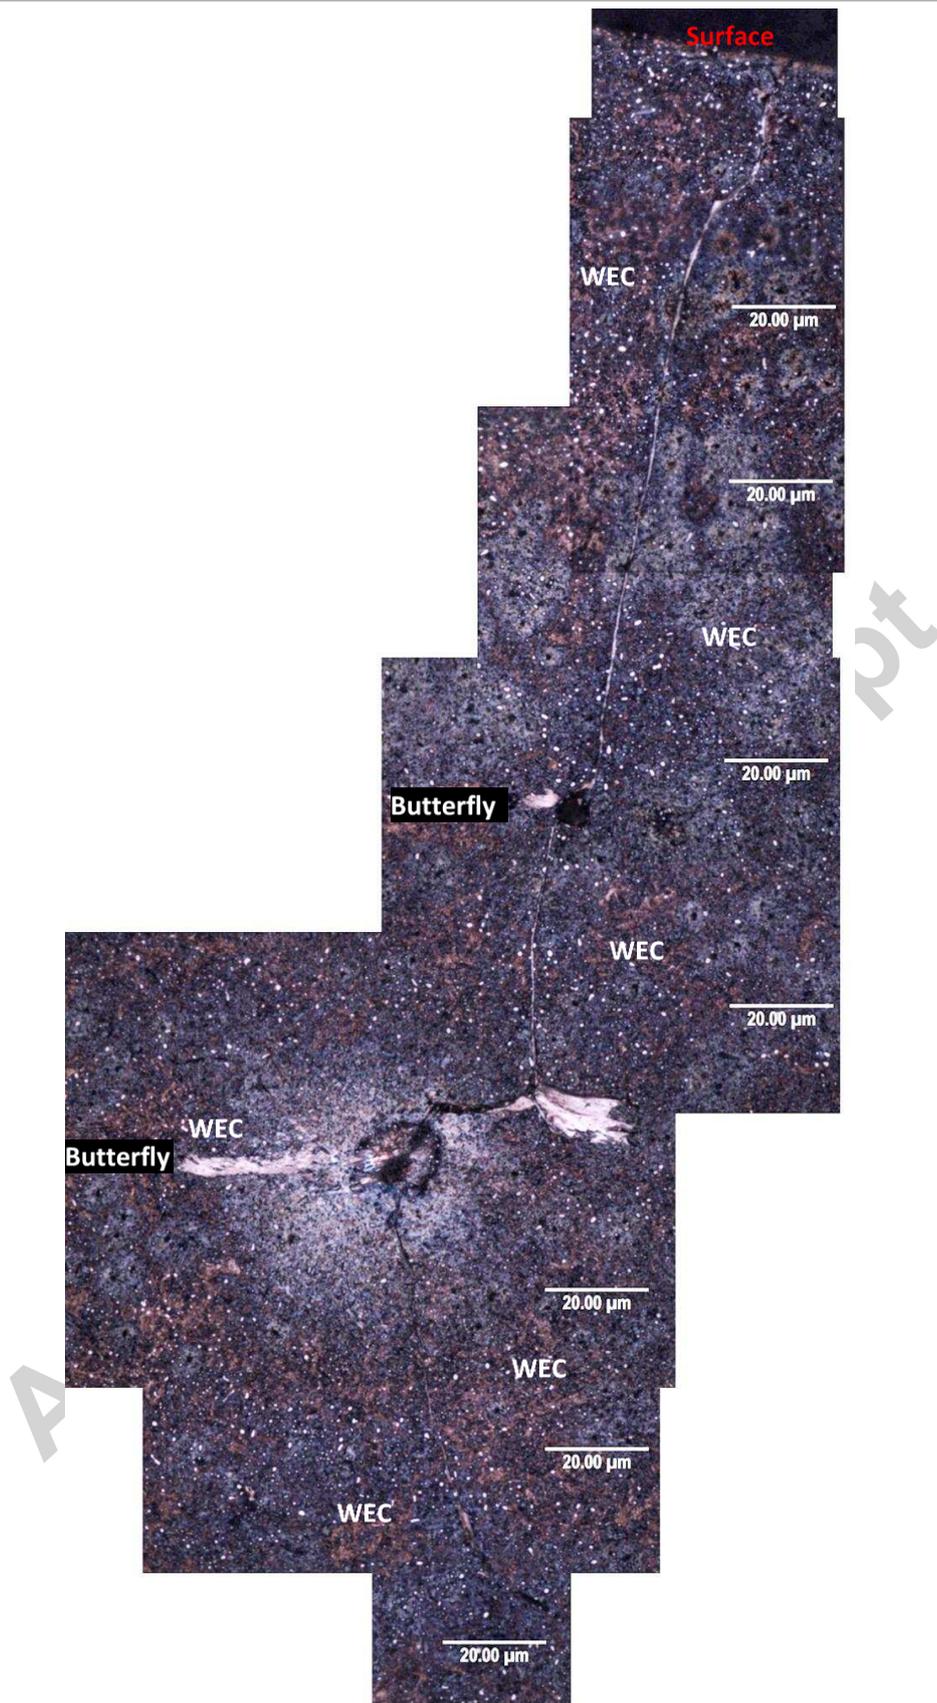
In addition to the micro-cracks, one fully developed crack linking the surface with two butterflies was found as shown in Figure 11. In this figure, no inclusions could be found in the butterflies which may have been removed by the sample preparation process. Since no spalling damage was linked to the WEC, it appeared most likely that this crack propagated from the butterflies and it was not initiated from the surface. It also showed that cracks and WECs could initiate from the inclusions, or the interface between a WEA and the steel matrix. These cracks propagated in a vertical direction towards the surface or deeper down without following the extension direction of the butterfly wings and this suggested a different mechanism for the initiation and propagation.

Fig 11: WEC propagated almost vertically toward the surface and linked to two butterflies

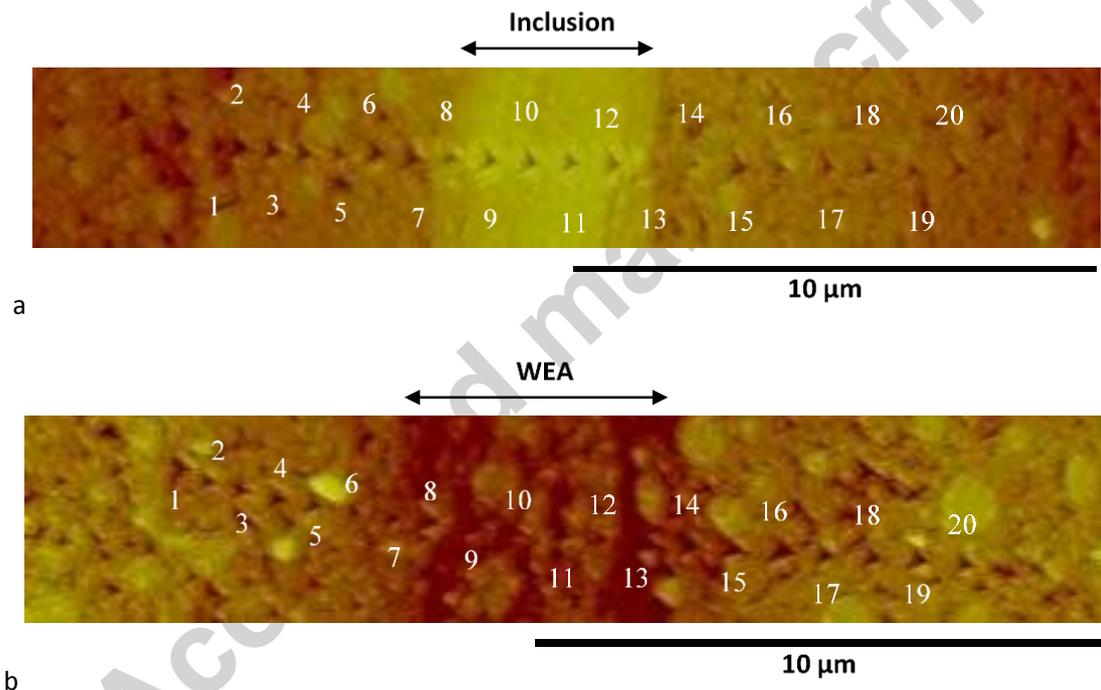
The hardness of a MnS inclusion and a WEA in a butterfly was measured using Nano-indentation. The measurement applied to both the inclusion and the WEA of the butterfly in Figure 9 (c) which located 63 μm from the surface. The pattern of indents used was a line of 20 as shown in the AFM images in Figure 12. These arrays of indents across the MnS inclusion and the butterfly wing showed the indents as dark triangles above or below the numbers. A spacing of 0.5 μm between indents and load of 800 μN were used in the measurements. These values of load and spacing were decided after testing the indent's size, which was around 0.2 μm , to ensure sufficient spacing between the indents and having sufficient number of indents across the inclusion and the WEA width. The spacing of around 2.5 to 3 times of the size of the indents should eliminate the effect of localized plastic deformation at each indent on the adjacent indents [31]. It can be seen in Figure 12 that not all the indents had the same size, especially within the steel matrix and the WEA. Some of the variation in the measurements was related to the multi-phase nature of steel on the nano-scale which was also true for the WEA [32].

Fig 12: Nano indents across (a) MnS inclusion and (b) butterfly wing in Figure 9 (c)

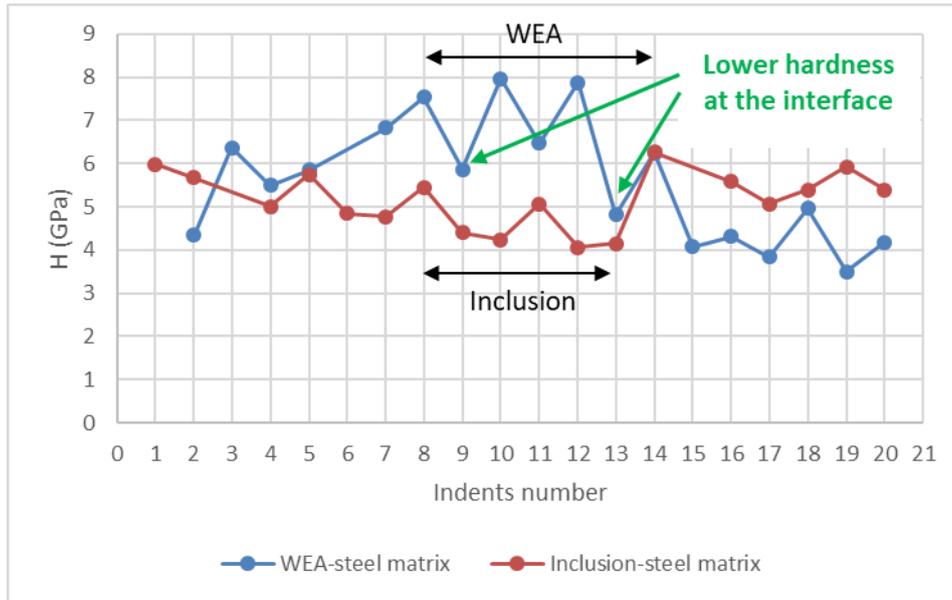
The curve in Figure 13 shows the variation of hardness across the inclusion, and the WEA (butterfly wing) with the indent numbers referred to those in Figure 12. The results from the first and the sixth indents in the WEA-steel matrix curve, and the third and the fifteenth in the inclusion-steel matrix curve were excluded because they were clear outliers. As shown in Figure 13, at indents number 9 and 13, the lower hardness revealed the weak interface between the WEA and the steel matrix, which could justify the observed butterfly micro-cracks at the edges of the butterfly wing. Also, the WEA was generally observed at one of the sides of the WECs however there was no general conclusion regarding which specific side.

Fig 13: Nano indentation hardness measurement across a MnS inclusion and a butterfly wing

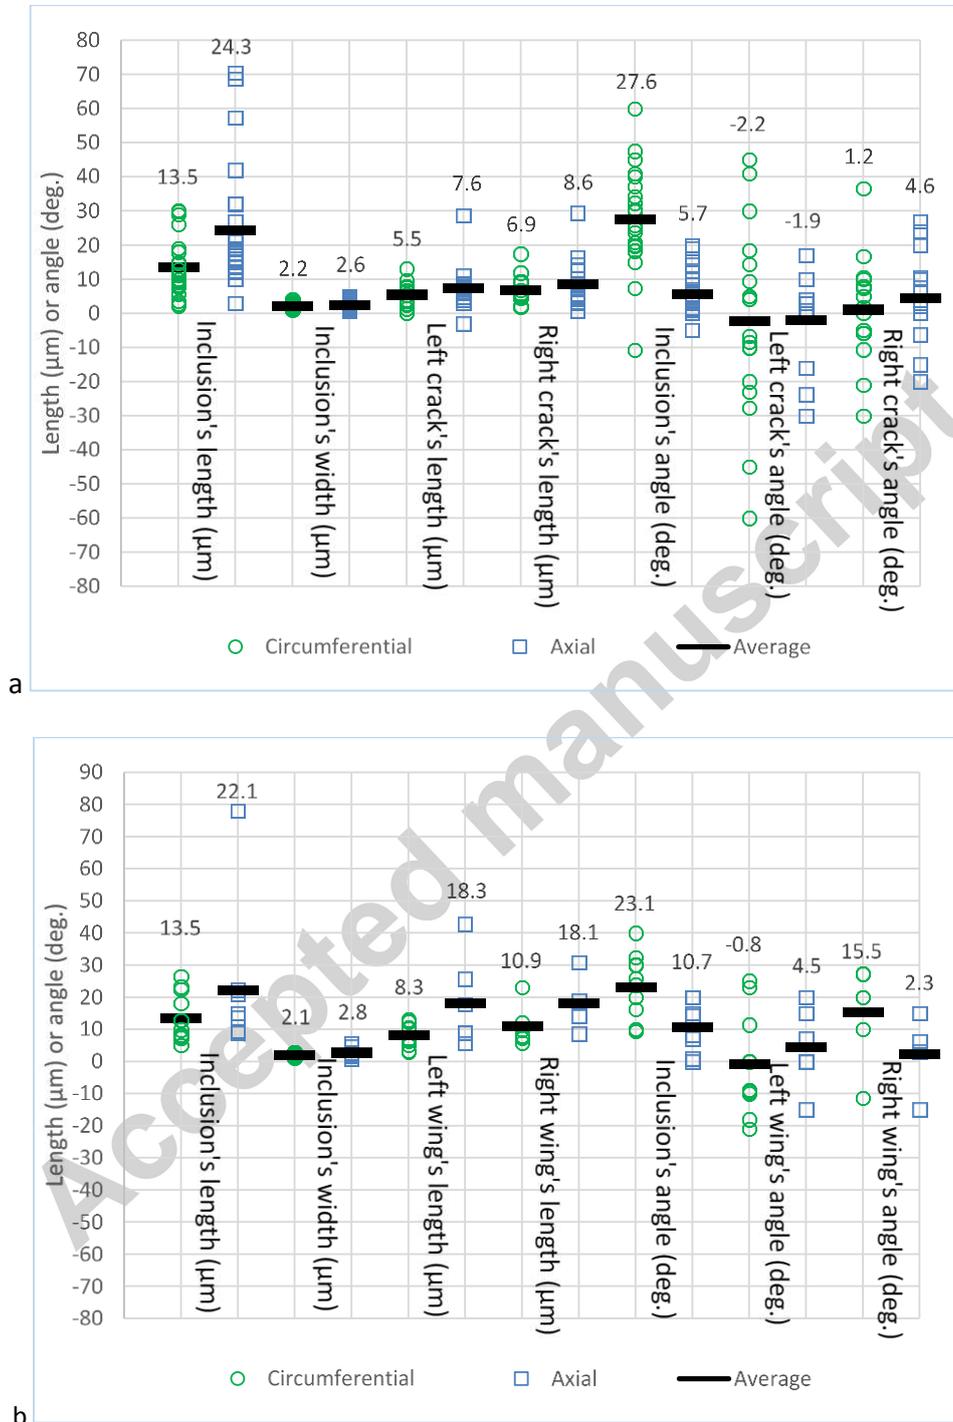
The characteristics of each catalogued inclusion included: length, width, inclination angle and depth from the surface. The measurements were made according to the definition given in Figure 5. The first observation was that inclusions initiated damage were bigger in size, length and width than that the inclusions not initiated damage. In Figure 14, the characterization of micro-cracks initiated by inclusion and butterflies are presented separately in order to investigate the characteristics of the inclusions that initiated them. In Figure 14 (b), the definitions of right and left wings relative to the ORD are shown in Figure 5 which are also applied to the left and right cracks in Figure 14 (a). The common observations from the length of micro-cracks and butterfly wings initiated from inclusions were: a) They

were longer in the axial sections than that in the circumferential sections. b) In the axial sections, their length on both right and left sides were almost the same, while for the circumferential sections the length of micro-cracks was slightly longer on the right hand side than on the left hand side.

Fig 14: Characterizations of subsurface damage (a) micro-cracks initiated by inclusions with their initiating inclusions (b) butterflies' wings with their initiating inclusions (the number above each characteristic feature refers to the average value)

One of the main differences observed was that the butterfly wings were longer than micro-cracks in both of the circumferential and axial sections. The most recognisable feature regarding the angles of the micro-cracks and butterfly wings as shown in Figures 14, was the positive and bigger angle of the butterfly wings on the right side in the circumferential sections. This may be compared with micro-cracks on the same side, and sectioning direction which had shallow angles varied between positive and negative values. The small average angles of the micro-cracks in axial and circumferential sections were due to the fact that the angle values varied between positive and negative values at almost the same absolute value. However, the range of angles for the micro-cracks and butterfly wings was lower than 45° and this was the angle for the maximum principal shear stress $\tau_{1(max)}$. The angle and depth of $\tau_{1(max)}$ can be changed due to the effects of surface traction, which could be the reason for the observations of the angles for the butterflies and the cracks in Figure 14. The effects of inclusion depth and the relationships with the load on the surface will be discussed further in Section 6.

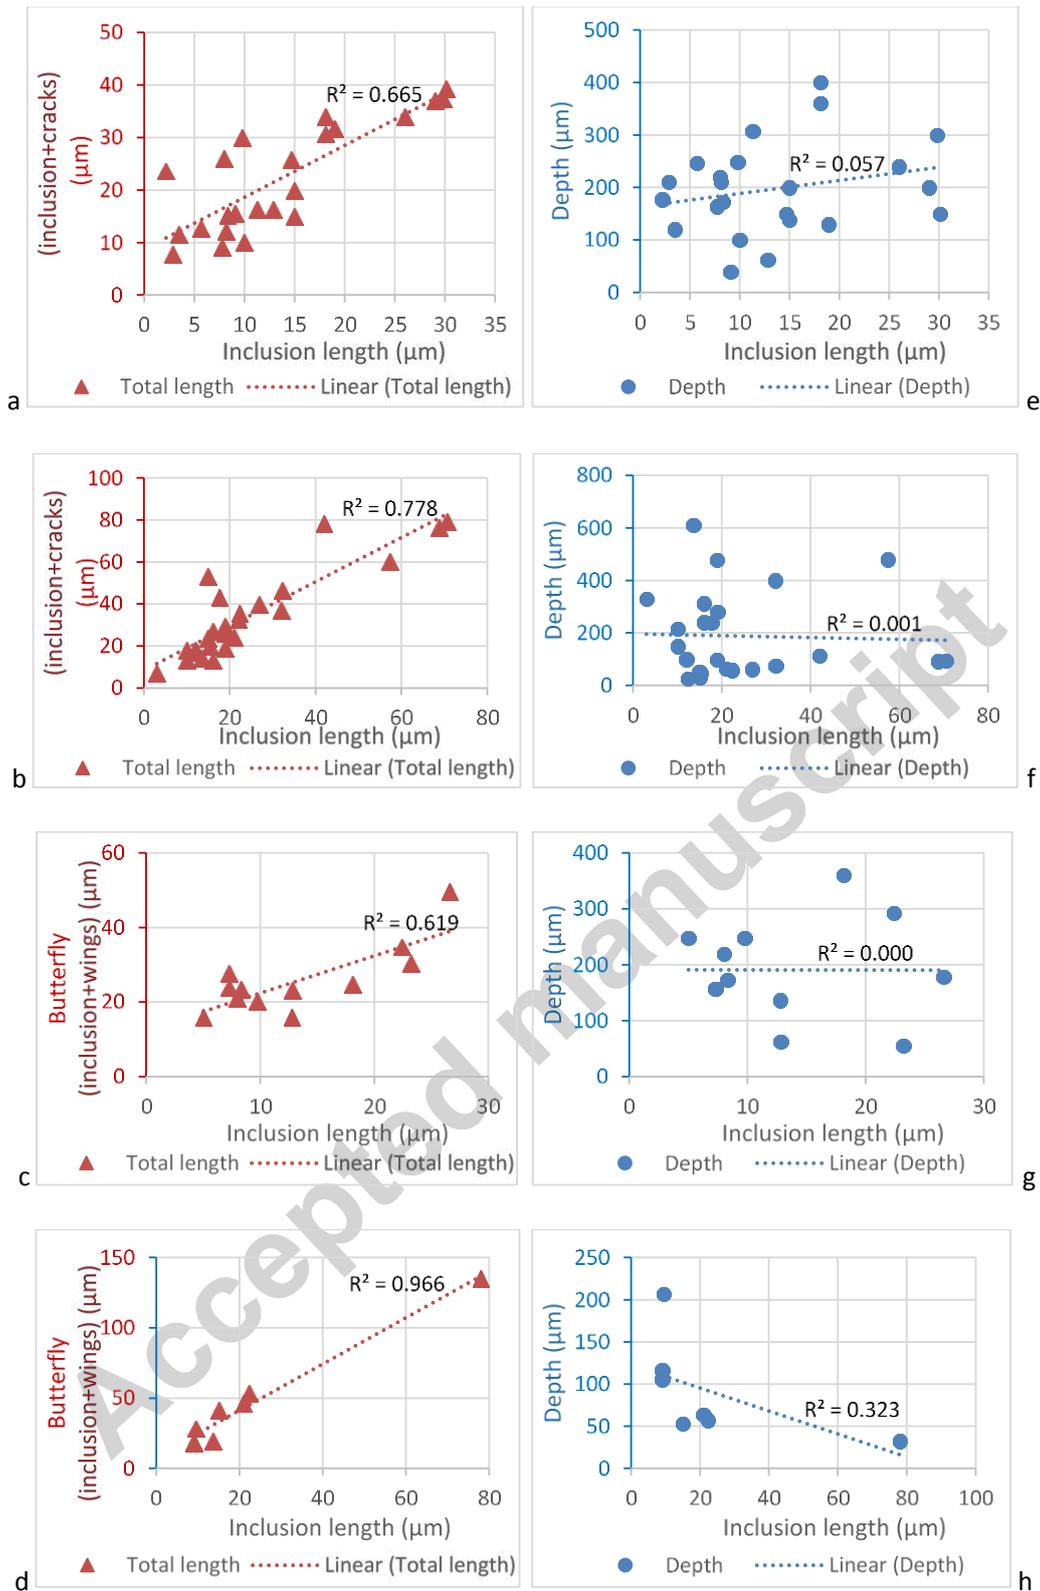
No clear relationship could be found between the size of the inclusions and the length of butterfly wings or micro-cracks initiated from inclusions. However, it was found that the total length of the inclusions and their associated cracks or butterfly wings showed a clear and direct relationship with inclusion length regardless of their depth as shown in Figures 15 (a) to (d), where the length of butterfly wings and micro-cracks on both the left and right side of the inclusions were measured. Accordingly, if the inclusion was considered as a weakening point of similar effect as a sub-surface micro-crack, the trend lines shown in Figures 15 (a) to (d) demonstrated that greater damage were created from bigger inclusions. These results, specifically those in Figures 15 (a) and (b), are in agreement with the expectation stated in the cleanliness standards such as ASTM E2283 [33] that the biggest inclusion is the most important for damage initiation. In the same context, Murakami derived relationships to describe the effect of inclusion size (\sqrt{Area}), on the fatigue limit of bearing steel, based on the assumption that a non-metallic inclusion acted like an initial crack length [34]. Although the number of butterflies found was less than that of the micro-cracks propagated from inclusions, the trend lines for the butterflies in Figure 15 (c) and (d) were similar to that of the micro-cracks in Figure 15 (a) and (b). Accordingly, the inclusion size affects butterflies and micro-cracks initiated from inclusions in the same way. Figures 15 (e) to (h) show that no consistent relationships can be recognized between the depth of butterflies or micro-cracks and the size of the initiating inclusions. Although Figure 15 (h) shows that inclusions causing butterflies are bigger when they are closer to the contact surface, the confidence in this trend is relatively low as can be seen from the R^2 value.

Fig 15: Inclusion length vs total length with the depth of inclusions: (a) and (e) cracks initiated from inclusions in circumferential sections; (b) and (f) cracks initiated from inclusions in axial sections; (c) and (g) butterflies in circumferential sections; (d) and (h) butterflies in axial sections.

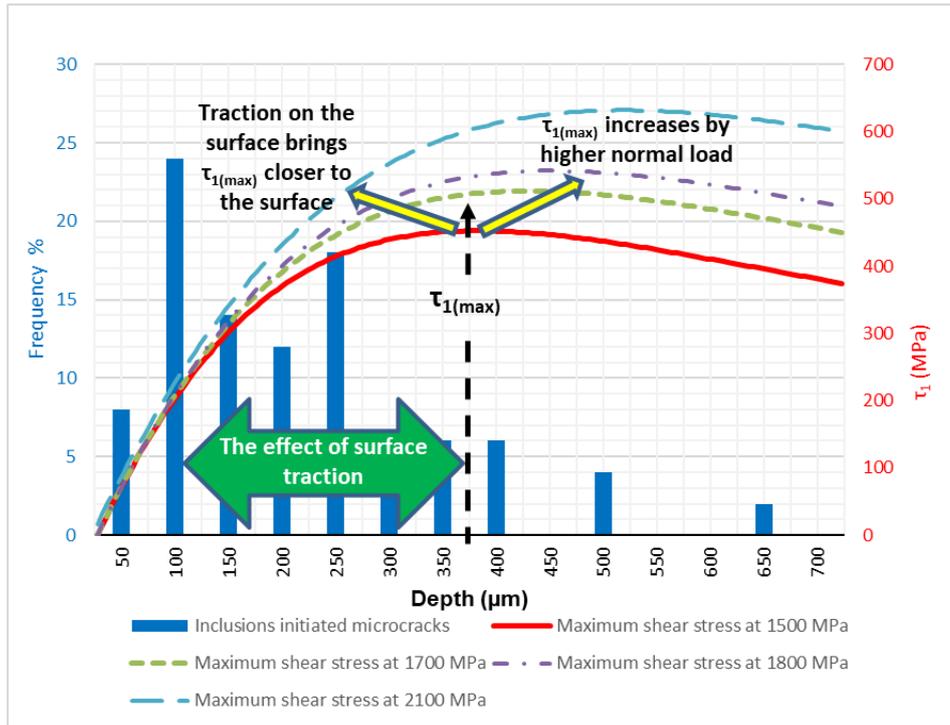
The load history of the examined bearing is unknown. However, the recommended maximum contact pressure p_{max} for a wind turbine planetary bearing is 1500 MPa according to the standards BS EN 61400-4:2013 [37] or IEC 61400-4 [38] and this was assumed in the sub-surface stress calculations. Since the bearing had failed prematurely, an even greater value for the p_{max} could be expected. Calculations were also made on the sub-surface stress distribution at higher contact pressure up to 2100 MPa. The depth of the maximum sub-surface shear stress $\tau_{1(max)}$ under $p_{max}=1500$ MPa was found to be 370 μm , which becomes deeper if under higher contact pressure. Figure 16 was created to show the percentage and frequency, of micro-cracks observed at each bin size of 50 μm of depth in this histogram. This figure shows that the occurrence of micro-cracks initiated from inclusion at a range of dominant depths, which is closer to the surface than the depth of $\tau_{1(max)}$ at various levels of contact pressure of 1500, 1700, 1800 and 2100 MPa. It is known that the location of the shear stress will be shifted towards the surface when surface traction occurs. If the maximum shear stress is considered to be the trigger for sub-surface damage, Figure 16 shows the observed damage initiated from inclusions at shallower depths that may have been affected by the occurrence of high surface traction. Under high surface traction, the location of $\tau_{1(max)}$ is shifted to the edge of the contact width and the value could be higher than that at the centre of the contact. The effect of surface traction could also be observed through the angles of the cracks and butterflies shown in Figure 14 which are not in line with the 45° of $\tau_{1(max)}$ under the centre of the contact when without surface traction. The additional stress due to surface traction or tensile stress, due to bearing seat waviness [17], could increase the stress concentration around the debonded inclusions and cause the WEA and WECs.

Fig 16: Depth of micro-cracks in axial and circumferential sections compared with the depth of sub-surface maximum shear stress $\tau_{1(max)}$ at various levels of contact pressure

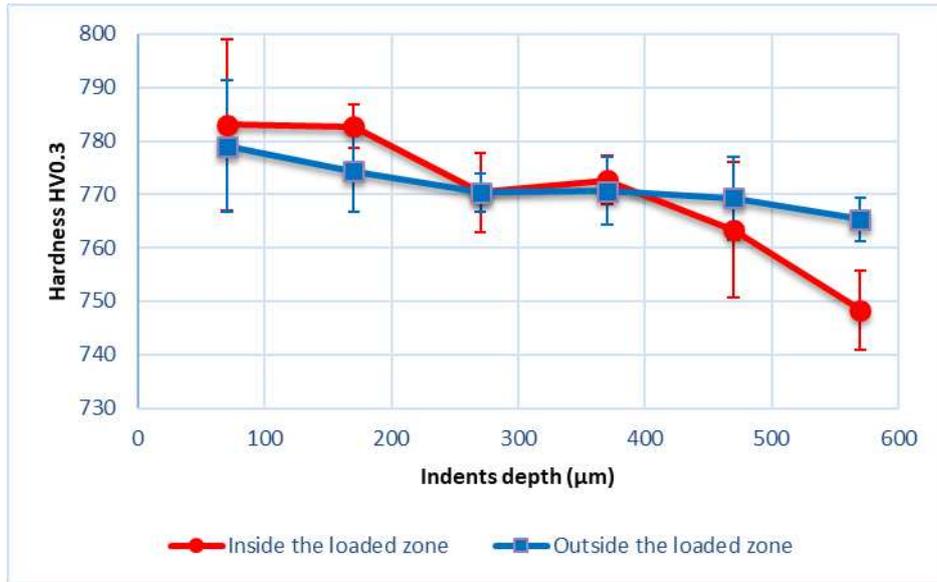
Another investigation was conducted to determine the depth of the sub-surface material that was most affected by the surface loading. The sub-surface hardness variation was measured by the method described in Section 2. The variation in hardness could reflect hardening due to a higher load exceeding the material yield limit, and this could also be an indication for the location of sub-surface initiated damage. Measurements of this were carried out on a sample from the transfer region between the loaded and unloaded zones of the failed bearing, as shown in Figure 2. The average values and the standard deviation from three measurements at each depth are shown in Figure 17. In this figure, the loaded zone was under the raceway surface showing damage, and the unloaded zone was under the raceway surface that did not show damage, but was at the entrance to the loaded zone. Although both curves showed high hardness closer to the surface, the hardness for the loaded zone was higher at this depth close to the surface. If there was no surface traction the maximum hardness would be expected to be located around the depth of $\tau_{1(max)}$ which is 370 μm at 1500 MPa. Accordingly, this measurement could be another indication for the occurrence of surface traction because the maximum hardness measured was at the subsurface depth of less than 200 μm .

Fig 17: Hardness variation with depth for the examined bearing
