1
2 **VERIFICATION OF THE USE OF MICRO-CT SCANNING TO ASSESS THE FEATURES OF**
3 **ENTIRE SQUAT TYPE DEFECTS**

22 Squats and studs are defects in railheads that share features, but have different causes. This paper examined four squat
23 and stud samples from three different traffic environments to compare features using μ -CT X-ray scans, surface and
24 subsurface inspection. μ -CT scanning has been used before as a non-destructive method to investigate rail defects, but
25 not the entire defect. The scans were verified and allowed the identification of areas of interest when sectioning the
26 samples further. The scan volumes were also used to create 3D models of the crack networks for the 3 samples that were
27 scanned. All defects contain similar superficial features but the depth and severity of the subsurface damage varies.

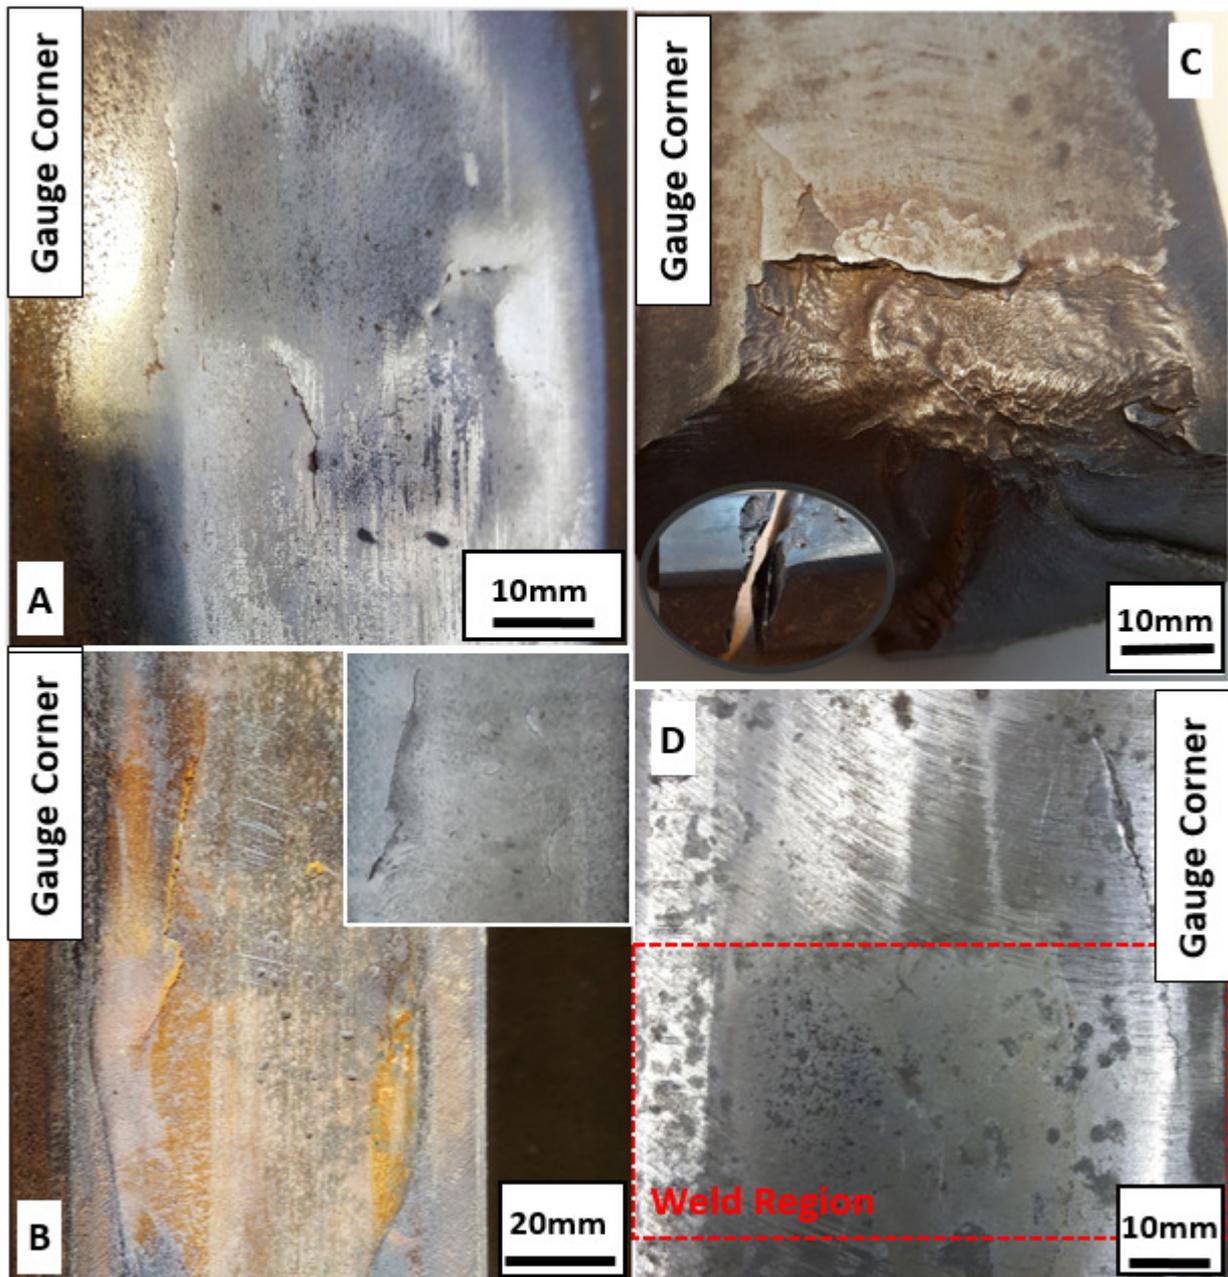
94 Not much is known about the track location and traffic experienced by sample 1 other than it was from an inclined track
95 near a station on a metro line. Sample 1 is shown in Figure 3a. It shows signs of sliding surface damage and the dark spots
96 are quite well developed. It contains a lot of surface damage including four obvious surface cracks, streaks of what is
97 assumed to be white etching layer (WEL), a pit in one of the cracks, what seems to be 'snakeskin' damage just outside
98 the widened running band. WEL is shown in results. 'Snakeskin' is also known as running surface checking or flaking
99 and is a precursor to spalling of the rail surface [12]. There is also the very common V-shaped crack that squats are known
100 to exhibit, although the angle within the V in this crack is more obtuse than expected. There is also a faint series of small
101 cracks along a ridge that extends from the apex of the V-shaped crack out between the two lobes which is often observed

113 Sample 2 is shown in Figure 3b, and is post MPI (magnetic particle inspection): a non-destructive test that uses magnetic
114 ink on a white contrasting background to highlight defects in the surface. The long crack seen on the left of Figure 3b,
115 seems to be a combination of the long cracks found at the edge of the running band in samples 1 and 4 (Figure 3a and d
116 respectively) and the expected V-shaped crack typically seen in a classic squat. The crack also has sharp edges unlike the
117 embedded cracks found on the other samples, possibly a sign that the crack is very recent. Sample 2 also has significant
118 discreet material removal. These look like corrosion pits, but are more likely localised delamination and flaking
119 characteristic of "ratchetting" [14]. Ratchetting is incremental plastic deformation of the upper surface of the rail material
120 due to cyclic strain build-up. Unique features in sample 2 are possibly because of traction control being used by the rolling

Figure 3: Images of the samples, all of which are a full rail width (~75mm wide) a) Sample 1 b) Sample 2 with magnetic particle inspection image inset to show apex cracks on field side c) Sample 3 with the other half of the defect inset d) Sample 4 with the weld region highlighted

Sample 3 is a broken rail of unknown MGT, which failed due to a transverse defect, within a squat defect, shown in Figure 3c. Most of the squat was damaged in the break, removing any surface evidence of the expected V-shaped crack. There was not much information to be gained from the shelled lobe either. However, the unbroken lobe of the squat was still available to view. The second lobe was very close to shelling and so presented the opportunity to remove the almost separated plate of surface material from the top of the defect. This allows the inspection of the crack plane below the squat. This plane was covered in oxide but the presence of water may have come from the cutting process due to the coolant flooding the sample. The plane was dry ice blasted to remove the oxide. The plastic flow shown by the folded material right next to the shelled section makes this most likely to be a squat.

Sample 4, shown in Figure 3d, was initially identified as a squat on an alumina-thermic weld and following an ultrasound test, was believed to be a combination of a squat interacting with a weld defect. The longitudinal crack that runs along the edge of the sample shows that the squat is slightly elongated, possibly linked to the higher train speeds [16]. The lack of deformation in the squat and the traffic total of ~28MGT makes it likely that this is in fact a stud, although a study has shown that 17% of squats are found at welds [17].

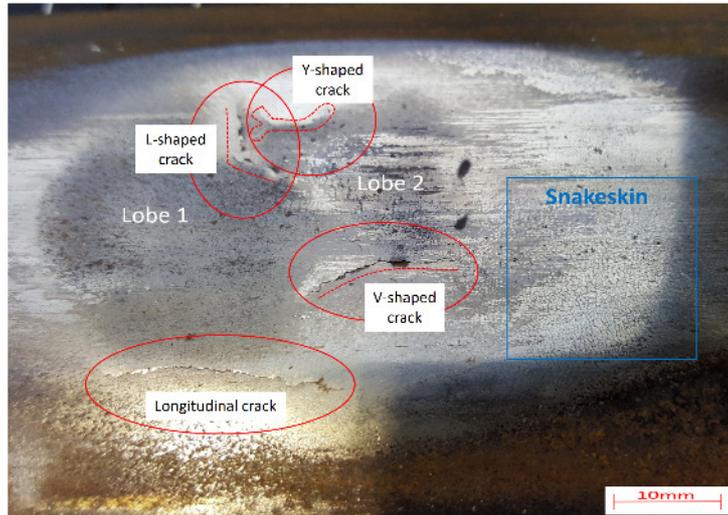
On sample 1 there were quite a few differences in surface finish, such as the shiny running surface next to the dark corroded region of the black spots, as well as the cracked 'snakeskin' region. There are four obvious cracks on the surface that are identified in: Figure 4 and the scanned images of them are in Figure 5. The longitudinal and obtuse V-shaped crack are found in the other samples, but the L-shaped and Y-shaped cracks are not (shown in Figure 4). The Y-shaped crack has been seen before in a squat sample reported on previously by Tata Steel [20] along with the 'snakeskin' surface damage (see Figure 6). In the Tata Steel report the snakeskin was also found on an area of the rail that did not contain a squat. The dark spot within the V-shaped crack is believed to be a spalled piece of snakeskin as the snakeskin can be faintly seen close to the crack (Figure 5c).

Figure 4: Sample 1 with the cracks marked in red and the snakeskin marked in blue

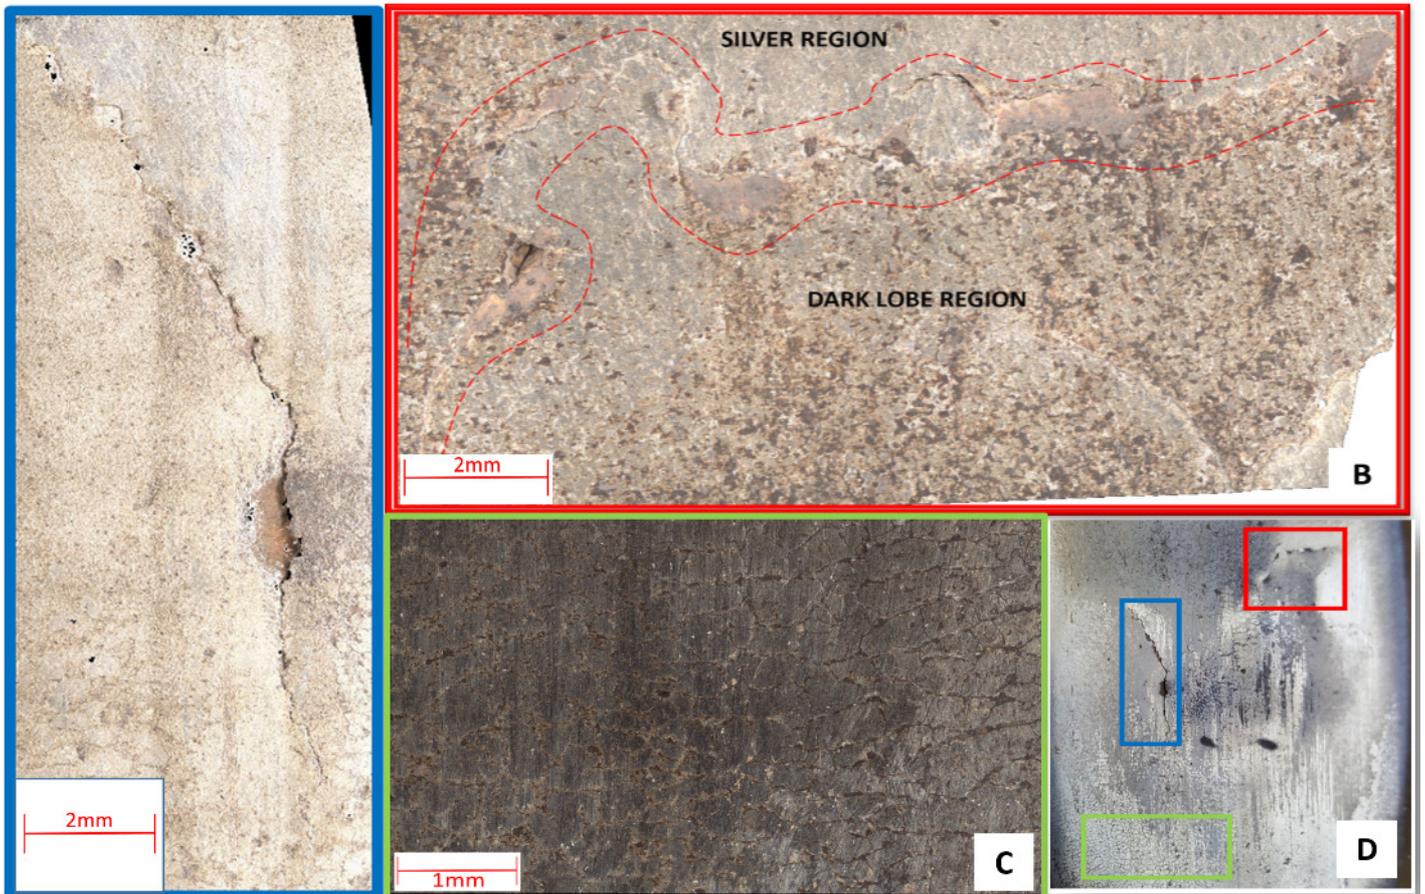
Figure 5: Some of the surface features imaged from sample 1 a) The L-shaped crack with 'islands' that appear pink in the scan b) The V-shaped crack with a pit that penetrates into the substructure c) 'Snakeskin' microcracks across the surface of the rail just beyond the defect d) A colour coded overview showing where the images are taken from

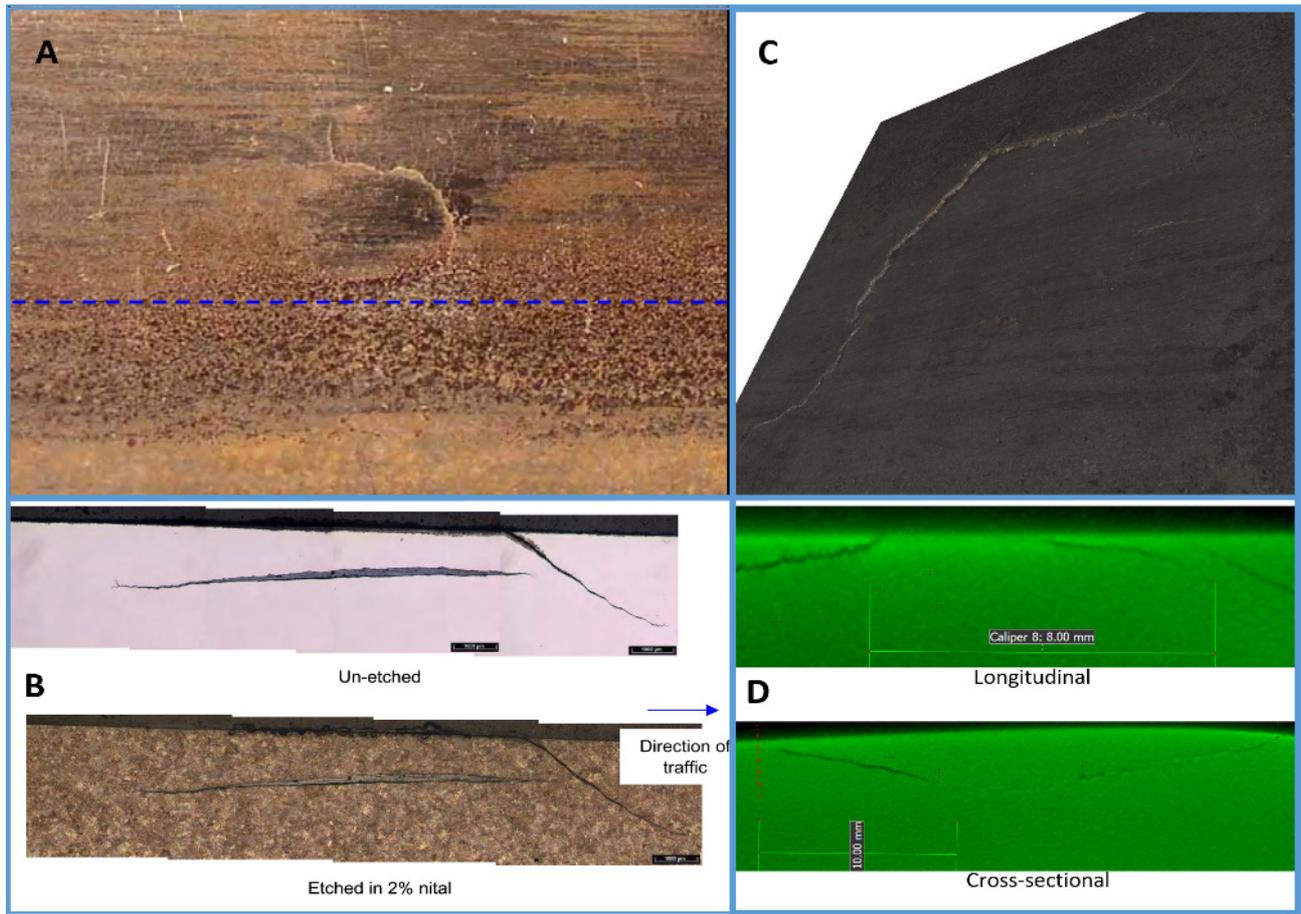
Figure 6 shows the Y-shaped cracks in sample 1 and the Tata Steel report as surface and subsurface defects. As the Y-shaped crack was the only surface crack in the Tata Steel report it can be assumed that this crack forms first. The shallow depth of the defect in the report compared to sample 1 also suggests that sample 1 is much more developed. Both samples are believed to be from the same metro network. The presence of the two cracks suggests the possibility of one crack initiating subsurface whilst the other initiated on the surface. Using the x-ray scanned volume that Figure 6d was taken from, it can be seen that moving through the sample towards the field corner shows that the cracks stay separate, although they may have connected within the region that was worn away. Moving through the sample towards the gauge corner shows the two cracks connecting as a very shallow crack parallel to the surface that makes up the bottom portion of the Y shape (when viewing the Y as written here).

Figure 6: Comparison of features of a squat from a Tata Steel report [20] with scan results from sample 1. a) The surface of the squat from the report, b) Longitudinal cross sections from the report, c) Surface scan from Alicona of sample 1, d) Longitudinal and cross sectional x-ray scans of sample 1 (red dotted line shows where orthogonal slices cross)

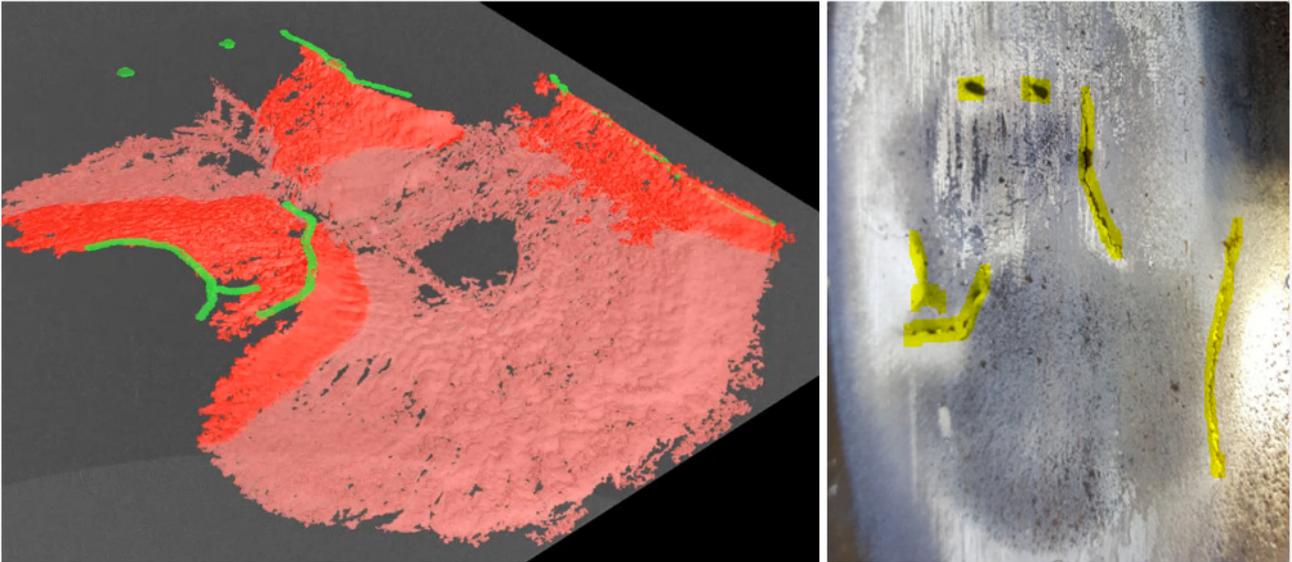
Comparing the report to the scans makes it highly likely that the initiation was in this area, and the branching of the longitudinal crack occurs within 4mm of the longitudinal slice in Figure 6d, moving towards the gauge corner. Being that the Y-shaped crack is closer to the field corner than the gauge corner suggests that a two point contact between the wheel and the rail may have been responsible. High surface temperatures occur with lower creepage and train speed when the contact patch is reduced like in a two point contact [21]. Sample 2 also contains a similar Y-shaped crack in a similar region but the clarity of the two cracks is not as clear, although a higher resolution scan of that area is planned for future work due to the branching of a possible transverse crack being in the same region. The L-shaped crack tracks the boundary between the dark lobe of the squat and the shiny surface of the running band, it also appears to contain islands of a different phase of steel, possibly martensite. This crack will be the subject of further investigations. For each of the 3 samples scanned, a 3D model was created both in Avizo and in VGStudio MAX. The model shown in Figure 7 was created in VGStudio MAX. The crack plane continues through the hole in the centre of the model: that region was not detected by the automatic construction module, but the crack was discernible manually. The crack plane also extends slightly further beyond the two green dots on the model.

Figure 7: Left) The model of the crack network in sample 1 created in VGStudio MAX showing a plane than runs parallel to the running surface to give a gauge or depth Right) a photographic reference of the surface cracks that are green in the model and yellow in the photograph

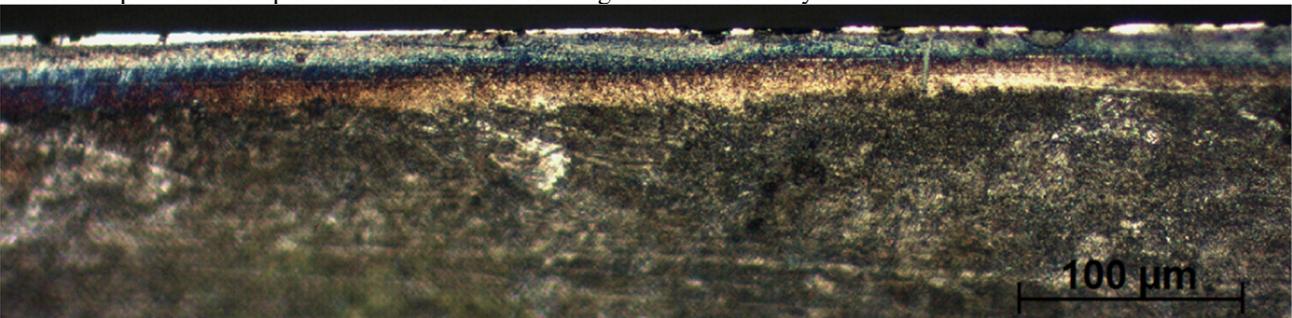
WEL varied; it appeared as both islands and long stretches, often within the same sample. An aerial view of the railhead showed long streaks of WEL and some are visible as contrast in the right image of Figure 7. Depending if the sample is cut in parallel or perpendicular to a streak probably partly explains this. The other part to consider is that WEL breaks away easily due to its brittle nature. Figure 8 shows one of the more unusual WEL found and is taken as a longitudinal slice from between the crack with a hole and the more central of the two black spots (Figure 7). It shows a bright white, fairly continuous band of WEL that seems very brittle as it has spalled in various places. This is on top of another fairly continuous WEL that has a distinct boundary with the upper layer and a more diffuse boundary with a deeper yellow patch of discrete WEL. The lower layer also has a diffuse boundary with the parent steel. It is believed that the lowest layer may have been caused by a grinding stone facet due to its discrete nature, like Figure 14, which is from outside running band. The other two layers were created by wheel slips of different magnitudes, leading to different temperatures being reached. Different temperatures will lead to differences in how much of the material reaches full austenisation as well as the penetration depth of the heat. Further investigation into these layers will be conducted in future work.

Figure 8: Three layers of WEL. The upper brighter WEL and middle duller WEL are fairly continuous for ~15mm of the 25mm sample. The upper layer is ~5 microns thick and the middle layer is ~19 microns thick. The lower, more yellow layer is a patch not much larger than the image and is ~14 microns at its thickest. A grey crack can be seen growing vertically through all 3 layers to the right of the image.

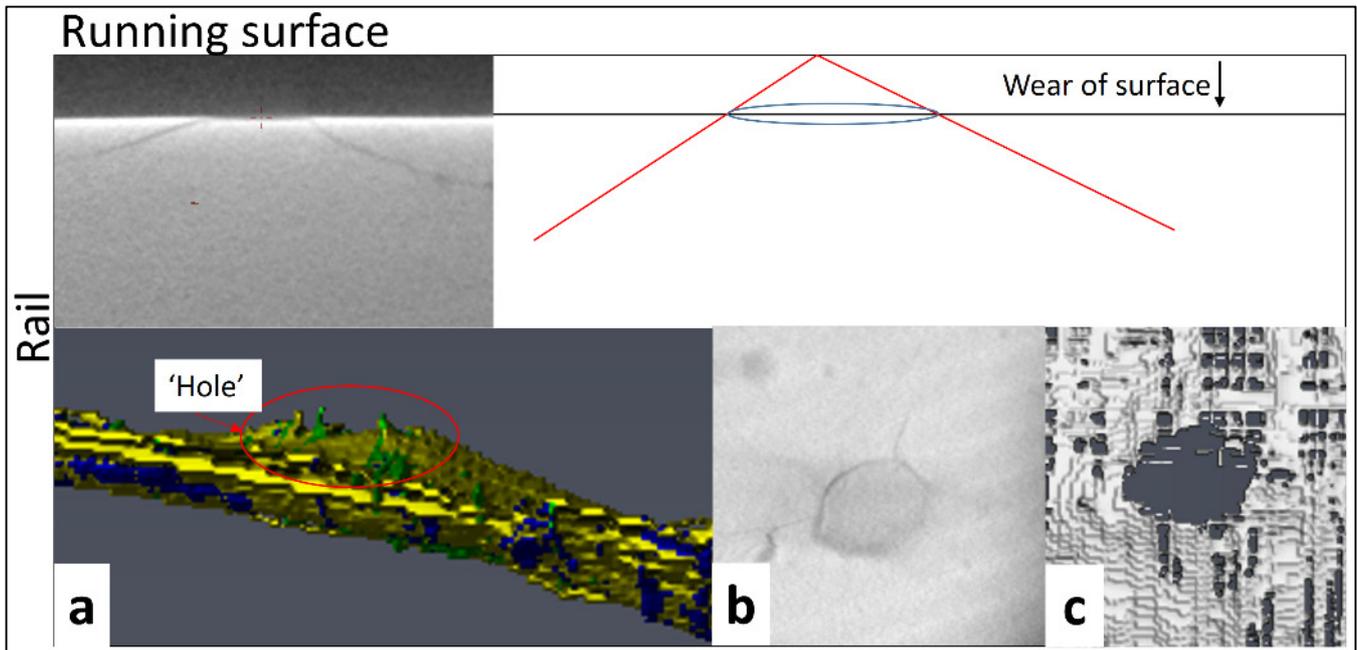
316 Another detail that showed through the full construction of the models was that the ‘C’ and ‘O’ shaped cracks found in
 317 the centre of the surface of samples 2 and 4 were the location where the inverted v-shaped crack had been truncated by
 318 wear (Figure 10). Sample 1 did not have this feature but sample 3 had a surface breaking crack in the same region but of
 319 a different morphology.

Figure 10: A diagram showing how wear truncates a pair of cracks to leave what is seen in the scan slice. Inset; a) The ‘hole’ from the longitudinal view as modelled in the Avizo model of sample 2, b) The original scan image of the surface of sample 2, c) The same view as (b), but of the Avizo model

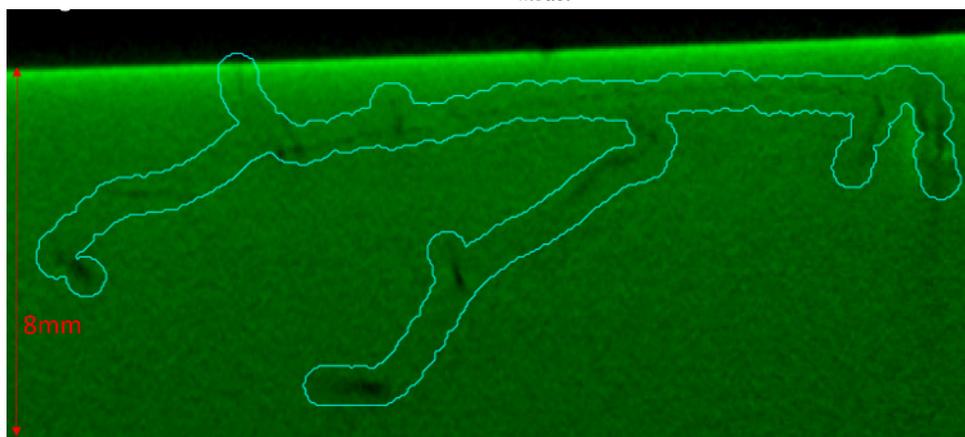
Figure 9: Longitudinal orthoslice of sample 2 showing the branching cracks

320 Sample 2 had much more damage than expected. Figure 9 shows a longitudinal section from the scan: although the
 321 resolution of the scan is low due to the size of the sample, parts of the transverse crack can be discerned up to 8mm deep
 322 into the railhead. Cracks can be seen reaching 10mm deep in other regions of lower clarity. A higher resolution scan will
 323 be conducted on this region to clarify the structure of the deeper crack and hopefully identify the region that caused the
 324 crack to start growing into what could become a transverse defect.

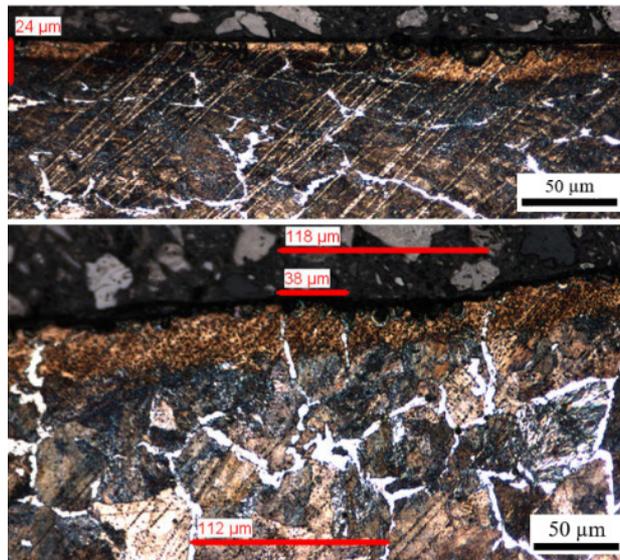
325 WEL was found at a fairly consistent depth of 5-10 μm in some locations inside and outside the defect. There were some
 326 locations where the thickness of the WEL varied even in a very small area such as in Figure 11. Figure 10 also shows
 327 one region that was found very close to the field side of the running band, where the widened band started to
 328 narrow again. This region contained WEL with the ferrite on the grain boundary still visible as shown in the
 329 first documentation of a stud [5].

Figure 11: Above) WEL thickness varying from 1- 24 microns thick in sample 2. Below) Ferrite grain boundaries still visible within the WEL.

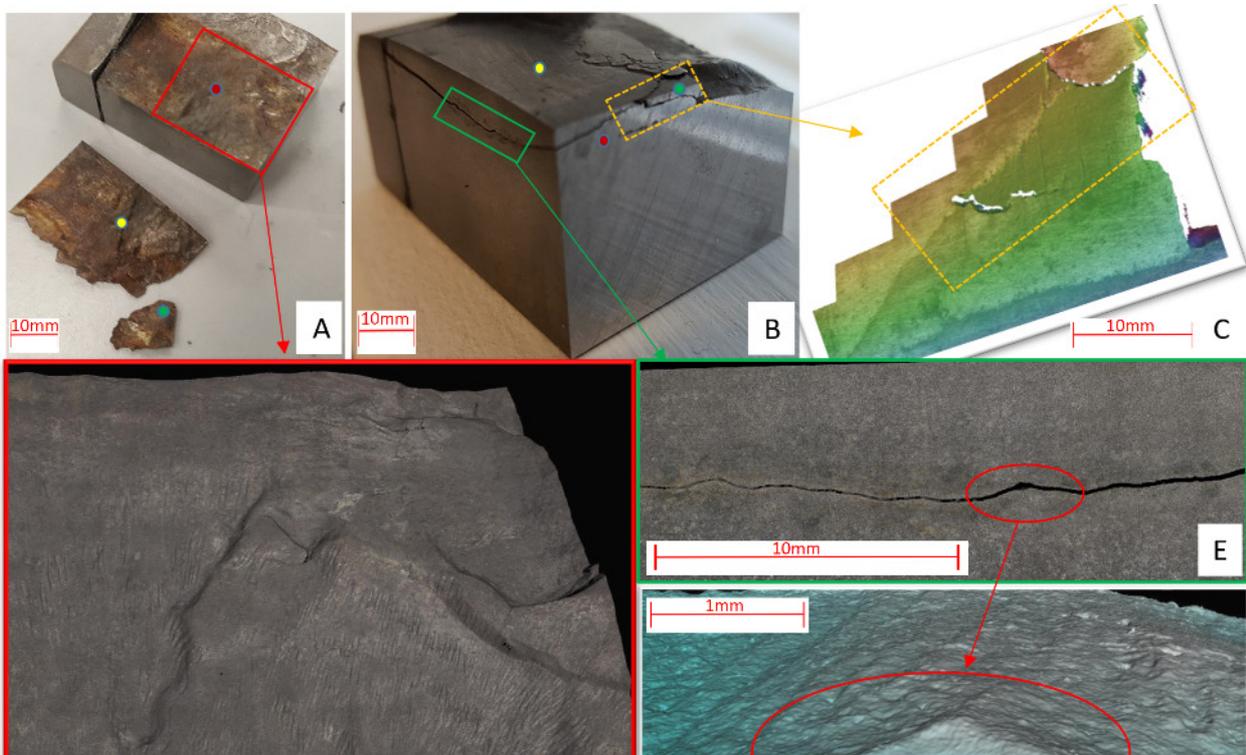
Due to the in-service break, the results obtainable from sample 3 were limited compared to the other samples. Its inclusion in the comparison was due to the known transverse defect. The undamaged lobe of the squat was still intact and it was possible to remove the upper plate using a cross-sectional cut between two of the longitudinal surface breaking cracks. This revealed a structure similar to the models of the scans along with a discrete vertical crack that broke the surface as a wide crack and penetrated slightly deeper into the rail as seen in Figure 12. The scan in Figure 12c shows the surface area before it was cut, which includes features that appear as two white cracks in the scan due to the information being lost within the crack rather than being captured by the detector. These fairly wide crack mouths are believed to be part of the remnant of the initiation site. Judging by the amount of folded over material just next to the ‘white holes’ there were high contact forces in this area. The material may have flowed from the ridge that often occurs between the two lobes of a squat as this ridge experiences very high contact forces. Figure 12e shows what appears to be a small void in the crack in area highlighted by the orange box in Figure 12b. This area was scanned (Figure 12f) and the morphology suggests that

Figure 12: The fracture surface under the remaining second lobe/ spot of the squat in sample 3. A) The fracture surface immediately after removing the upper surface. B) The sample before the removal of the surface showing the two cracks propagating down into the rail from a possible initiation point. C) The 3D model of the possible initiation area taken before cutting with the orange box showing the common area D) The 3D model of the crack plane shown in A. E) An enlarged view of the green box in B showing where material has spalled away during cutting. F) A 3D model of the ‘pore’ in E

344 an isolated region of material ('island') caused by a branching, then converging crack. These 'islands' are found
345 throughout the crack networks of all scanned defects and cause shadows to appear as shown in Figure 17.
346 Micrographs of longitudinal slices through the region confirmed the presence of many long inclusions as well as an
347 unexpected overall microstructure (Figure 13). Inclusions were distributed throughout the steel orientated in the rolling
348 direction, the same direction as the unusual ferrite 'stripes' within the microstructure. The presence of these two unusual
349 features suggests an ingot cast steel, meaning this was probably a very old rail as many companies have moved to
350 continuous casting rather than ingot casting to produce cleaner steel. The cracks that travelled through the subsurface of
351 the rail also match the orientation of the inclusions and ferrite 'stripes' and so there is a very good chance that this unusual

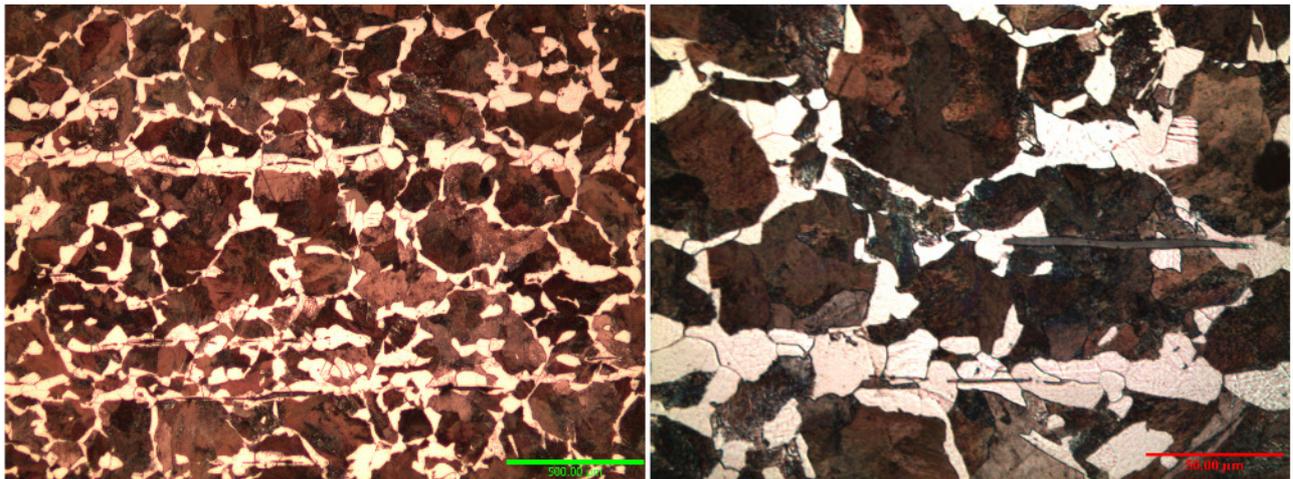
352 microstructure was the cause of the shelling and failure of this rail.
353 WEL was found in thick islands in cross sectional micrographs from the gauge corner of sample 3 as shown in Figure 14.
354 This is one of three discrete but deep patches of WEL from just before the defect / widening of the band.
355

Figure 13: Micrographs of sample 3 at two different magnifications, showing the unusual microstructure and the inclusions found throughout the steel

449 The wider crack in the V on sample 3 is where the cracks meet near the surface making this a likely initiation point due
 450 to ductility exhaustion. Sample 3 was had long inclusions running parallel to the cracks that caused the failure, so they
 451 are believed to have been heavily responsible. However, the whole rail probably had these inclusions so there must have
 452 been an event that initiated it, but not enough is known about the rail or its location. The presence of so many inclusions
 453 suggest that the steel was from ingot casting rather than the cleaner method of continuous casting.
 454

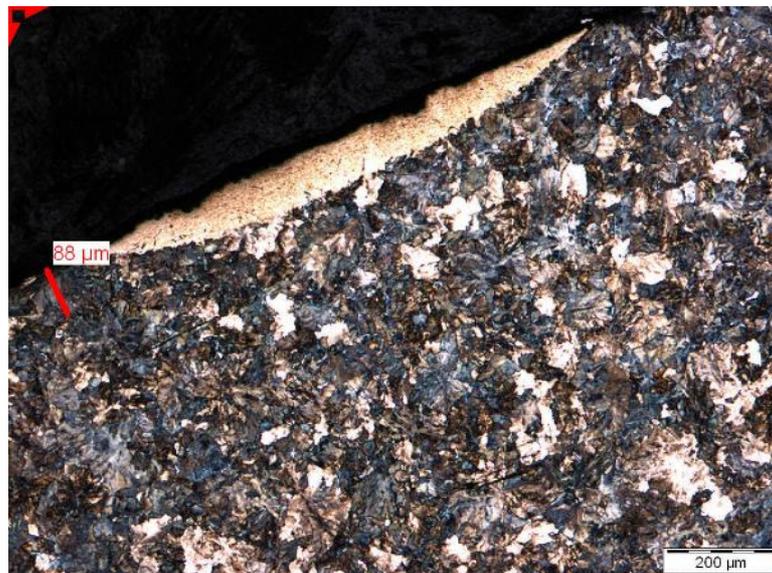
Figure 14: Thick white etching layers on the gauge corner of sample 3

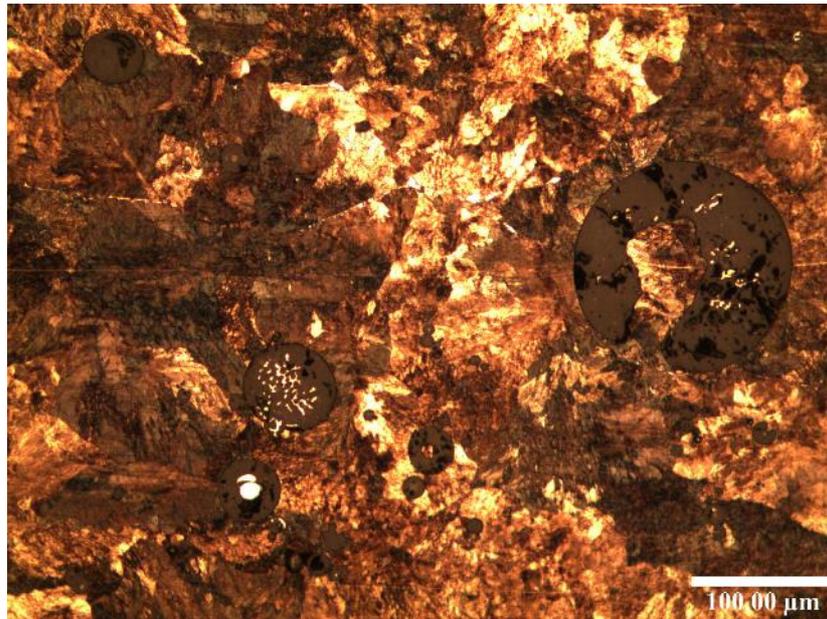
358
359 Sample 4 had much less damage than expected, based on the results of the ultrasound tests. The ultrasound gave reason
360 to expect a weld defect as well as the surface defect. However, there was no sign of a weld defect in the upper 26mm of
361 the head and the welds heat affected zone (HAZ) did not seem to have much influence on the crack planes overall
362 morphology. The crack plane was extensive but travelled at a fairly constant angle with few deviations other than the
363 'hole' (Figure 10a) where it surfaces into the C-shaped hole, which is on the boundary between the weld and the rail. No
364 unusual hardness variation was noticed across the HAZ.
365 The initiation is believed to have been due to the spheres/ bubbles found above and below the proposed initiation site
366 (Figure 15). Small cracks were seen travelling between these spheres in the region directly below the cracks. Sample 4

Figure 15: Spheres or bubbles found in the microstructure of the weld edge of sample 4 from within the green box in Figure 18. Probably either gas trapped in the melt or slag from the welding process

455 Contamination in the very upper part of the weld is believed to be responsible for the initiation of the defect in sample 4.
 456 The contamination consists of just a few spheres/ bubbles of unknown composition (probably gas or slag) very close to
 457 the surface. Cracks were observed between these spheres/ bubbles.

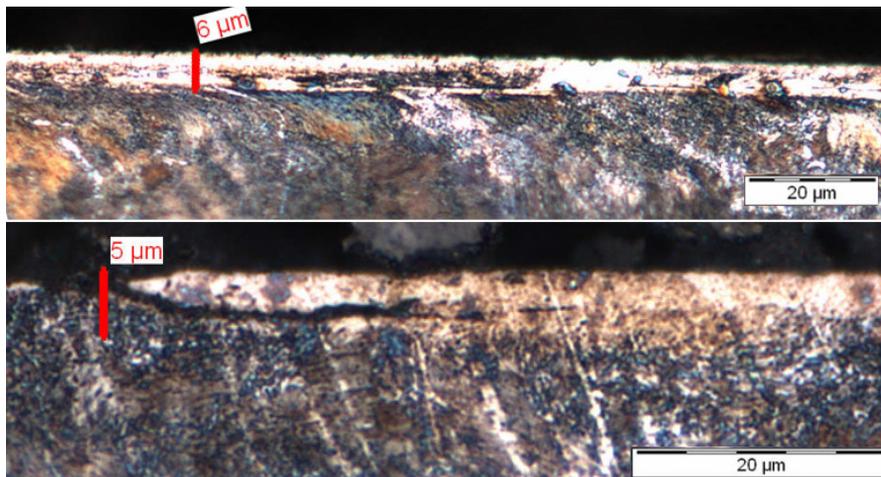
Figure 16: Above) WEL from within the defect. Below) WEL outside the defect

371 WEL was also found at a very consistent depth of 5-7 microns inside and outside the defect (Figure 16). The visible
372 grinding marks on the surface make it probable that this WEL is due to the grinding process. The WEL inside the defect
373 had a more distinct boundary with the parent material compared to outside the defect.

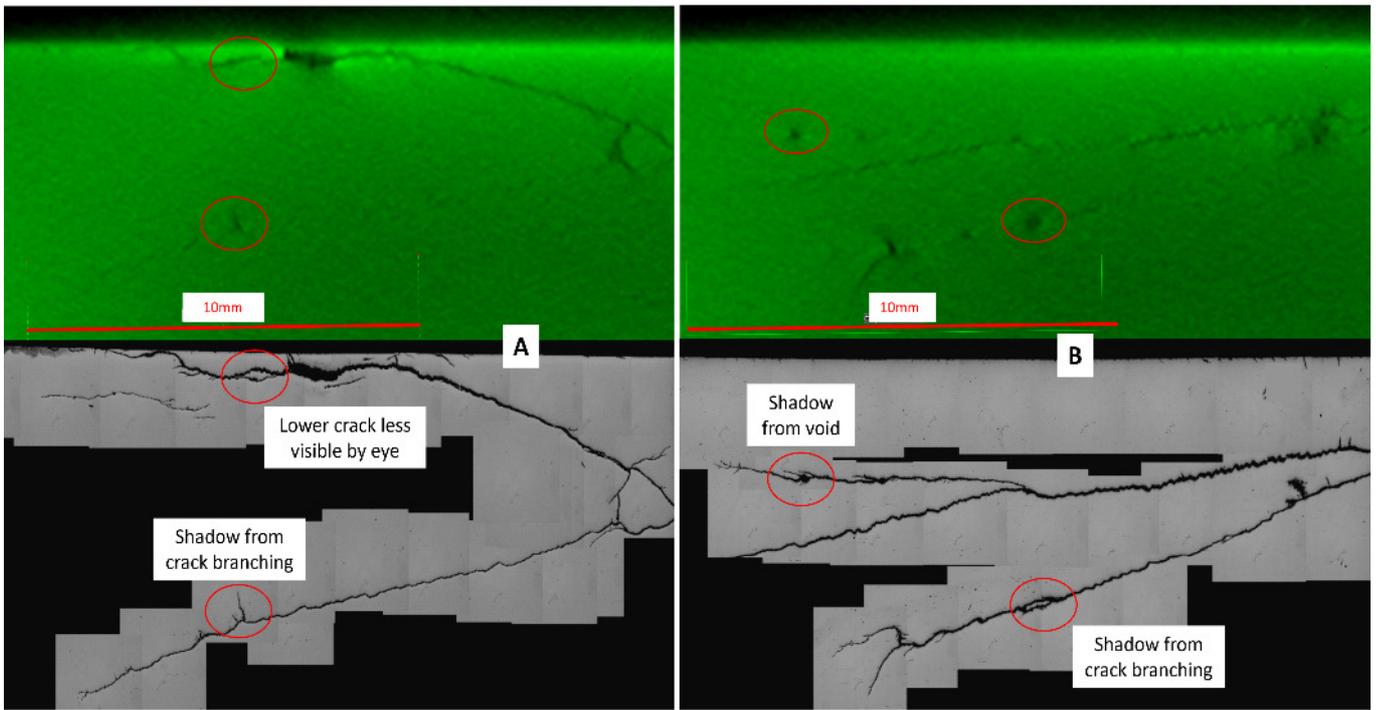
376 In sample 1, an orthoslice of interest was one that showed a crack branch down from what appeared to be a small void on
377 the surface, which was visible from the surface scans. The crack then displayed interesting behaviour by branching in a
378 circular shape as though propagating around something that it could not penetrate. There were also small shadows on the
379 scans, which were investigated to see how real they were. Figure 17 shows the two comparisons of the scan slices
380 mentioned and their accompanying micrograph. The upper red circle shows a region where the finer crack does not show
381 but the larger crack does and the lower circle shows how a branching crack can create a shadow.

Figure 17: Comparison of longitudinal CT scan orthoslice to longitudinal section in sample 2 a) The surface void visible from the surface scans with a shadow and its cause highlighted b) Branching that shows shadows in the scan and the same cause as (a) in the micrograph.

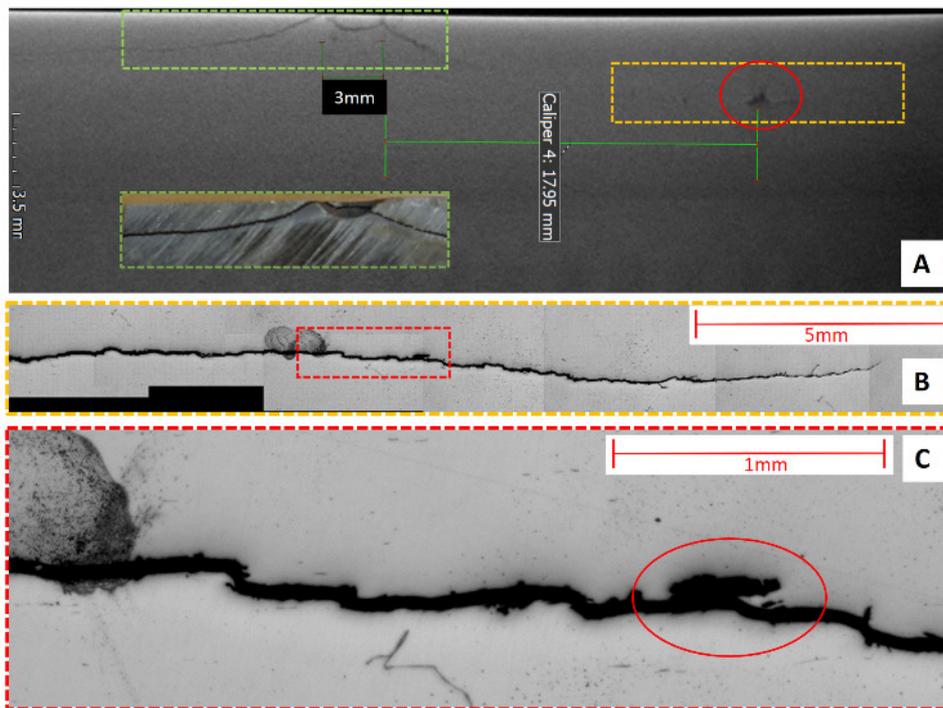
382 Sample 4 also showed a shadow near the surface breaking feature in the centre of the rail and the verification of that scan
383 is shown in Figure 18. Figure 18 shows; a shadow found on the crack within the CT scan, the cause of that shadow and
384 verification of the structure shown in the green box, which is responsible for the C shaped crack that breaks the surface
385 of the running band. It also shows a zoomed image of the area that caused the shadow to appear: a small void. These voids
386 are believed to develop from the small 'islands' like the one labelled "shadow from crack branching" in Figure 17b due
387 to rubbing of the crack surfaces wearing away and eventually breaking up the 'island'. The broken debris from the island
388 could cause variations in the x-ray interaction that, when reconstructed into a CT volume, would appear like a void. The
389 broken debris would then be washed out during sample preparation.

Figure 18: Longitudinal slice through the c-shaped crack in the centre of the surface of sample 4. a) CT scan orthoslice showing the surface breaking crack highlighted in the green box with a photo of the sectioned sample inset in the lower green box b) An unetched micrograph of the area highlighted in the orange box c) An expanded view of B, with a red circle showing the cause of the shadow in the CT scan orthoslice (a).

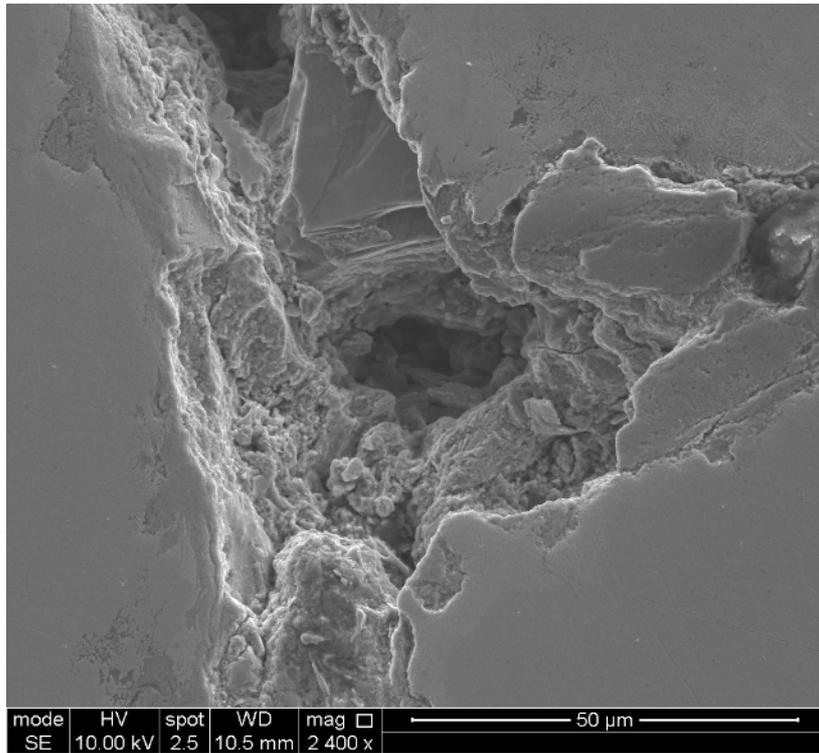
392 These voids are possible branching points for the crack as features like these voids have been noticed at the junction of
 393 crack boundaries as shown in the SEM image in Figure 19. The void is from the circular crack in Figure 17a, and may
 394 have been why a crack branched down from the main crack, or may be due to fretting after the crack branched. It is hard
 395 to be sure due to so much damage and corrosion. Sample preparation will also cause some material loss from the area
 396 shown.

397
398
399 **Figure 19:** SEM image of a junction where a crack branched off deeper into the rail.

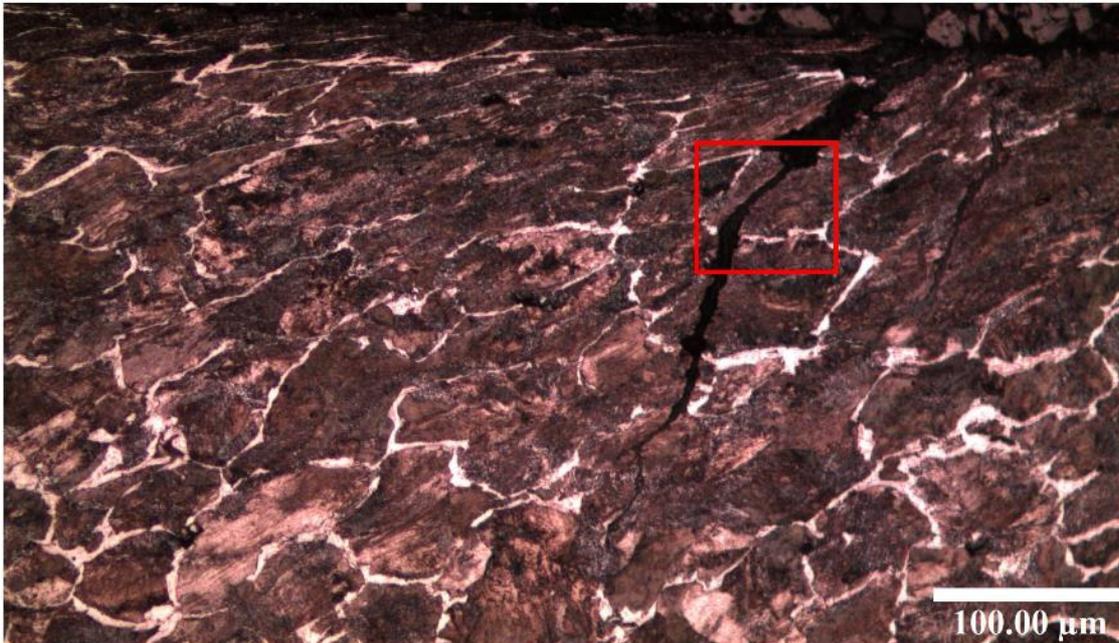
Figure 20 shows an optical micrograph of sample 3 with a surface breaking crack. The crack travels fairly vertically through the material rather than at an acute angle to the surface as is usually expected from RCF cracks. This is seen in thermally damaged steel [22]. The interesting behaviour regarding the crack path is that unlike squats, which typically follow inter-granular ferrite, this crack seems to cut across the grain as documented by Grassie et al. [5]. However, unlike the studs investigated by Grassie et al. this behaviour also occurs within 450 microns from the surface as well as below.

404
405 **Figure 20:** Optical micrograph of sample 2 showing a surface crack with apparent non-sensitivity to microstructure. The red box shows where SEM images were taken from (shown in Figure 21)

406 It should be noted that although the crack seems to ignore the grain in this orthoslice of the rail, it may follow the microstructure more carefully closer to its origin and lose that sensitivity as it propagates out in 3D.

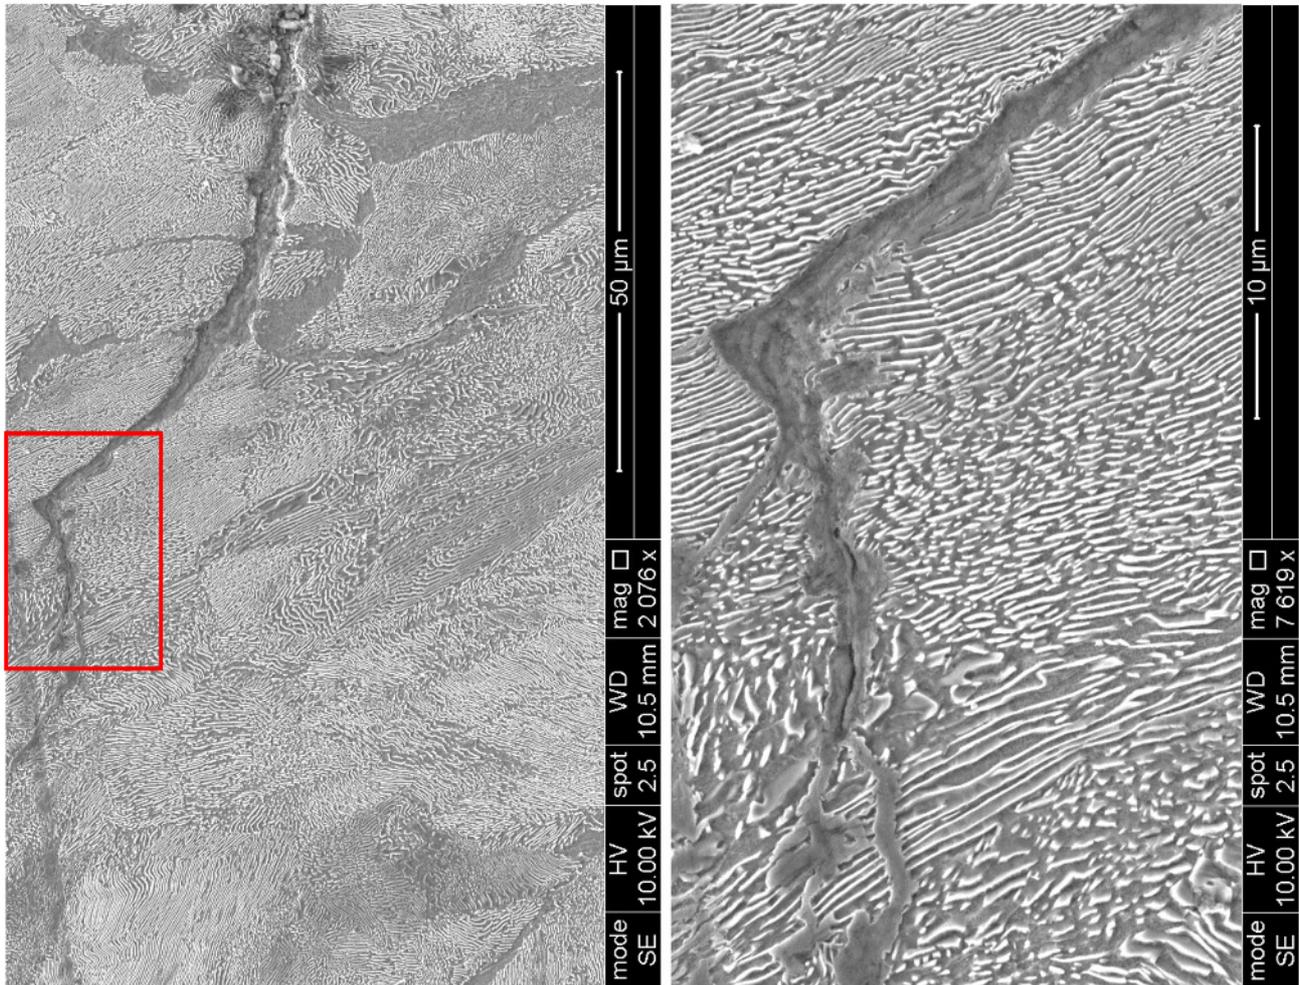
408 As seen in Figure 21, the cracks travel between lamellae plates a majority of the time but not always. They seem to be able to change direction when the plates become small and more spheroidal. There are places where this is not true such

410 as the bottom of the right SEM image where the cracks cut straight through plates. This could be because the crack was
 411 well developed in orientation to the lamellae of a neighbouring grain and so continued in that orientation as it widened.
 412 This would mean that the crack did not initially grow within this slice following these grain orientations. Looking at the
 413 CT scan data in 3D the crack plane grows down into the rail and diagonally across the rail as it propagates longitudinally
 414 and laterally at the same time. This means that the initial crack path cannot be viewed in its entirety, with regards to the
 415 microstructure, within one micrograph. Many thin slices will need to be taken around the possible initiation site to
 416 investigate the relationship between microstructure and the crack path to its full extent. This will be part of further work.

Figure 21: Left) SEM image of the box from Figure 20 showing that the crack still prefers to travel between the lamellae plates of the pearlite when cutting across grains. Right) magnified view of the box in the left image.
