Garrity, SW (2010) The rehabilitation of a Victorian clay brick railway viaduct. In: Bartlett, FB, (ed.) Proceedings of the 8th International Conference on Short and Medium Span Bridges. 8th International Conference on Short and Medium Span Bridges, 03 Aug 2010 - 06 Aug 2010, Niagara Falls, Ontario, Canada. Canadian Society for Civil Engineering , Montreal, Canada .

THE REHABILITATION OF A VICTORIAN CLAY BRICK RAILWAY VIADUCT

Stephen W. Garrity
University of Leeds, England, UK

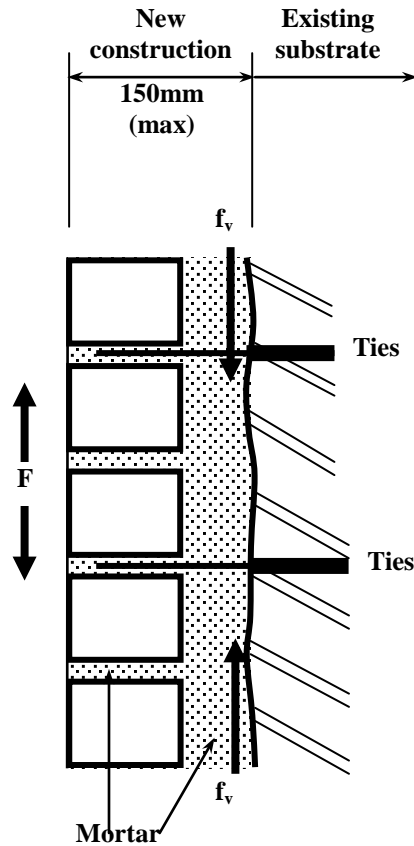
Figure 5. Typical detail of the pier rehabilitation works

NEW BRICKWORK

- a). Red class B engineering clay bricks laid in a 1:½:4½ (Cement : lime : sand) mortar.
- b). New brickwork facing to consist of alternate stretcher and snap header courses.
- c). Snap headers to be cut from full bricks using a bolster to provide a rough end surface profile for maximum bond.
- d). Space between new facing brickwork and existing substrate to be carefully filled with 1:½:4½ mortar as bricklaying progresses.
- e). At the repair boundaries, new brickwork to be “toothed” into existing undamaged brickwork.

TIES

- i). Single triangle 3.3mm dia. grade 304 austenitic stainless steel remedial ties (tensile strength = 750 N/mm²).
- ii). Ties anchored into 10mm dia. pre-drilled hole using a water -tolerant polymer resin grout.
- iii). Min. anchorage length into existing substrate = 50mm.
- iv). Ties provided every alternate course vertically and at a maximum spacing of 500mm horizontally.
- v). At corners, ties are to be provided in every course vertically.

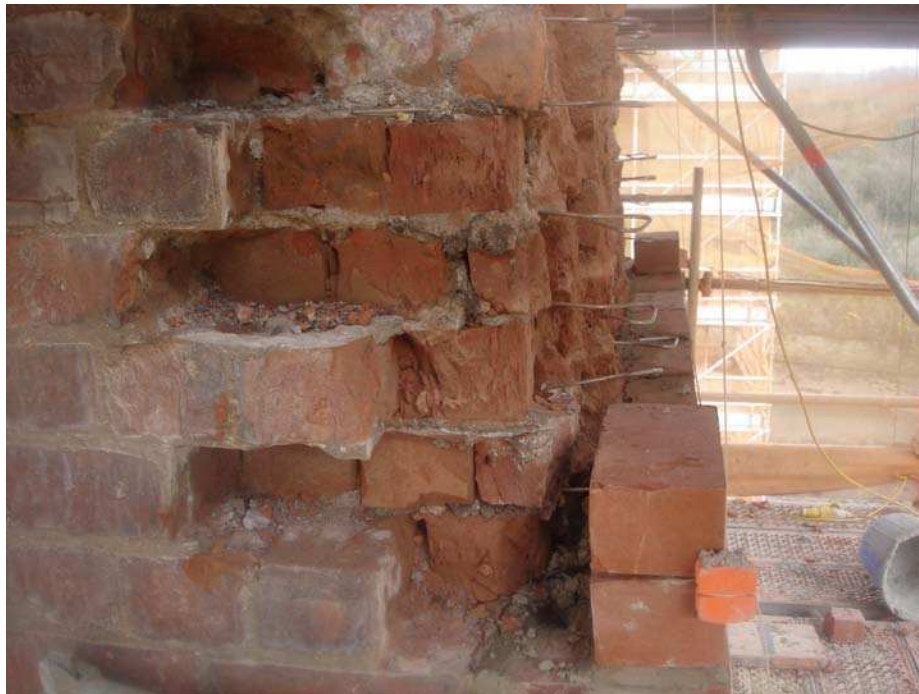
Figure 6. View of the pier rehabilitation works

- a). The contractor used a power saw with a circular blade to break up the damaged parts of the surface brickwork using a series of vertical cuts. This facilitated removal of the damaged brickwork using small hand tools and created a very rough texture to the existing substrate. This was considered to be good practice as it was not only an efficient means of removing the damaged material but it also helped to maximise the shear connection between the new and existing brickwork through improved bond.

- f). Even at the early stages of construction there was evidence of poor backfilling of some of the facing brickwork with, in some cases, large voids between the new facing brickwork and the existing substrate. These voids were subsequently filled with grout by the contractor when instructed to do so by the Client’s site representative.

- g). Many of the ties appeared to be well anchored into the existing brickwork substrate but the Client’s site representative confirmed that a small number could be pulled out from the existing brickwork by hand. These were subsequently replaced by new ties.

In summary, the materials selected for the new brickwork construction matched that of the existing viaduct as well as can be reasonably expected. Although some aspects of the contractor’s method of working helped to maximise bond between the new and existing materials, the standard of workmanship and quality control on site were in need of improvement. These issues were addressed by increasing the level of independent supervision on site and by carrying out a pull-out test on randomly selected ties at regular stages throughout construction.
