Grassie, Stuart L, Fletcher, David I, Gallardo Hernandez, Ezequiel Alberto et al. (1 more author) (2011) "Studs": a squat-type defect in rails. *Proceedings of the Institution of Mechanical Engineers, Part F: Journal of Rail and Rapid Transit* , 226 (3). pp. 243-256. ISSN 0954-4097

# **“STUDS”: A SQUAT-TYPE DEFECT IN RAILS**

**Stuart L Grassie<sup>1</sup>, David I Fletcher<sup>2</sup>, Ezequiel Alberto Gallardo Hernandez<sup>3</sup>, Paul Summers<sup>4</sup>**

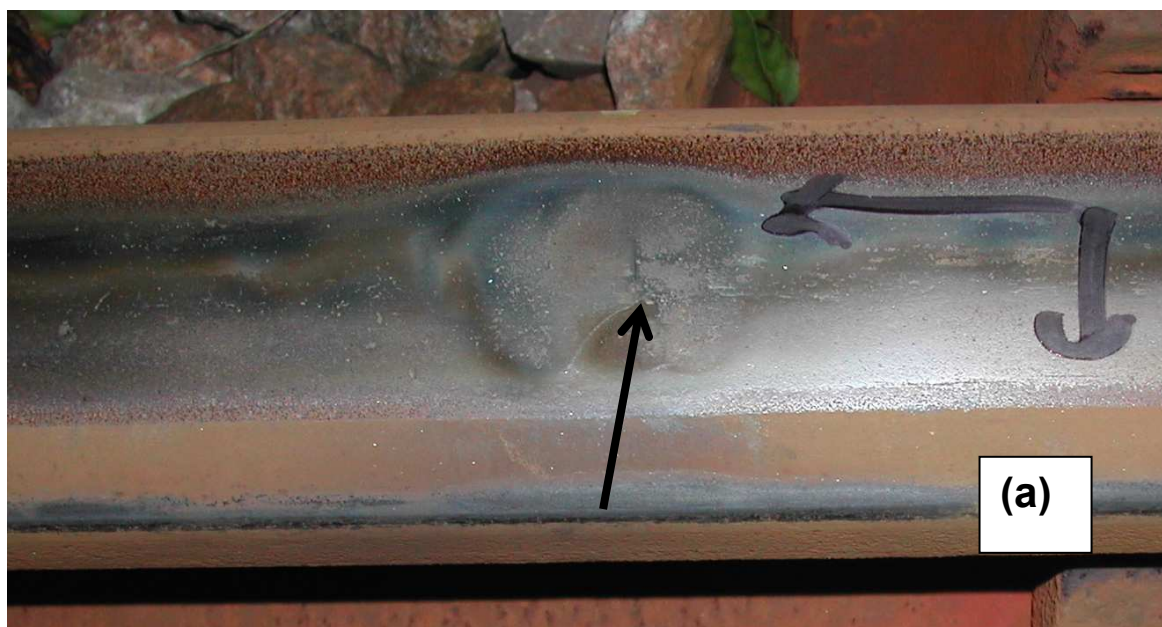
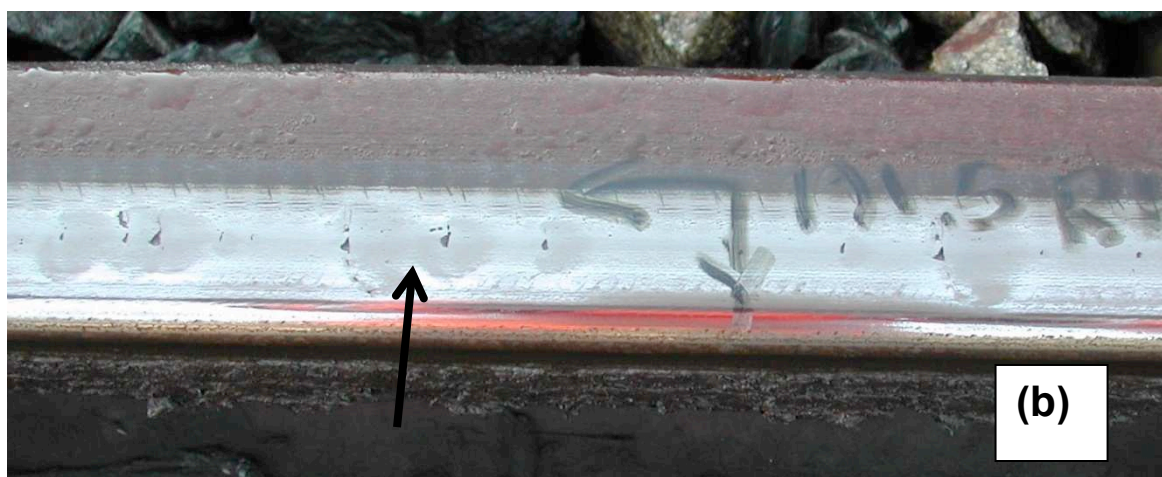
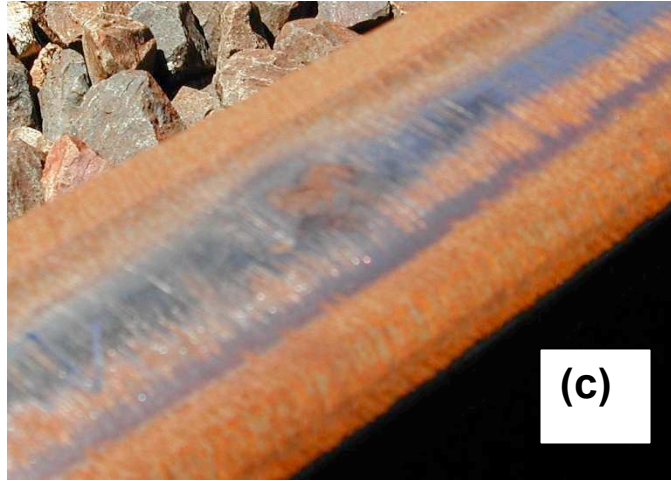
**Figure 1**

Examples are shown of studs from the Northern Line and from two other metro lines (Figures 1(a)-(c) respectively). In the first two cases there were several dozen defects within a few hundred metres of track. Defects were observed in curves and also in straight track, and in almost all cases had the characteristic appearance of the defects shown in Figures 1(a) and (b), with a V-shaped surface-breaking crack whose apex pointed to the field side of the rail. In all cases the stud is more or less in the centre of the running band. In some cases, as in Figure 1 (a), corrugation was present and had been exacerbated by the irregularity of the stud. The stud shown in Figure 1(b) was in the high rail of a curve. This had some gauge-corner cracking (GCC), but there was no sign of the stud being associated with surface cracks on the gauge corner. There has

been some spalling from the defect in Figure 1(c), probably as a result of relatively recent grinding.

- 1 “Studs” from three railways (arrows on the rails in (a) and (b) point in direction of traffic and towards gauge face; arrows superposed on photos point to the apex of the “V” shaped crack)

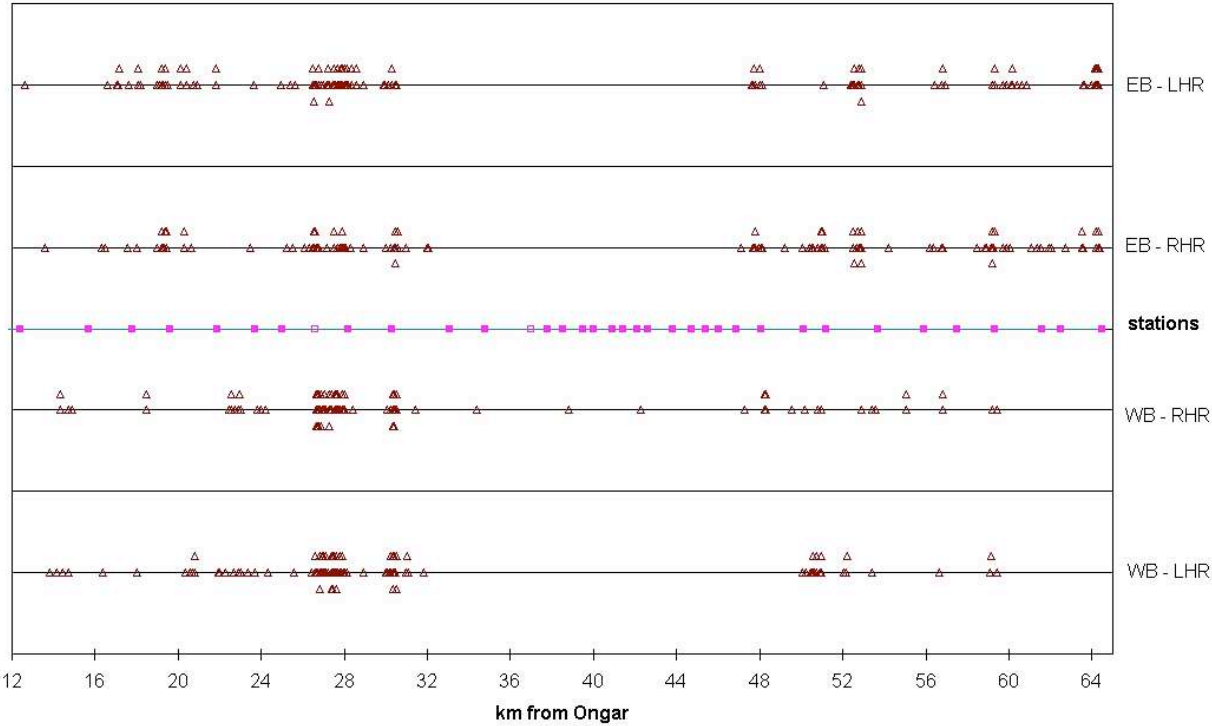
Defects on LU were concentrated not only on specific lines but also in so-called “hot spots” on those lines: 10 sites on the Jubilee and Northern Lines were responsible for 45% of Tubelines’ defects. Defects occurred almost exclusively in open rather than covered/tunnel sections: this has also been observed by Marich and his colleagues e.g. [4]. Both characteristics are apparent from the “map” of defects shown in Figure 2 (for the Central Line). Stations are shown along the middle of the map. Left and right rails on the eastbound and westbound tracks are shown above and below the stations respectively. There are clear concentrations of defects e.g. around 28km on both lines and also a gap from about 32km to 48km with very few defects. The line is underground in this area. Several “hot spots” are on the approach to signals, where many trains would first be braking and then under traction. This characteristic has also been observed by the first author on other railway systems. Marich and his colleagues claim to have found no correspondence between defects and signals on RailCorp track in Australia [4]. Some hot spots on London Underground are not where a train would be expected to stand awaiting signal clearance, but on the straight approaching a signal, where drivers may coast at low speed for a signal check then apply traction when the signal turns to green. Other hot spots on the Northern Line and on other metro systems are found on the grade rising out of the underground section, where trains would be

- 2 Defect “map”, showing position of defects on the Central Line
- 3 Cross section of defect, showing depth of a few millimetres below rail surface and length of about 30mm

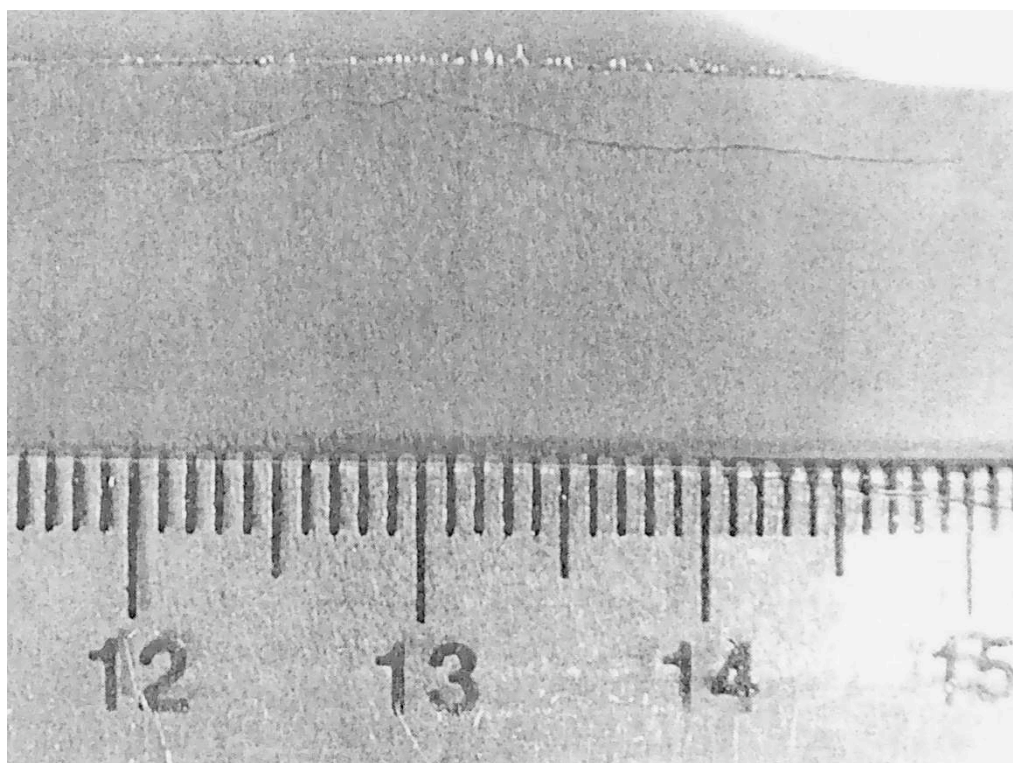
**Figure 3**

It had been suggested from previous metallurgical analysis that the defects initiated at a depth of about 3-5mm and then propagated in both directions i.e. along (and slightly down) into the rail, and up to the rail surface. No initiation mechanism was proposed. A typical cross section from a defect that was removed from the Jubilee Line in 2006 and classified as a squat is shown in Figure 3.

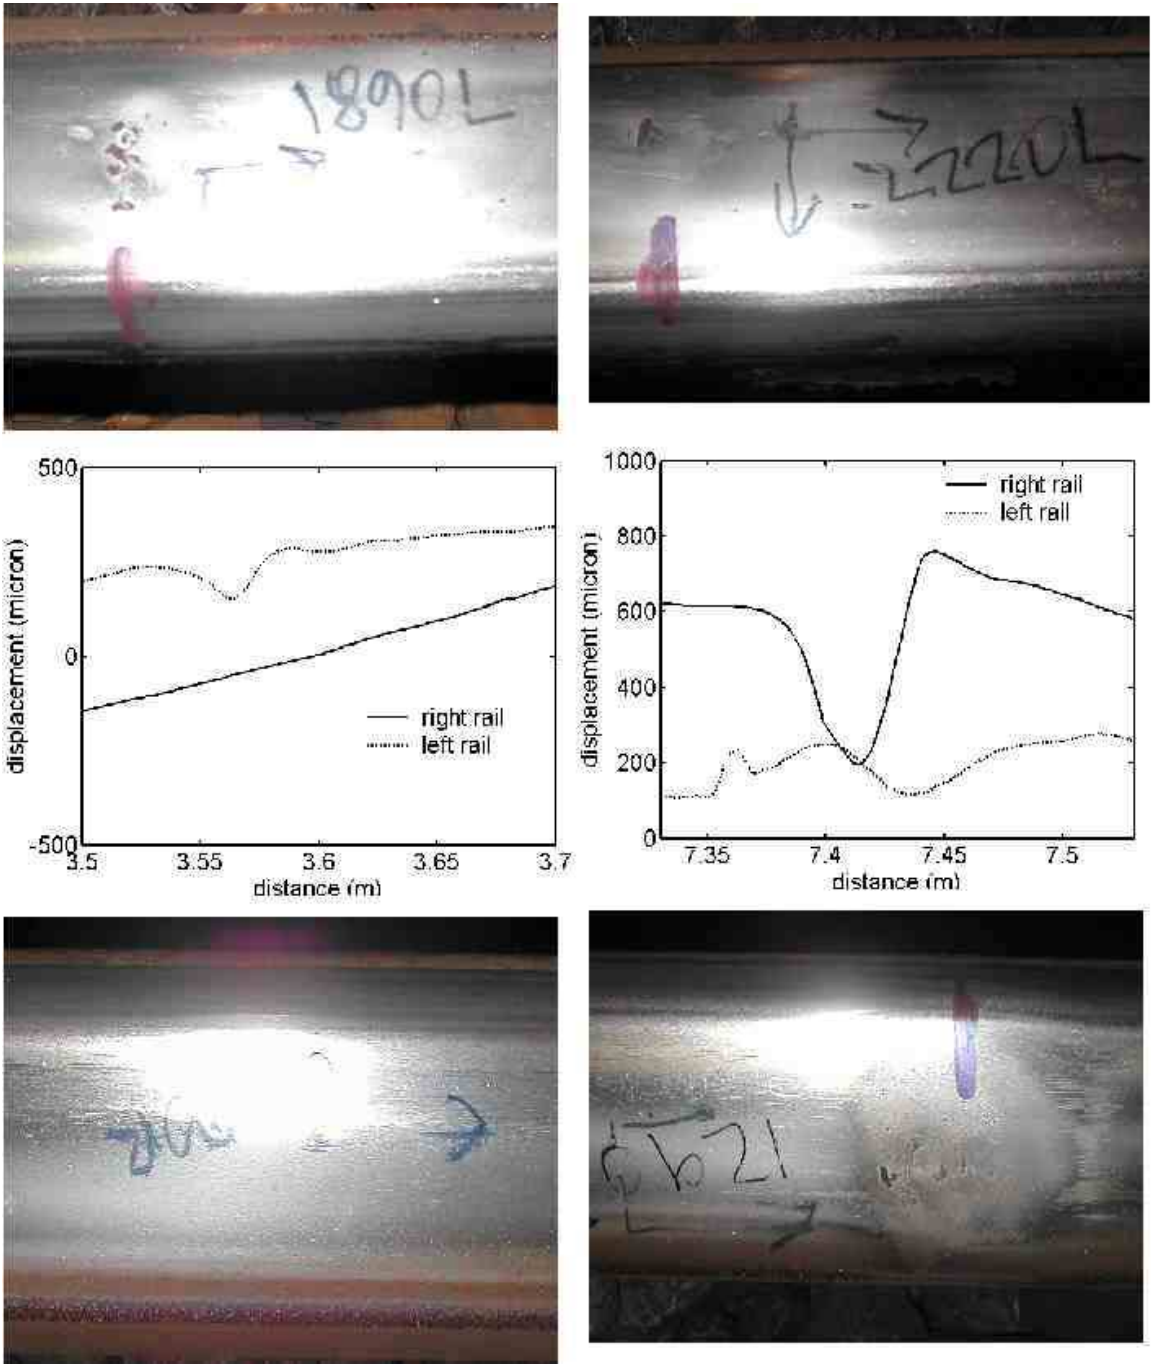
Measurements and photographs are shown in Figure 4 from a known “hot spot” on the Northern Line where sub-surface cracking had been observed ultrasonically at about 3.55m and 7.4m on the left and right rails respectively (on the scale in Figure 4) and the defects classified as “squats”. Measurements of irregularities on the rails were made with the CAT (Corrugation Analysis Trolley) [9], which is not designed for this purpose

At the larger defect, on the right hand rail at 7.4m, irregularities were visible almost directly opposite one another on both rails. Their depth was about 0.4mm and 0.1mm on right and left rails respectively. At 3.55m, an irregularity was visible on the left hand rail, and was barely 0.1mm deep. No irregularity was measurable on the right rail, and although no defect was visible the surface appeared heavily scuffed. The surface of both rails was relatively smooth, whereas a rail with surface-initiated RCF (such as a squat) is rough to the touch in one direction and smooth in the other. This roughness is attributable to the uni-directional accumulation of strain at the rail surface typical of RCF initiation. At the site shown in Figure 4 there were locations with quite distinct “blobs” of white phase directly opposite one another on the two rails, but no ultrasonic defect had been noted. Quasi-periodic white phase of this nature is a feature of stud sites more generally, and may (for example) occur because of torsional oscillation of axles when starting from standstill. This is discussed further in Section 2.3.4. It was also noted, and is to some extent visible in the photographs, that there was lubrication on the gauge face of the rail opposite the defect i.e. the right rail at 3.55m and left rail at 7.4m. Evidence of an obvious difference in friction on opposite rails has been noted at other sites where studs are present.

- 4 Observations and measurements from opposite rails at defect locations (classified as “squats” on left rail at 3.55m and on right rail at 7.4m)
- 5 Overview of rails at site A 430mm defect

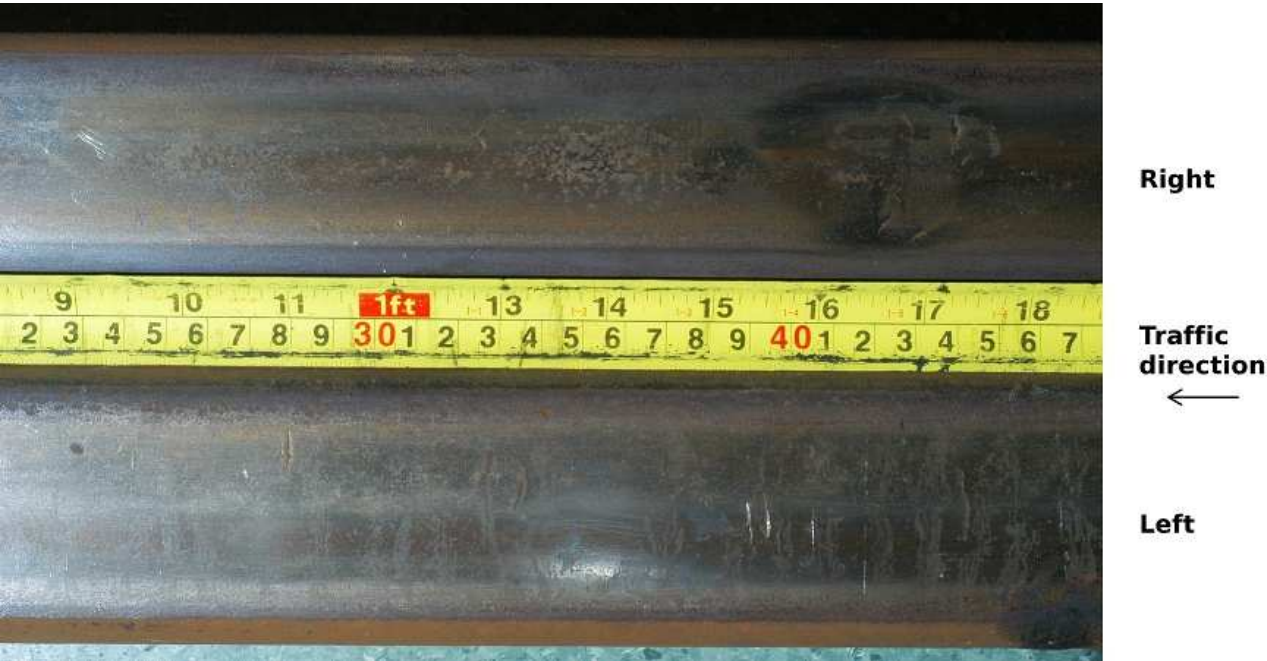
Figure 5

Several defects were removed from an open section the Northern Line, on ballasted track, for detailed metallurgical examination. Results are given here from a rail removed from one of the sites examined (designated site A) at which samples were taken close to two visible defects. One defect was at 370-470mm within the rail section removed, and is referred to as being nominally at 430mm, whereas the other was at 1360-1480mm and is referred to as being nominally at 1450mm. The rail from site A was removed from 65m before a signal. In view of the hypothesis that studs may be a consequence of wheelslip, samples were removed from both rails opposite one another. These were aligned in the laboratory using the marks that had been made by the sleepers on the railfoot (Figure 5 shows the defect at 430mm aligned with the opposite rail). The ultrasonic defects, which were the reason for removing the rail section, were in the right rail (where right and left are defined looking in the direction of traffic). The defect from location 430mm is shown in greater detail in Figure 6 and has the characteristic appearance of an inverted V, with the apex towards the field side of the rail. The right rail defect at 1450mm was in fact a series of defects similar to Figure 1(b). In both cases there was visible damage on the opposite (left) rail.

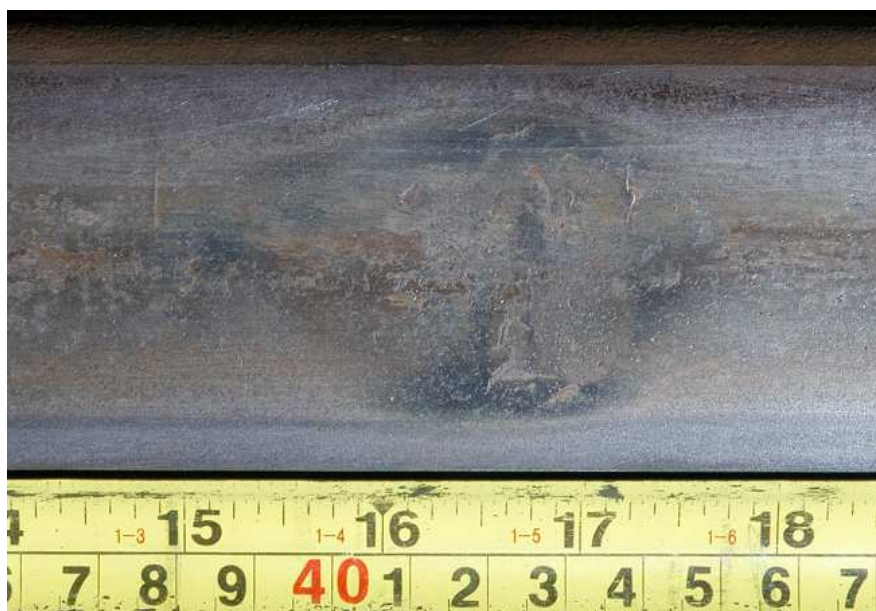
**Figure 6**

The two cracks that are apparent in the cross section (Figure 8(a), forward and reverse of the surface breaking location) correspond to the two surface depressions in the rail. The crack mouth coincides roughly with the ridge at about 420mm in Figure 6(a).

- 6 Detail of defect on right rail
- 7 Irregularities on defective rail, opposite rail and a reference section of rail. The reference data is vertically offset for clarity. (a) Defect location 430mm. (b) Defect location 1450mm.

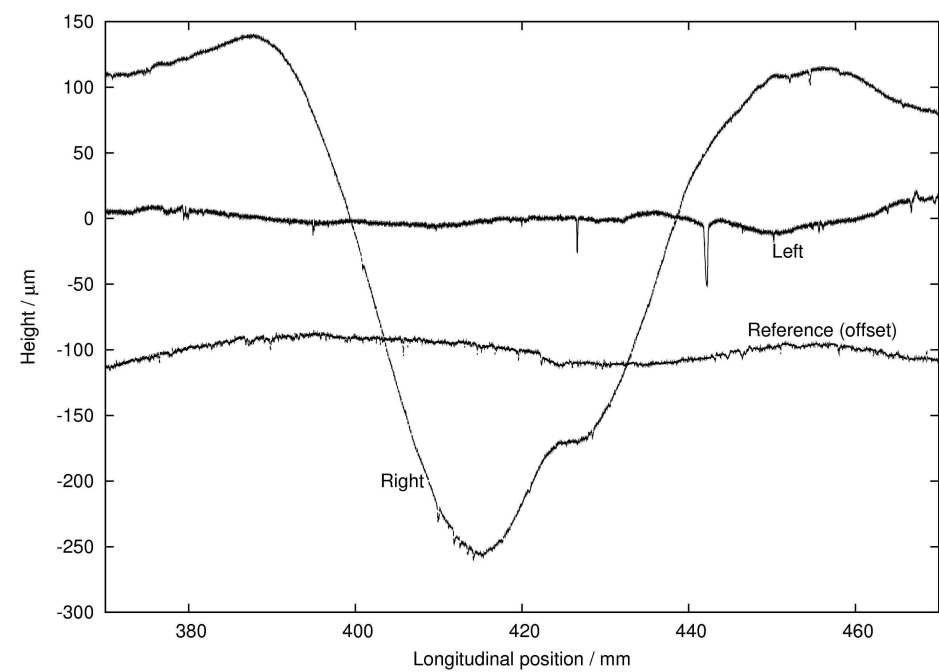
(a)

compared to the profile of a section of rail at which there were no visible defects or surface irregularities (Figure 7). For defect location 430mm the depth of the dip in the defective rail is about 400 $\mu$ m, which is similar to that of the defect measured elsewhere in track (Figure 4). The depression spans about 60mm (390mm to 450mm, where the scale is that shown by the tape in Figures 5 and 6). The ridge in the middle of the depression (between the two “lobes” of the defect) is barely an inflection in the height of the dip, at about 425mm. On the opposite rail there is a very much shallower irregularity with a length of about 30mm (435mm to 465mm) and surface scratches of 20-50 $\mu$ m depth at about 427mm and 442mm, which are apparent also in Figure 5. This irregularity on the ‘opposite’ rail is not greatly different from the background level of surface irregularity measured well away from any visible defects.

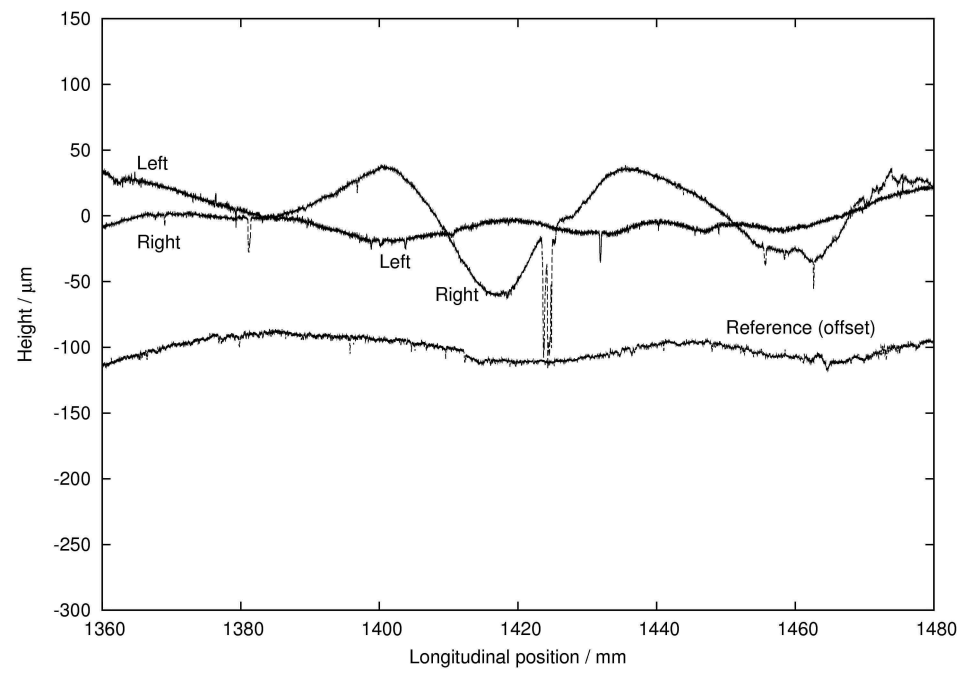
(b)

For the defect at 1450mm the undulations reflect the multiple defects present. There are also undulations on the opposite rail. On the right rail the peak to trough surface height difference is about 100 $\mu$ m, a quarter of the defect depth at the 430mm location. The large spike in the right rail profile at 1425mm was caused by a crack mouth in the main depression of the series of defects. The spike at 1460mm was caused by a crack mouth in the adjacent depression. The small spikes on the opposite rail (1380 and 1460mm) are similar to those on the left rail of the 430mm sample. Inspection of the rail surface showed the most likely cause in both cases was damage sustained in removing the rail from track. At the 1450mm location damage to the right rail (large visible defect)

consists of two depressions of 80-100 $\mu$ m depth, while on the opposite rail there is a trough of approximately 50 $\mu$ m depth over a length of about 120mm.

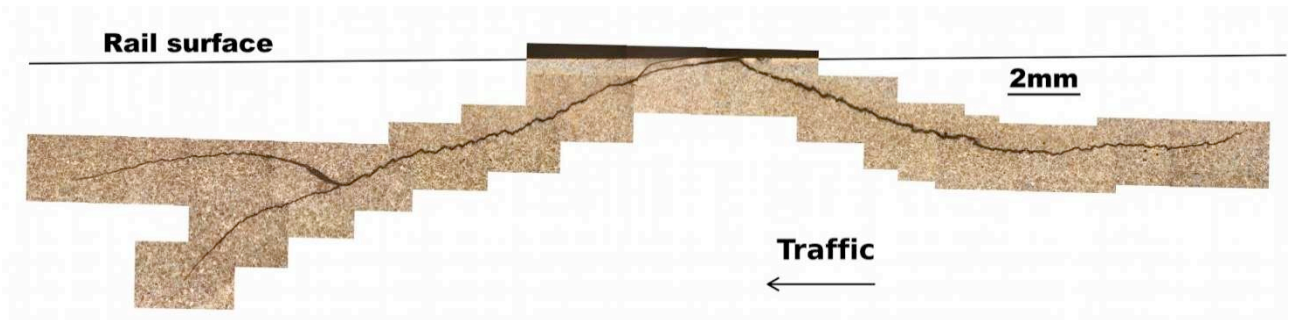
Although there is superficial similarity between the cracks in Figure 8 and a conventional RCF crack, closer inspection reveals that there are also significant differences. Close to the surface there is almost no accumulated plastic flow in the rail except just above the crack mouth. Minor distortion of the microstructure to a maximum depth of about 130µm is present across the sample. This is far below the ‘ductility exhaustion’ level typically seen in RCF crack initiation for which plastic flow accumulates in a heavily sheared layer throughout the rail (see e.g. Figure 3 of ref [6]). RCF cracks initiate when the ductility of this layer has been exhausted. The only location of greater plastic flow (to a depth of 450µm) is in the poorly supported material just above the crack. However, even here the well supported material below the crack remains undeformed below 130µm. This localisation of plastic flow indicates that flow is a consequence of the crack rather than its cause: the material has become poorly restrained due to the crack and has then undergone plastic deformation. The ‘ductility exhaustion’ level of plastic flow at the surface needed for crack initiation is not present.

At depths below 450µm the cracks follow an erratic path crossing grains of pearlite. They are not restricted to the softer inter-granular ferrite. There is also no evidence in the individual micrographs which make up the composite pictures in Figure 8 of corrosion of the crack faces. It is therefore unlikely that water contributed to crack growth. This strongly suggests that fluid entrapment, which is a commonly accepted mechanism for propagation of surface-initiated RCF cracks was not active for these cracks. There is also no evidence from the meandering crack faces of the smoothing that would have taken place if significant shear displacement with rubbing of the crack faces had been responsible for crack growth.

- 8 Detail of crack in defective rail, formed using multiple micrographs. (a) Location 430mm. (b) Location 1450mm.

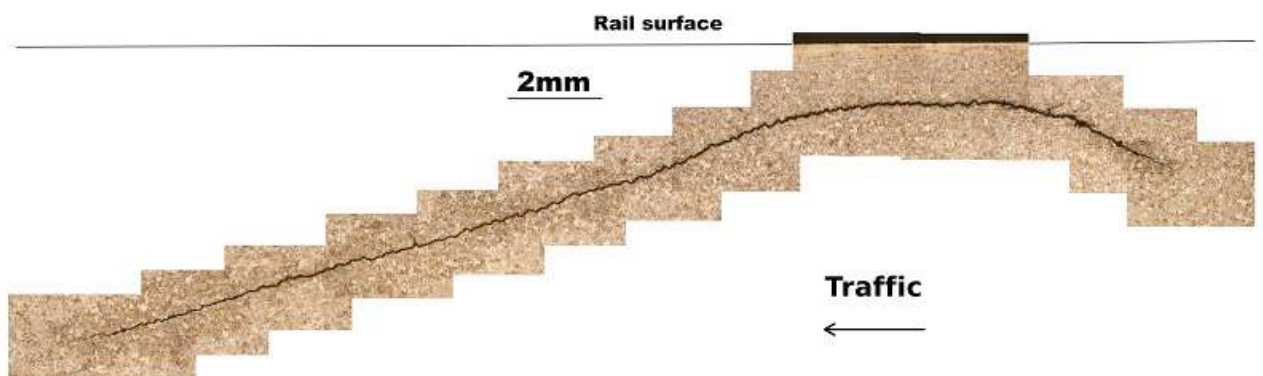
(b)

surface on this sectioning plane through the rail. Both defects had developed more extensively from their shallowest point in the direction of traffic, but also had branches running in the opposite direction to traffic.

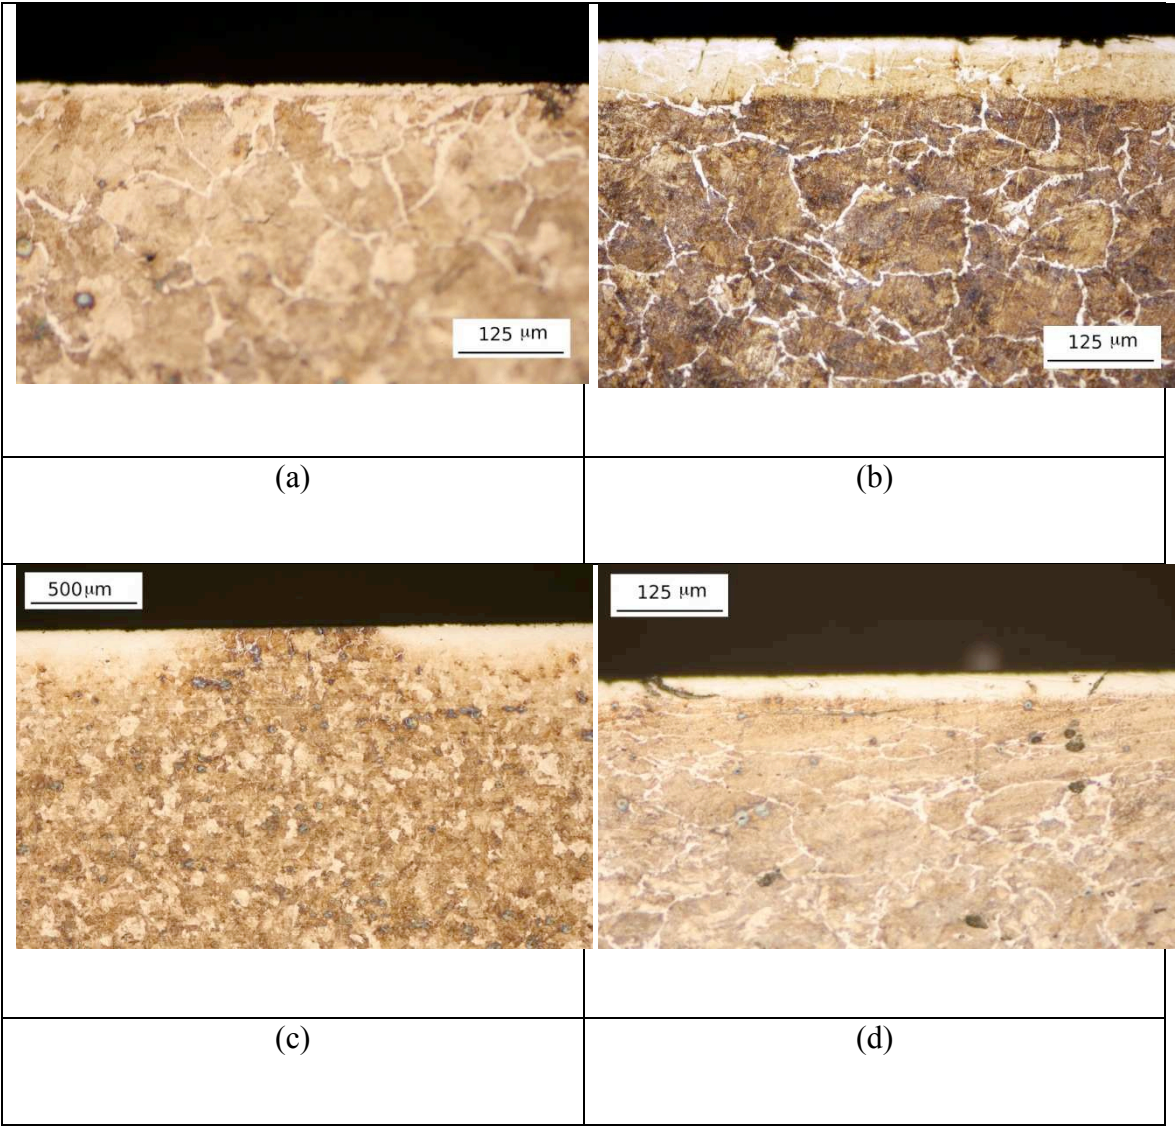
Figure 9 illustrates the white etching layers found very close to the main defects on the right rail, and in the ‘opposite’ left rail at the same location. The WEL in most cases is well attached to the rail surface. In some locations there were small voids below patches of WEL, although these were not observed close to the major defects. Figure 9 also shows the absence of all but minor plastic flow at the rail surface.

At location 430mm the WEL thickness was greater on the right rail (70 $\mu$ m depth) than on the left rail (18 $\mu$ m depth). On both rails it was found in patches rather than as a continuous layer. From Figure 9(b) it is clear that the pro-eutectoid ferrite has persisted within the WEL, and this emphasizes how little plastic damage is present. This strongly supports formation of this layer by a thermal mechanism rather than by the plastic work mechanism proposed in ref [3] and by Ivanisenko et al [11].

The WEL on the left rail at location 1450mm was different from that observed elsewhere in that it was much thicker. The boundary between WEL and the underlying pearlite was also much less distinct. The patchy nature of the WEL is revealed in this sample, with a separation of about 2mm between the centres of WEL patches. Although the bottom of the WEL layer is indistinct, the layer is nevertheless more than 125 $\mu$ m thick. In track this sample was opposite the site of the undulating surface (Figure 7(b)). Such a thick layer of WEL strongly suggests that the rail steel was exposed to very high

‘flash’ temperatures. Formation of martensite, which gives the white etching appearance, requires that the rail steel reaches a temperature in excess of 727°C followed by rapid cooling [12]. Sufficiently rapid cooling occurs because of the high thermal inertia of the rail, with heat at the surface rapidly dissipated into the surrounding steel [13].

- 9 White etching layer on the rail running surface. (a) Location 430mm, left rail. (b) Location 430mm, right rail. (c) Location 1450mm, left rail. (d) Location 1450mm, right rail. All sections are in the rail longitudinal direction, except (b) which is from a transverse section.
- 10 Variation in surface hardness on defective rail and opposite rail (aligned) for locations (a) 430mm and (b) 1450mm. Average of two readings at each position.

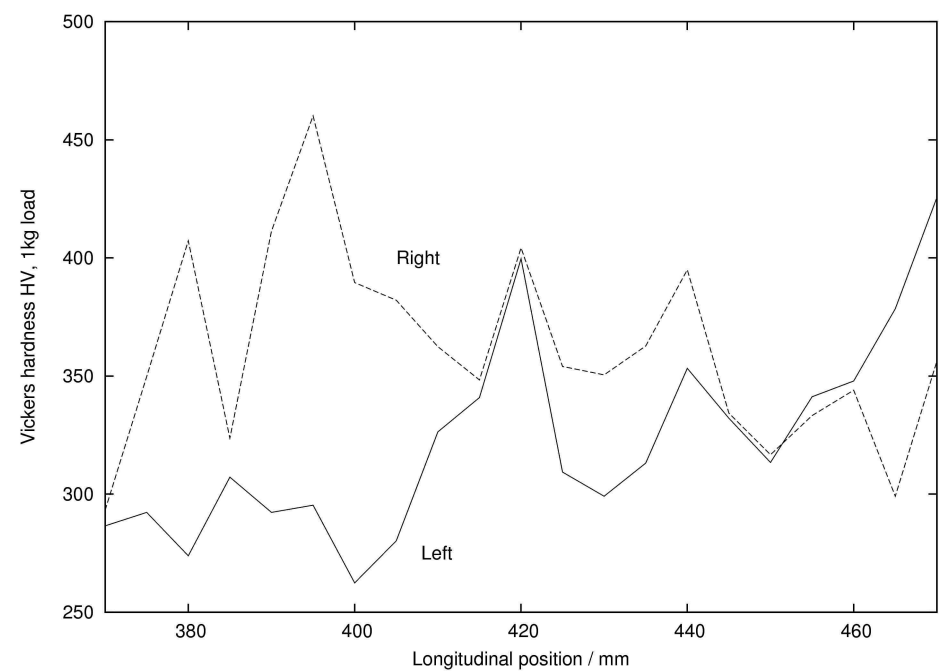
(a)

Surface hardness (HV with a 1kg indenter) was measured along the running band on both left and right rails (Figure 10). There is some periodicity in the hardness on both rails and at both sites with a similar wavelength of about 20-30mm. At location

430mm, where there is a single defect, the peaks in right rail hardness at 390mm, 420mm and 440mm correspond roughly to the running-off end of that defect, the centre and the running-on end respectively (Figures 5,6). At location 1450mm the correlation of hardness and features of the multiple defects is less clear.

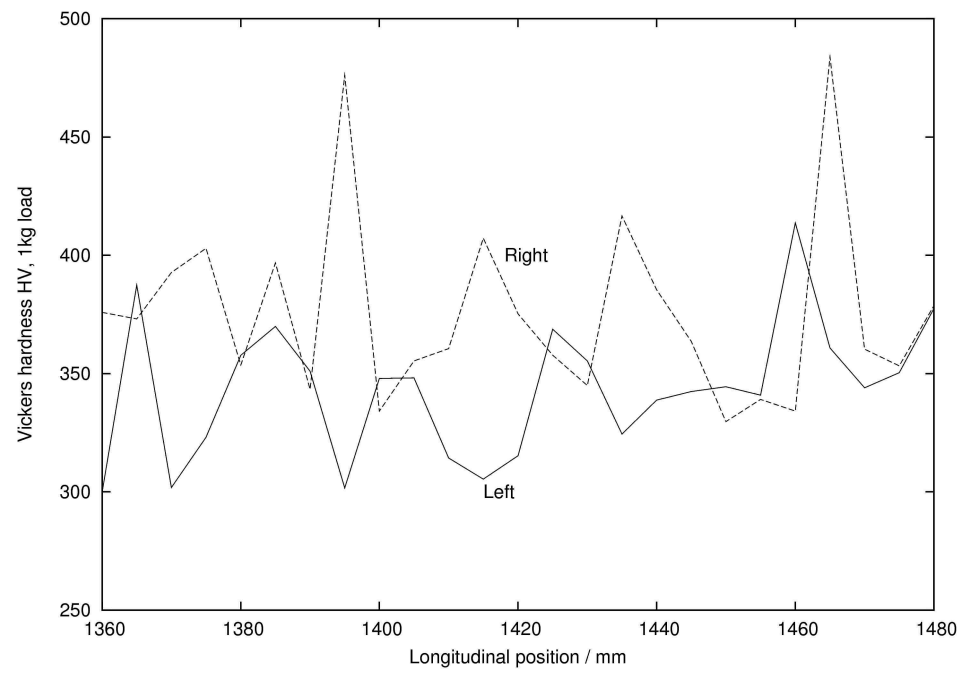
(b)

The hardness variations are the result of patchy, quasi-periodic white etching layer (WEL) on the rail crown. One possible cause of the quasi-periodic WEL is that it was established by some periodic behaviour of the wheelset. A second possible cause is short-wavelength rail corrugation associated with the track's pinned-pinned resonance [10]. This is commonly at about 460Hz on London Underground as a result of the small rail section and wide sleeper spacing, so a 20-30mm wavelength would correspond to a speed of 33-48km/h. However, in view of the slightly different wavelength of the variation in railhead profile (Figure 7), particularly on the undamaged rail, it would be desirable to examine other samples to resolve the interdependence of periodicity of WEL and corrugation, and to what extent (if any) their periodicity is associated with the stud. In the work of Li et al e.g. [5] it appears that the periodicity of corrugation is closely related to the spacing of the two "lobes" of defect, although it is unclear whether this is a necessary condition for either the defect or corrugation to exist. It is quite possible that WEL is established in a quasi-periodic manner at some locations whereas at others it is initially more continuous and then worn away (or detached) quasi-periodically by traffic.
