Santa, J.F., Toro, A. and Lewis, R. (2016) Correlations between rail wear rates and operating conditions in a commercial railroad. *Tribology International*, 95. pp. 5-12. ISSN 0301-679X

CORRELATIONS BETWEEN RAIL WEAR RATES AND OPERATING CONDITIONS IN A COMMERCIAL RAILROAD

J.F Santa^{1,2}, A. Toro², R. Lewis³

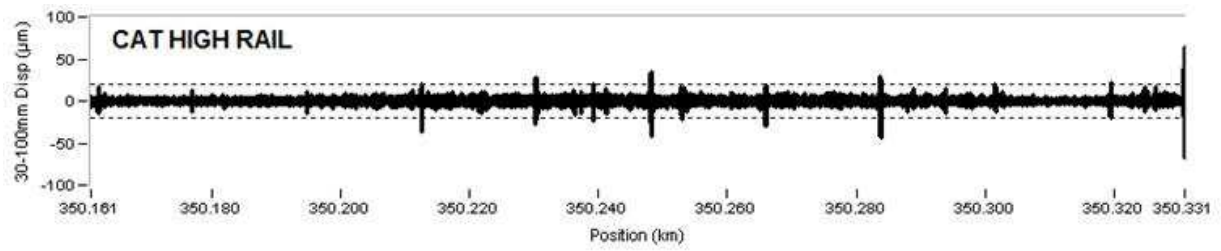
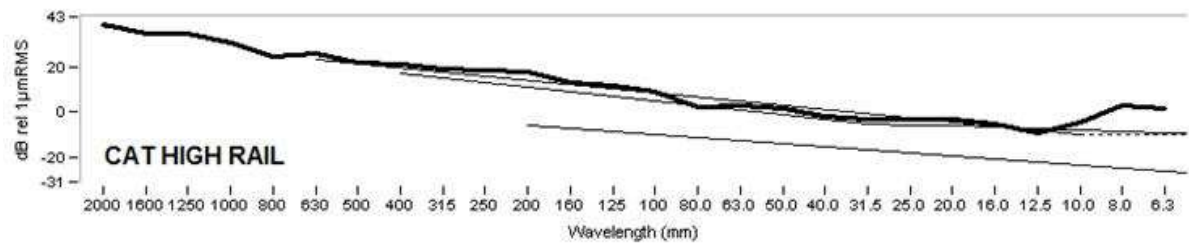
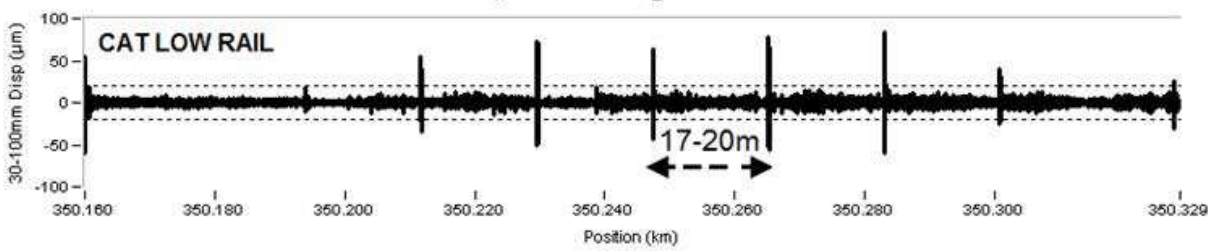
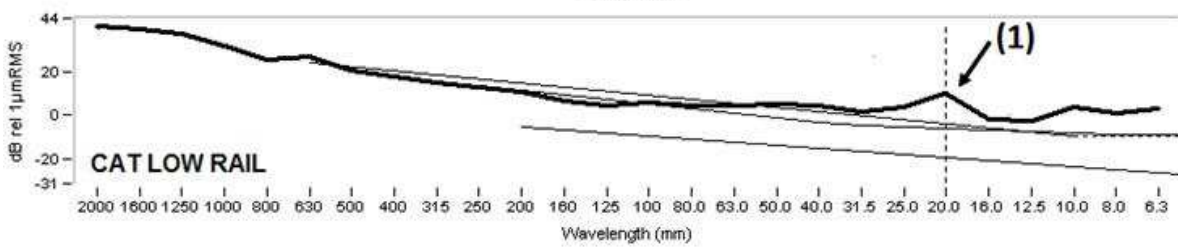
Corrugation occurred preferentially on the low rail with dominant frequencies between 100 and 250 Hz. Figures 5a and 5b show a low rail with corrugation and the corresponding high rail without damage. Figure 5b shows a peak (arrow (1)) exceeding the limits according to ISO 3095. According to the criteria used in the field, the mean time between reprofiling is 3 months for the worst curve and among 5-7 months for other curves. The predominant wavelength found indicates that the corrugation comes from the excitation of the vertical dynamic behaviour of the vehicle/track system at a frequency of about 200-250 Hz [6]. This result implies that corrugation is an important issue for the analysed railway.

Figure 5. CAT analysis of the commercial line. a) CAT of high rail, b) CAT of low rail, c)

In the field, the criterion used to grind the rails relies on the calculation of the r.m.s. amplitude of longitudinal irregularities in a set of given wavelength ranges along the track. The fraction of the track length for which the r.m.s. amplitude exceeds an specified limit is the base to prescribe a grinding operation. According to European class 1 grinding standard, the exceedence percentages applicable are 5% for 10-30 mm, 5% for 30-100 mm, 5% for 100-300 mm and 10% for 300-1000 mm wavelength ranges [6]. It is proposed in this work that the use of such strict criteria to control rail roughness and noise would have been responsible for the excessive high wear rates on low rails.

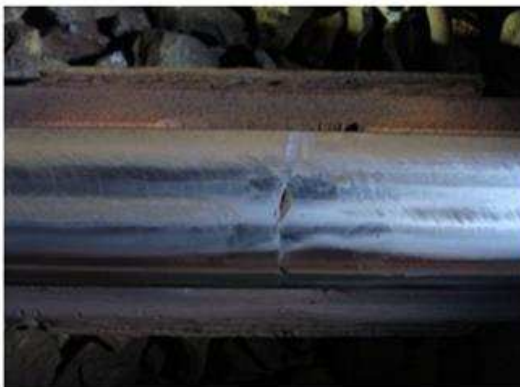
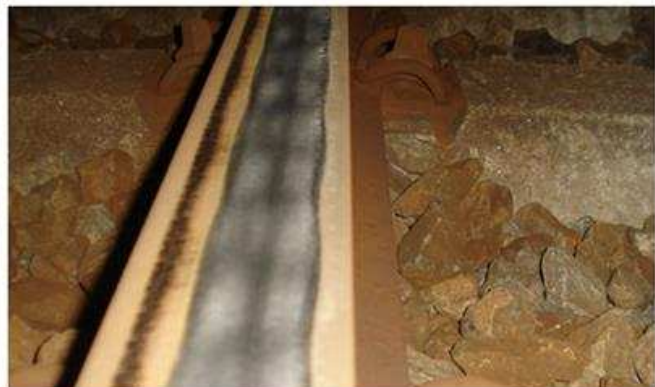
The first type arose from excitation of the vertical dynamic behavior of the vehicle/track system at a frequency of about 200- 250 Hz. From measurements of the track's dynamic response, it was concluded that large dynamic contact forces in this frequency range were associated with an almost rigid coupling of the rail and sleeper. The second type of corrugation appeared to arise from lateral excitation of the track, and was associated with an excessively rigid coupling of rail and sleeper. From the analysis of ground rails, it was also found that an incomplete removal of corrugation may in part be the cause of the very short grinding cycle on the track since most of the time taken for a corrugation to develop is during the Initiation phase when a small corrugation exists. The results of CAT analysis showed that the most important type of corrugation occurred predominantly in curves. Some peaks at regular intervals of about 17 m (which is the length of a single rail) and several fatigue marks revealed issues with welds as it was previously reported [6].

c) Defects on welds

d) Corrugation on the low rail

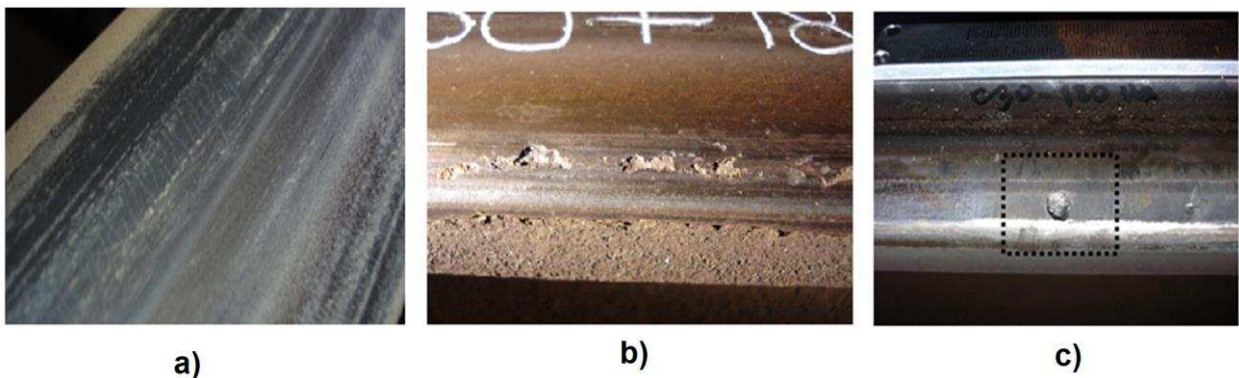
Figure 6 shows the most important defects observed in the commercial line. Head checks, corrugation and some fatigue detachments were found after twelve inspections (one per month during a year). The estimated traffic was around 7 MGT per year. Generally speaking, corrugation was observed preferentially on low rails while head checks were found on the high rail in tight curves, i.e. those with higher wear rates. Fatigue detachment (spalling) was also observed in some cases after rail grinding. The most important defects found in the field are head checks.

The maintenance of the railroad by rail grinding is done when the head checks are detected by visual inspection in the field. According to the operator, the mean time between grinding depends on each curve and ranges between 4 and 10 months although precise data are not easily available. However, given the cumulative traffic on the line after 10 months, it can be concluded that the mean grinding interval is very low compared with those typically found in the literature [12].

Figure 6. Defects found on the inspection of railroad. a) Head checks on the rail's surface, b) Fatigue detachment due to head checks, c) Defect not removed by rail grinding.

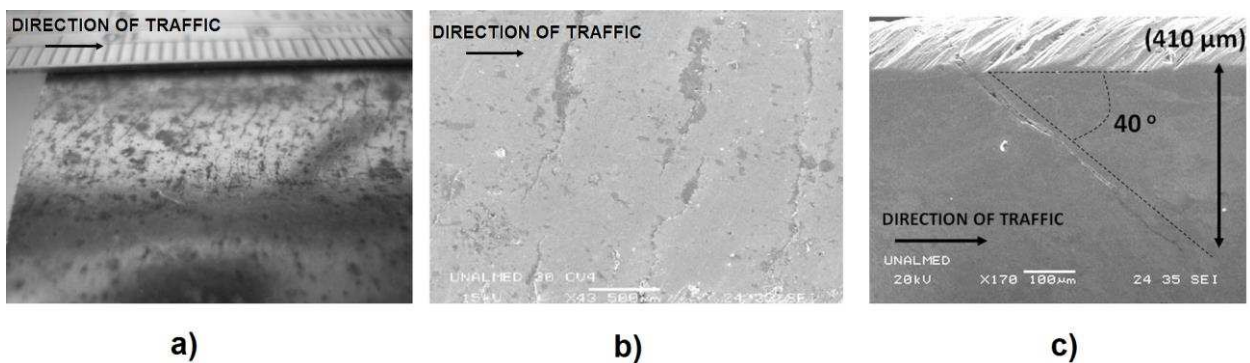
The inspection of fatigued rails revealed the presence of parallel cracks at the surface (head checks). Head checks nucleate at the surface and can cause catastrophic rail failures so its removal

by rail grinding is mandatory [2]. The amount of material to be removed during rail grinding is usually defined by considering the actual depth of head checks in the rail. Accordingly, the incubation time and crack's growth rate play a key role in artificial wear caused by rail grinding [2]. In this study, the inspected rail had an average of 3 cracks per square millimetre (see figure 7a for reference). The inspection of a longitudinal section in the central part of the contact zone (where the cracks were located) revealed that, on average, the crack depth was 0.5 mm (figure 7b). The angle between the rail surface plane and the cracks was around 35-45 degrees (figure 7c). Some iron oxides were found inside the cracks as a result of the interaction with the ambient. According to these findings and the operator's experience, the grinding procedures were designed to remove 0.5 mm from the rail surface.

Figure 7. Head checks found in railroad inspection a) Head checks on the rail's head b) Top view of the head checks c) Longitudinal section of cracks

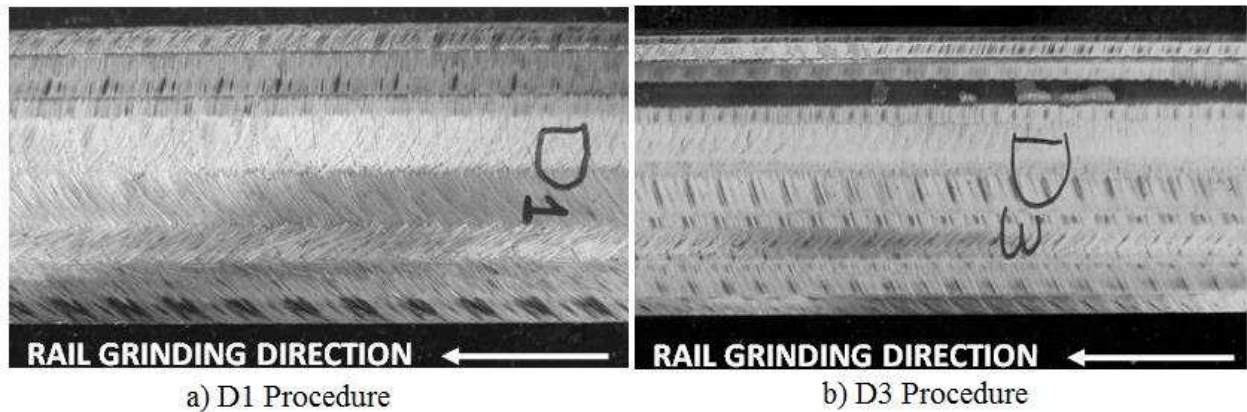
Figure 9 shows the ground surfaces after procedures D1 and D3. Only D1 procedure was effective over the entire rail surface, as opposed to procedures D3, D4 and D6 that left a black zone where the wheels did not grind the rail's surface [10]. On the other hand, the marks seen after the low velocity procedures (D1 and D3) were clearly more uniform. According to these results, low velocity grinding (within the range analysed in this study) is recommended for better results in

Figure 9. Aspect of rail's surface after the grinding tests. a) D1 procedure b) D3 procedure

terms of homogeneity of the surface.

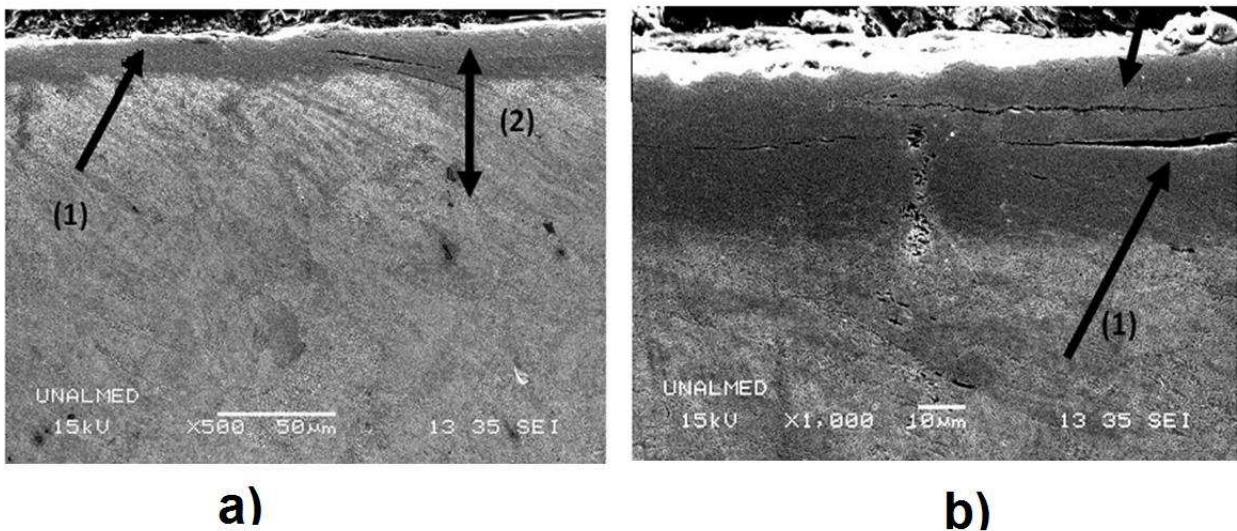
The metallographic inspection of the rails ground with D1 procedure revealed a hard white layer with cracks parallel to the surface (Figure 10). This layer is composed of fresh martensite formed due to localized heating and fast cooling during the grinding procedures, which has been previously reported by Chandrasekar et al [18] and Kanematsu et al [19].

Figure 10. Rail microstructure of sub-surface white layer. Procedure D1. a) Crack observed at the surface; (1) shows the white layer, (2) shows the thickness of deformed layer, b) Detail of cracks found at or near the surface.

Additionally, it was found that new defects are induced in the surface during the grinding procedures. The cracks in the white layer were caused by the combination of the grinding equipment used in the field and the grinding parameters defined by the operator. However, it must be emphasized that state-of-the-art grinding should not introduce new defects during grinding. The defects observed include a white hard layer on the surface of the rails, which can significantly reduce the resistance to rolling contact fatigue of the rails since it acts as a source of preferential nucleation site for new cracks.

The detail shown in figure 10b reveals several cracks in the white layer. According to those results, the D3 procedure is recommended since it applies a lower normal force to the surface, but the number of passes of the grinding wheel over the rail must be increased to ensure that the entire surface of the rail is being ground.
