Fatigue Failure of Polyethylene Electrofusion Joints Subject to Contamination

Pedrom Tayefi, Stephen. B. M. Beck, Rachel A. Tomlinson

Department of Mechanical Engineering, University of Sheffield, Mappin St, Sheffield, S1 3JD, UK

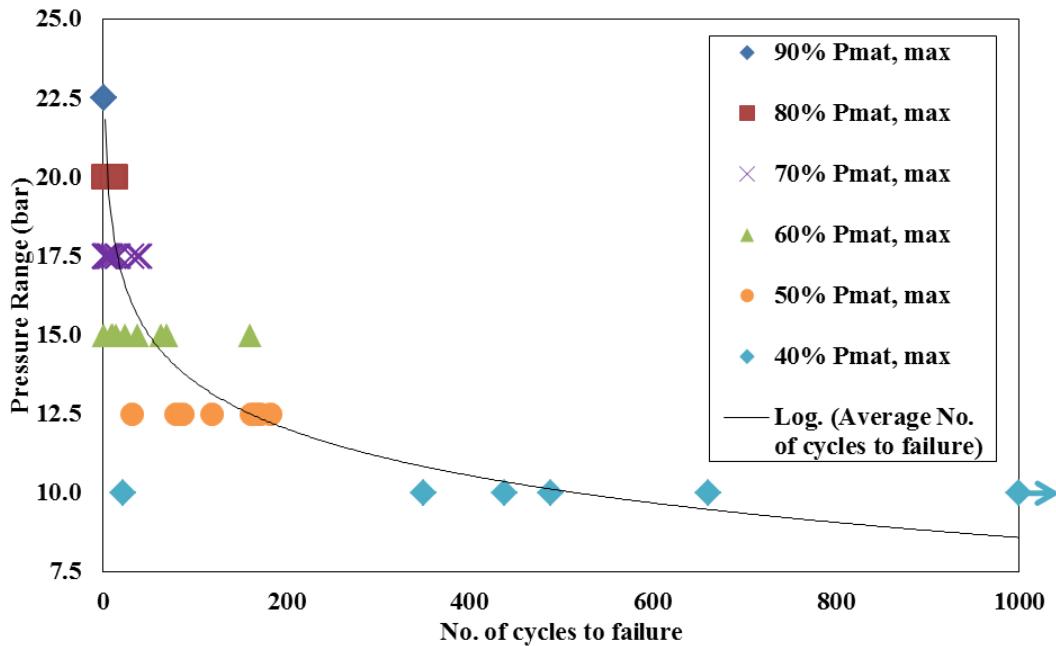
Fig. 2 Pressure range vs. number of cycles to failure for the fatigue test [12]

Fig. 2 suggests that as the pressure range is decreased, the spread of results becomes greater. Therefore the predictability of the number of cycles to failure becomes more difficult. Furthermore, at the lowest testing pressure range, 40% $P_{\text{mat, max}}$, shows results that exceed 1000 cycles which may suggest that there is a fatigue limit to this testing programme.

With regards to **Fig. 2**, the most logical failure mechanism would be crack propagation [10] of the jointing surface. This hypothesis was explored further through the use of destructive and non-destructive methods of analysis.

There is a dramatic decrease in joint performance when EF tapping tees are subject to contamination prior to the welding process. It is clear from **Fig. 2** that if the jointing interface were to be contaminated, failures associated with fatigue can occur in a relatively short space of time. It should be noted that the pressure amplitudes used in the fatigue test were aimed to replicate the pressures that may be expected in surge events. However, the frequency of the pressure ranges are slower than a surge, as the frequencies used were between 0.007 – 0.016 Hz (90% to 40% $P_{mat, max}$ respectively). The predictability of failure also becomes more difficult as the pressure range decreases – this was evident due to the increase in scatter as the pressure range was reduced.

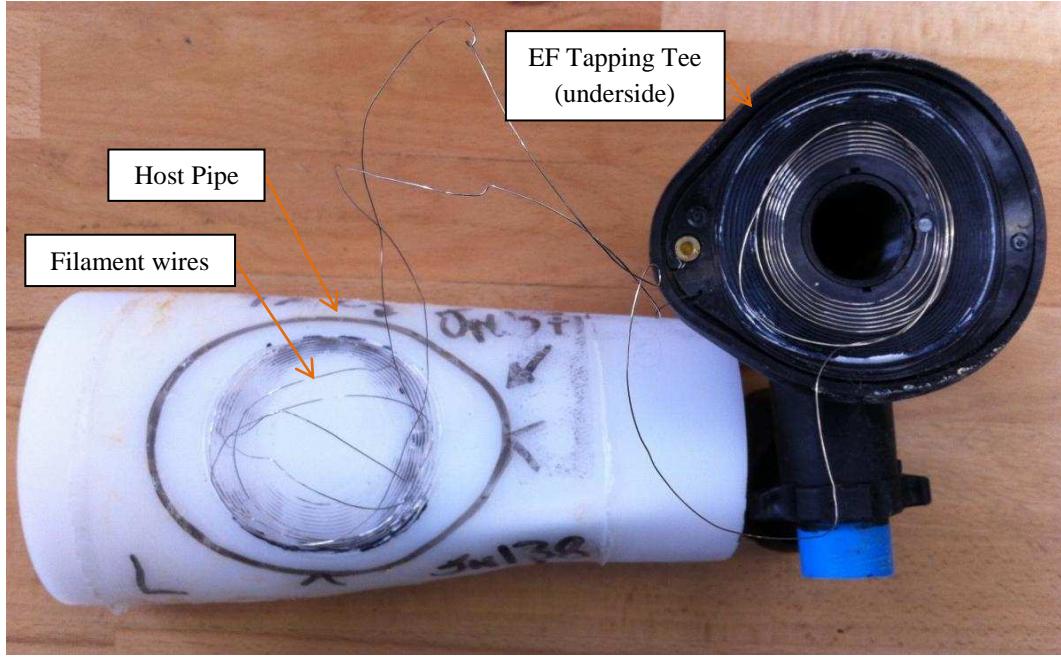
Destructive tests were performed to observe the failure modes by comparing contaminated joints visually to those that had been manufactured to best practice principles. A crushing decohesion test was performed in accordance with ISO 13955 [13] on EF tapping tees. The results showed the failure mode was brittle about the joint when the welding interface was subject to contamination prior to welding (**Fig. 3**). Notice that there are remnants of black polymer on the surface of the pipe and white polymer on the tapping tee where it appears a bond was beginning to form. Filament wires also appear to be still embedded into the host pipe.

Fig. 3 Talc contaminated specimen subject to crush test

As **Fig. 3** shows evidence of bonding beginning to take place it was assumed that the crack growth would be visible if non-destructive methods of analysis were used to observe the crack growth (i.e. leak paths) of joints failed to the fatigue testing regime highlighted in **Fig. 2**.

It is interesting to note that the destructive tests showed a visually distinct difference in mechanical failure if the joint were to be subject to a talc contaminant prior to welding. With regards to the specimen subject to contamination (**Fig. 3**), there was evidence to suggest that a bond was beginning to form. Some filament wires were still present once the fitting was removed from the host pipe. This suggests that the filament wire may have been providing some degree of structural strength to the joint assembly which may let the fitting pass the initial pressure test before it is put in service. However, the joint would still fail in a brittle manner if it were subject to the fatigue testing regime.

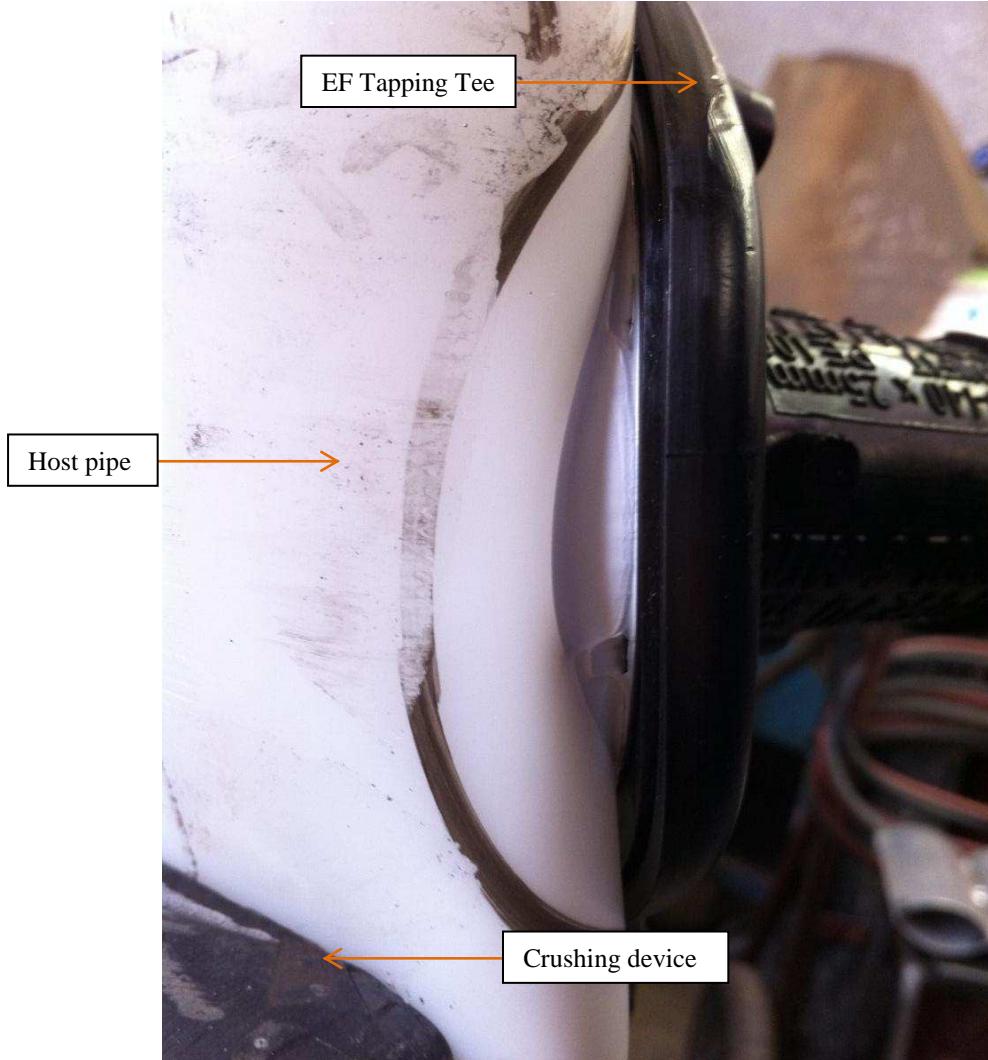
Contrarily, joints welded to best practice principles showed fully ductile behaviour about the jointing interface. **Fig. 4** shows the tapping tee after it was subject to the maximum crushing distance. There appears to be preliminary signs of crazing about the jointing interface after the pipe had been crushed. It is interesting to note that removing the tapping tee from the host pipe proved extremely difficult. This was mainly because there was minimal room to operate a lever to prise the fitting away from the pipe. Secondly, the joint had a distinct difference in mechanical strength compared to the brittle failure of the contaminated joint; which fell apart during the crush test.

Fig. 4 Post-crush of ‘perfect’ specimen

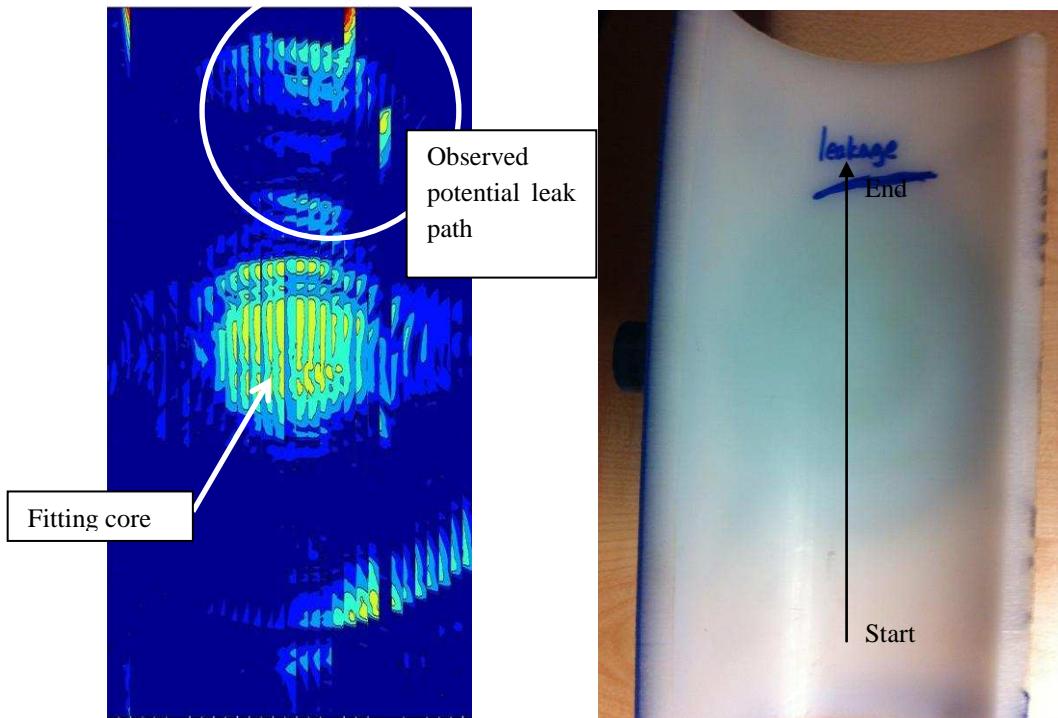
Preliminary line scans were conducted on the internal bore of the pipe in order to observe the delaminated surface of the fusion interface. The line scans were then knitted together to create a map of the fusion zone thus observing the leak path (Fig. 6).

Fig. 6 Preliminary line scan results showing leak path (Left) and scan direction (right)

Once the map was created, the predicted leak path was confirmed by applying a flow of water through the EF tapping tee fitting. This was achieved using a basic hand pump.
