Bryant, MG, Buente, D, Oladokun, A et al. (2017) Surface and subsurface changes as a result of tribocorrosion at the stem-neck interface of bi-modular prosthesis. *Biotribology*, 10. pp. 1-16. ISSN: 2352-5738

Surface and subsurface changes as a result of tribocorrosion at the stem-neck interface of bi-modular prosthesis

M.G. Bryant, D. Buente, A. Oladokun, M. Ward, G. Huber, M. Morlock, A. Neville

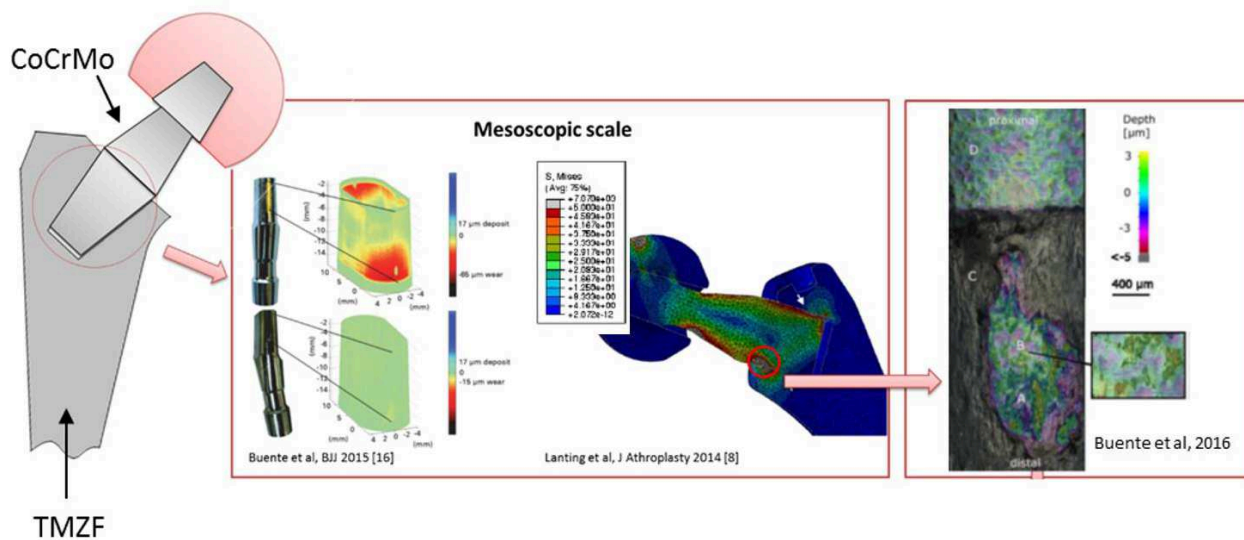
Figure 1

Buente *et al* [16] recently quantified the material loss from 27 failed Rejuvenate™ prostheses (Figure 1). Material loss of the CoCrMo trunnion was observed. A correlation between total material loss and implantation time was observed with mass loss concentrated on the medial – lateral and anterior – posterior edges and evidence of debris across the surface of the trunnion component (Figure 1). The findings complemented those of Lanting *et al* [8]. Over the past 20 years extensive research has aimed to elucidate biomechanical, electrochemical, patient and system factors in the ultimate performance of conical modular taper systems [3,17,4,18]. Whilst a lot of work has been conducted in this area a full understanding of the degradation processes occurring within the local regions of the interfaces still does not exist around.

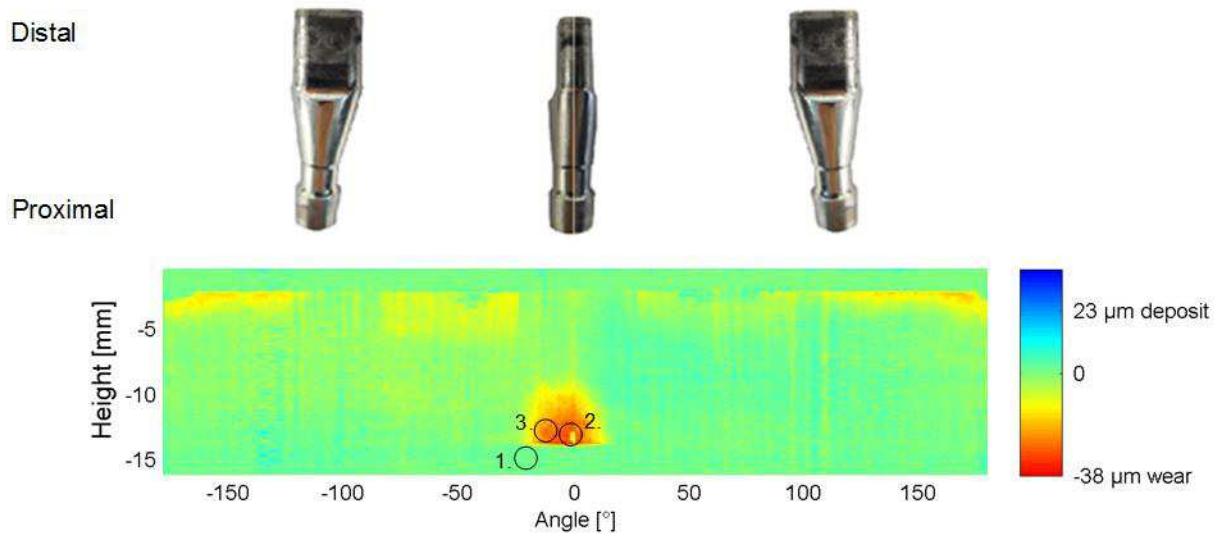
CMM contour plots are shown in Figure 2 for the CoCrMo trunnion component. Material loss varied as a function of the interface height and angle. High amounts of material loss was observed at the proximal-medial edges of the CoCrMo trunnion. A preserved patch of material was observed, surrounded by regions of high wear. Three areas of interest were highlighted by the CMM analysis and subject to further examination. These are indicated on Figure 2 and described as: 1 – Reference (i.e. unworn material outside the region of contact), 2 – Retained patch (i.e. localised region within the highly worn area where original topography was retained) and 3 – Highly worn (i.e. regions of highest material loss). The taper component was also analysed in the same regions. Details of this particular patient can be found in [16] (Patient 4).

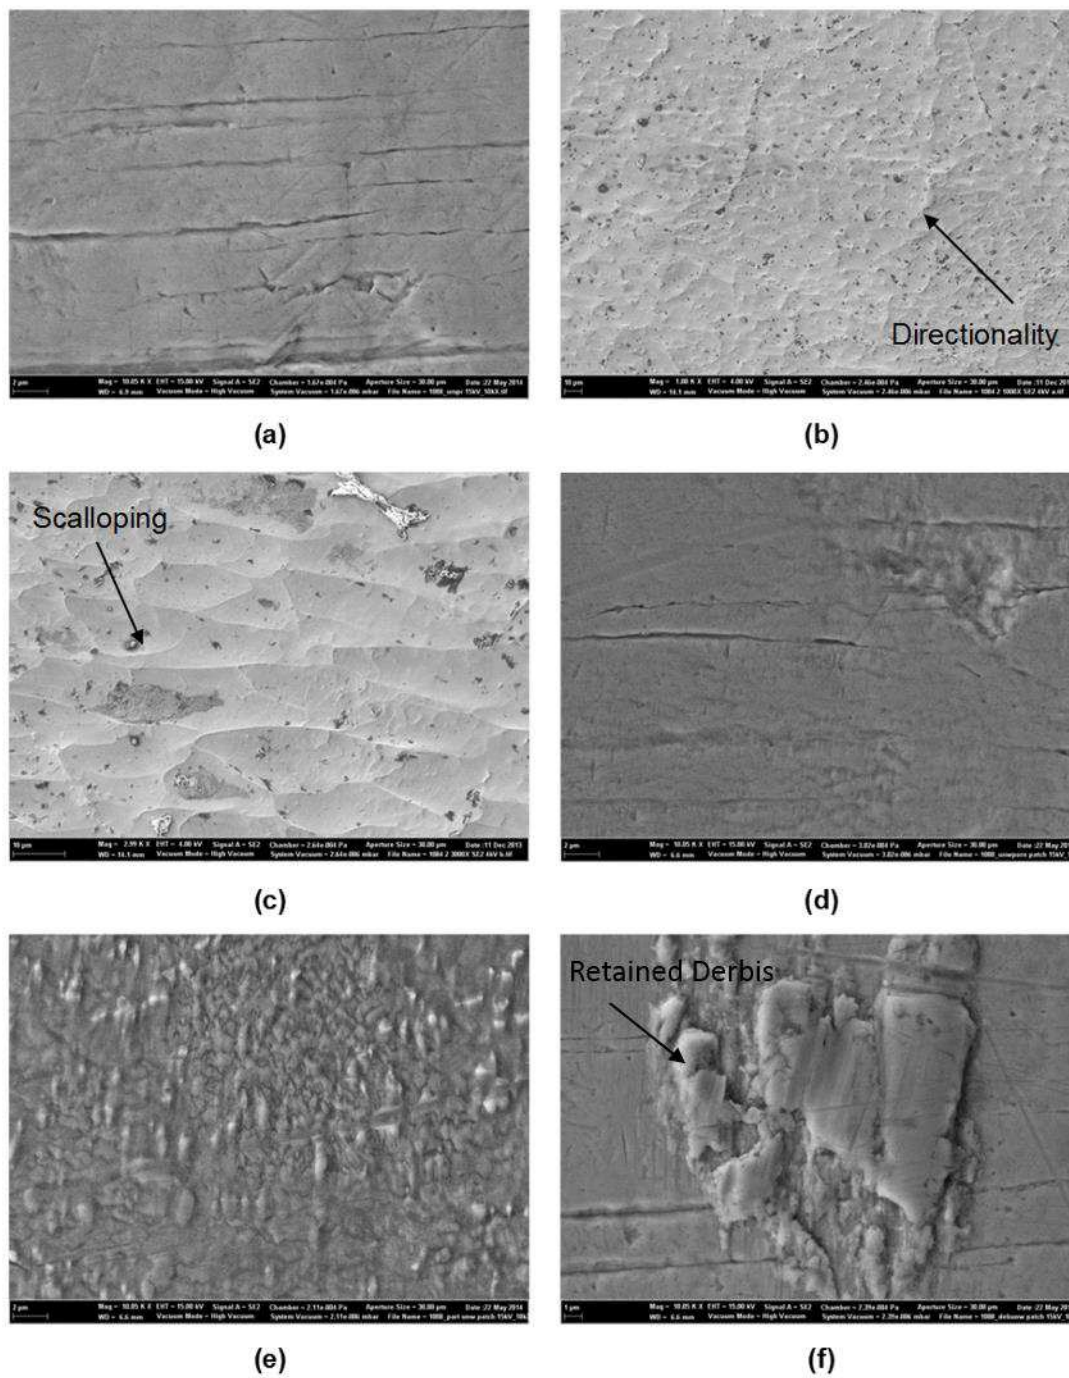
Figure 3 demonstrates the surface topographies observed on the CoCrMo trunnion component at revision. A number of different topographies existed due to the different contact conditions established at the interface; a result of the local variations in device geometry, surgical placement and loads established during daily activities. These range from the original machined topography (Figure 3a, Figure 2 region 1), regions that depicted evidence of fretting-corrosion (Figure 3b and c, Figure 2 region 3) and areas that seemingly retained the original machined surfaces whilst surrounded by regions of high wear (Figure 3 d-f, Figure 2, region 2). In regions where surface topography was seemingly retained (Figure 2, region 2), a 'wrinkled' type surface morphology was observed. Localised areas of debris emanating from the TMZF taper component was observed on the patch area (Figure 3e-f, Figure 2 region 2). This was confirmed using EDS analysis as presented in section 3.1.5. In regions in which fretting corrosion was observed, scalloping and directionality of the surface was observed.

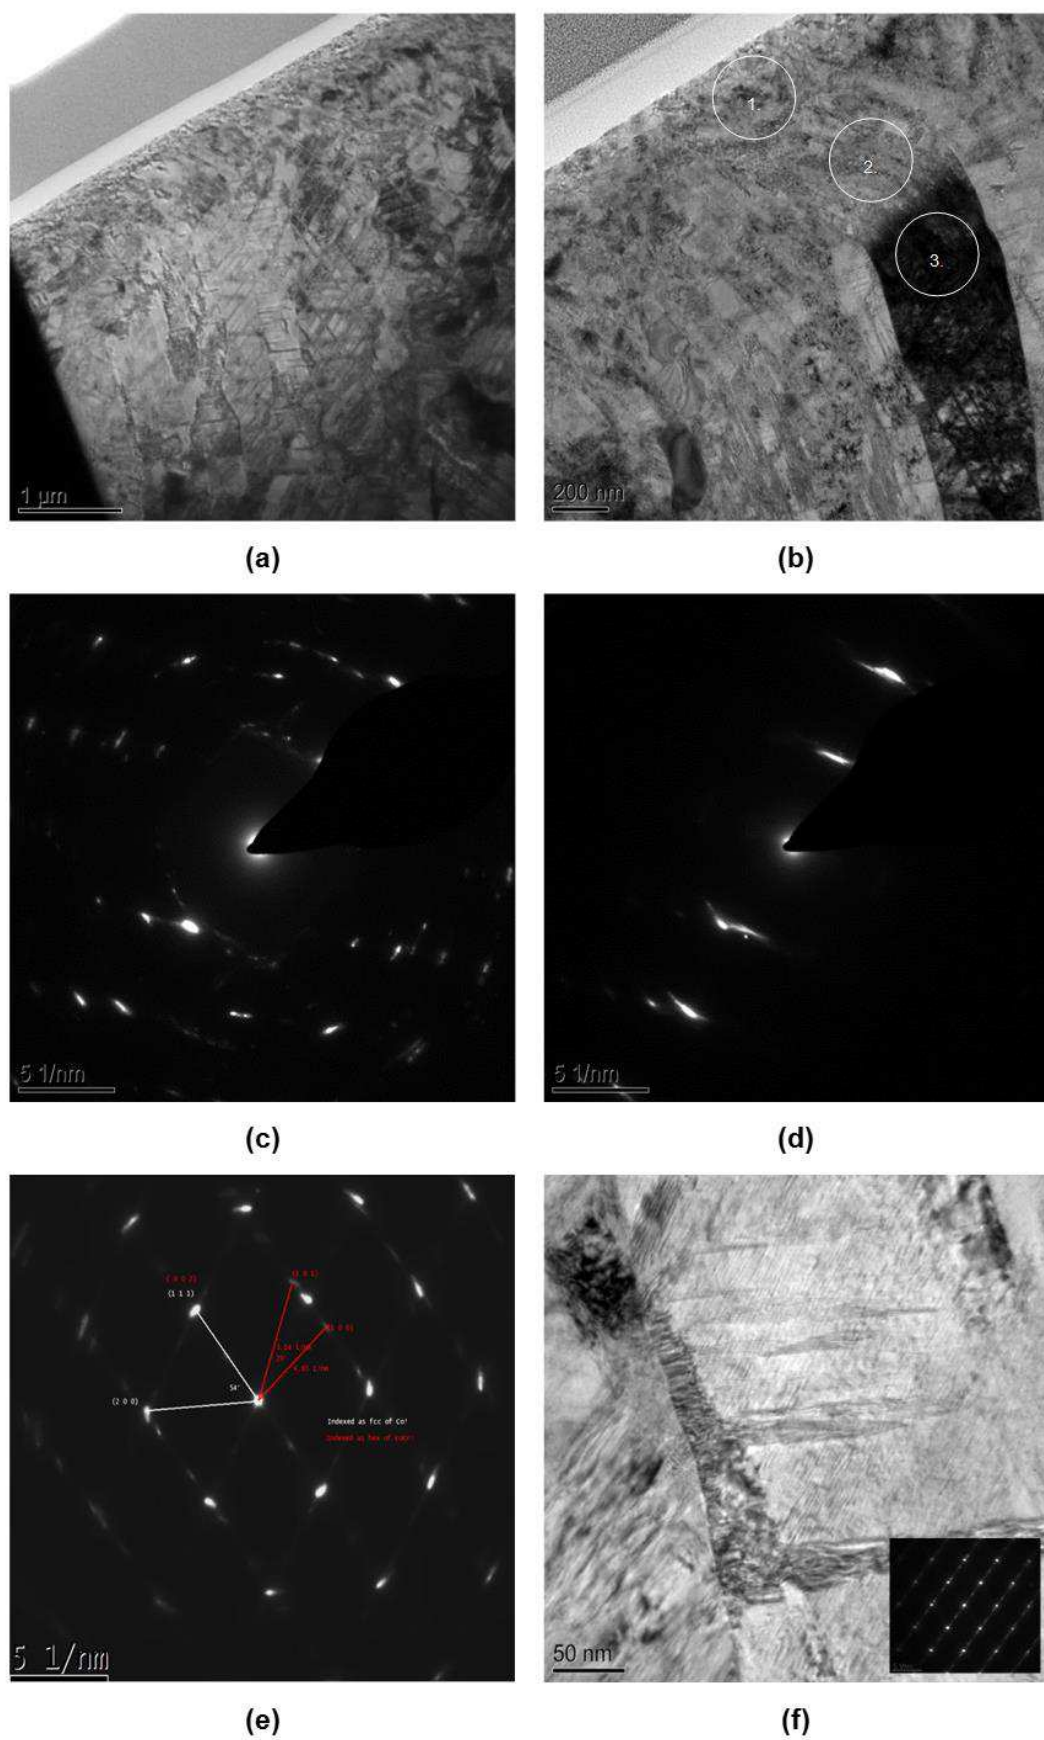
Figure 6 shows bright-field TEM and electron diffraction analysis of subsections prepared from the patch area of the CoCrMo trunnion component (ie Region 2, Figure 2). It must be noted that this is the area in which surface topography was seemingly retained whilst surrounded by regions of high material loss. Within this region it is hypothesized that a tribological regime with sufficiently high contact pressure and low displacement is established so a stick or partial slip fretting regime exists resulting in a retention of an unworn area and worn gradient across the surface similar to that described by [21]. Figure 6a shows refinement of the microstructure within the top 300 nm, formation of ϵ -martensite, stacking faults and the presence of twinning when compared to the reference subsection (Figure 5a). Deformation of grains and evidence of directionality was observed within the top micron of the surface (Figure 6b). Bulk single crystals being sheared to form a nano-crystalline layer was observed in the absence of any visible ϵ -martensite. This correlated with the direction of joint loading.

Electron diffraction analysis was taken in three areas of interest (Figure 6b). It can be seen in region 1 (Figure 6c), a nano-crystalline structure with no preferred orientation was observed with crystals in the region of 50 nm. This again was indexed at a HCP structure. In region 2 (Figure 6d), a nano-crystalline structure was also observed. This again was indexed to a HCP structure. However preferred orientation was observed. Towards the bulk of the alloy (region 3, Figure 6e) a composite electron diffraction pattern was obtained, this was could be indexed as both FCC and HCP atomic

orientations suggesting a composite diffraction signal. The formation of ϵ -martensite, stacking faults and shear banding was observed in the lower subsurface ($>3 \mu\text{m}$) (Figure 6f). FIB and subsequent TEM was conducted on the areas of localised debris observed on the patch area (Figure 3f). Layers in the region of $1\text{-}2 \mu\text{m}$ were observed (Figure 7). STEM-EDX analysis demonstrated that this was rich in Ti and O with traces of Cr, Fe and Al (Figure 8).

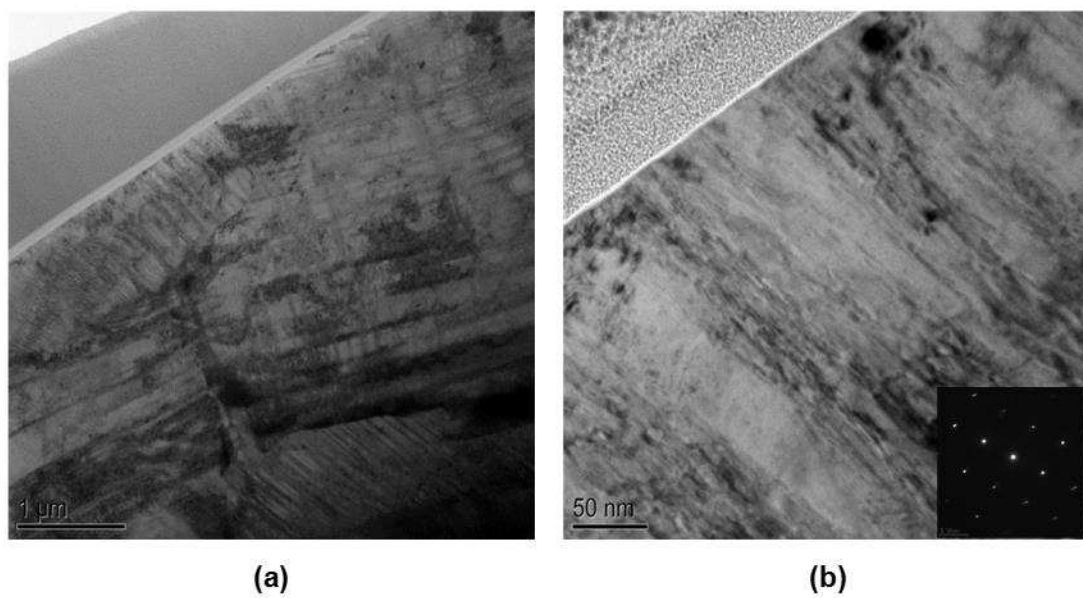
Figure 9

Typical subsurface microstructures observed in the sample taken from the highly worn regions on the CoCrMo trunnion (Figure 2, region 3) can be seen in Figure 9. A loss of the nano-crystalline layer was observed with no evidence of reformation. A bulk single crystal structure remained at the interface. Less residual strain was seen within the crystals, indicated by sharp, streak-free electron diffraction pattern. This was indexed as a typical FCC orientation found for bulk CoCrMo alloys. An interfacial layer, presumed to be Cr_2O_3 , was observed and confirmed by EDX at the CoCrMo-Pt interface in the region of $3\text{-}5\text{nm}$.

- TEM analysis in highly degraded region demonstrated a different subsurface response. A loss of the manufactured induce nano-crystalline layer was observed resulting in a single crystal FCC being observed at the interface (Figure 9). Although difficult to quantify from retrieval analysis which only presents one point in time, loss of any nano-crystalline layers may occur as a result of mechanical and electrochemical processes. For this particular contact, electrochemical reactions could become dominant as the crevice depth becomes sufficiently deep enough so mechanical deformations are insufficient to result in metal-metal contact, mechanical material removal and further subsurface microstructural changes. Acidification of the solution at the interface is likely to occur increasing rates of dissolution due to localised crevice corrosion. Such

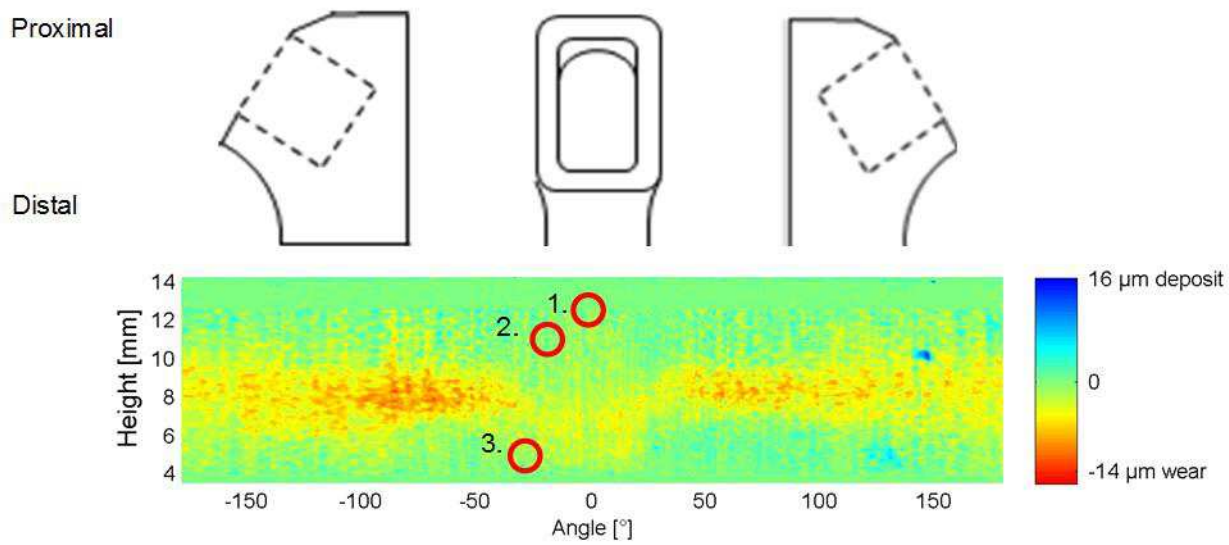
Figure 10 shows the tactile CMM contour plots obtained from the TMZF taper components. Measureable material loss had occurred within the resolution of the CMM. However the depth of material loss was less compared to the CoCrMo trunnion (Figure 2). Evidence of material loss could be observed in the transverse section of the TMZF component with a maximum penetration of $14 \mu\text{m}$ being observed at $\pm 35\text{-}120^\circ$ (Compared to $38 \mu\text{m}$ around $\pm 25^\circ$ for the CoCrMo trunnion component). The TMZF taper presented a different wear pattern with no localisation of degradation been observed when compared to the CoCrMo trunnion (Figure 2). SEM, FIB-TEM analysis was

conducted in similar regions to those described in Figure 1 in attempt to identify local degradation modes. For the reference surface, region 3 (Figure 10) was used as this provided a non-contacted blasted surface; the same found in the contacting regions.

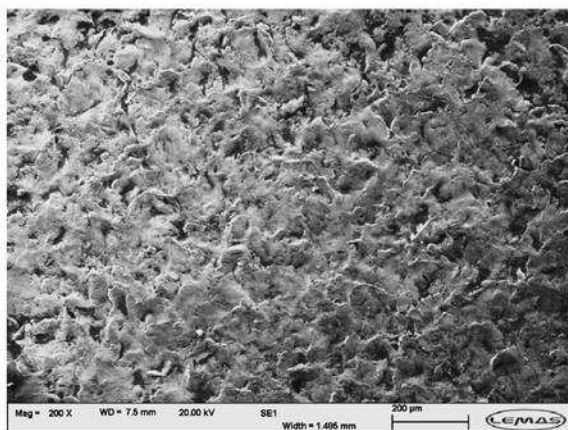
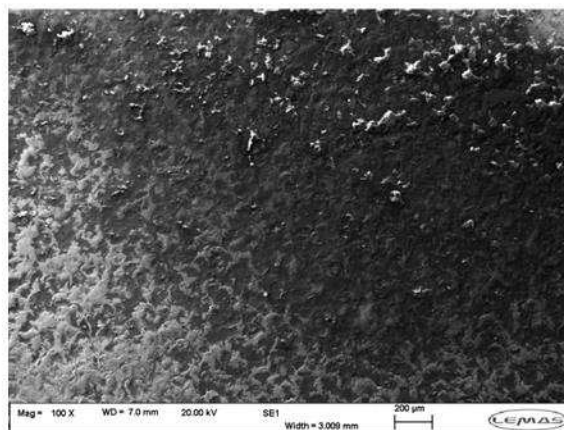
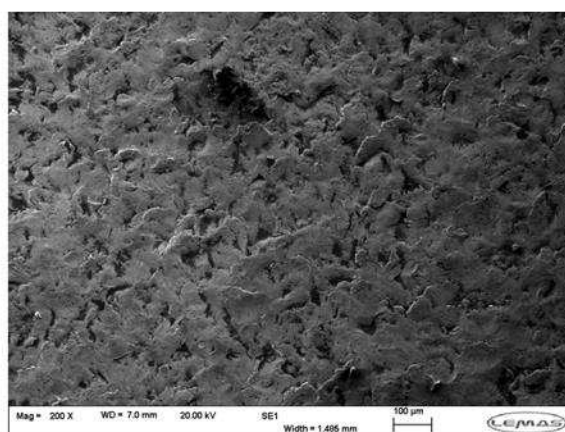
Figure 11 shows the surface topographies observed on the TMZF taper component. Again, a range of topographies could be observed as a function of location. In regions where little to no degradation was observed (Figure 10, region 1 and Figure 11a) topographies were homogenous in texture and similar to those obtained through a blasting process was observed. Towards the mid portions of the interface a loss of surface topography and the presence of a surface deposit was seen (Figure 11b). Back scattered detection imaging indicated areas of deposit consisted of a lower atomic mass (ie C, Ca, P, O). Towards the distal portion of the interface, Figure 11c, a similar topography was observed to Figure 11a. A textured surface similar to that of a blasted surface was again observed. Figure 12 shows semi-quantitative SEM EDX mapping at 20 kV for the image presented in Figure 11b. Areas where a surface deposit was observed were rich in Cr, C and O. A depletion of Ti was observed in this area. No Co was observed at 20 kV. At higher magnifications, deposits were seen to be localised between the asperities of the rough surface.

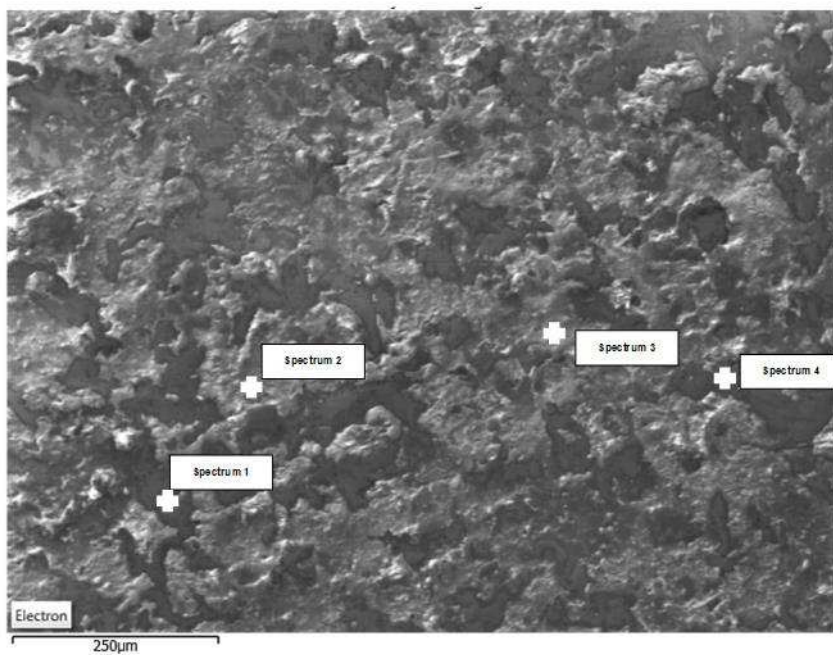
Figure 13

Further point EDX analysis was conducted at 5 kV in order to quantify the surface chemistry of the upper most surface (≈ 100 nm, Figure 13). Table 1 shows the semi-quantitative values obtained from point EDX analysis at 5 kV using $L\alpha$ emission lines. Across the different areas an in-homogeneous surface chemistry was observed. Surfaces were seen to be rich in C and O with Si, P and Mo observed in all areas analysed. Ti, Cr, Co and Zr were observed in spectrum 1 and 3 however Co was observed at low levels compared to the other elements.

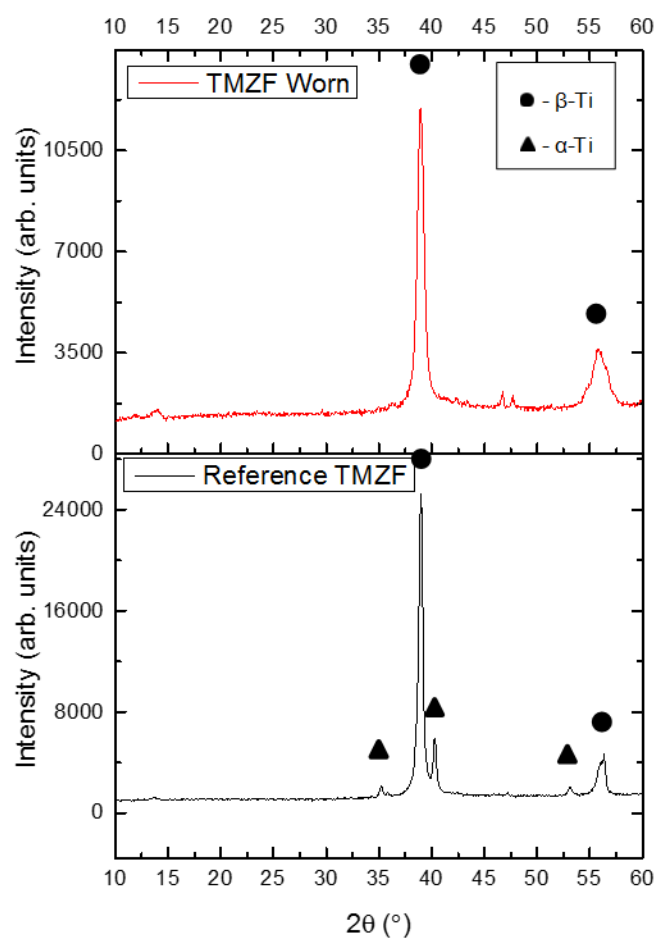
Figure 14 presents the XRD plots obtained for the reference TMZF alloy and areas that had incurred highest incidences of degradation (Figure 10). For the reference TMZF surface a predominantly β -phase alloy was observed with evidence of α -phases at lower intensities. This is as expected according to literature regarding the metallurgy of the alloy [22]. Distinct difference

between the reference and degraded surface were observed. A loss of the α -Ti peaks was observed in the highly degraded regions. Significant broadening of the β -phase peaks was also observed, characteristic of an increased strain within the crystal lattice and reduction of crystal size. A gain of peaks at $2\theta \approx 46$ and 47° was observed. These were unidentifiable from XRD data libraries due to the lack of higher angle peaks however maybe related to the formation of Fe compounds as demonstrated later through TEM analysis. It is evident from XRD data that phase transformation and a high degree of strain is introduced into the TMZF alloy due to the degradation and plastic deformation processes occurring at the stem-neck interface.

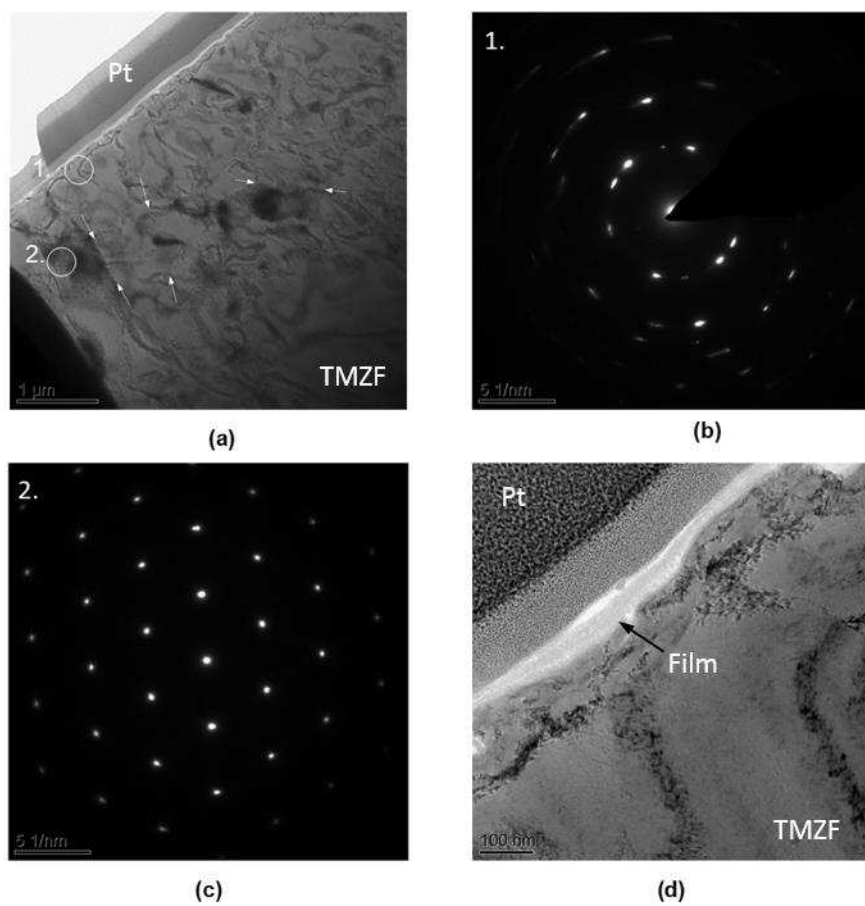
Figure 15 shows TEM electron micrographs of the TMZF alloy taken from manufactured surfaces which had not being subjected to any wear processes. A poly-crystalline structure was observed (white arrows indicate grain boundaries). Multiple electron diffraction micrographs of the subsurface were taken for the reference samples. Two distinctly different diffraction signals were observed. In regions 1 and 3 a ringed diffraction pattern (Figure 15) was observed. In combination with bright-field TEM images (Figure 15a) it can be seen that a two phase structure exists with β -grains containing a mixture of nano-crystalline intragranular α -precipitates. A 50 nm interfacial layer was also observed. Closer examination of the film indicated that a mixture of amorphous and crystalline material (Figure 15d).

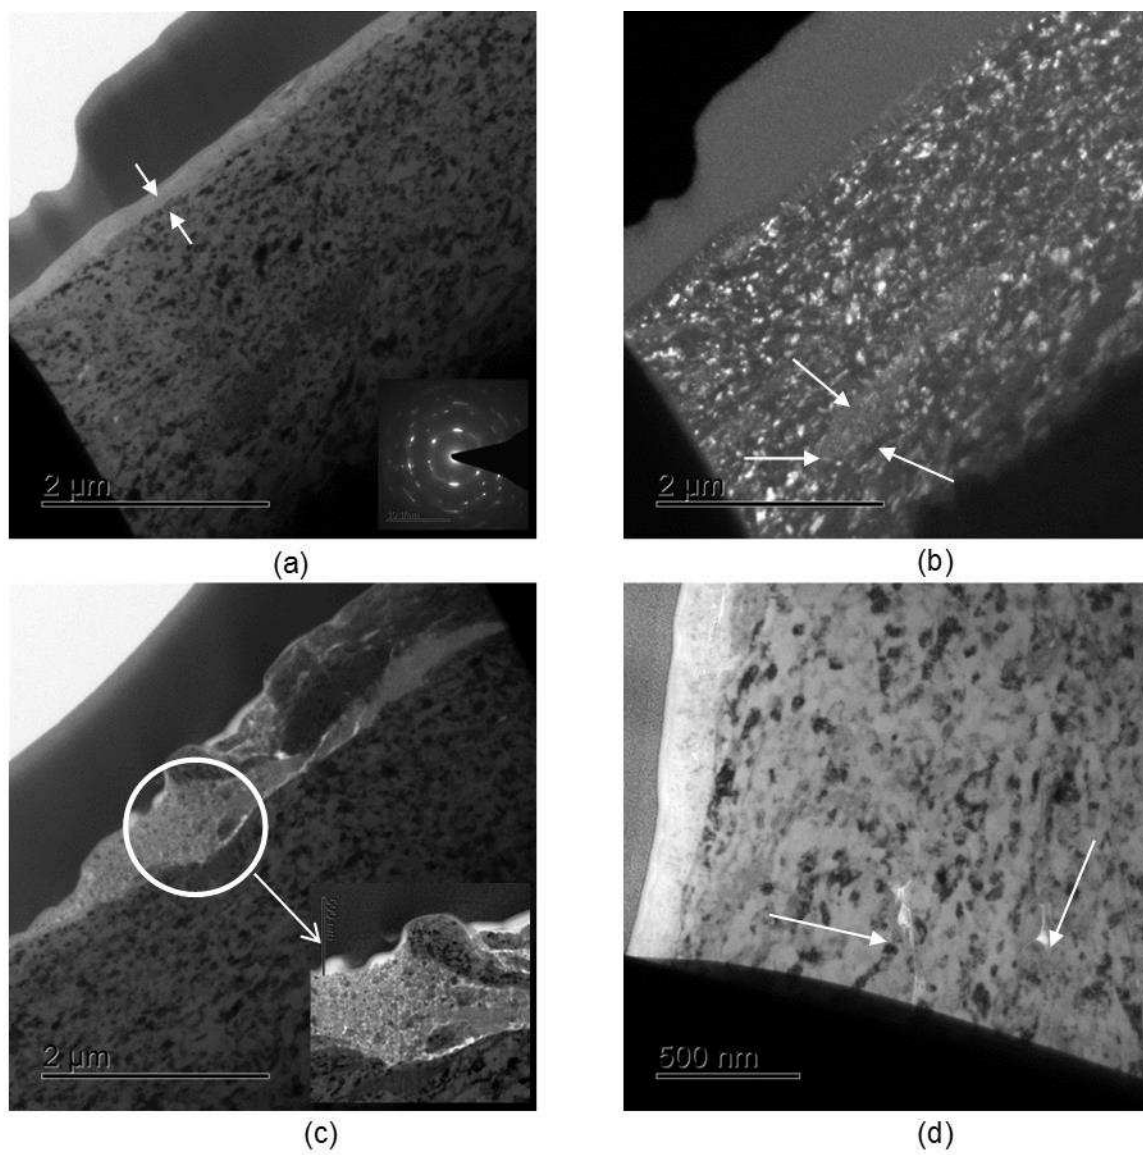
Figure 16

In the regions in which surface topography was retained on the CoCrMo trunnion component, refinement of microstructure in the bulk alloy and the formation of a metallic oxide layer could be observed on the counterpart TMZF surface (Figure 16). A nano-crystalline microstructure with preferred orientation of the crystals was observed (Figure 16a). It can be seen in Figure 16b that areas with different microstructure exist within the polycrystalline structure as highlighted by the white arrows. Precipitation and oxidation of elemental species from and within the subsurface of the TMZF alloy was confirmed with combined STEM–EDS analysis (Figure 17). In comparison with the

reference TMZF subsurface, a transformation of the subsurface microstructure and formation of metal oxides at the surface was observed.

Films consisting of metallic oxides were seen to range between 100-500 nm in thickness (Figure 16c) depending upon location. The thickest films were seen in areas around 0 degrees according to CMM contour plots (Figure 2 and 9). These were compact, crystalline and granular in nature. Films were seen to penetrate into the bulk alloy. STEM-EDX analysis (Figure 17) showed films to be Cr and O rich. Cracking of the interfacial surface and ingress of the Cr and O rich debris into the subsurface could be seen. Segregation of Fe at and below the interface was seen. The formation and propagation of subsurface cracks was also witnessed in this area (Figure 16d).

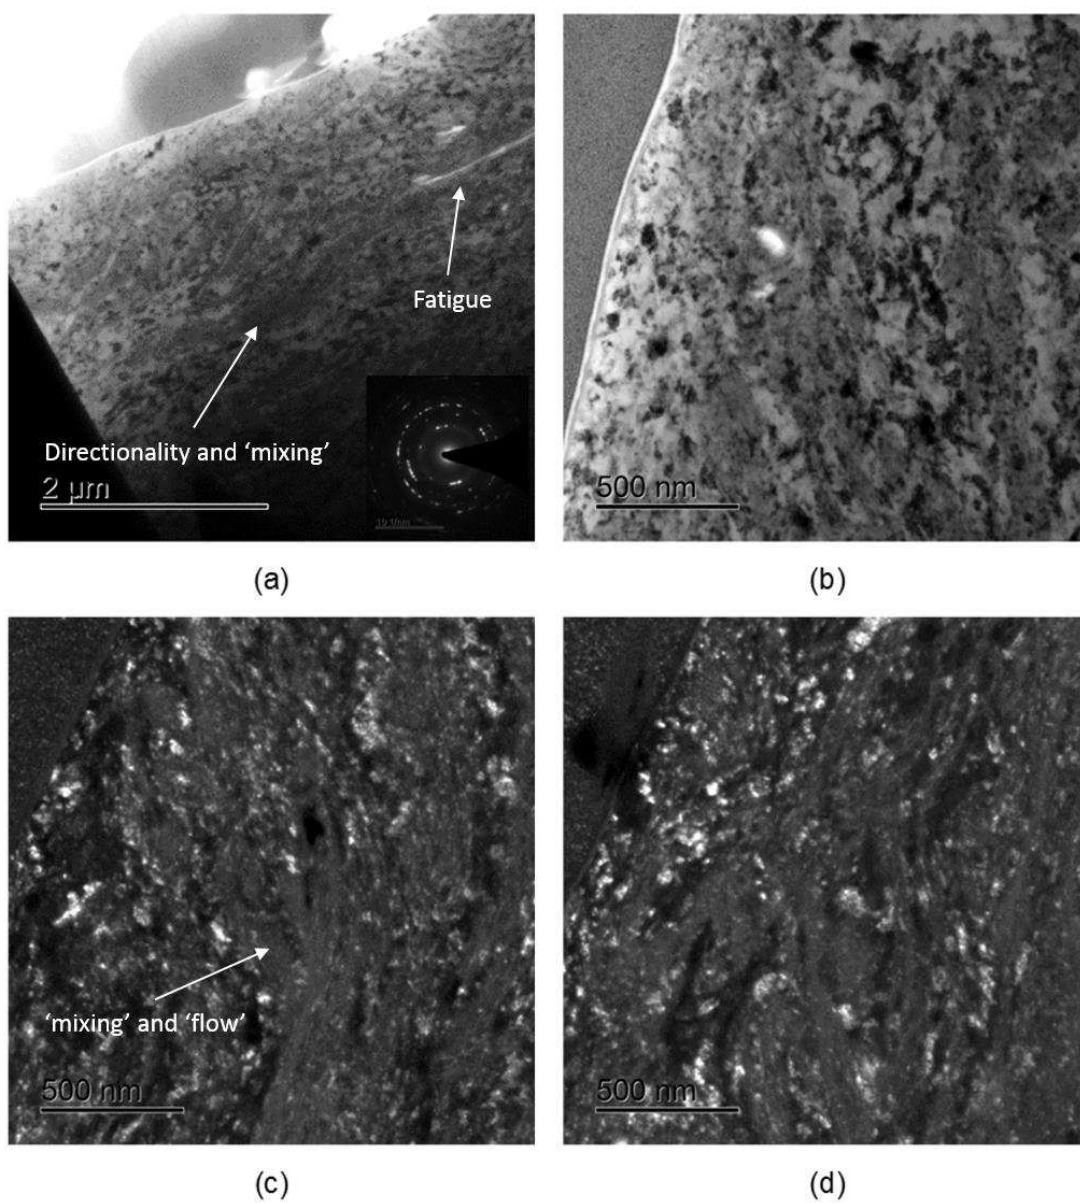
Figure 18

In areas where high amounts of degradation could be observed on the CoCrMo trunnion component (Figure 2, region 3), changes in the subsurface microstructure were also observed for the counterpart TMZF surfaces. The formation of a nano-crystalline microstructure was again seen (Figure 18a and b) along with evidence of subsurface cracking and propagation.

The oxidation and segregation of species within the subsurface region of the alloy was evident. This was consistently seen up to depths of $\approx 5-10 \mu\text{m}$. Dark-field TEM micrographs (Figure 18c and d) present evidence of nano-crystalline material, directionality and 'flow' or mechanical mixing of the TMZF alloy. STEM-EDX (Figure 19) analysis further identified the formation of oxides within the subsurface of the alloy at depths of at least 2 - 5 μm . These were Fe and O rich with depletion of Ti in the areas where iron oxides had formed. C was also found to be present and at localised regions within the subsurface of the TMZF alloy.
