Buente, D, Bryant, M orcid.org/0000-0003-4442-5169, Ward, M et al. (3 more authors) (2017) The taper corrosion pattern observed for one bi-modular stem design is related to geometry-determined taper mechanics. *Medical Engineering & Physics*, 46. pp. 79-88. ISSN 1350-4533

1 **The Taper Corrosion Pattern Observed for One Bi-Modular Stem Design**
2 **is Related to Geometry-Determined Taper Mechanics**

23 Bi-modular primary hip stems exhibit high revision rates owing to corrosion at the
24 stem-neck taper, and are associated with local adverse tissue reactions. The aim of
25 this study was to relate the wear patterns observed for one bi-modular design to its
26 design-specific stem-neck taper geometry.

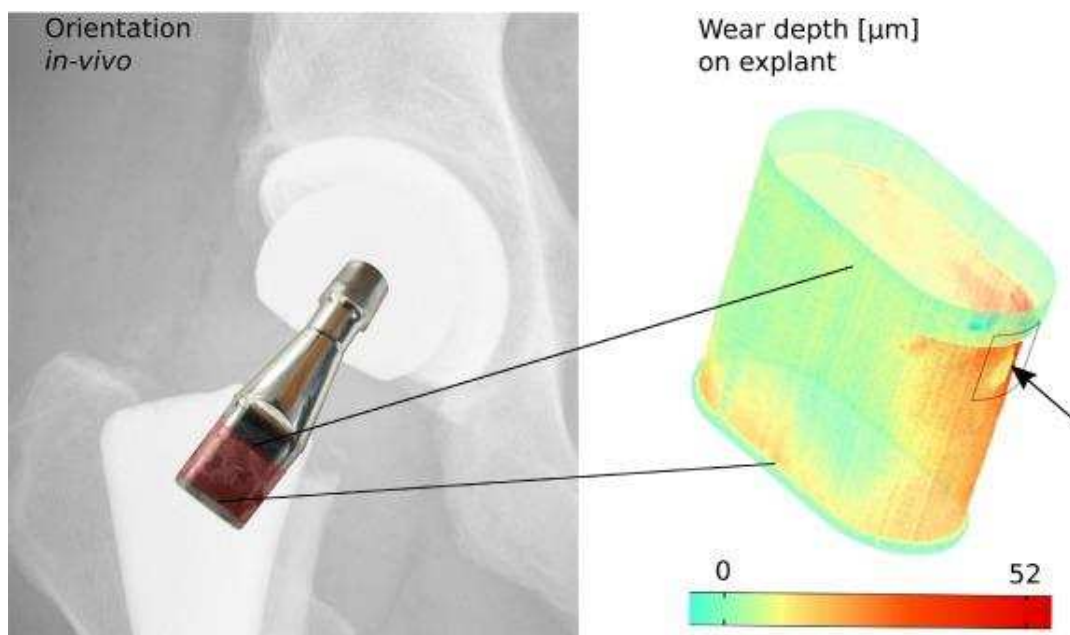
223 **Taper wear:** The infinite focus microscopy from the medial apices of the male tapers
224 revealed a high-gradient wear pattern at the proximal taper opening (Figure 1).
225 Surrounded by worn areas, characteristic patches with preserved original texture

561 *Figure 1: In vivo orientation of wear pattern for a male non-circular neck taper, 26*
 562 *months in situ. Surface deviations from the estimated pristine geometry*
 563 *are color-coded from green (no deviation) to red (wear). Wear in highly*
 564 *loaded regions exhibited a characteristic pattern, developing around the*
 565 *confined patches at the apex of the conical sections (most prominent*
 566 *medially at the proximal taper end (arrow), but and also diagonally*
 567 *across on the lateral apex).*

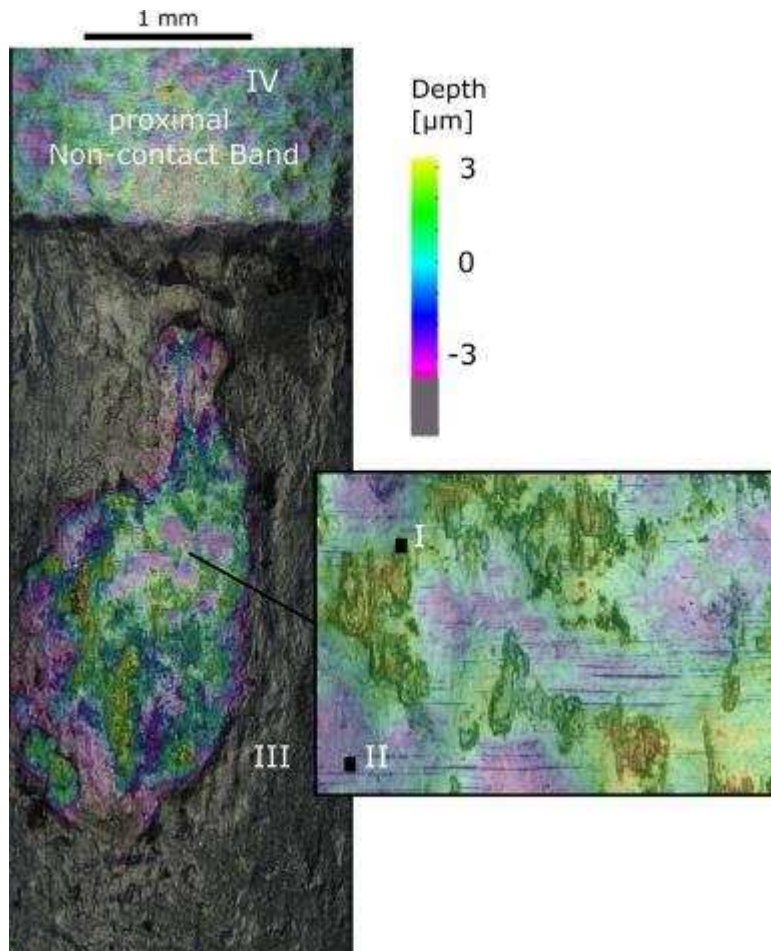
226 were discovered (Figure 5). These patches appeared to have remained unchanged
227 from the wear process. Their maximal surface heights deviated less than $\pm 5 \mu\text{m}$ from
228 those of the proximal non-contact regions. Although a few patches were only
229 partially exposed to the worn surrounding ($n = 5$; material loss $< 2.3 \text{ mm}^3$) or multiple
230 patches appeared ($n = 3$), most explants ($n = 18$) presented singular patches that
231 were completely surrounded by deep wear and shiny texture (site III, wear depth
232 $> 40 \mu\text{m}$). These patches all covered the medial apexes of the tapers, and their
233 centers had slightly shifted toward the taper anterior (patch width: $700 \pm 400 \mu\text{m}$;
234 the patches on the left implants shifted clockwise, whereas the right implants shifted
235 anti-clockwise by $140 \pm 90 \mu\text{m}$). Pristine surface texture with horizontal

236 manufacturing lines was identified on proximal regions on the patches (Figure 5,
237 insert; Figure 6). Furthermore, singular deposits were observed in this region. More
238 distally, patches were densely covered by bulk deposit. In these regions, vertical
239 scratches and other marks that were probably caused during disassembly were
240 observed .

597 *Figure 5: Material loss around a characteristic patch produced high gradient wear*
 598 *patterns at the proximal tapers' opening. The patches at original surface*
 599 *height were identified at the medial apexes (reference: proximal non-*
 600 *contact band). Distinct locations on one taper were selected, in which*
 601 *site-specific subsurface measurements were performed (sites I & II on the*
 602 *patch, site III at high wear depths, site IV on the non-contact band).*

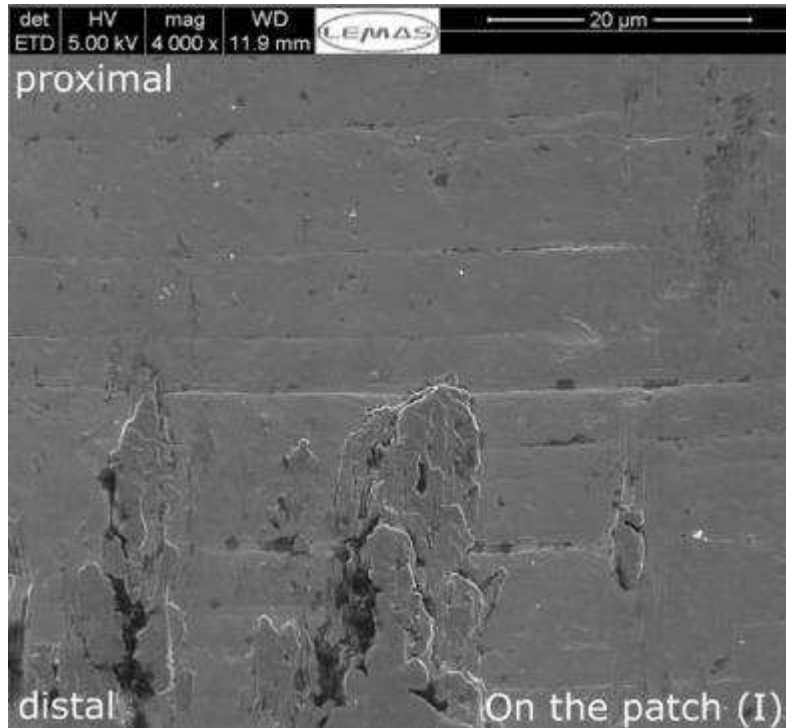
604 *Figure 6: SEM on site I (Figure 5) reveals the original surface texture with intact*
 605 *machining marks and singular deposit.*

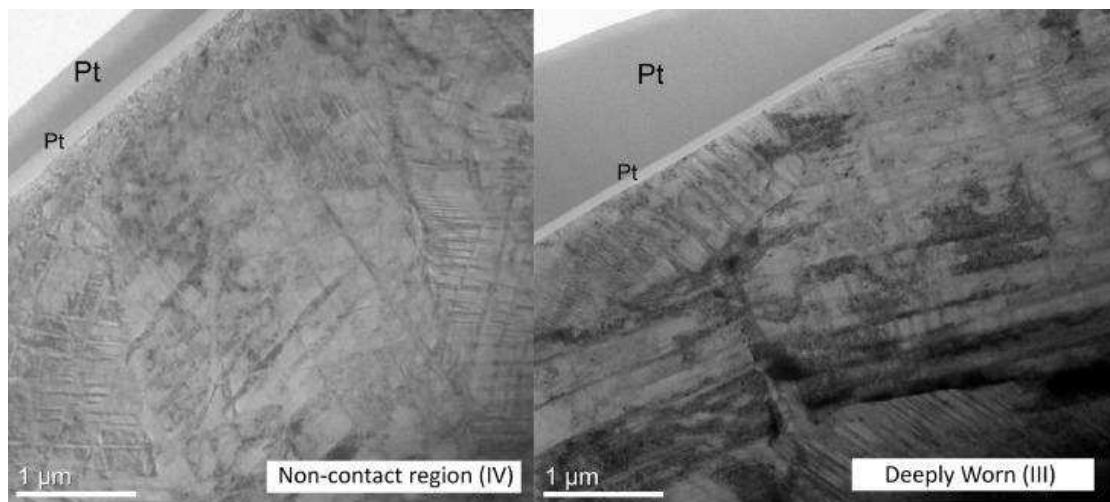
607 *Figure 7: TEM bright field images showing the microstructure underneath the*
 608 *sputter layer of Platinum (Pt). Left: Non-contact site IV. Right: Site III of*
 609 *high wear depths in proximity to the medial taper apex. Large grains*

610 reaching the surface indicate the dominance of corrosive wear in this
 611 region.

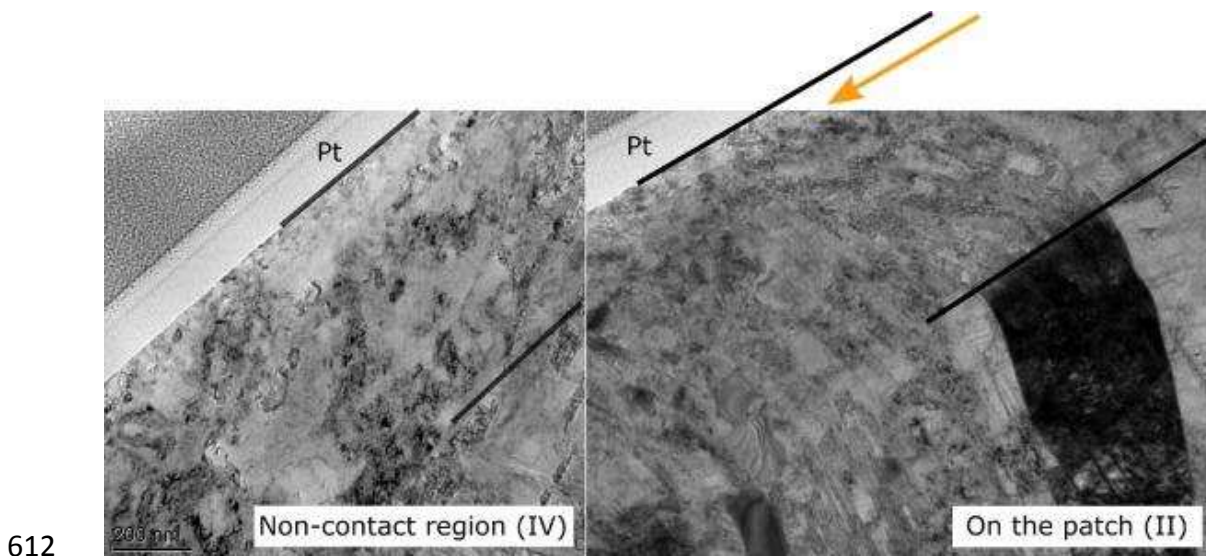
613 *Figure 8: TEM bright field images showing the microstructure underneath the*
 614 *sputter layer of Platinum (Pt). **Left:** Non-contact site IV. **Right:** Site II on*
 615 *the proximal patch. Black lines were added to indicate the crystalline*
 616 *surface layers. No signs of a corrosive attack to the neck piece material*
 617 *were observed. A collective grain shearing within the uppermost*
 618 *subsurface layers was observed (indicated by an arrow).*

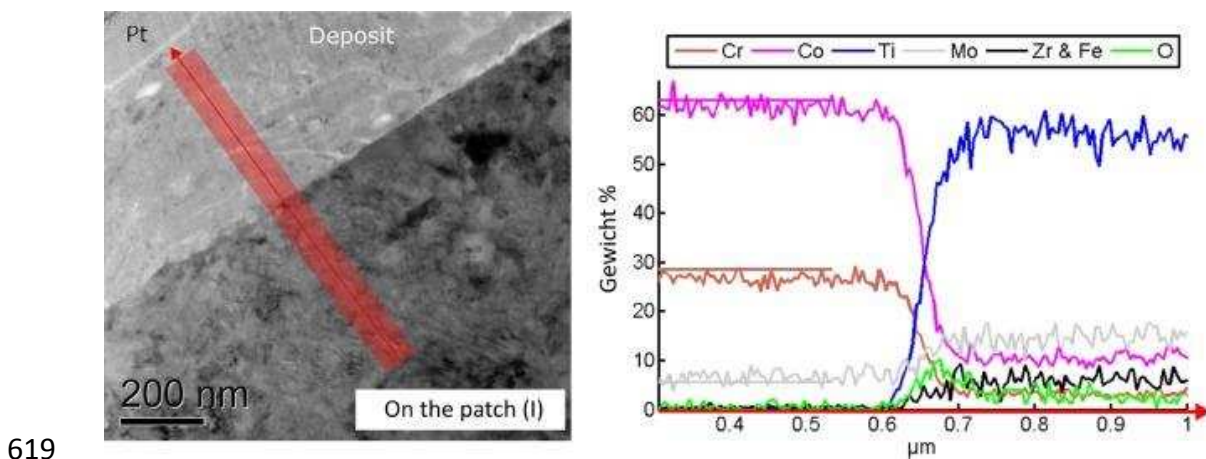
309 Deposit was apparent on medial patch regions (site I). Subsurface measurements
310 identified TMZF bulk constituents that had attached onto male CoCrMo bulk (Figure
311 9). This may be explained by high adhesive forces between the CoCrMo and the
312 TMZF, which locally exceeded the disassembly shear and the ultimate strength of the
313 female taper TMZF material. Cobalt is expectedly soluble in this electrochemical
314 context [44]. It was responsive throughout the deposit, thus indicating microscopic
315 damages of the TMZF side, which are not further addressed here. The Oxygen
316 content was only responsive in a 100 nm band at the interface (Figure 9). This
317 suggests a frictional welding phenomenon between the CoCrMo and the TMZF. The

620 *Figure 9: TEM bright field image at site I shows the deposit onto the neck piece*
 621 *material (left), and the element composition scanned across the deposit*
 622 *interface (100 nm wide; right): A transition from CoCr bulk neck alloy*
 623 *(reference lines according to [46]), separated by an oxygen responsive*
 624 *layer (~100 nm wide) to the deposit containing TMZF bulk alloy elements*
 625 *were recorded. While the Molybdenum content increases to above 10%*
 626 *according to the reported TMZF composition [45], the appearance of Co*
 627 *and Cr content within the deposit remains unclear.*

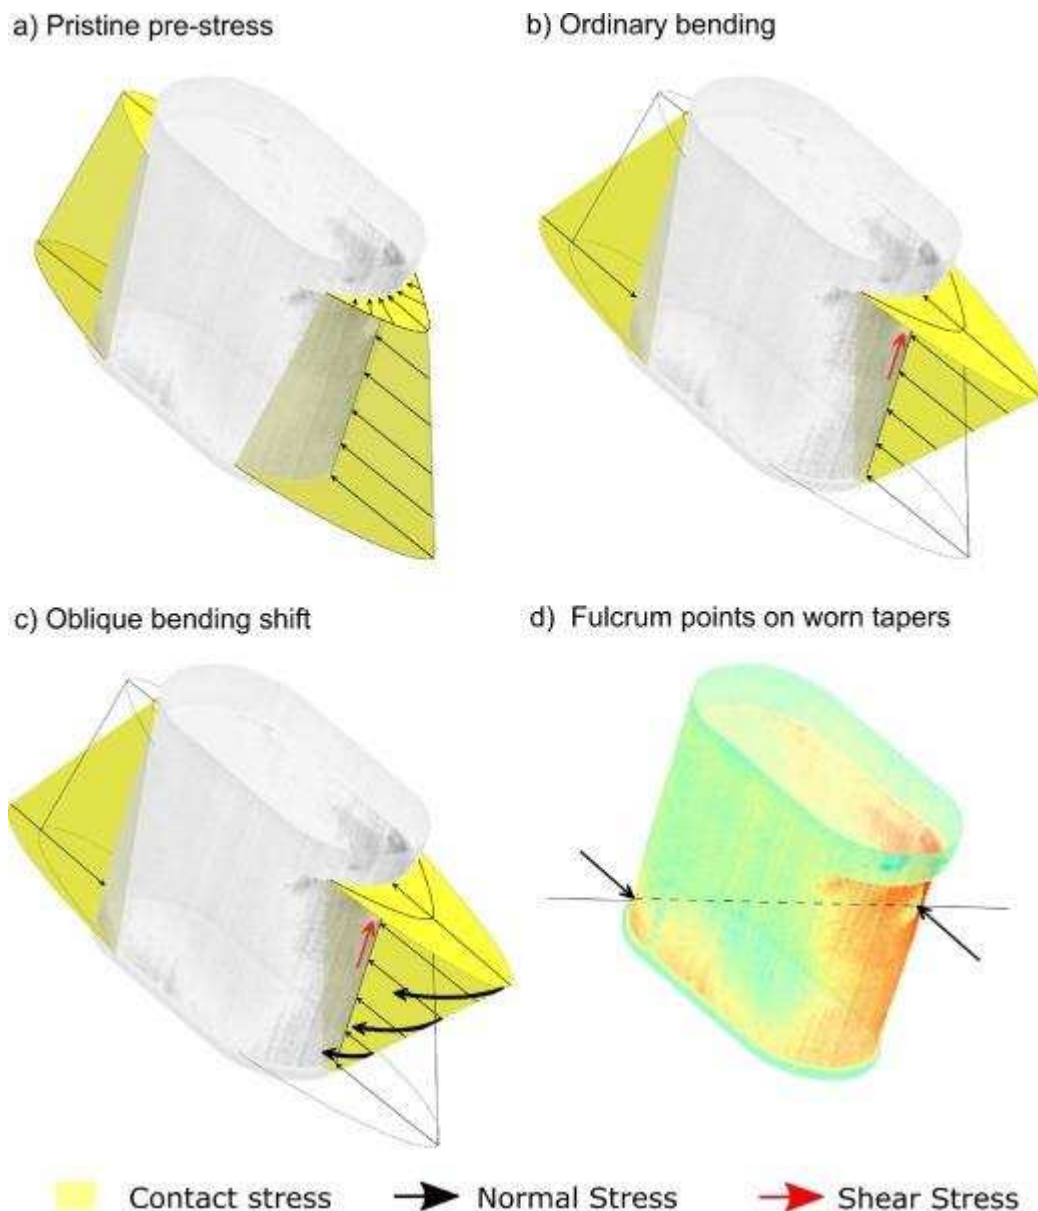
332 their angular clearance. Instead of the engaging at the throat (Figure 10a), the tapers
333 had changed the permanent pre-stress to a diagonal engagement (Figure 10b). It was
334 thus suggested that the retrieved taper had seated into a canted position prior to
335 being worn. This indicated that the fixation had been insufficient for a stable transfer
336 of loads with the predicted engagement strategy (Figure 4). The permanent tilting of
337 the taper might impose additional incongruences to the taper contact surfaces that
338 potentially gave rise to local-wear phenomena and the observed wear transitions.
339 Once initiated, these “spacers” prevented a more homogenous contact
340 configuration with smaller crevices (Figure 10d). An increased fretting motion
341 toggling around these fulcrum points was suggested. This may explain the

629 *Figure 10: Prediction of the configuration of normal contact stress (yellow) on a*
630 *male taper of the analyzed design, from pristine to worn. a) Initial taper*
631 *pre-stress in a potential, full apex seating position. Normal stresses*
632 *(yellow) are expected highest at the apexes, deep inside the taper*
633 *throat (Figure 3). b) An in vivo load within the longitudinal plane*
634 *connecting the taper's apexes produces bending in the direction of the*
635 *taper symmetry plane. In this case, the highest stress will remain at the*
636 *apexes. The elastic deformation of the components may result in a*
637 *temporary shift to diagonally distributed contact stresses. c) Loads with*
638 *an offset to the taper's symmetry plane create an oblique bending. In*
639 *this case, the highest stress at the taper interface may be tilted from the*
640 *location of maximal pre-stress available at the apexes. Anterior and*

641 *posterior flat taper sides may also experience contact loads. At a*
642 *distance from the apexes, lower pre-stress makes the tapers prone to*
643 *relative motion. d) Once wear has developed in a diagonal pattern,*
644 *engaging patches at the conical sections are suspected to act as fulcrum*
645 *points. Relative motion within the taper is then dominated by a single*
646 *axis toggling between them.*
