Microscopic investigation of subsurface initiated damage of wind turbine gearbox bearings

Jasim H AL-Bedhany and Hui Long*

Department of Mechanical Engineering, The University of Sheffield, Sheffield, UK.

Abstract. Wind turbine gearbox bearings experience premature failures by White Structure Flaking (WSF), often occurs much earlier than their designed life of 20 to 25 years. This results in increased operational and maintenance costs due to unplanned maintenance and early replacement. The main causes and damage initiation mechanism of this premature failure are not fully understood; despite extensive research and investigation in recent years. In this paper, two planetary bearings from a failed gearbox of a multi-megawatt wind turbine are destructively investigated to characterize the subsurface microstructural damage and to understand damage initiation mechanism leading to surface WSF. The results show that the non-metallic inclusions are not the only initiator of subsurface damage. The microcracks are also initiated in the subsurface to form macrocracks which then propagate or connect to other macrocracks to reach the rolling contact surface causing WSF. The characterization

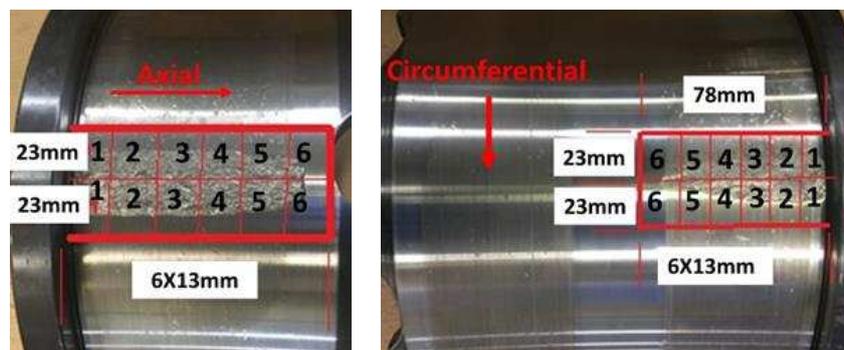
In this study, the severely damaged regions of two planetary bearings are destructively investigated. The samples for microscopic investigation are cut and examined in both axial and circumferential directions of the bearing raceway, as illustrated in figure 1. Samples are mounted using conductive resins to show the investigated surfaces. By using this cutting procedure, the entire axial plane located in the centreline of the severely damaged zone as well as six equally spaced circumferential sections of the raceway can be microscopically investigated. Samples are grinded, polished then etched with 2% Nital (2% Nitric acid and 98% ethanol). Optical microscope and Scanning Electron Microscope (SEM) are used in parallel with EDX technique to investigate the microstructure alterations and different forms of damage. Damage forms such as inclusion-initiated cracks and butterfly wings are characterised according to their damage features defined by dimensions, depth beneath the rolling contact surface, inclination angle relative to the rolling surface and inclusion Aspect Ratio (AR). The subsurface damage initiation is analysed by correlating the damage features with possible loading conditions experienced by the bearings during their operation. Subsurface stress distributions beneath the contact surface and the stress variation due to various loading levels are determined using Hertzian contact theory. Stresses distributions under the effect of surface traction are also calculated to analyse its expected role on damage initiation.

Figure 1. Investigated failed bearings and sample locations (upwind and downwind bearing raceways).

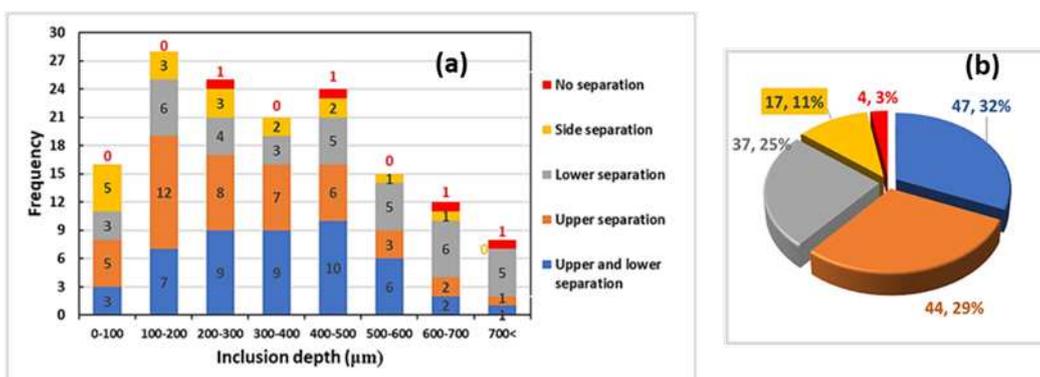
Different forms of inclusion related damage are found in subsurface of the bearing rolling contact, including: inclusions separated from the matrix, cracks extended from inclusion into the matrix and butterfly wings. Percentages of different types of damaged inclusions with their depths are presented in figures 3 and 4. All separated inclusions are found to be located approximately within the depth of the maximum shear stress zone in the subsurface of the contact. For inclusions with separation in the centre of the upper side of the inclusion boundary, the damage may be due to shear stresses with surface traction, since the traction effect brings the maximum shear stress zone closer to the contact surface. The numbers of inclusions with separation at the lower side of the inclusion increase with the depth. By comparing the depths of damaged inclusions by separation in figure 3(a) with the depth of the maximum shear stress shown in figure 2, it is clear their depths are closely correlated.

Figure 3. Damaged inclusions by separation: a) in relation to subsurface depth; b) numbers and percentages of separated inclusions.

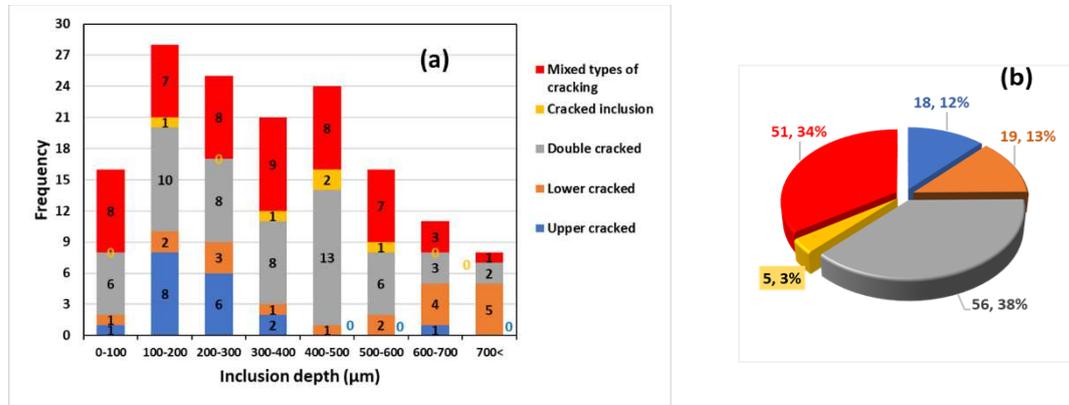
Inclusions with separation are the most dominant damage form however damaged inclusions by cracking are also observed. The cracks appear in different forms: in the tip of the upper side of the inclusion (towards the rolling contact surface), in the tip of the lower side of the inclusion, internal cracking of the inclusion itself, or combined cracking of these different forms. Inclusions associated with cracks are approximately located within the depth of maximum shear stress in the subsurface of

the contact as shown in [figure 4](#). The characterization of damaged inclusions supports the previous suggestion that the inclusion-initiated damage in subsurface may be resulted from effects of shear stresses and the cracking appears along the maximum shear stress plane.

Figure 4. Damaged inclusions by cracking: a) in relation to subsurface depth; b) numbers and percentages of cracked inclusions.

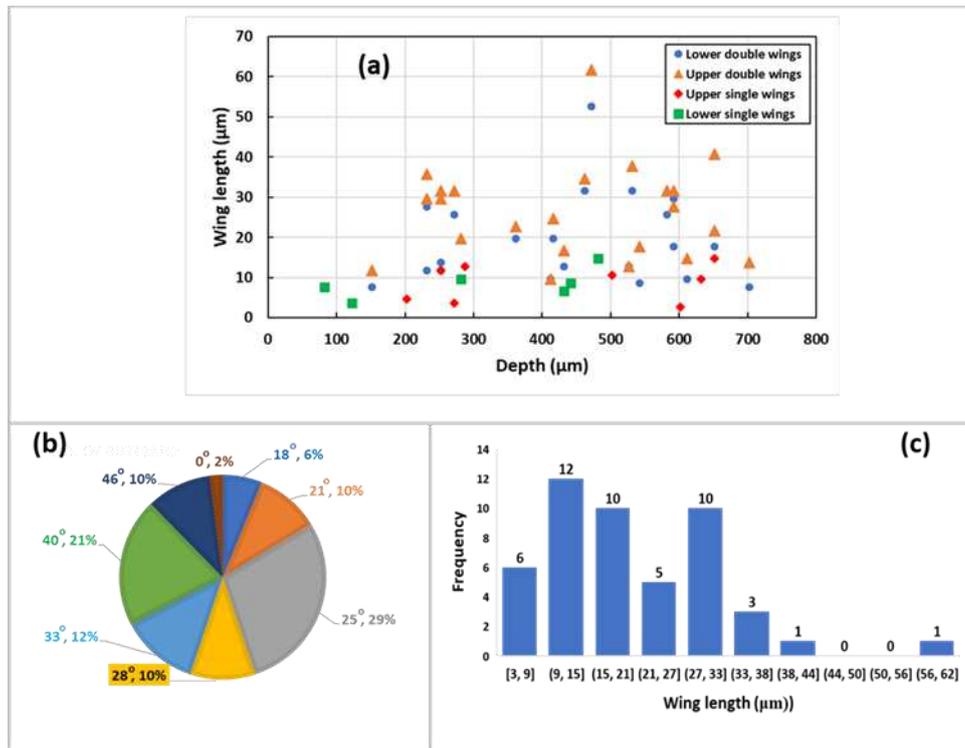
The depth distribution of the 49 observed butterfly wings is shown in [figure 5\(a\)](#). All butterflies are in the circumferential-sectioned samples, approximately located at the depth of the maximum shear stress. Number of butterflies observed increases with increasing depth, however no butterfly is found in depth greater than 700 µm. Only one small butterfly wing is found parallel to the contact surface. Considerable butterfly wings have an inclined angle to the rolling contact surface at 25° or 40° respectively, counted as 29% and 21% of all butterflies, as shown in [figure 5\(b\)](#). [figure 5\(c\)](#) presents the distribution of butterfly wings according to the lengths of their wings. Because the investigated samples are cut from the severely damaged region of the bearing raceways where some parts of the contact surface are removed by severe spalling therefore no butterflies are found in shallow depths of the rolling contact surface.

Around 71% of the butterflies found have double wings while 57% of the remaining butterflies (29% of all butterflies found) have single wing at the upper side of the initiation inclusion and the rest butterflies have single wing at the lower side. Single winged butterflies have shorter lengths when compared with the double winged butterflies. This leads to a hypothesis that butterfly wings may have initiated as a single wing first and the other wing appeared later, then they propagated together to grow into longer wings. There is no evidence to support whether the upper or the lower wing has initiated first however the point of wing initiation may depend on the location of the damage initiating inclusion in relation to the location of maximum shear stress. These observations support the suggestion that the maximum shear stress is an influence factor on the initiation of butterfly microstructure damage [22]. It is observed that cracks associated with butterfly wings are probably not a part of macrocrack network that linked to rolling contact surfaces because they disappear after regrinding the sample surfaces where the butterfly wings are observed. However, the butterfly cracks may not play an important role on subsurface damage propagation. All forms of damage are probably produced due to the shear stress levels have exceeded a critical limit of the bearing material.

Figure 5. Butterflies: a) wing lengths in relation to subsurface depth; b) wing angles and percentages c) occurrences in relation to wing length.

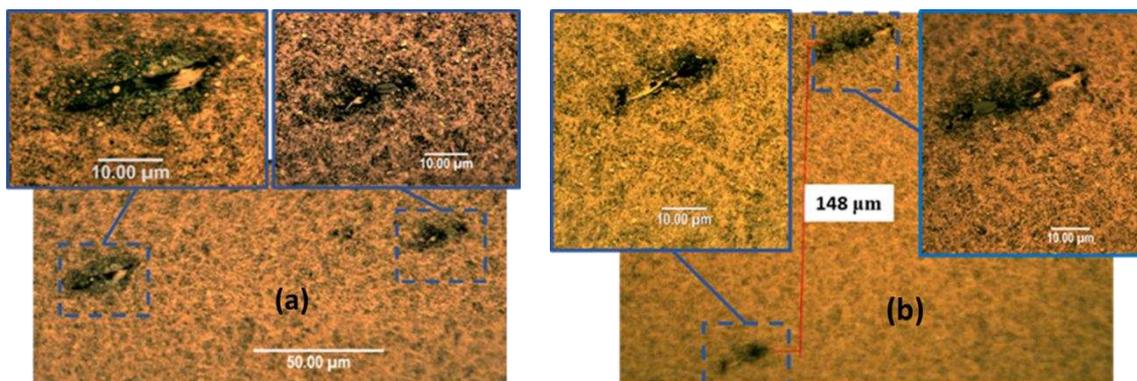
There is no clear correlation between the depths of damaged inclusions with the occurrence of butterflies with upper or lower wing. [figure 6\(a\)](#) shows two inclusions located approximately at the same depth (~320 µm); however, one inclusion has an upper single wing while another has a lower single wing. [figure 6\(b\)](#) shows two inclusions with butterfly wings, the inclusion with an upper wing is located at depth of ~250 µm; however, the inclusion with a lower wing is located deeper at ~148 µm.

Figure 6. Depths of butterflies a) two butterflies with upper / lower wing located at the same depth; b) two butterflies with upper / lower wings located at different depths.

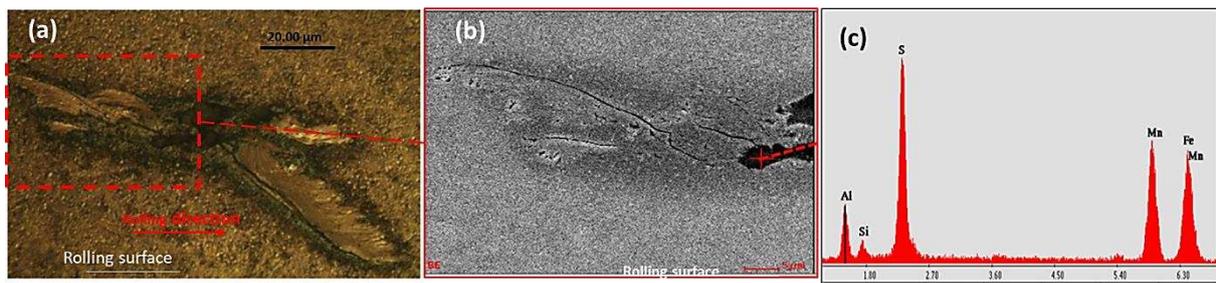
One of the largest butterflies found in this study is shown in figure 7(a). It is located at the end region of the severely spalling area away from rim of the downwind bearing (sample No.6 in figure 1). This butterfly has a depth of ~470 µm beneath the rolling contact surface, within the maximum shear stress zone as shown in figure 2. The inclusion in the centre of the butterfly wings shown in figure 7(b)

has a darker colour compared to that of MnS inclusions which have light grey colour[13]. Energy Dispersive X-ray (EDX) analysis is used to confirm the inclusion's chemical compositions, as shown in figure 7(c). The analysis shows that it is a compound inclusion of MnS, aluminium oxide and silica in addition to other chemical compositions. Thus it is the inclusion type D_{Dup} according to the International Standard ISO-4967:2013[13]. Aspect Ratio (AR) is defined as the ratio of inclusion lengths along the major to minor axes and it is used to evaluate the inclusion shape. It is found that the majority of the butterflies are initiated at inclusions having low aspect ratio of around 2:1. It is also observed that the butterflies are likely associated with inclusions with internal cracks in a direction approximately parallel to the direction of maximum length of the butterfly wing.

Figure 7. Inclusion initiated the largest butterfly: a) optical image; b) SEM image of one wing; c) EDX of central inclusion.

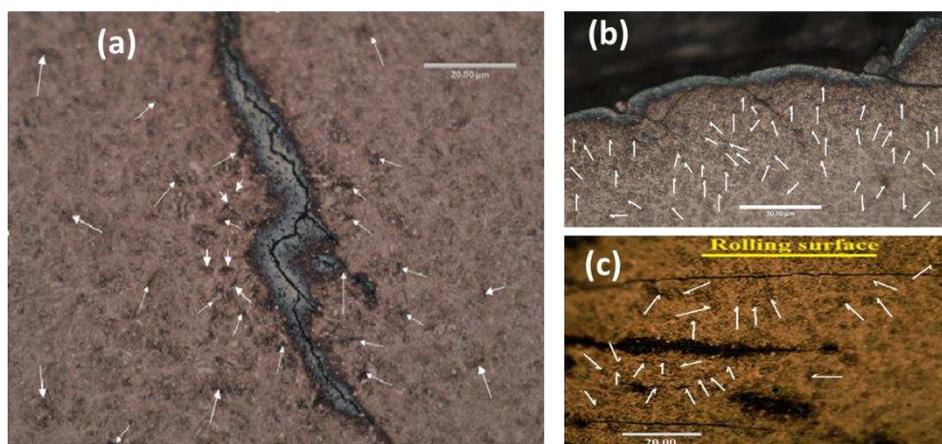
A considerable number of microcracks along a macrocrack are observed on a sample which is over etched as shown in figure 8(a) (marked with white arrows). Further inspections find that considerable microcracks exist on other samples in both axial and circumferential directions as shown in figure 8(b) and 8(c). The considerable number of subsurface microcracks and macrocracks have also been observed in the previous studies [2][22][23][24] however so far limited investigations exist to explain their role on WSF.

Microcracks are found near the sides and ends of the macrocracks where the number of microcracks is much higher than the number of the damaged inclusions. This leads to a postulation that both inclusion and microcracks are the initiators of subsurface microstructural damage leading to WSF. However, the weak boundaries and the residual stress around inclusions play an important role in subsurface damage initiation.

Figure 8. Over etched specimens showing microcracks: a) and b) circumferential sectioned samples c) axial sectioned sample.

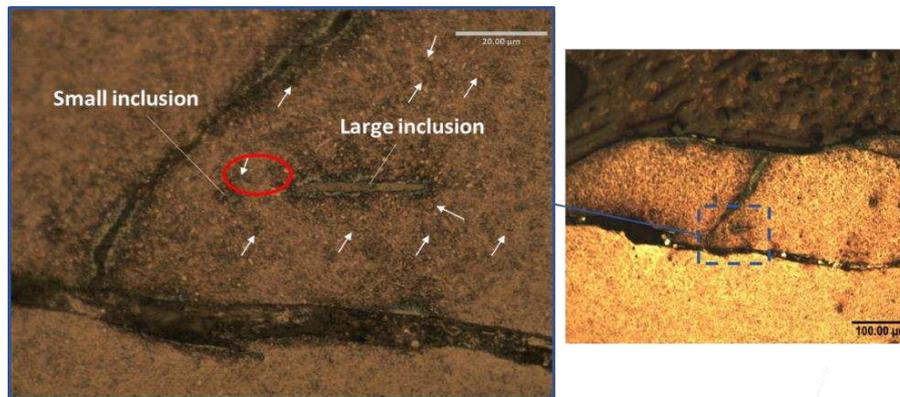
Figure 9. Large inclusion unconnected to surface crack network in axial sectioned sample.

The evidence of the role of subsurface microcracks on damage initiation is also shown in an axial sectioned sample in figure 9. A relatively large inclusion located close to the contact surface does not connect to the macrocracks network around it, despite the inclusion is connected to another small inclusion with a crack (marked with a red ring), the two connected inclusions are not connected to the macrocrack network. A considerable number of microcracks around these two inclusions can be seen (marking by white arrows). This leads to a postulation that subsurface microcracks and/or the cracks initiated from the separation of inclusion boundaries probably propagate towards each other, depending on the direction of the maximum shear stress in high stress locations, they then propagate towards the contact surface causing WSF.
