Tayefi, P., Beck, S.B.M. and Tomlinson, R.A. orcid.org/0000-0003-2786-2439 (2019) The fatigue performance of electrofusion tapping tees subject to contamination. *International Journal of Pressure Vessels and Piping*, 171. pp. 271-277. ISSN 0308-0161

**THE FATIGUE PERFORMANCE OF ELECTROFUSION TAPPING TEES
SUBJECT TO CONTAMINATION**

P. Tayefi, S.B.M Beck, R.A. Tomlinson

Department of Mechanical Engineering, University of Sheffield

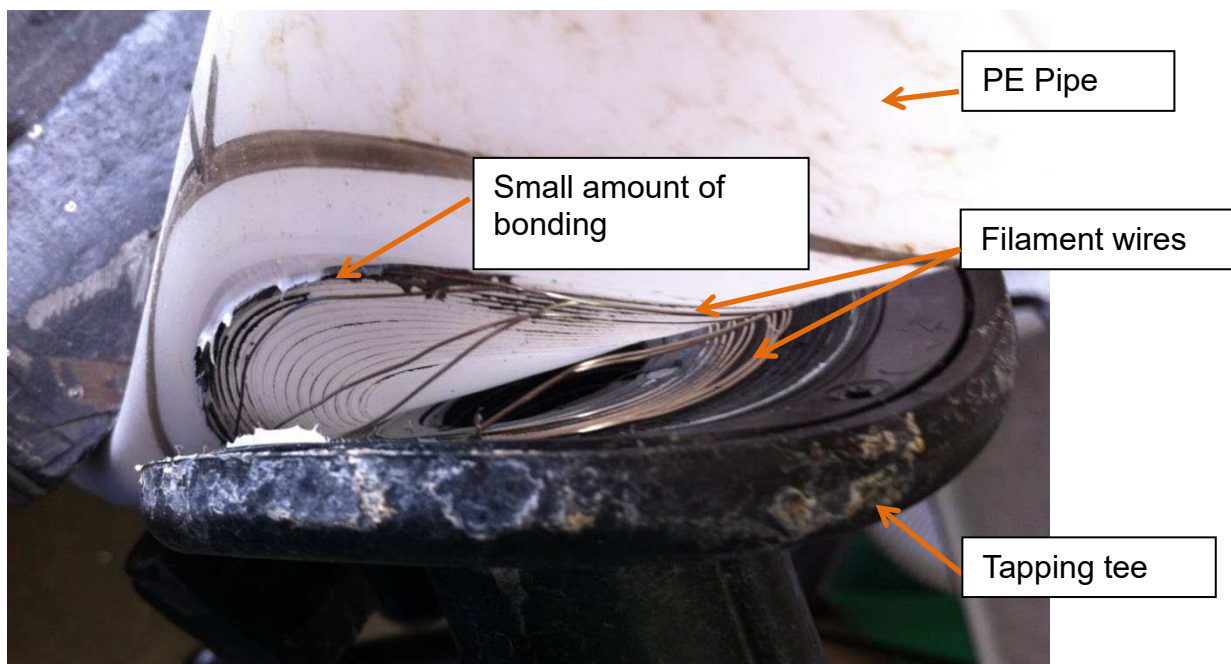
Figure 4.2 Aerial view of contaminated specimen following the crushing decohesion test

Figure 4.2 shows an aerial view of the pipe and fitting when the crushing device reached its maximum distance. Once the maximum displacement was reached in the crushing test, the

fitting was further removed from the host pipe by using a relatively small amount of force which was applied by hand, just using the stem of the tapping tee as a lever. As can be seen in Figure 4.2, there were small black marks on the pipe where it appears a small amount of bonding had taken place between pipe and fitting. However, indentations on the surface of the pipe from where the filament wires were embedded into the pipe show that they may have been offering some structural support to the assembly.

Small amounts of ductility are visible about the outer circumference of the fusion zone. Note that this area was where the filament wires were mostly embedded into the parent pipe. It is important to note that the failure of the joint when subject to this test should be classed as a brittle failure. However, the ductility observed is very small and localised about the outer circumference of the fusion interface; more specifically, either side of the indentations on the parent pipe created by the filament wires during the welding process.

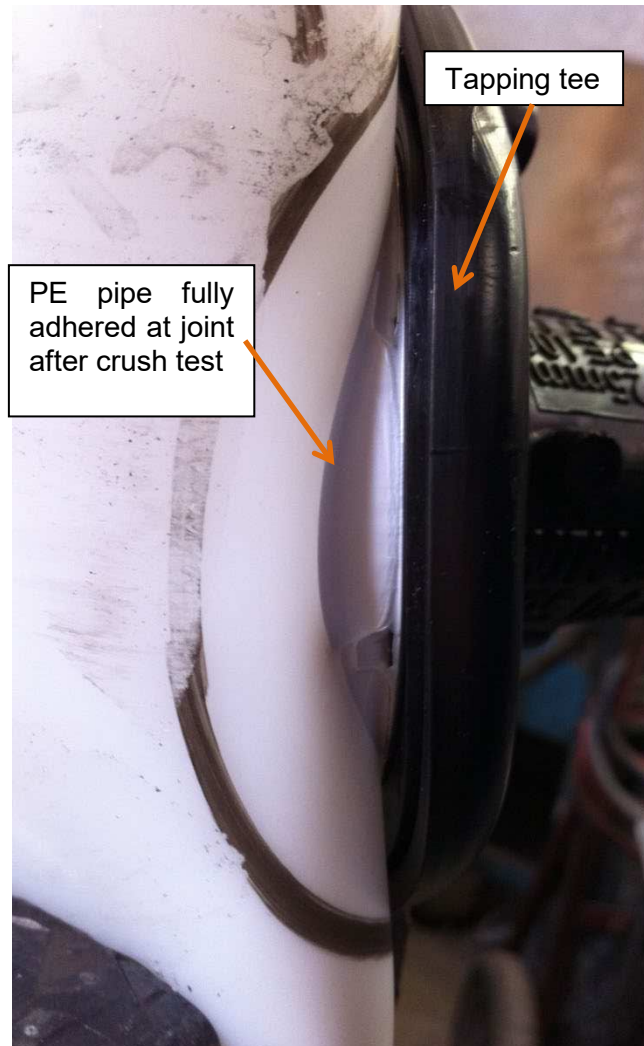
Figure 4.3 'Perfect', uncontaminated specimen following the crushing decohesion test

extent of the crushing device. As can be seen, the specimen was just beginning to fail on the outer part of the fusion zone but still remains fully adhered to the PE pipe when the maximum crushing distance is reached; suggesting that a ductile failure would occur.

The assembly was further crushed on the opposing side of the fitting assembly in an attempt to yield the specimen but with no success. It can also be seen (in Figure 4.3) that there is very little opportunity to insert a lever to persuade the specimen away from the pipe. ISO 13955 [18] states that no impact forces shall be used to yield the fitting from the pipe, therefore using only a lever to remove the fitting from the pipe was a next to impossible task. It was

therefore concluded that the specimen would fail in a fully ductile manner. This comparison further enforces the detrimental nature that contamination has on joint integrity.

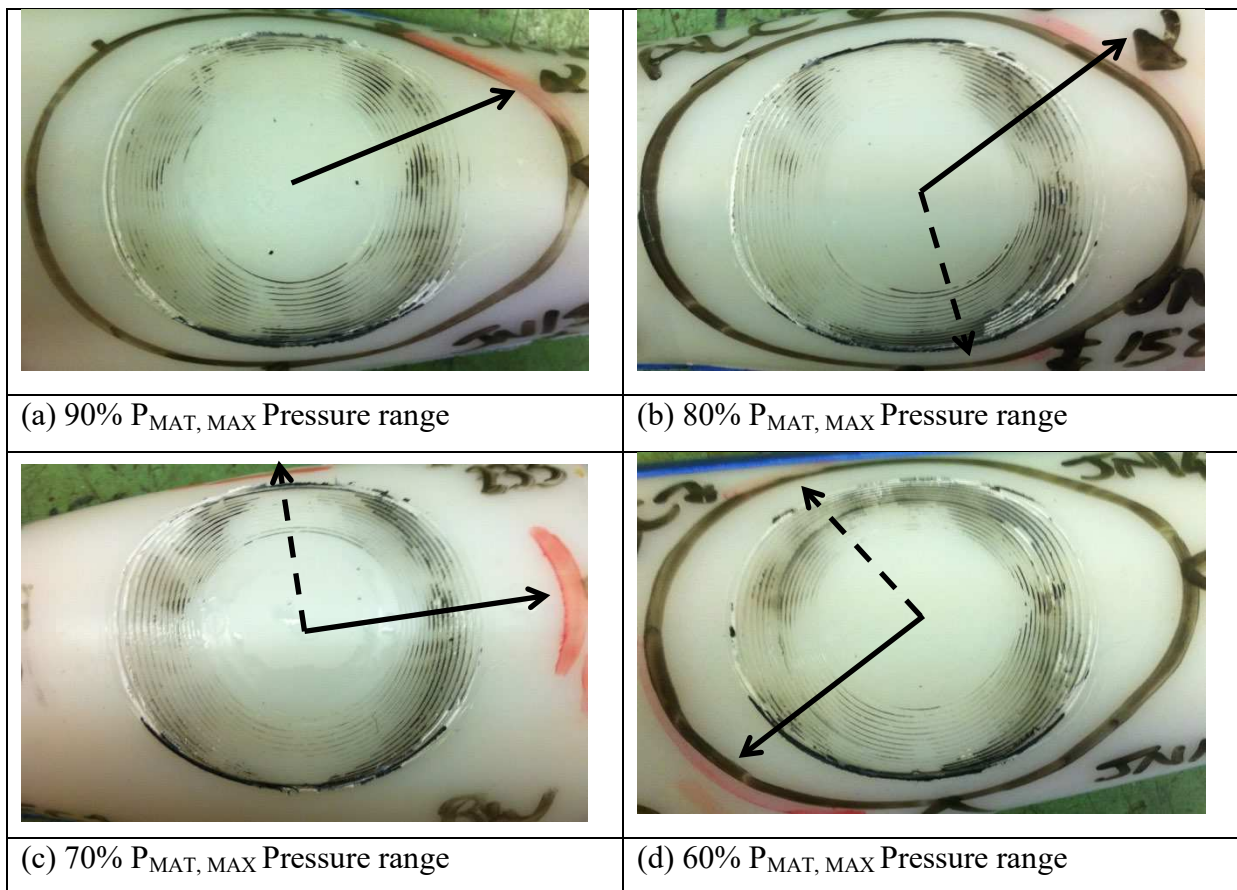
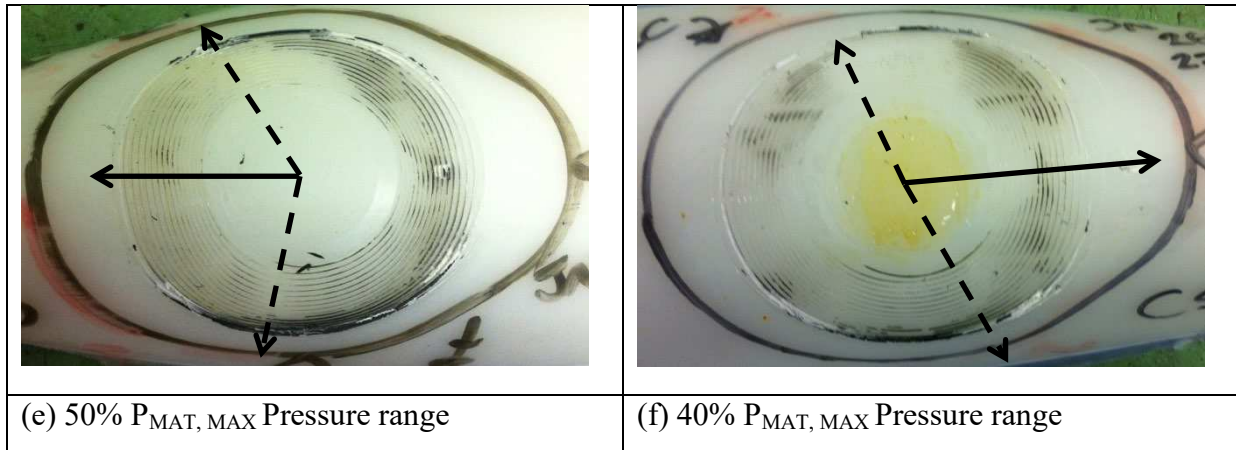
Figure 4.4 Pipe joint surfaces following fatigue test to failure, leak path test and crush decohesion test. The solid lines indicate major leak paths and dashed lines indicate minor leak paths

For illustration purposes, for each pressure range tested, a contaminated specimen was selected whose number of cycles to failure was the closest to the average number of cycles to failure. Figure 4.4 figure shows pipe surfaces following the crush decohesion test and also indicates the approximate leak paths. The leaks were classed as major and minor leaks, where a major leak can be described as the primary flow of water; whereas a minor leak would be almost a trickle of water that is subsidiary to the major leak.

Post-failure analysis of the contaminated joints revealed very little bonding between the electrofusion tapping tee and the host pipe, therefore it can be assumed that all specimens failed in a brittle manner. In all of the samples tested, the effects that contamination has on the adhesion of the fitting to the parent pipe are clear, in that, when compared to the “perfect joint” (Figure 4.3), the fittings were easily fully removed from the pipes using the crush decohesion test (Figure 4.4). The most logical failure mechanism for brittle failures would be crack propagation [19] of the jointing surface. However this was proved not to be the case. As can be seen in Figure 4.2, sections of the electrofusion filament wire were embedded into the host pipes. This suggests that wire itself may have been offering some degree of structural integrity if little or no polymer bonding were present. Bonding appears to be the best at the outer circumference of the fusion zone (See Figures 4.2 and 4.4). Here, only a very small amount of ductility can be seen and it is believed that this bonding is located either side of the indentations caused by the filament wires during the welding process. Furthermore, failure (leak) paths appeared to be random which suggests that the product itself has no obvious weak points. Minor leak paths seem to become more predominant as the pressure range is decreased in the fatigue testing regime. For example, the specimen in Figure 4.4(a) (90%

$P_{MAT, MAX}$) has one clear major leak path, whereas in Figure 4.4(f) (40% $P_{MAT, MAX}$) the specimen has one major leak path and two minor leak paths. This may suggest that the lower pressure ranges promote crack growth under dynamic loading; potentially in a circular manner.
