Damage characterisation of white etching cracks in a black oxide coated wind turbine gearbox bearing

H.A. Al-Tameemi, H. Long, R.S. Dwyer-Joyce

This study presents a damage investigation of a failed BO coated planetary bearing retrieved from the gearbox of a multi-megawatt wind turbine. The investigation consisted of a metallurgical damage examination and BO layer characterisation. The examination focused on characterising the initiation of both surface damage and sub-surface damage associated with non-metallic inclusions. In order to characterise the subsurface microstructural defects associated with non-metallic inclusions, steel cleanliness of the BO bearing was examined. To evaluate the mechanical properties of BO coating layer, hardness, modulus of elasticity and thickness of the BO layer in damaged and undamaged raceway surface regions were measured by using Nano-indentation technique. Various forms of microstructural damage were observed in the BO coated bearing, which were compared with the microstructural damage observed in the uncoated bearings investigated in our previous published studies [13][14][38].

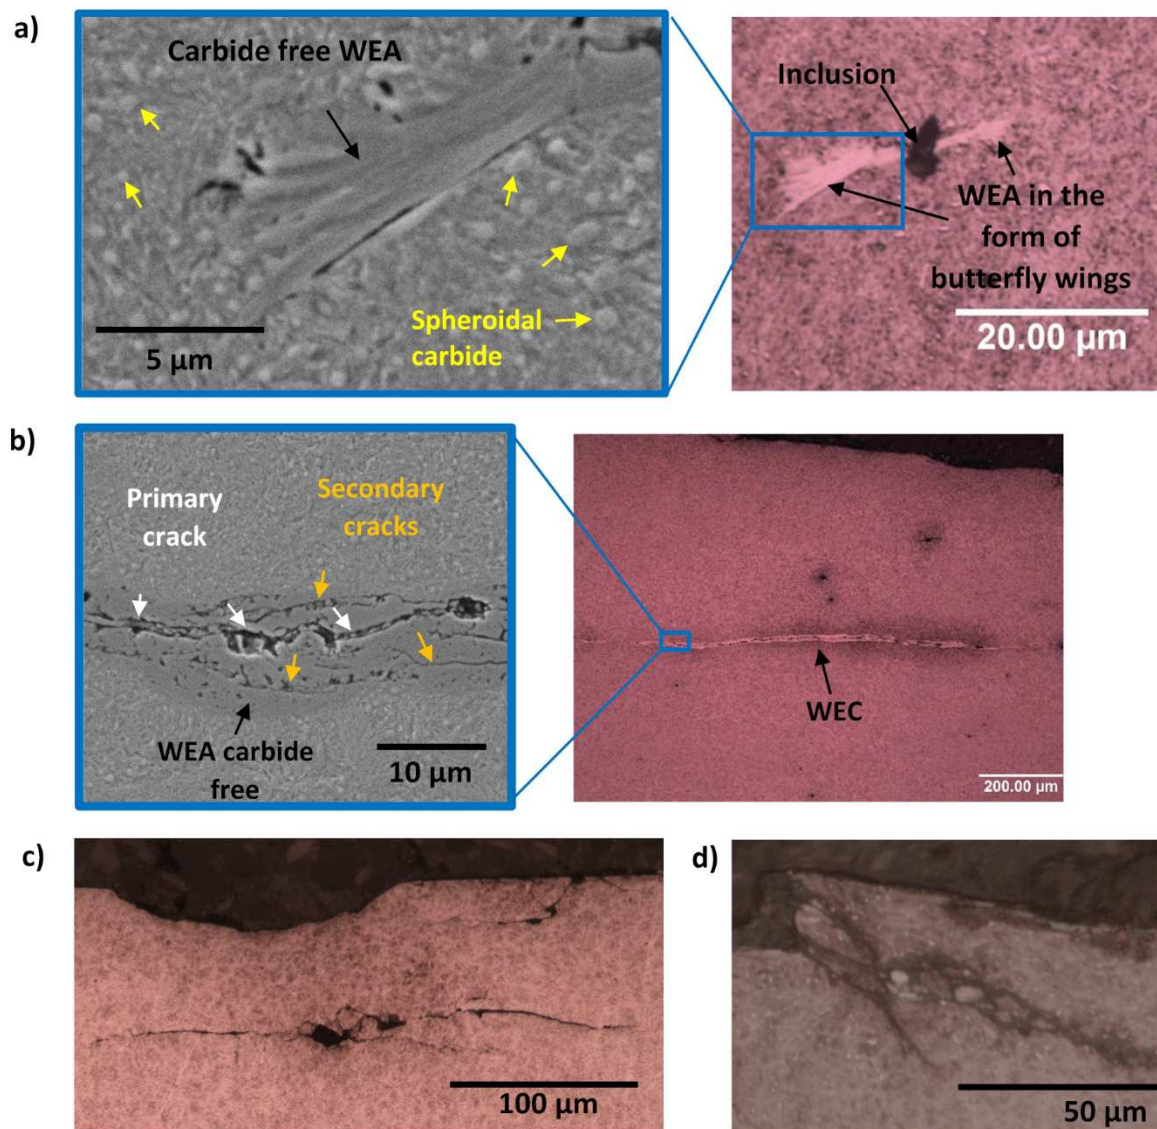
Representative images of these observed forms of microstructural damage are shown in Figure 3. These forms of damage in the BO coated bearing were similar to those observed in the uncoated planetary bearings from our previous studies published in [13][14][38] which focused on investigating subsurface initiated damage. In sections 3.1, 3.2 and 3.3, the microstructural damages in the forms of butterfly wings, subsurface cracks, and surface breaking cracks will be discussed in detail.

Figure 3: Examples of different forms of microstructural damage in the BO coated bearing: (a) Butterfly wings; (b) WEC; (c) Subsurface cracks in the axially sectioned sample; (d) Surface-breaking RCF cracks.

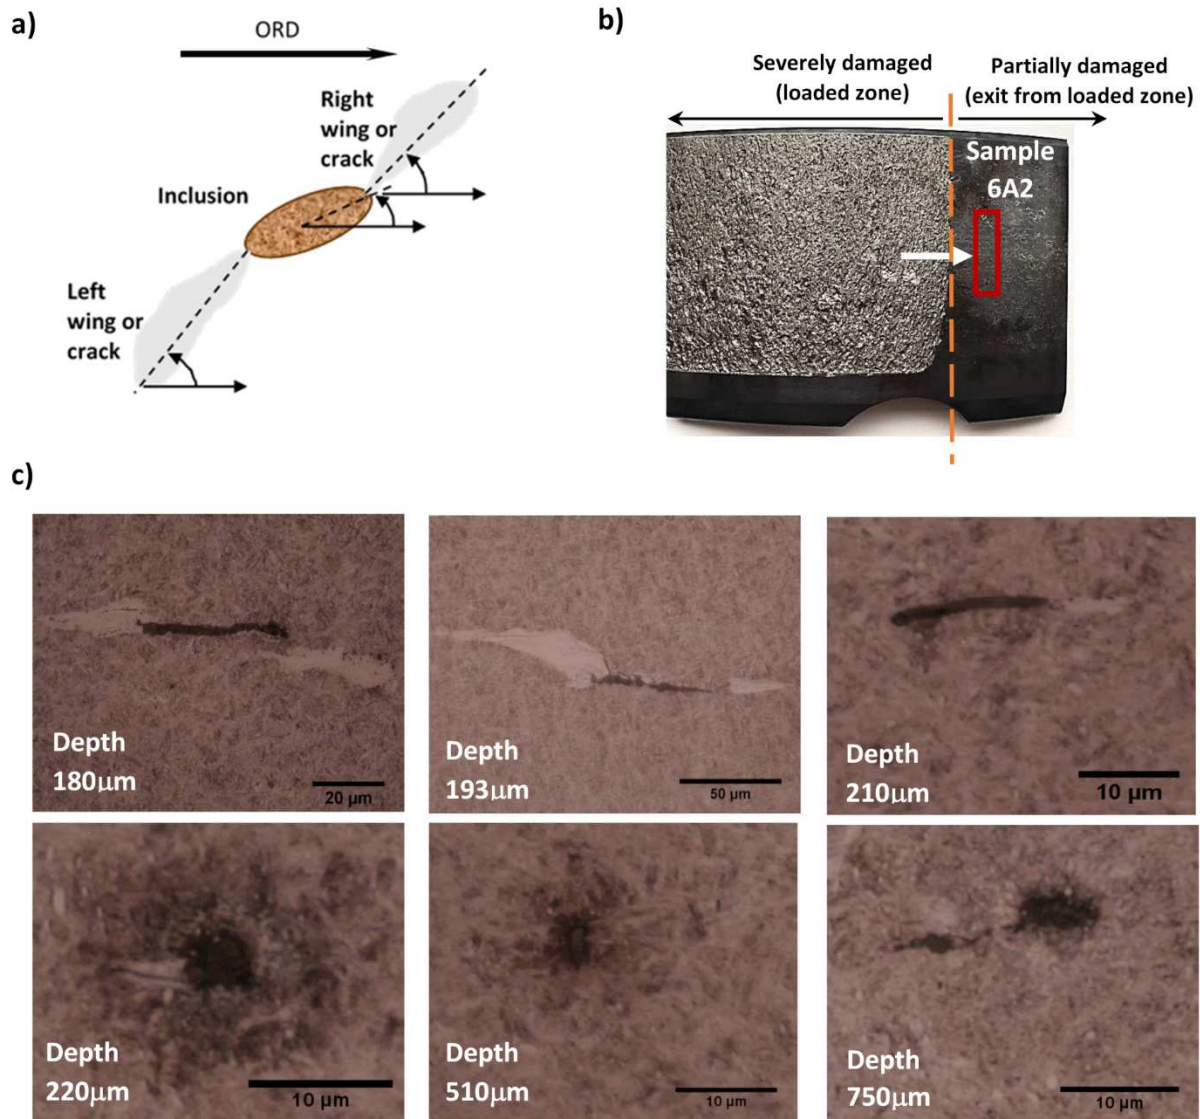
Figure 4: Inclusion initiated damage: a) Definition of angles of inclusion and butterfly right and left wings; b) Sample 6A2 axially sectioned sample located at exit region to loaded zone; c) Examples of butterfly wings initiated at inclusions and their depths.

A high number of butterflies at inclusions was observed in Sample 6A2 (shown in Figure 4(b)), which was the vertically cut sample on the right-hand side of Region 6 located at the exit from the loaded zone (shown in Figure 1). Some examples of damage initiating inclusions found in this sample are shown in Figure 4(c). An inclusion located at a subsurface depth of $750\mu\text{m}$ had micro-cracks propagated from an inclusion and the inclusion at depth of $510\mu\text{m}$ had separation but without butterfly wings, while all other inclusions at various depths, shown in Figure 4(c), were associated with butterflies. The butterfly of the inclusion at depth $193\mu\text{m}$ had the longest wings among all other butterflies observed in this sample. In this sample, the layer of the BO coating was not completely removed but the surface showed many big indents (more than 3mm in maximum dimension). The indented surface was observed by the metallurgical examination as a concave surface without any surface linked cracks, which was different from another vertically cut sample on the left-hand side of Region 6 located within the loaded zone, shown in Figure 1. This indicated that the bearing might have experienced high levels of loading and surface traction during its operation that led to the initiation of micro cracks and butterfly cracks in greater depths when the BO coating on the raceway surface was still partially intact. It provided further evidence that there were multiple initiators leading to the WEA/WEC microstructural damage.

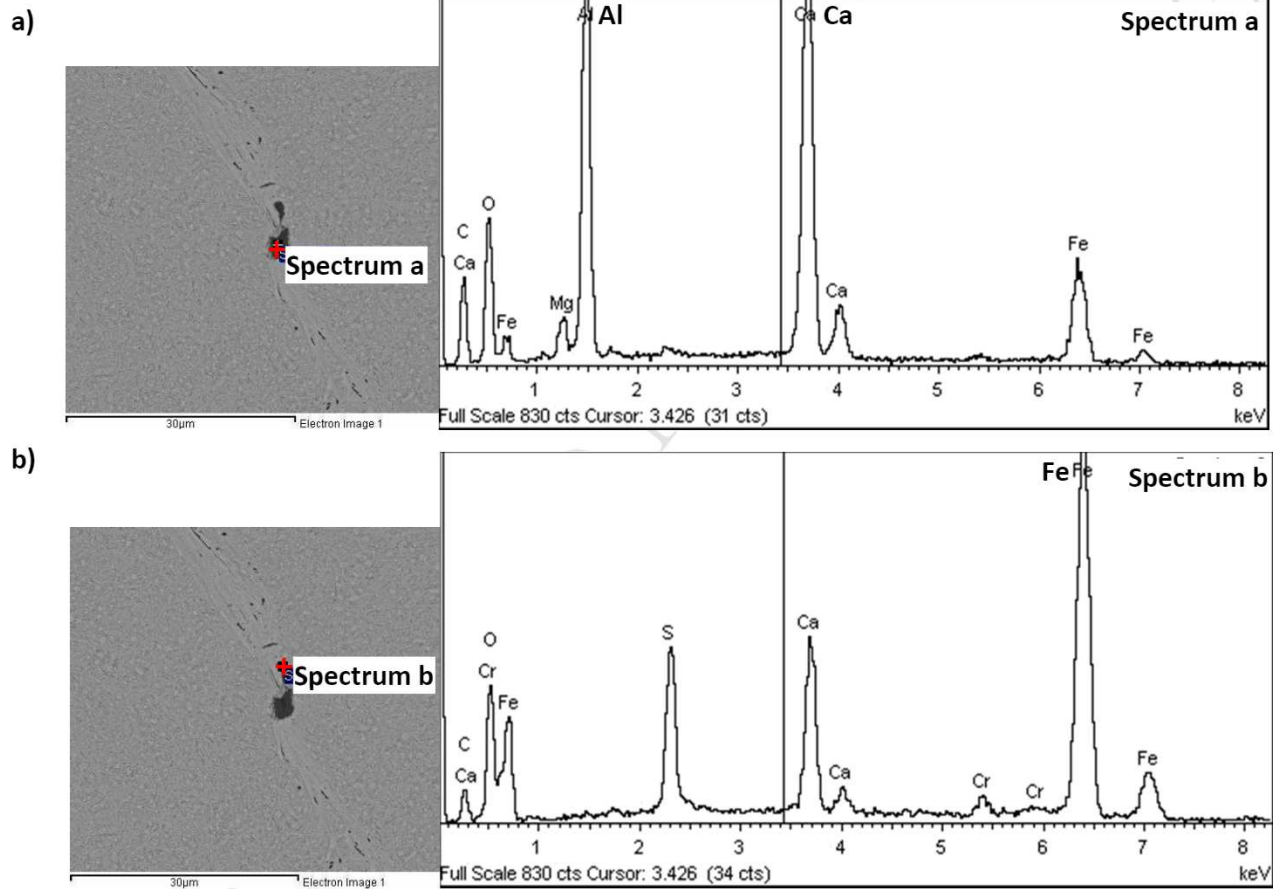
Figure 7: EDXA of the inclusion that initiated the longest butterfly in a circumferentially sectioned sample

The EDX analysis of the inclusions that initiated most of the butterflies revealed they contained the chemical elements similar to those of Type D inclusions. However, some of the inclusions showed chemical elements of a soft sulphide inclusion adjacent to a hard oxide inclusion, as can be seen in Spectrums shown in Figure 7, with an aspect ratio <3 that matches Type D inclusions. The longest butterfly found from a circumferentially sectioned sample had this combination of inclusions, the only one found. This butterfly was found in a sample taken from the raceway edge on the flange side, the top sample horizontally cut from Region 4, as shown in Figure 1. To show the distribution of chemical elements of the inclusion, EDXA mapping was conducted and shown in Figure 8. It shows that the key chemical elements to form one of the four types of inclusions (Types A, B, C, D) were

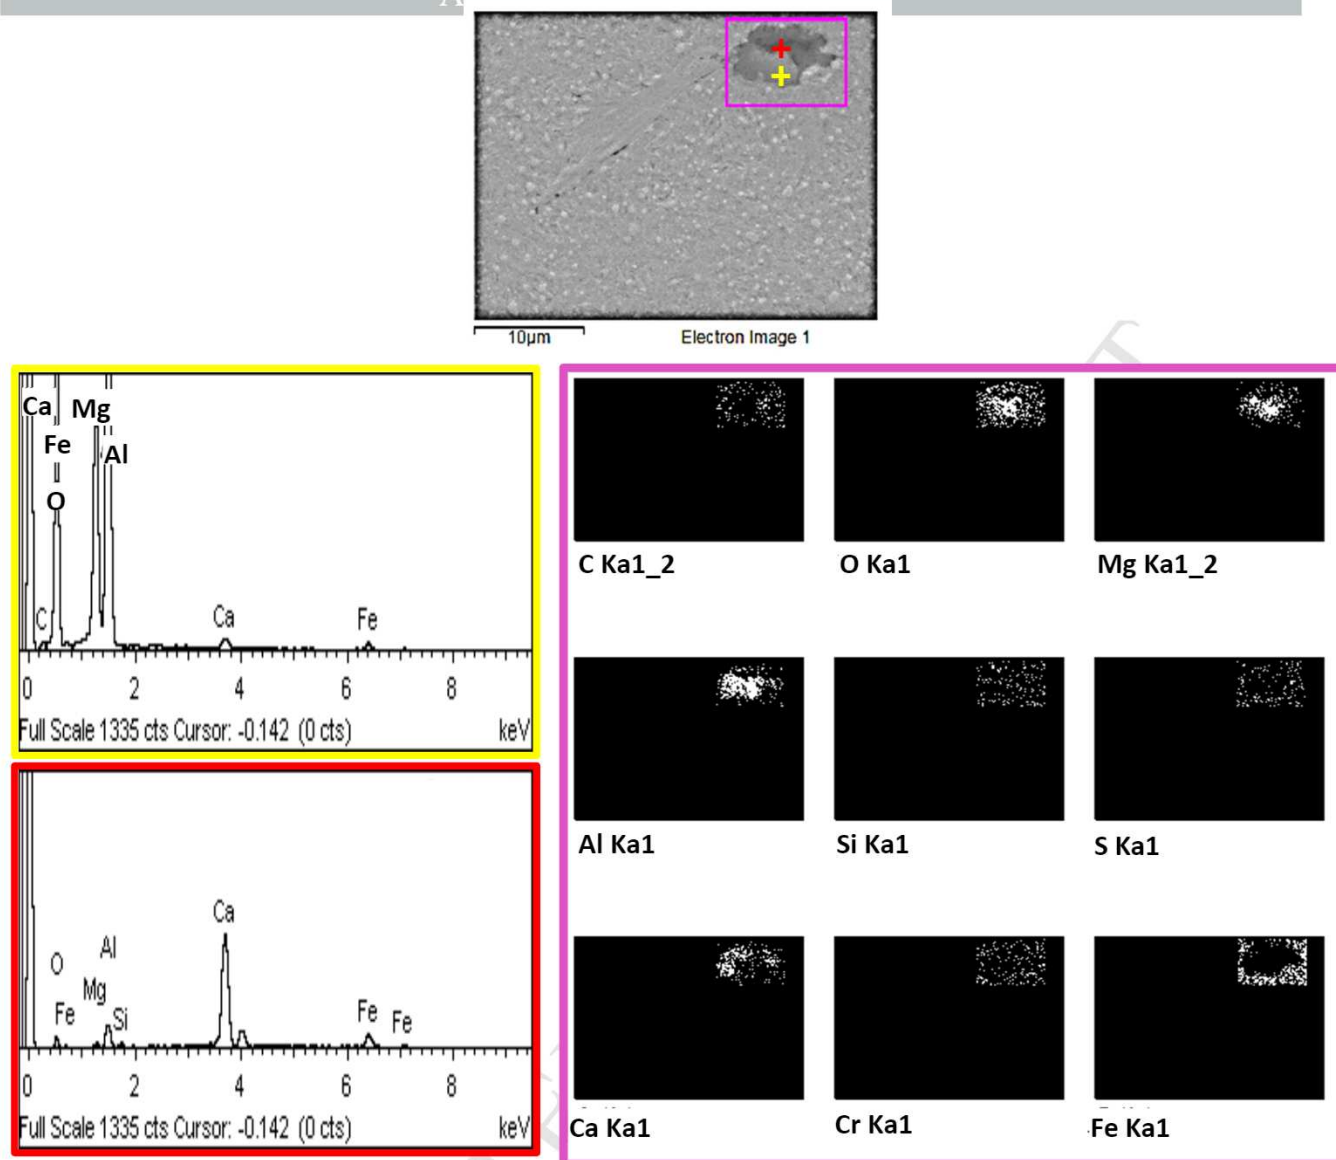
Figure 8: EDXA of chemical elements of Mg-Al-O inclusion

nucleation of the carbide [39]. Thus, this type of inclusions would most likely contribute to the formation of the WEA, since this microstructure alteration is characterised by the dissolution of carbide.

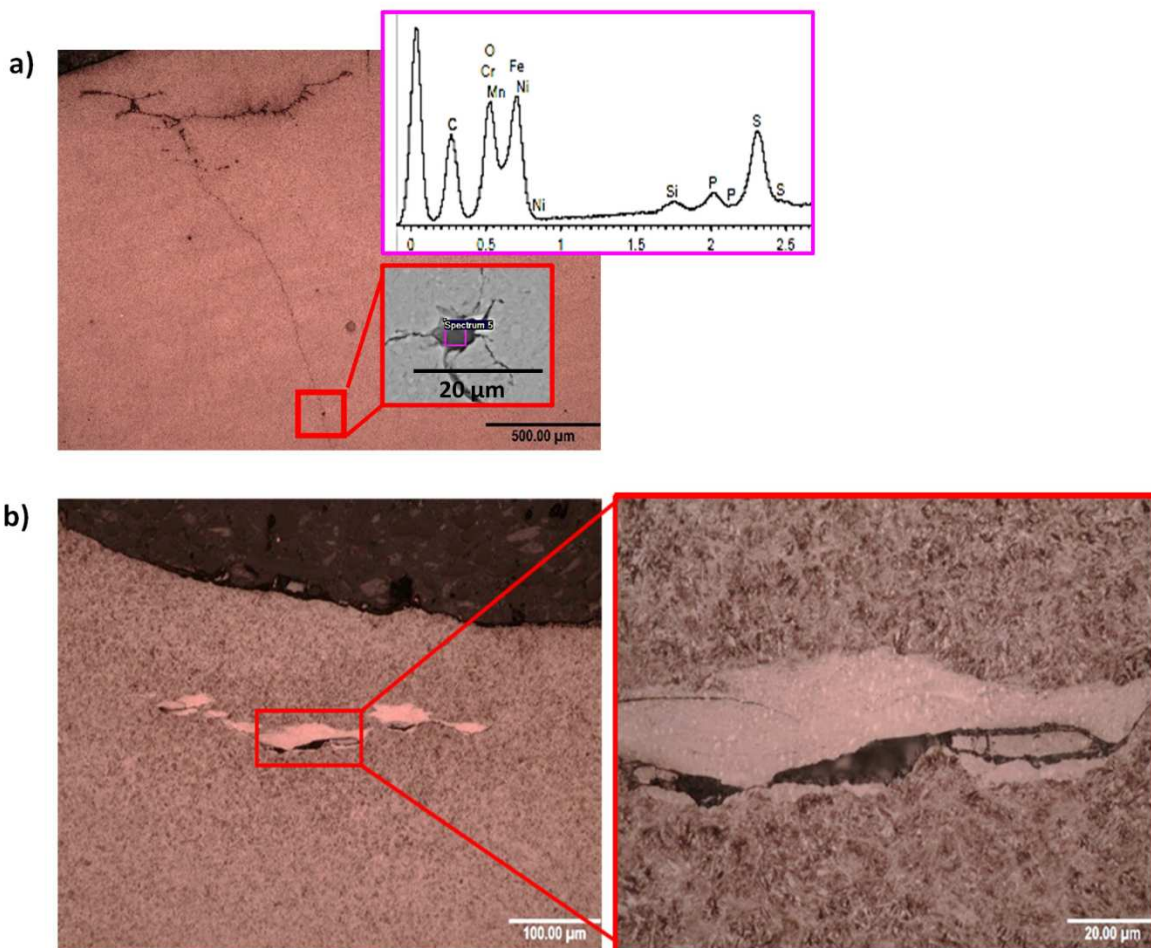
In the circumferentially sectioned samples, the subsurface cracks had irregular shapes. Some of the cracks were found to attach to inclusions that propagated almost vertically to the contact surface, an example is shown in Figure 10(a). The crack could be initiated from the inclusion shown or another inclusion, since the crack was completely under the surface and the only stress concentration point found along the crack was this inclusion. There might be another inclusion where the crack could initiate from, which might have been removed during the sample preparation process, or it could be behind the examined surface of the sample. The EDX analysis of this inclusion shows it was a MnS inclusion, even though Type D inclusions were the dominating type inclusion initiating most damage in this bearing. However, without examining the entire inclusion of 3D in shape including the part under the examined surface or the part that might have been removed by sample preparation, it could not be confirmed that the inclusion was a pure manganese sulphide since it could be aluminates embedded in manganese sulphide [40][41].

The subsurface cracks observed in the axially sectioned samples showed consistent features. They were mostly flat, parallel to the contact surface, and some ends of the cracks were inclined to the surface at a specific angle, an example is shown in Figure 10(b). It was found that the inclination angle was shallow, about 15° to the bearing axis. These cracks could propagate toward the surface to form the subsurface initiated spalls on the surface. It was found that the depth of some of the WECs were

Figure 10: (a) Subsurface crack network initiated from an inclusion at depth $>1500\mu\text{m}$, in a circumferentially sectioned sample; (b) Subsurface WECs in an axially sectioned sample.

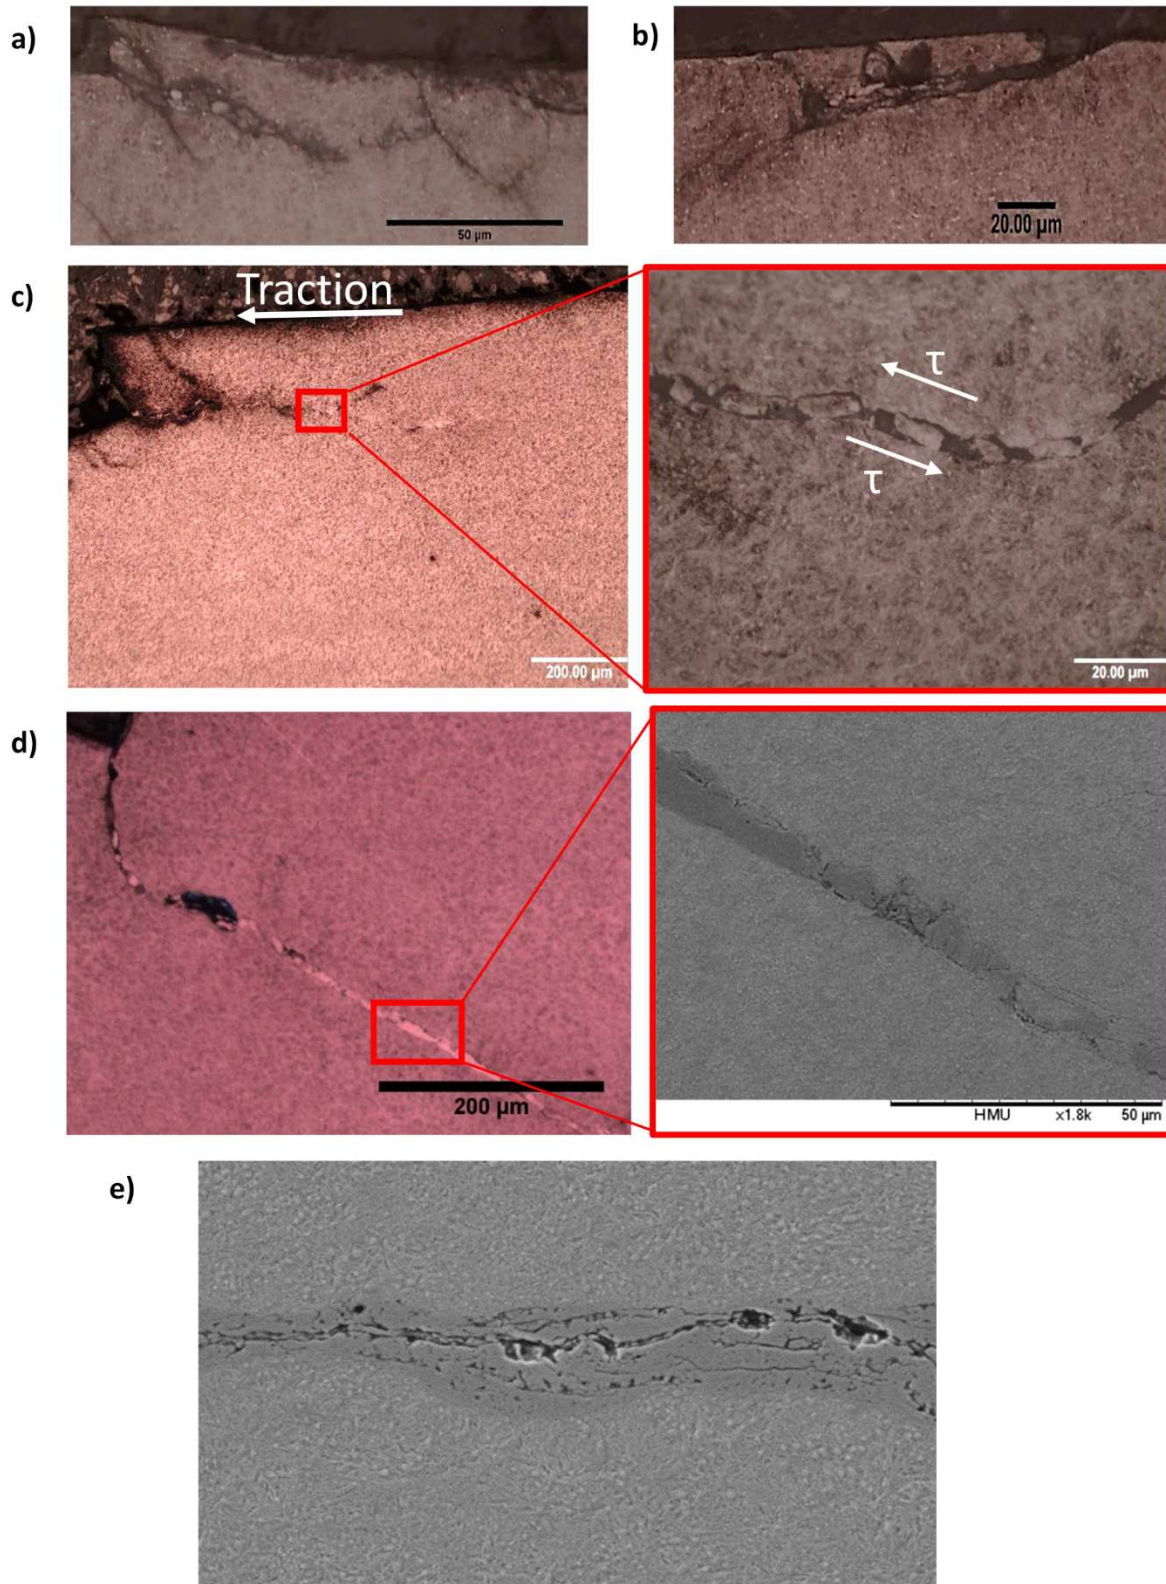
Some of the cracks linked to the surface showed similar characteristics, for example the inclination of the cracks. In some of these cracks, fragments of steel particles were confined within the space created by a crack, as shown in Figures 11(a) and (b). For some surface-breaking cracks the colour of these confined particles appeared to be similar to the WEAs attached to the WECs, especially when they had propagated from the surface into deeper locations, as shown in 11(d), which can be

Figure 11: Surface-breaking RCF cracks: (a), (c) and (d) surface-breaking RCF cracks in circumferentially sectioned samples; (b) surface-breaking RCF cracks in axially sectioned sample; (e) WEC from an axially sectioned sample appeared to be similar to surface-breaking RCF crack in (d).

The inclination angles of the surface-breaking RCF cracks in the axially sectioned samples were similar to those of the subsurface cracks. This indicated that the cracks had propagated almost at the same angle in the axially sectioned samples regardless of their initiation locations, either surface or subsurface. The surface-breaking RCF cracks that initiated from the surface and propagated downward were found to turn upwards after a certain distance, generating surface spalling or micropitting, an example is shown in Figure 12(a). Relatively small spalls or pits were generally formed by surface-breaking RCF cracks, then from these spalls other cracks started propagating downwards and forming bigger spalls, as shown in Figures 12(b) to (d). It was possible that the BO coating provided benefits protecting the raceway surface to a certain extent however this examination showed that the BO layer did not fully alleviate the effect of surface initiated damage which caused severe spalling.

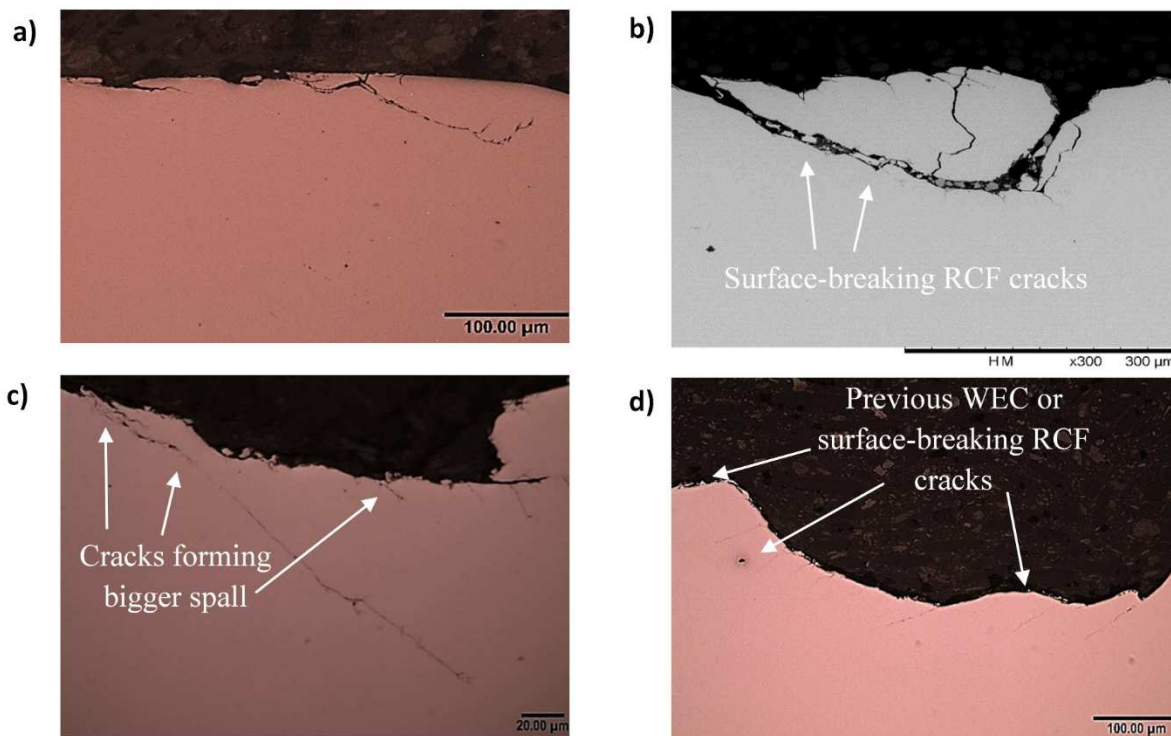
Figure 12: Surface cracks: (a) crack changed direction toward the surface to form a spall; (b) to (d) stages of spall formation by surface-breaking RCF cracks, in circumferentially sectioned samples.

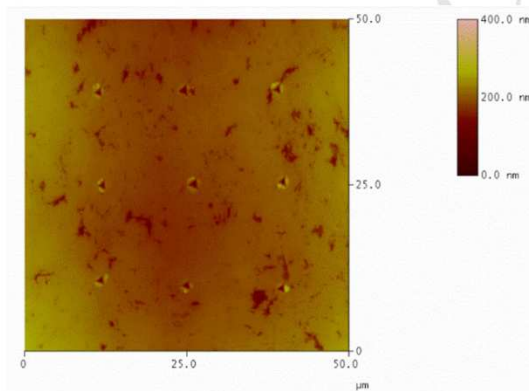
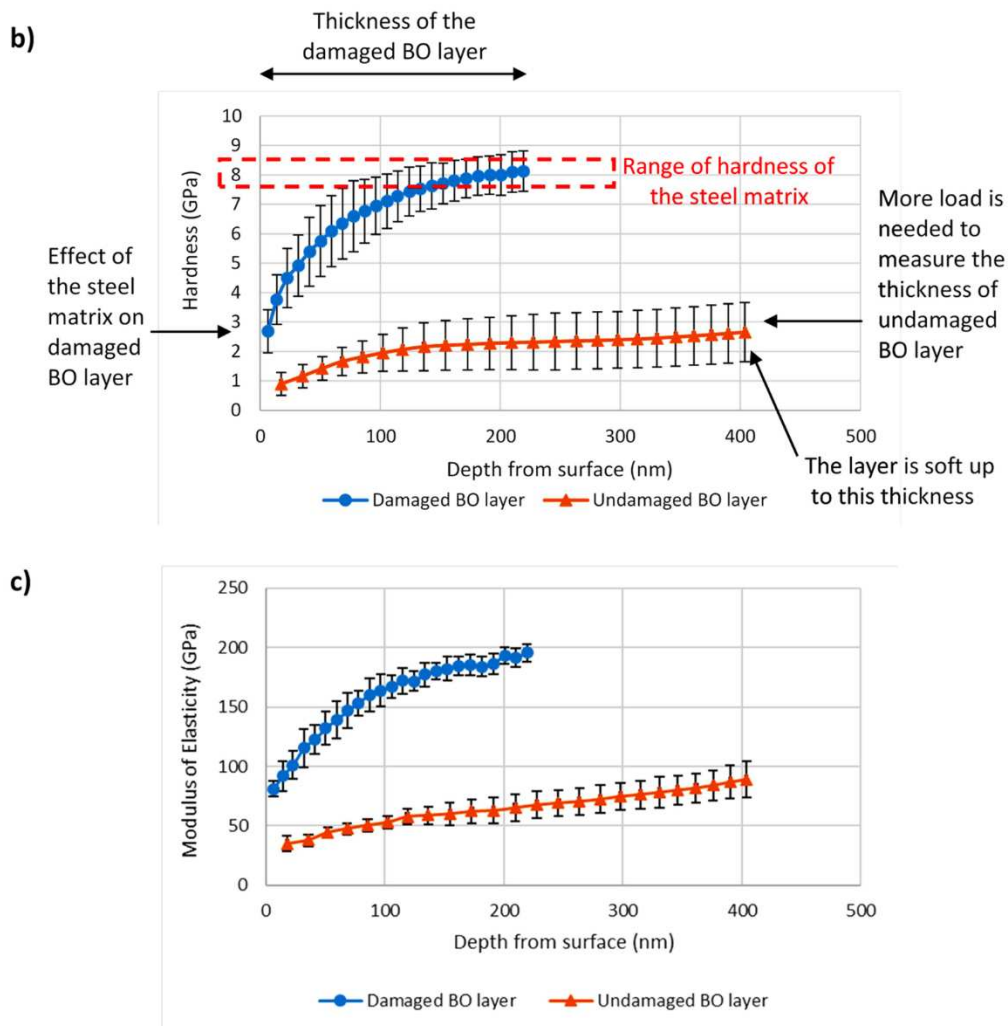
For the low load test using Hysitron Triboscope, the indentation pattern used was a matrix of 3×3 indents with 15 μm spacing, as shown in Figure 13(a). The maximum indent size was 1.6 μm for the partially removed (damaged) region and 2.2 μm for the undamaged region of the BO layer. The sample used to measure the thickness and Nano-mechanical properties of a partially removed BO layer was taken from the entrance region to the raceway loaded zone, which was inside Region 1 in Figure 1(b). The Nano-indentation test on the surface of this sample showed a very thin BO layer, as revealed by the depth values in Figures 13(b) and (c). The hardness and modulus of elasticity of the steel matrix could be seen at the end of these curves indicating the end of the BO layer thickness. However, the Nano-indentation on the surface of a sample from the undamaged BO region, shown in Figure 1(b), did not show the total thickness of the BO layer as shown in Figures 13(b) and (c)

Figure 13: Damaged and undamaged BO layers: (a) AFM image showing Nano-indentation pattern on the surface of a sample from Region 1 in Figure 1; (b) Nano-indentation hardness; (c) Modulus of elasticity; measured using Hysitron Triboscope (\pm one standard deviation).
