Bal, İE, Dais, D orcid.org/0000-0002-0533-5171, Smyrou, E et al. (1 more author) (2021) Monitoring of a Historical Masonry Structure in Case of Induced Seismicity. *International Journal of Architectural Heritage*, 15 (1). pp. 187-204. ISSN 1558-3058

Monitoring of a Historical Masonry Structure in Case of Induced Seismicity

Ihsan Engin Bal^{*1}, Dimitris Dais^{1,2}, Eleni Smyrou¹, Vasilis Sarhosis²

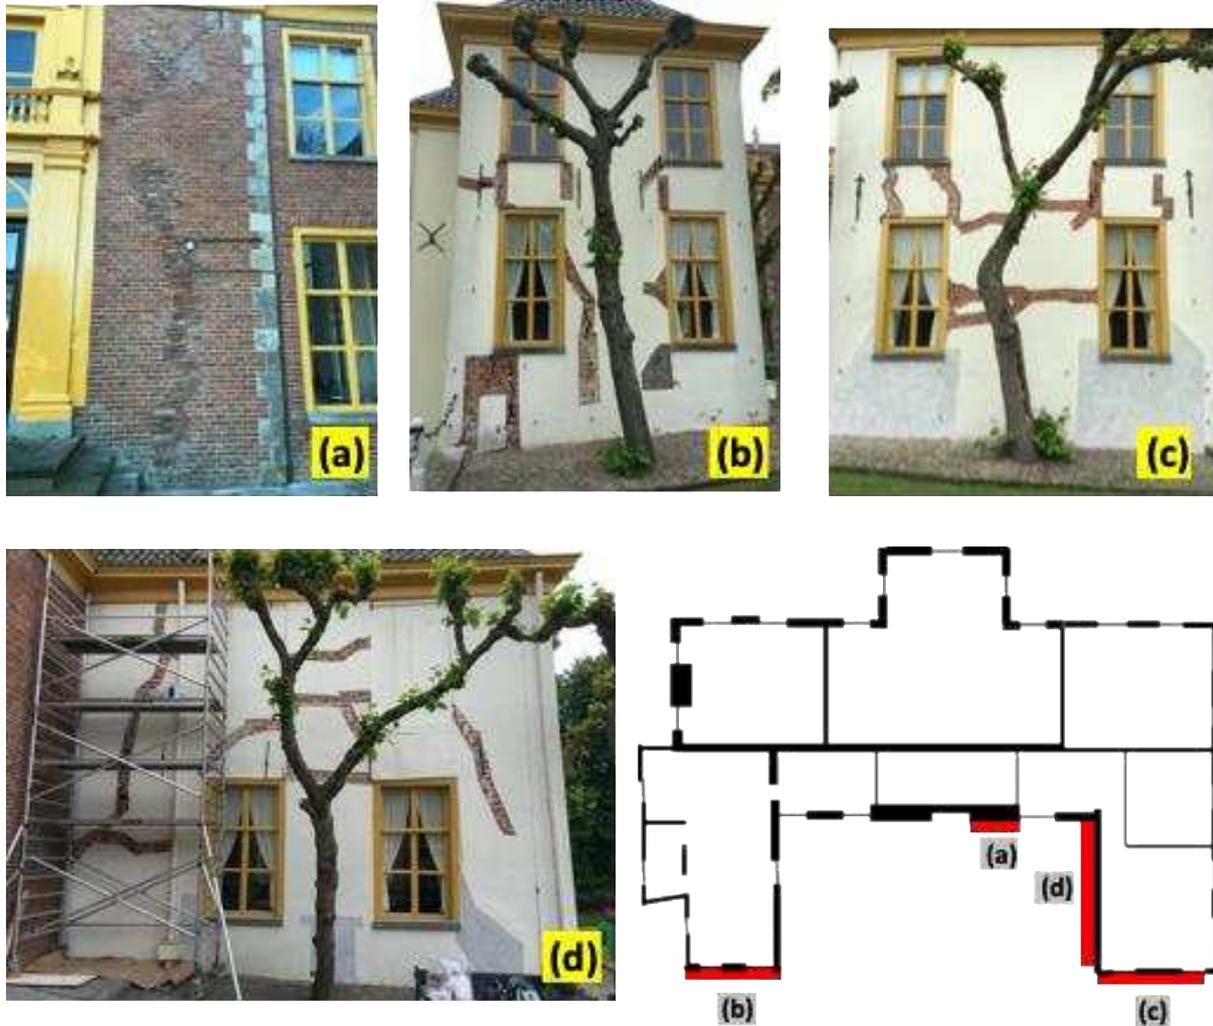
Figure 3. Cracks registered during 2015 restoration, and the red lines on the right-corner plan view denote external walls subjected to damage.

The latest major restoration works took place at the end of 2015 and the beginning of 2017, mostly due to the damage caused by the induced earthquakes in the area. It is highlighted that in 2015 the onset of damages on the structure was recorded while before that no damage was observed. The restorations in 2015-2017 included some structural repair, that was mostly removal and replacement of bricks from the cracked parts of the load bearing walls. These parts were plastered afterwards.

There have been 24 earthquakes above magnitude ML 2.0 since 2012, in epicentral distances 3 to 23 km from the structure. Structural damage and cracks were observed in an increasing pace between 2014 and 2015. The 2015 restoration included interventions on the front façade of the structure where extensive cracks had been formed (Figure 2), while the cracks on the internal walls of the structure were repaired during the 2017 restoration. These cracks were mostly vertical and partly horizontal and diagonal, concentrated on the Northwest (NW) wing as well as on the front façade of the middle zone (see Figure 1) of the structure. The cracks were as wide as a couple of millimetres in some regions. The plaster was removed and the damaged bricks were replaced during the 2015 restoration.

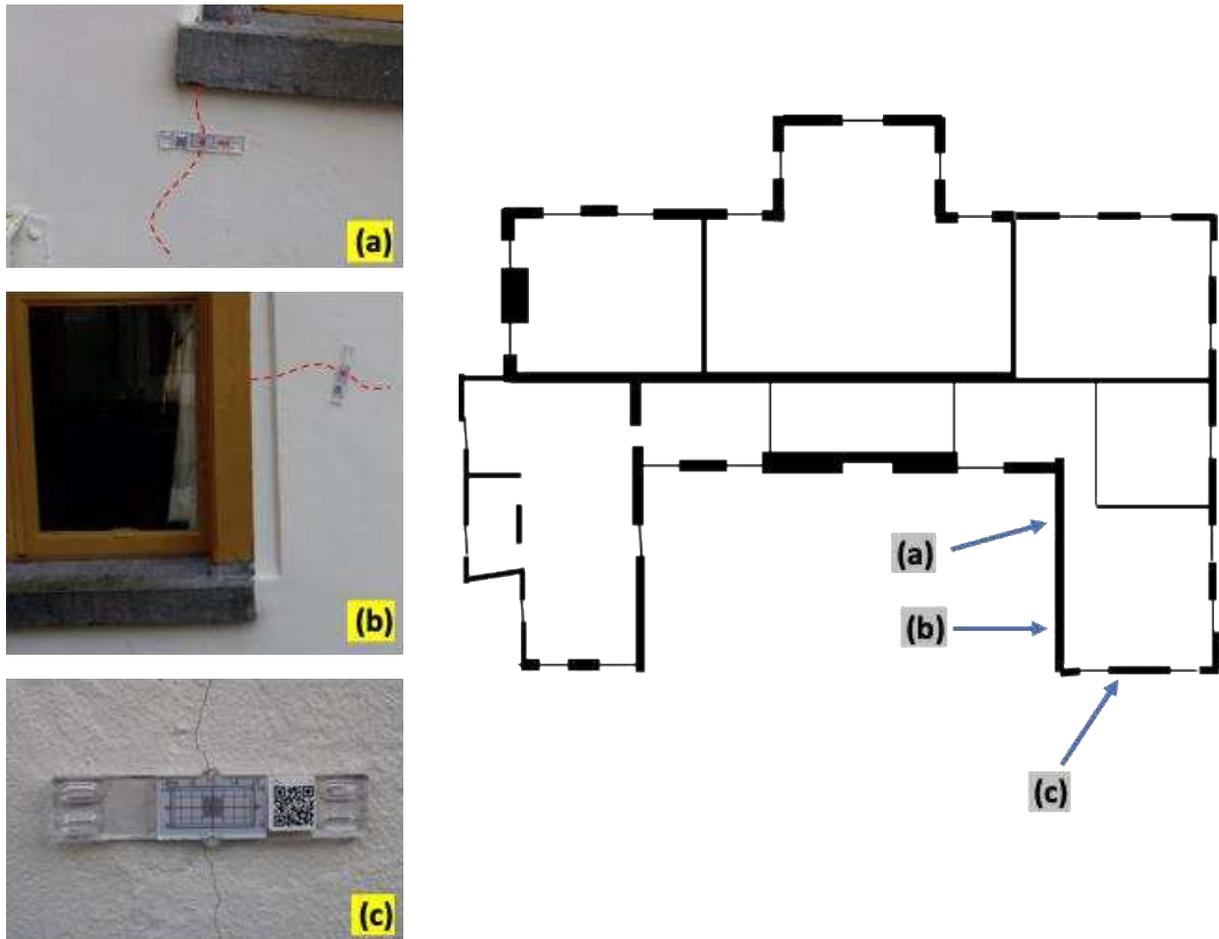
Although the increased seismic activity went hand in hand with increased number of cracks, the shape and location of latter did not resemble earthquake-related cracks. Most of them were in vertical direction, with a larger width close to the base and smaller widths in higher elevation, while diagonal X-shaped cracks, the standard sign of in-plane masonry response to lateral earthquake loading, were not observed in the structure. The existing cracks reminded more cracks caused by soil movements rather than by seismic load. After the end of restoration the manifestation of new cracks in the summer of 2018 in the most problematic part of the structure, i.e. the façades of the NW wing (Figure 3), was a puzzlement given the relative limited seismic activity in the respective period. However, after monitoring results have been combined together with finite element analyses and observations in the field, it was possible to reach a plausible explanation for the old (prior to 2015 and in 2015) and the new (summer 2018) damage in the building, as discussed further in this paper.

Figure 5. Minor cracks appeared in August 2018 (left) and their locations on the plan view (right).

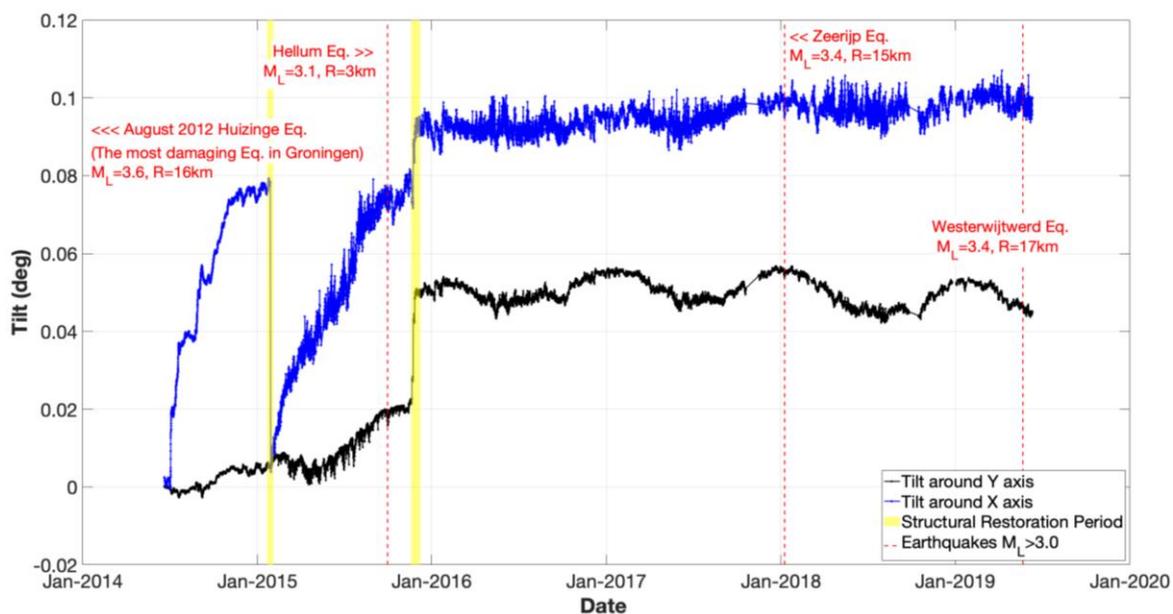
The tiltmeter data since 2014 are given in Figure 7. It should be noted that there was a local repair work in January 2015 and in December 2015 that has shifted the tilt values around both axes. The data jumps around the restoration periods are because of this. In overall, it is evident since the beginning of the monitoring (sometime mid-2014) until the end of the structural restoration and repair (beginning of 2016) that the tilt values systematically increased with the exception of the major structural restoration period that took place right after the Hellum Earthquake of M_L 3.1 that occurred just 3 km from the structure. Furthermore, the significant earthquakes (magnitude above 3) recorded during the monitoring period do not present evident effects on the overall plot, however, this may be because the changes in tilt during or after these earthquakes are not big enough and remain concealed by the temporal changes and noise of the tilt measurements. Thus, as explained in detail later, the evaluation of the structural response to each event needs to be done individually. Finally, it is also observed (Figure 7) that the tilt around Y axis is stabilized around a virtual baseline after the restoration and repair works, as only fluctuations for the seasonal changes can be observed after that date. On the contrary, the tilt around X axis exhibits an increasing trend since the end of the restoration and repair works.

Figure 7. Tiltmeter measurements since 2014, together with significant earthquakes and restoration periods.

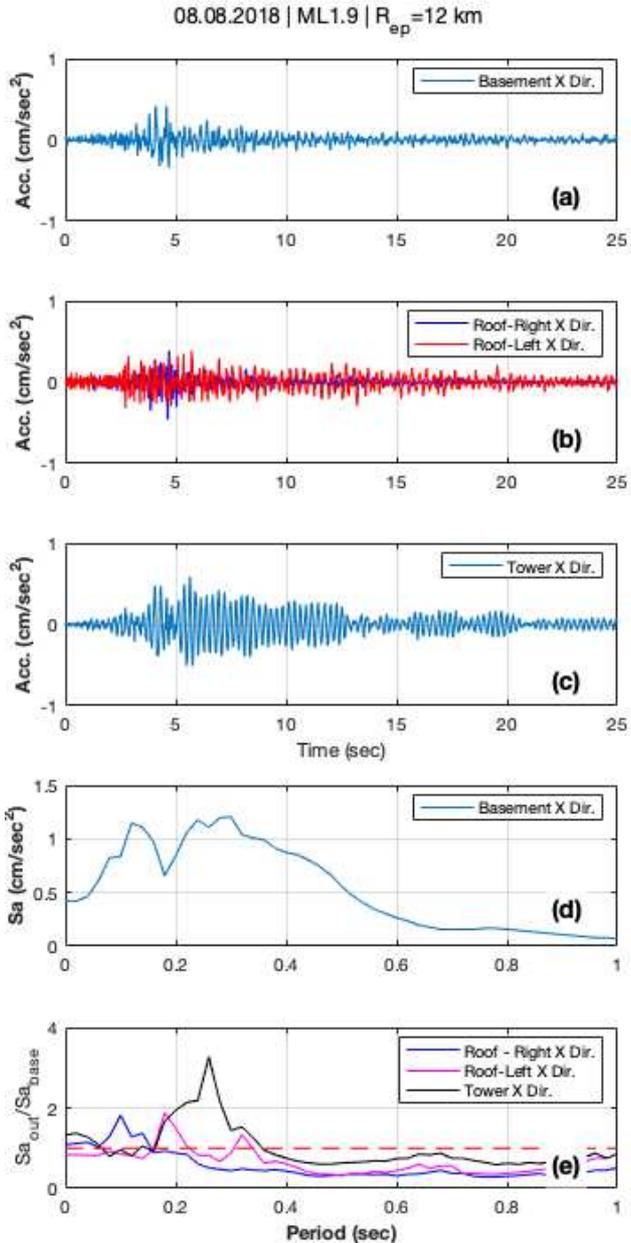
The Appingedam earthquake (ML 1.9) was recorded by the accelerometers in the building (the full dataset is available online in open source by (Bal and Smyrou 2019b)). The time-histories at the basement, at the roof level on the two wings of the structure as well as at the tower are given in Figure 8. The presented time-histories are baseline corrected and bandpass Butterworth filtered between 0.1-20 Hz. The motion was detected by the sensors although the maximum accelerations do not exceed 1 cm/sec^2 (0.001 g). The tower amplified the input motion approximately 3 times, while the structure itself amplified it 2 times, both still remaining well below the horizontal acceleration levels that would normally cause any cracks.

Figure 8. For the 8th of August 2018 Appingedam Earthquake of ML 1.9 in epicentral distance of 12 km are presented: acceleration time-histories (Acc.) in the X direction for the sensors at (a) the basement level, (b) the roof level (right and left side of the structure, shown in Figure 4b), and (c) the tower, (d) 5% damped spectral acceleration (Sa) as obtained from the sensor at the basement in the X direction, and (e) transfer functions (spectral acceleration on the structure (Sa_{out}) divided by the spectral acceleration at the base (Sa_{base})).

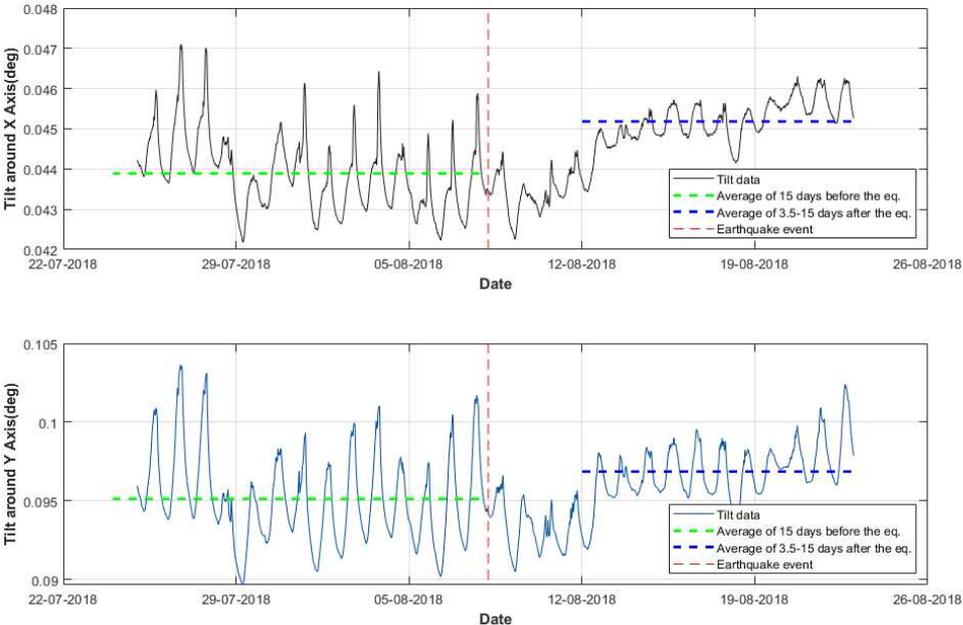
During the seismic excitation the fluctuation of tilt recorded was rather insignificant. Thus, only examining real-time tilt data would not offer an insight into the degree of damage that actually led to the formation of new cracks. In order to better understand the cause of damage, low sampling rate tiltmeter data have also been examined (Figure 9). For the last 15 days before the earthquake the daily temperature cycles oscillate on average around a baseline but the motion builds up in a way in the three days following the earthquake. From the 4th to 15th day after the earthquake tilt values in both axes increase significantly jumping to a new baseline. Furthermore, the range of angles in daily temperature changes also decreases causing the tilt values to fluctuate in a narrower band. A new baseline of tilt values indirectly signifies a certain level of plastic deformation, indicating that damage took place.

Figure 9. Low sampling rate tiltmeter data 15 days before and 15 days after the earthquake of 08.08.2018 Appingedam (ML 1.9).

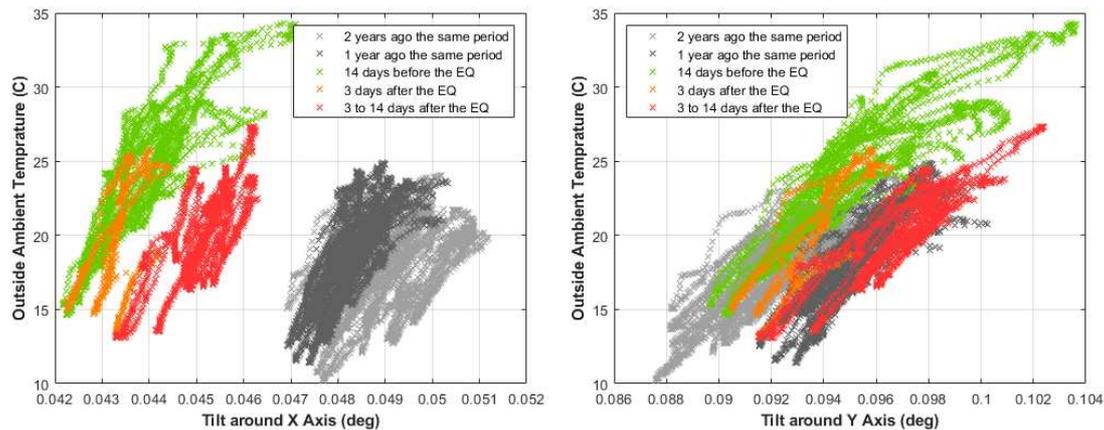
It is naturally expected that the tilt values are highly influenced by the temperature changes. In order to decouple the temperature effects from the measurements, plots in Figure 10 were prepared where the 30-day period (15 days before and 15 days after the earthquake) have been plotted against the measured ambient temperature. Furthermore, in order to understand the progress of the tilt, the exact same 30-day periods are also plotted for one and two years before (2017 and 2016 respectively) for the same period of the year. These data are used to understand the relevance of the observed damages with the Appingedam Earthquake of ML 1.9. The first and striking observation is that the temperatures in 2018 were much higher than the prior two years, which led to a different correlation between the ambient temperature and the tilt values in the range of 25 °C to 30 °C. Furthermore, it was shown that the relationship between the tilt values and the temperature is within an expected range 15 days before the earthquake (green lines) and 3 days following the earthquake (orange lines), while 4th to 15th days after the earthquake a different relationship is observed (red lines), where the tilt values increase independent of the temperature values. In brief, it is concluded that the change of baseline in the tilt values is not related to the ambient temperature.

Figure 10. Tilt angles recorded +/-15 days from the earthquake and last two years before.

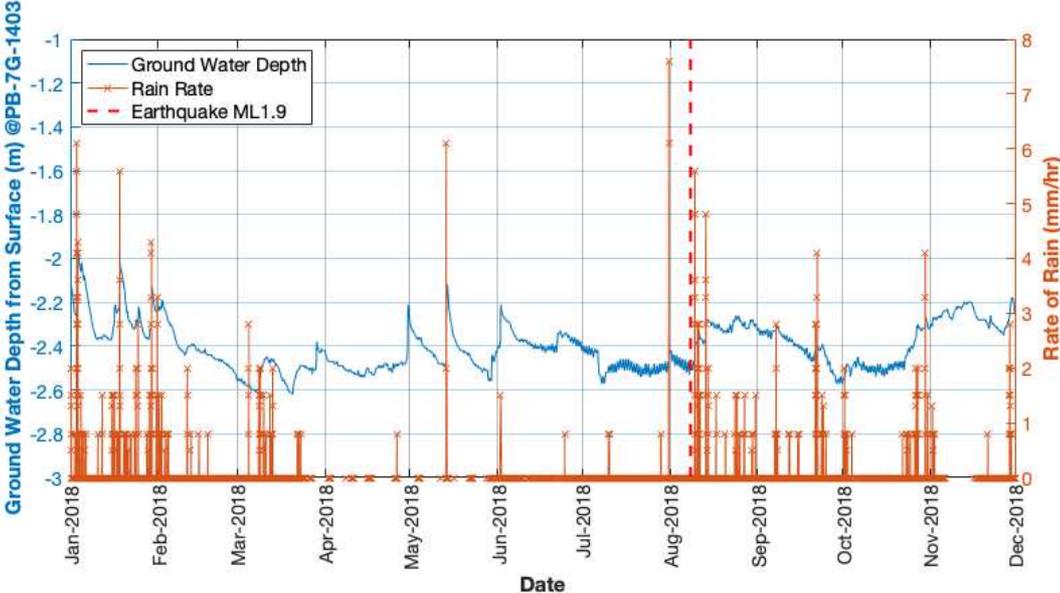
The ground water movement in the same days was also investigated. The rain rate is plotted in Figure 11 together with the ground water measurements, in order to decouple possible ground water raise due to the earthquake action. The ground water is monitored in the monitoring well with approximately 4 m total depth. Due to the monitoring setup, the sensors used and the sampling rate (2 hours), the monitoring data can provide only slow movements of ground water and not the changes during the seconds of the earthquake motion.

Figure 9 reveals a very dry period from mid-March to mid-August in 2018, reported as a disastrous period for the farmers in the region due to the extremely dry soil. It was also witnessed in soil drilling works that the clay layers were hard and dry due to lack of rain for a very long period. As seen in Figure 11 the start of the rainy period coincides with the earthquake (in fact, a couple of days later). When other rainy periods in the data are examined, tiltmeter data are found mostly insensitive to the rain. Furthermore, the out-of-the-ordinary movement (i.e. change in tilt baseline) in the tiltmeter data starts right after the earthquake, proving that the movement is related to the earthquake motion too.

Figure 11. Ground water depth from the surface and the rate of rain in 2018 in the monitoring well 600 m south of the site.

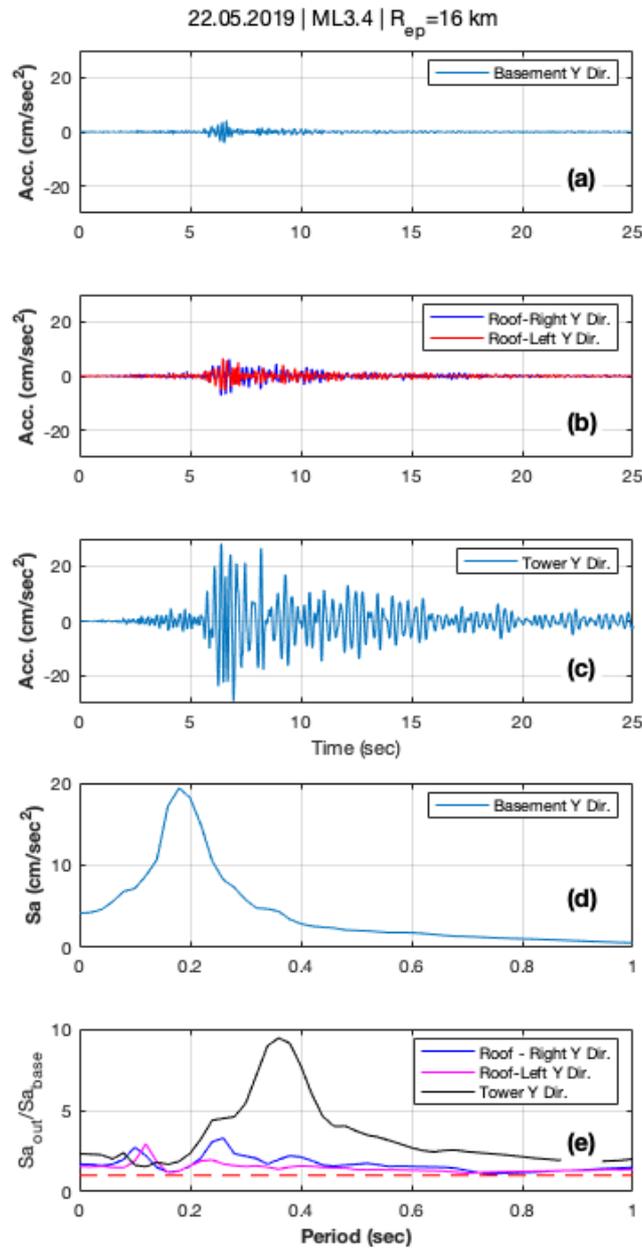
If the monitoring results constituted merely by acceleration measurements, one could argue that the structure should have had much more cracks after the 22nd of May 2019 earthquake of ML 3.4 since the accelerations at the base, on the structure and at the tower were much higher than the respective of the event in the 8th of August 2018 (Bal and Smyrou

2019a). Note that the horizontal PGA at the basement was 0.004 g and the maximum absolute horizontal acceleration at the tower was recorded as 0.03 g. Although still very small, these accelerations are larger, more than an order of magnitude, as compared to the acceleration levels of the August 2018 event (Figure 12). A detailed check on the photographs of the crack rulers showed that no significant movement took place during the May 2019 earthquake. When the tilt data of 15 days before and 15 days after were examined, no change of tilt baseline or any other out-of-the-ordinary movement was observed. Had the seismic SHM system relied only on the accelerometer data, the fact that the August 2018 earthquake caused damages, while the stronger (in terms of acceleration) May 2019 earthquake caused no damage, would be inexplicable.

Figure 12. For the 22nd of May 2019 Westerwijrtwerd Earthquake of ML 3.4 in epicentral distance of 16 km are presented: acceleration time-histories (Acc.) in the Y direction for the sensors at (a) the basement level, (b) the roof level (right and left side of the structure, shown in Figure 4b), and (c) the tower, (d) 5% damped spectral acceleration (S_a) as obtained from the sensor at the basement in the Y direction, and (e) transfer functions (spectral acceleration on the structure ($S_{a_{out}}$) divided by the spectral acceleration at the base ($S_{a_{base}}$)).

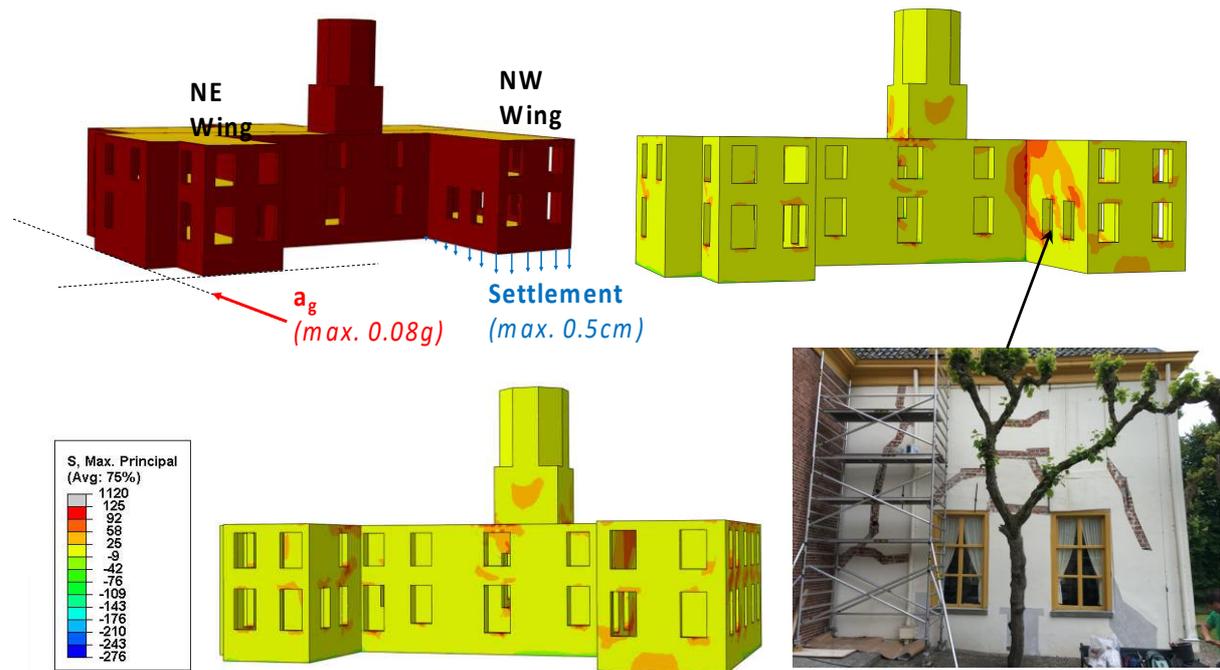
The nonlinear numerical model was subjected to different scenarios to see if a correlation can be established between the analytical findings and the past damage. As explained in (Dais et al. 2019), there are findings (i.e. crack patterns, concentration of damage) in the structure that support the occurrence of a soil settlement in the NW wing, thus a settlement was applied in that wing analytically. In particular, a 0 to 0.5 cm vertical settlement is applied on the NW wing (i.e. 0.5 cm at the edge, 0 cm at the connection with the main zone) and the response of the structure is shown in terms of tensile maximum principal stresses (Figure 13). In case of the scenario of only-settlement, although some of the cracks prior to the renovation and repair in 2015 (Figure 2) were captured, the results were not satisfactory in overall. Match between the damage distribution and the observed damages was not achieved. When an earthquake load is applied in conjunction with the settlement, the location of the cracks in the NW wing and at the front façade of the main zone were captured successfully (see the comparison in Figure 13). The earthquake load is applied as incremental lateral equivalent static force proportionally to the mass and from 0 to 0.08g. The earthquake load is applied in the short direction of the structure because this was the dominant direction of the 2015 Hllum Earthquake of ML 3.1 (i.e. the direction perpendicular to the travel path). Hllum Earthquake was reported as the reason of the damages in the structure in 2015 and the crack photos presented in Figure 2 belong to a period right after that earthquake.

The point of this numerical exercise is to show distribution of cracks derived after the combination of two actions. In more detail, when settlements are applied, concentration of damage is observed at the wall shown in Figure 2d and beneath the tower. After the superposition of seismic load, further damage appears at the walls as also shown in Figure 2a, b and c.

Figure 13. Distribution of maximum principal stresses from the nonlinear static analyses in the scenario of 0.5cm maximum vertical settlement at the NW wing superposed with lateral earthquake equivalent static load of 0.08g and comparison with the observed damages after 2015 Hellum Earthquake.
