Failure Analysis of the Piston Used in a Pneumatic Down the Hole Impactor

Abstract: In this study, the piston's failure mechanism in the pneumatic down the hole (DTH) impactor has been investigated. To study the cause of surface fracture, material microstructure and hardness have been analysed using SEM and nanoindentation as well as the Vickers hardness tester. The stress state of the piston in the impact process was analysed using ABAQUS finite element software. The results show that the carburized layer transits from the acicular martensite to plate martensite from the surface towards inside. In fracture, the acicular martensite is an intergranular fracture, and the plate martensite is a transgranular fracture. According to the finite element simulation results, the maximum Mises stress occurs when the piston strikes the bit at an angle of 0.22° . High von Mises stress makes the carbides, or the defects in the carburized layer, to crack. Meanwhile, in propagating the stress wave at the piston's impact point, a tensile stress of 560 MPa will be generated on the piston's outer edge, which causes the crack in carbide to grow along the radial and axial direction of the piston.

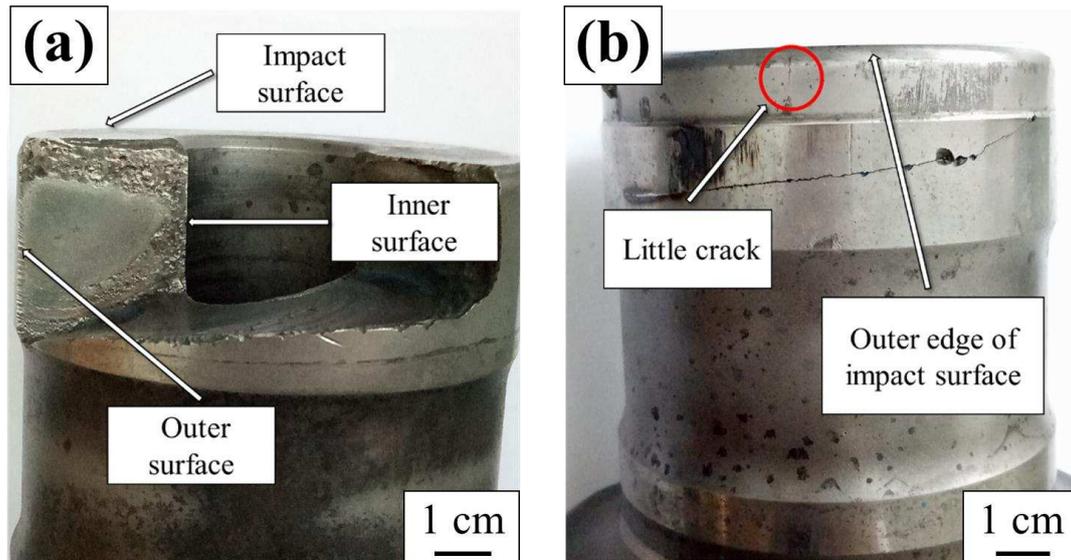
Down the hole (DTH) impactor is a kind of drilling tool used in the mining field. It uses high pressure air to push the piston to hit the rotating drill bit. When the DTH impactor is working, the piston impacts the bit with a final speed of 8-12 m/s, and impact frequency of about 20 Hz. Under this level of high-frequency and high-speed impact, the piston's front is subjected to a significant force at the moment of impact, which causes the piston to fracture as shown in Figure 1.

Figure 1 The impact end of the piston, a) The fractured surface, b) The small crack at the outer edge of the piston

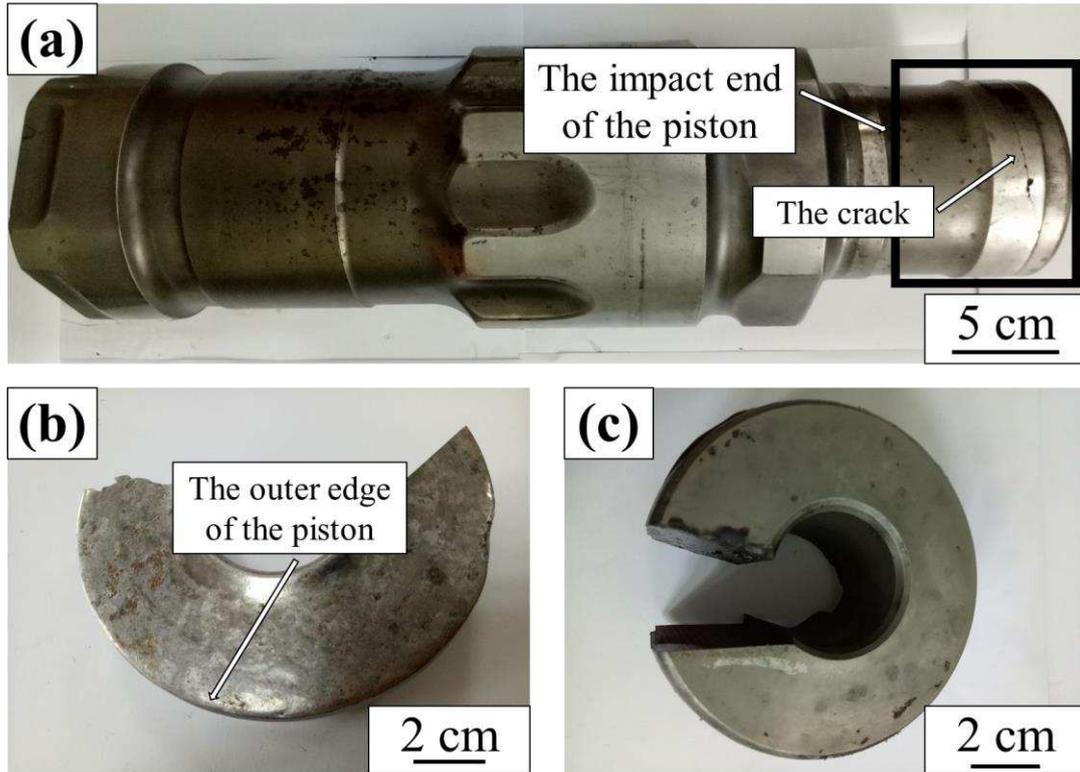
The pistons in this study were made of 23CrNi3Mo, and their chemical composition is listed in Table 1. They were carburized at 850 °C for 18 hours, and following carburizing, the pistons were quenched and tempered to improve the strength and hardness. After heat treatment, the tensile strength, yield strength and fatigue strength of the material are 1100 MPa, 800 MPa and 330 MPa respectively. All data about 23CrNi3Mo are provided by the equipment manufacturer. Examples of the failed pistons studied in this paper are shown in Figure 2. The impact end of the piston, shown in Figure 2 (a), has a noticeable crack indicated by the arrow and Figures 2 (b) and (c) show the failure part dropped from the impact end. The pistons in Figure 2 are fractured at the cumulative drilling depth of about 3000 m.

Figure 2 The failure piston of DHT. a) The failure piston with cracks, b) and c) Failure part falling from the impact end of piston

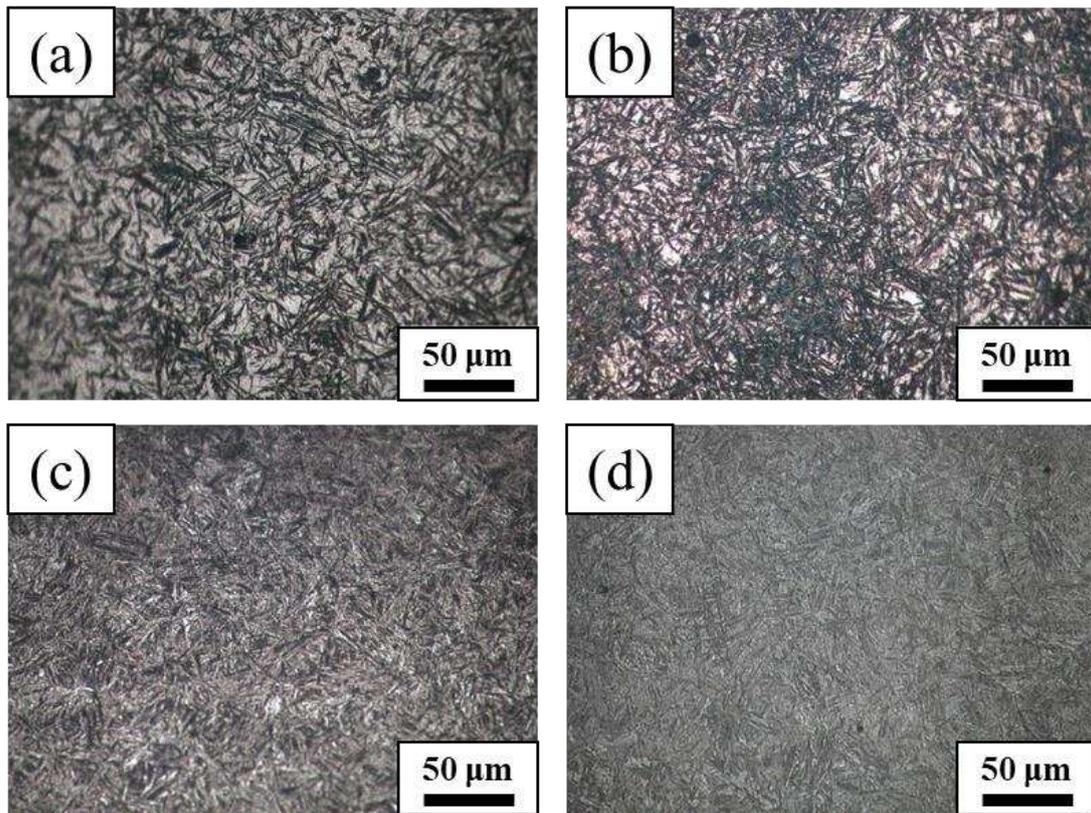
The internal microstructure of the pistons is shown in Figure 3. Figures 3 (a) and (b) show that the cross-section of carburized layer on the inner and outer surface of the impact piston (see Figure 1.) is acicular martensite. This is due to high carbon content in the carburized layer. When the carbon content is more than 1%wt, the acicular martensite will be formed during quenching. The acicular martensite has the characteristics of high hardness and brittleness^[14]. Figure 3 (c) shows the carburised layer's microstructure at the impact surface (see Figure 1.) of the piston. Comparing the microstructures shown in Figures 3 (a) and (b), it can be found that the microstructure of the impact surface is relatively of fine structure. The piston's internal microstructure shown in Figure 3 (d) is lath martensite and a small amount of lower bainite. As 23CrNi3Mo is the low carbon steel, the quenching microstructure should be lath martensite. However, due to the piston's large size, the quenching cooling process did not result in rapid cooling of the inner part of the piston, explaining the presence of lower bainite. The toughness and plasticity of lath martensite and lower bainite phases are greater than acicular martensite, in contrast to the strength which is lower than the strength of the acicular martensite. In general, the structure of the piston has a hard carburized shell and a softer interior. In the process of impact, the carburized layer cracks easily and leads to piston failure.

Figure 3 Microstructure of piston at different positions, a) Microstructure of carburized layer on inner surface, b) Microstructure of carburized layer on outer surface, c) Microstructure of carburized layer on impact surface, d) Internal microstructure of piston

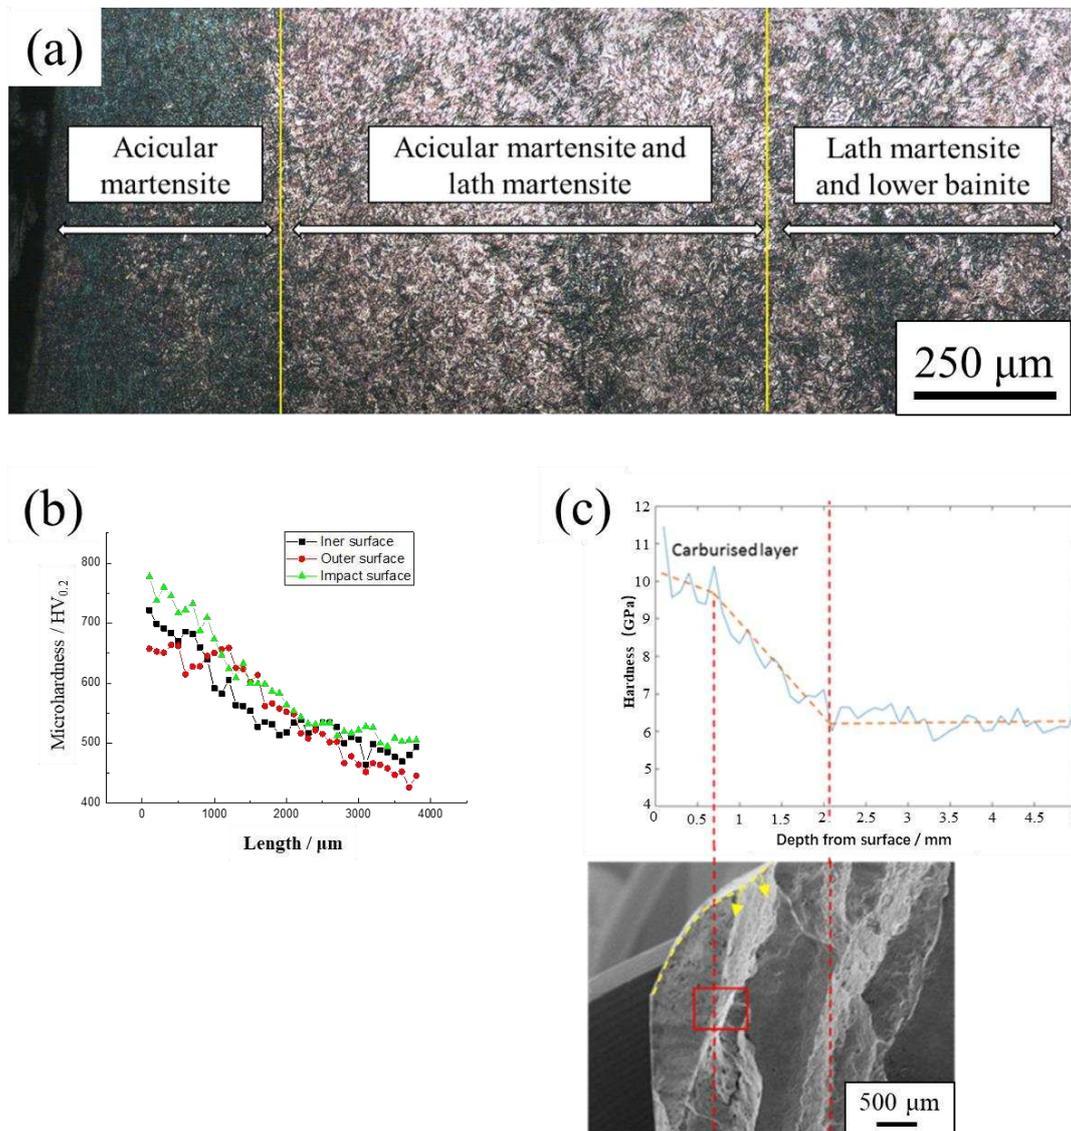
The piston's carburized layer is divided into three regions, from the surface to the interior. The observed regions, mainly formed due to different carbon concentration, are characterized with different microstructures and properties (as shown in Figure 4). The first region is within 420 μm from the surface, and its microstructure is acicular martensite due to the highest carbon concentration. The second region is in the range of 420 μm -1300 μm , and this region is mainly a mixed microstructure of acicular martensite and lath martensite. The third region is the internal region of the piston, which is mainly lath martensite and lower bainite. The Vickers hardness gradient of the carburized layer at different piston surface is shown in Figure 4 (b). The hardness decreases gradually with the increased distance from the surface, and finally stabilizes at about 400-500 HV. The hardness of the carburized layer at 2 mm away from the surface is higher than 500 HV, which means that the piston surface hardness meets the production requirements. The hardness of the impact surface is the largest due to the refinement of microstructure and dislocation. Figure 4 (c) shows the detailed hardness gradient by using nano-indentor and its corresponding fracture surface. There are three distinct hardness regions from the surface to the substrate, with the significant transition at a depth of 0.7 mm and 2.1 mm. Corresponding to the fractured section of the surface in Figure 4 (c) (adjusted to the same

scale), the transition points of the hardness shows obvious fracture steps. The hardness distribution of the carburized layer indicates that the hardness is related to microstructure. The outer layer of acicular martensite has the highest hardness, which can improve the wear resistance of piston surface and the steps in the fracture is also related to the change of microstructure accordingly.

Figure 4 a) Microstructure and b) The Vickers hardness gradient of the carburized layer of piston c) The nano-hardness and the fractured surface

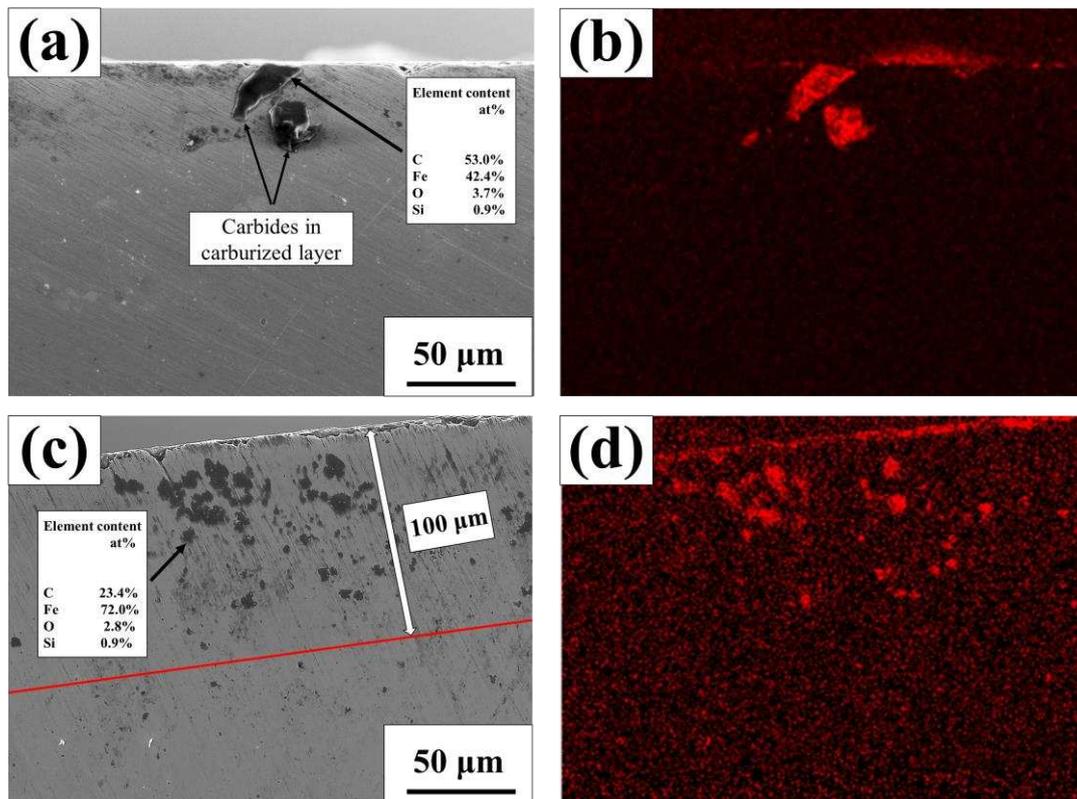
Prior research has shown that after the carburization of the piston at 850 °C for 10h, carbides may be also be formed in the carburized layer^[10-12]. Figure 5 shows two kinds of carbides precipitated in the carburized layer. The carbide shown in Figure 5 (a) is granular and its size

is between 10-30 μm . According to the composition analysis of EDS, the carbide is mainly composed of iron and carbon. Figure 5 (c) shows a smaller carbide dispersed in the area within 100 μm from the surface. These carbides are mainly composed of carbon and iron. Compared with the carbide shown in Figure 5(a), the carbon content of these carbides is lower. In general, there will be carbides precipitation in carburized layer and these carbides may become the crack sources of piston during impact due to its brittleness. When the distance exceeds 100 μm from the surface, the amount of carbides in the carburized layer is significantly reduced.

Figure 5 Carbide distribution in the carburized layer, a) Granular carbides and their composition, b) The distribution of carbon element by EDS of Figure 5 (a), c) Dispersed carbides and their composition, d) The distribution of carbon element by EDS of Figure 5 (c)

According to stress analysis, the Mises stress of the piston impact surface's outer edge is the largest during the impact process. This suggests that the outer edge of the impact end is damaged first, which is consistent with the actual piston failure. From Figure 5 it can be seen

that the outer edge of the piston impact surface will precipitate a large number of carbides during carburizing, and these fragile carbides will crack under the high Mises stress^[25, 26]. After the carbides on the outer edge produce cracks, they will gradually propagate along the direction perpendicular to the tensile stress under the action of tensile stress (as shown in Figure 10).

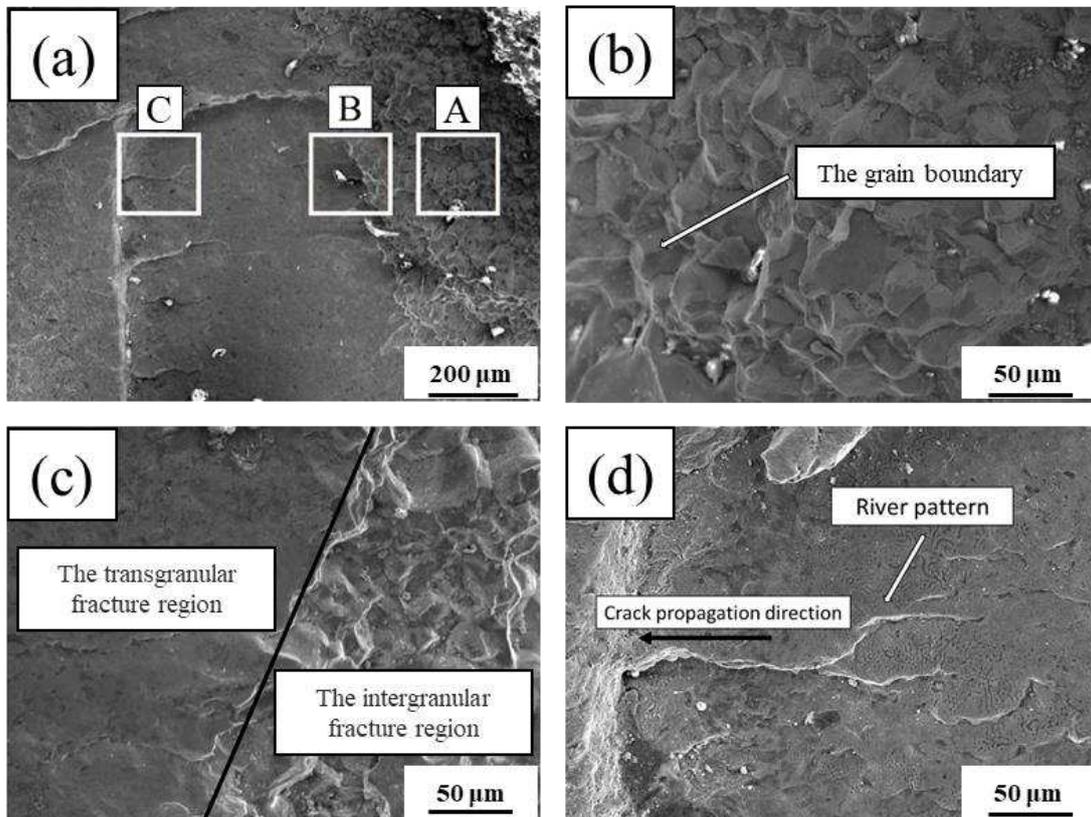
Figure 6 shows the SEM image of the fracture surface located in the red circle in Figure 1 (b). According to the SEM observations in Figure 6(a), with regions A, B and C indicated, the fracture surface of the small cracks is seen to consist of two distinguished regions: the intergranular fracture region A (as shown in Figure 6 (b)) within 430 μm from the surface and the transgranular fracture region C with thickness greater than 430 μm (as shown in Figure 6 (d)). The thickness of the intergranular fracture region is the same as the acicular martensite thickness shown in Figure 4 (a). Therefore, it can be concluded that the intergranular fracture

of the carburized layer is related to the high concentration of carbon in the surface of the carburized layer^[15]. Several researchers have investigated the fatigue fracture mechanisms of carburized steel. It was observed that the cementite formed in the process of carburization accelerates crack propagation along the grain boundaries^[6, 7, 16, 17]. Region B (Figure 6 (c)) shows that there is an apparent boundary between the intergranular fracture region A and transgranular fracture region C. In the transgranular fracture region C, there are obvious river patterns (as shown in Figure 6 (d)). Analysing the river patterns, it can be deduced that the crack propagates from the intergranular fracture region A towards the transgranular fracture region C^[18, 19], so the crack may initiate from the intergranular fracture region A of the carburized layer.

Figure 6 SEM showing the fracture surface of the piston, a) The overall fracture surface, b) The intergranular fracture surface (region A), b) The boundary between intergranular fracture and transgranular fracture (region B), d) The transgranular fracture surface (region C)

According to formula (2), the initial crack size is 51.2 μm which is much larger than the carbide crack size shown in Figure 10. It can be seen from Figure 6 (b) that the fracture mode is intergranular, after crack initiation in the acicular martensite. Due to the precipitation of cementite and carbides at the grain boundary in the region of acicular martensite, fracture toughness is much lower than that in other material regions. Therefore, in the acicular martensitic region, stable crack growth may occur when the crack size is lower than the calculated initial crack size. The length of the acicular martensite region is 430 μm , which is much larger than the initial crack size of the piston. When the crack propagates to acicular martensite boundary, the crack size is much larger than the initial crack size, which means that the crack has entered the stable growth stage.

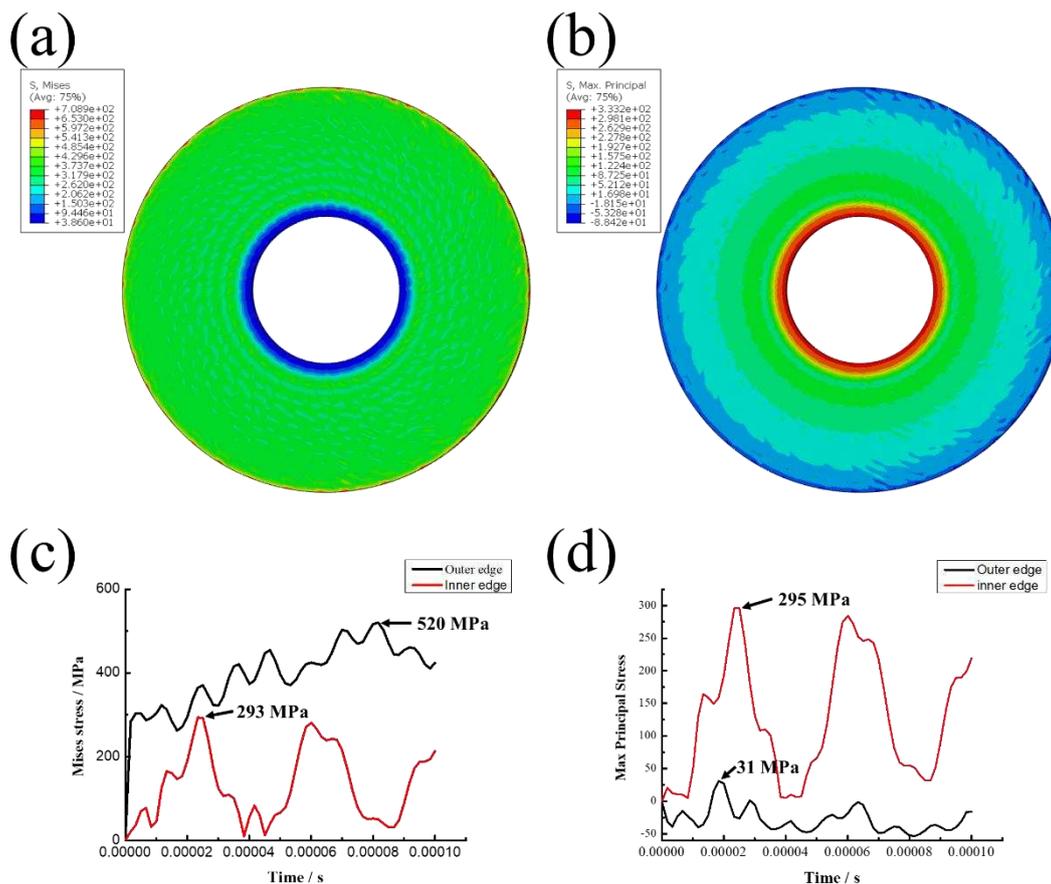
Figure 7 presents the distribution of von Mises stress and the maximum principal stress on the impact surface when the piston strikes the bit vertically at a speed of 12 m/s. The von Mises stress of the outer and inner edges is larger than that of other regions (as shown in Figure 7(a)). The maximum von Mises stress is located at the outer edge. The value is 520 MPa, which does not exceed the steel's yield strength for the piston. The maximum von Mises stress at the piston's inner edge is 293 MPa, which is lower than that of the outer edge. Compared with the inner edge, the outer edge is more prone to failure when there are defects and inclusions in the material. The maximum principal stresses on the impact surface are shown in Figures 7 (b) and (d). Contrary to Mises stress distribution, the maximum principal stress is distributed at the inner edge of the impact surface. The maximum principal stress of the inner edge is 295 MPa, and that of the outer edge is 31 MPa. Although the maximum principal stress of the inner edge is greater than that of the outer edge, its value is lower than the fatigue limit of the material, so it is difficult to occur fatigue fracture.

Figure 7 The Mises stress and maximum principal stress distribution, a) The von Mises stress distribution on the impact surface, b) The maximum principal stress distribution on the impact surface,

c) The stress-time curves of outer and inner edge, d) The maximum principal stress-time curves on the outer and inner edge

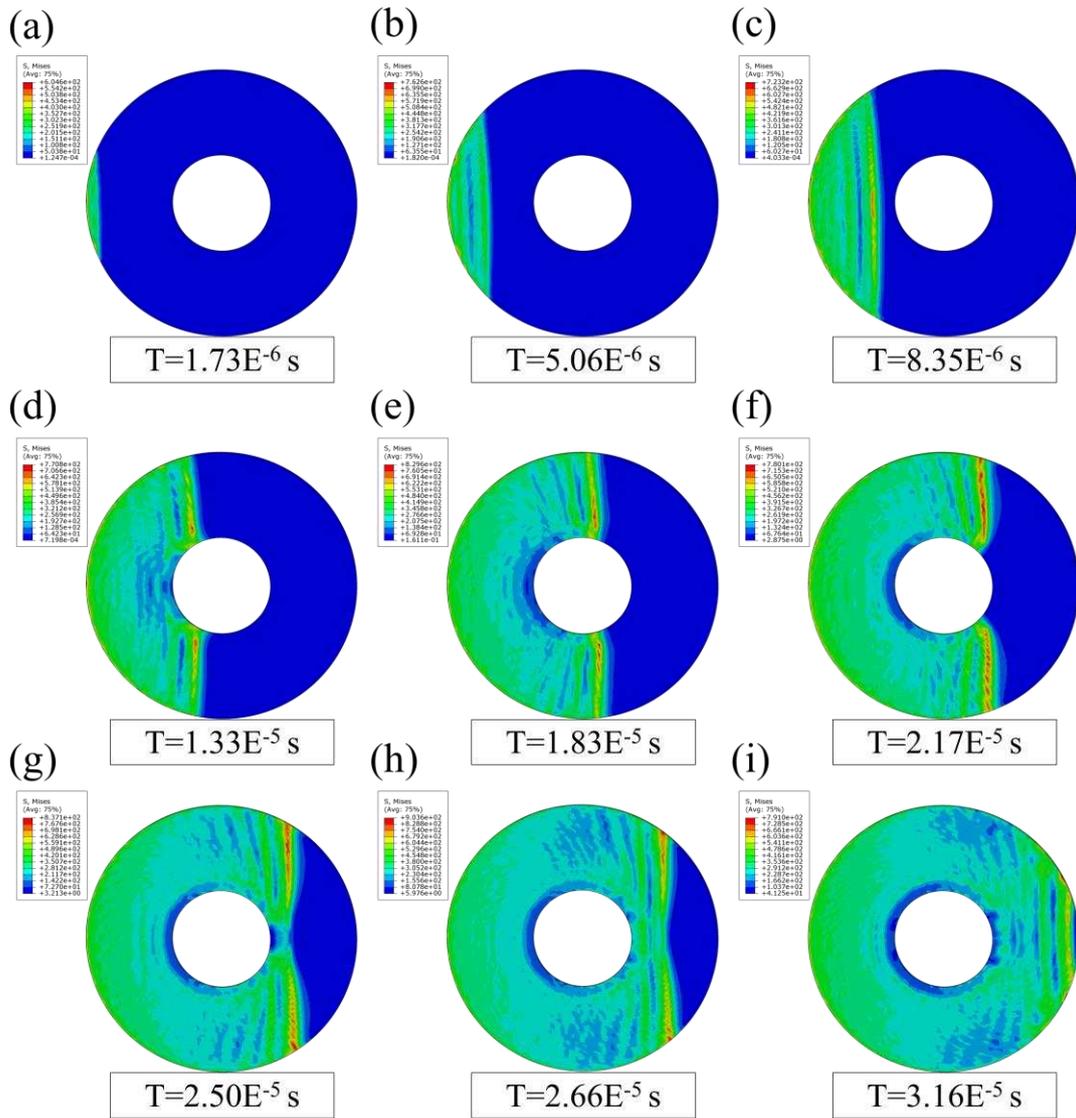
Due to assembly and wear, there is a gap between the piston of the DTH and the cylinder, which will cause the piston to hit the drill bit obliquely. In this paper, the clearance between the piston and the cylinder is 0.2 mm, and the clearance length is 52 mm, so there is a maximum impact angle $\theta = \arctan \frac{0.2}{52} = 0.22^\circ$ during the impact process. Figure 8 shows the distribution of von Mises stress on the piston impact surface at different times, when the piston strikes the bit at an angle of 0.22° . The von Mises stress increases gradually as it propagates from the impact point to the surrounding. The von Mises stress at the outer edge of the impact surface reaches the maximum value at about 2.66×10^{-6} s, which is 903 MPa (as shown in Figure 8(h)). Compared with the piston vertical impact the drill bit, the von Mises stress value increases by 73%, which means that the damage caused by piston tilting impaction is more serious. The von Mises stress on the inner edge of the impact surface is low during the whole impact process, so the failure probability of the inner edge is lower than that of the outer edge.

Figure 8 The von Mises stress colour picture of the piston impact surface at a different time when the piston impacts the drill bit at an angle of 0.22°

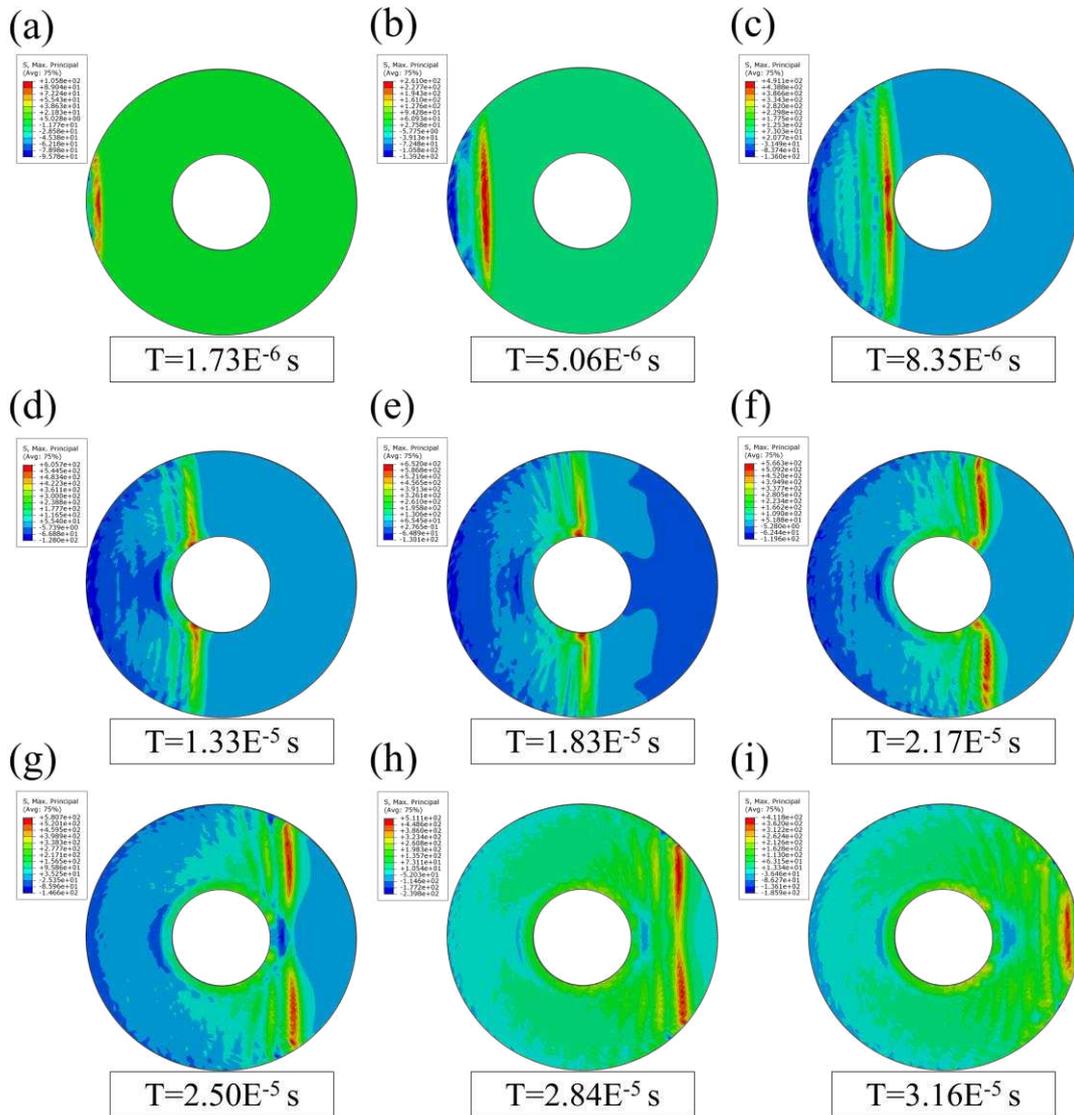
Figure 9 shows the maximum principal stress colour picture. According to the results in Figure 9 (e), when the piston tilts against the bit, the largest maximum principal stress is located at the inner edge of the piston. Figures 9 (g) and (h) show that the maximum principal stress at the outer edge of the piston is also large during the impact process. The largest maximum principal stress on the outer edge is 560 MPa, which is also higher than that of figure 7 (b).

Figure 9 Maximum principal stress colour picture of the piston impact surface at a different time when the piston impacts the drill bit at an angle of 0.22°

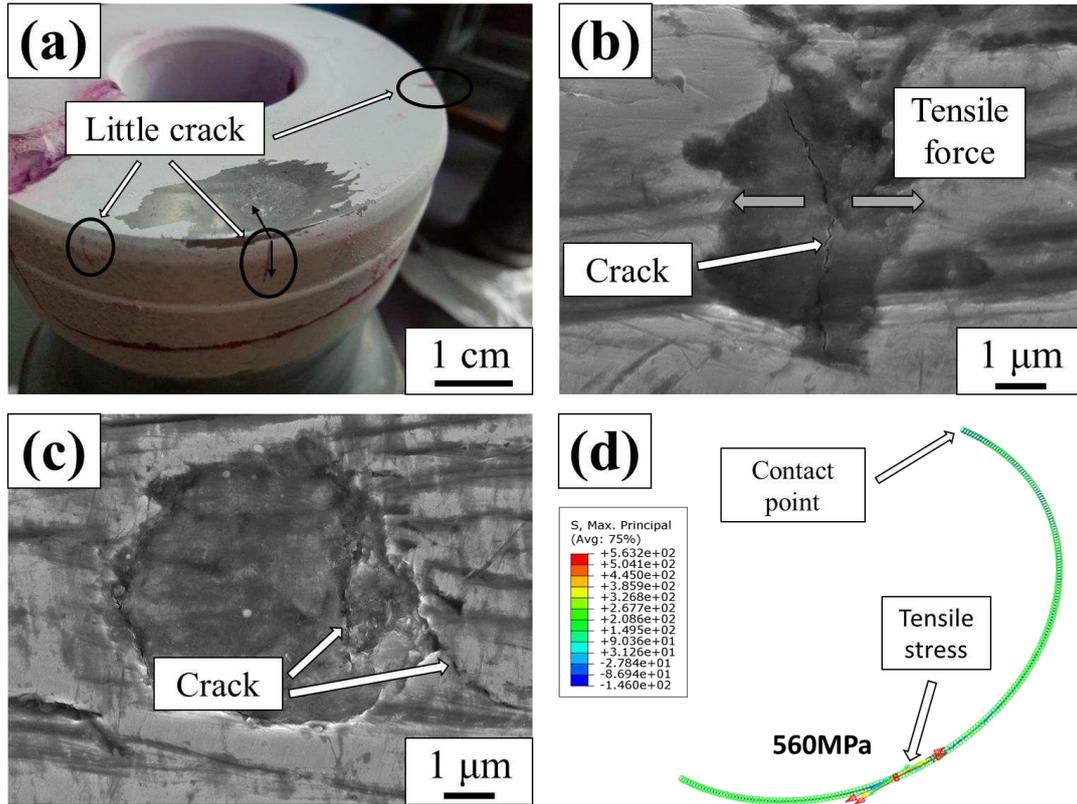
Figure 10 (a) shows the failed piston's macro small cracks located at the outer edge of the impact surface. These macro small cracks are caused by under the combined action of von Mises stress and maximum tensile stress. Figure 10 (b) and (c) indicate the carbide crack at the outer edge of piston. In the fatigue test of carbon steel, it is proved that carbides in the carburized layer can easily become fatigue source because of their brittleness [13, 20, 21]. In the case of the carburized piston, these carbides are located in the high Mises stress region so they will crack when the piston strikes the bit. Figure 10 (d) point out the maximum principal stress direction and value of the outer edge. The direction of the maximum principal stress is perpendicular to the crack shown in Figure 10 (a), (b) and (c).

Figure 10 Crack initiation position and stress analysis, a) The crack initiation position and propagation direction, in which the black arrow direction is the crack propagation direction, b) and c) The crack initiated from carbide, d) The direction and value of the maximum principal stress on the outer edge of the piston when hitting the bit at an angle of 0.22°

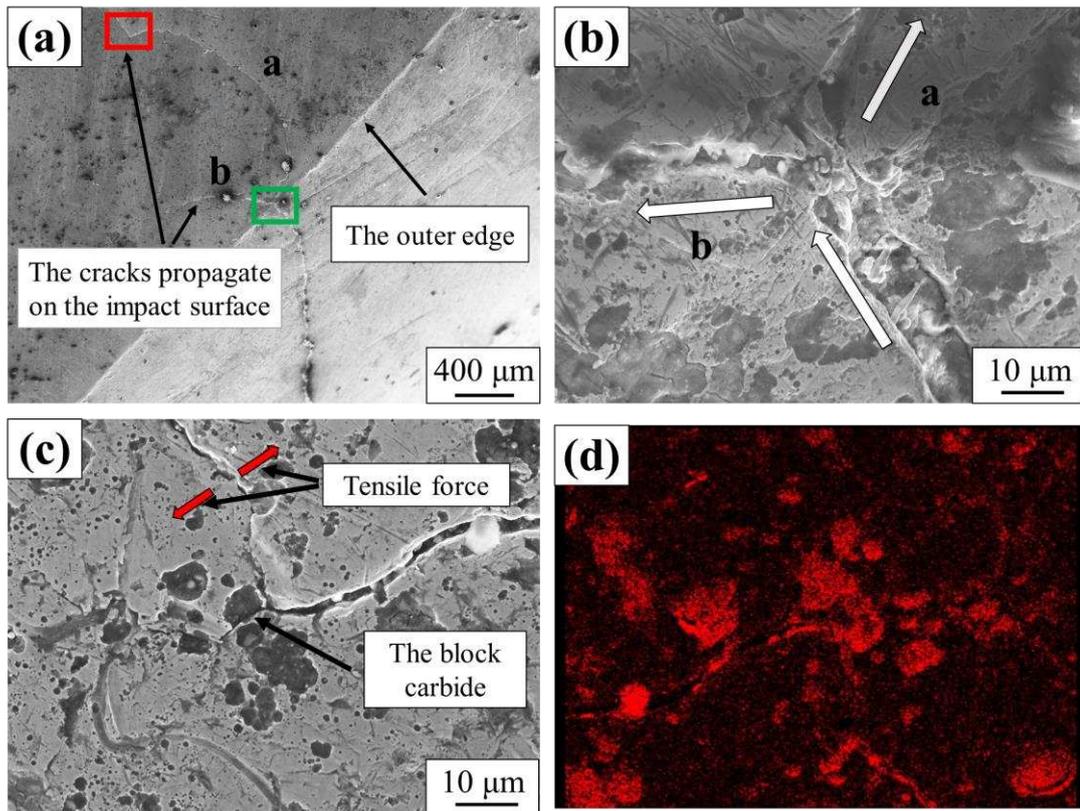
The crack propagation is mainly affected by tensile stress and carbides. Figure 11 (a) shows a little crack propagation from the outer edge of the impact surface and this crack splits into *a* and *b* two cracks during propagation process (as shown in Figure 11 (b)). The propagation paths of cracks *a* and *b* are quite different. The crack *a* propagation direction is generally perpendicular to the outer edge of the impact surface. Different from crack *a*, crack *b* gradually changes its direction in the process of propagation, and finally its crack propagation direction is parallel to the direction of tensile stress. The crack propagation direction parallel to the tensile stress will lead to the termination of crack propagation, just like crack *b*, which is also the reason for the different length of crack *a* and crack *b*. As shown in Figure 11 (c), the crack *a* has a sudden change in the propagation direction during the propagation process, which is related to the carbides in the carburized layer of steel. When the crack in Figure 11 (c) propagates to the block carbide, it splits into two cracks along the boundary between the carbide and matrix. One of the cracks can continue to propagate because it is perpendicular to the outer edge, while the other crack stops to propagate because its direction is parallel to the outer edge. In the study of crack propagation, it is also shown that the existence of carbides will affect the crack propagation. The low bonding force between carbide and matrix makes it necessary for crack propagation at carbide boundary^[29, 30]. Beside, the existence of carbides will increase the Mises stress field around it, which makes the area around carbides easy to crack^[31].

Figure 11 The crack propagates from the outer edge, a) Propagation paths of two cracks *a* and *b*, b) The crack splits into cracks *a* and *b* (Green box in Figure 11 (a)), c) The crack *a* changes its propagation direction (Red box in Figure 11 (a)), d) Figure (c) corresponding carbon EDS

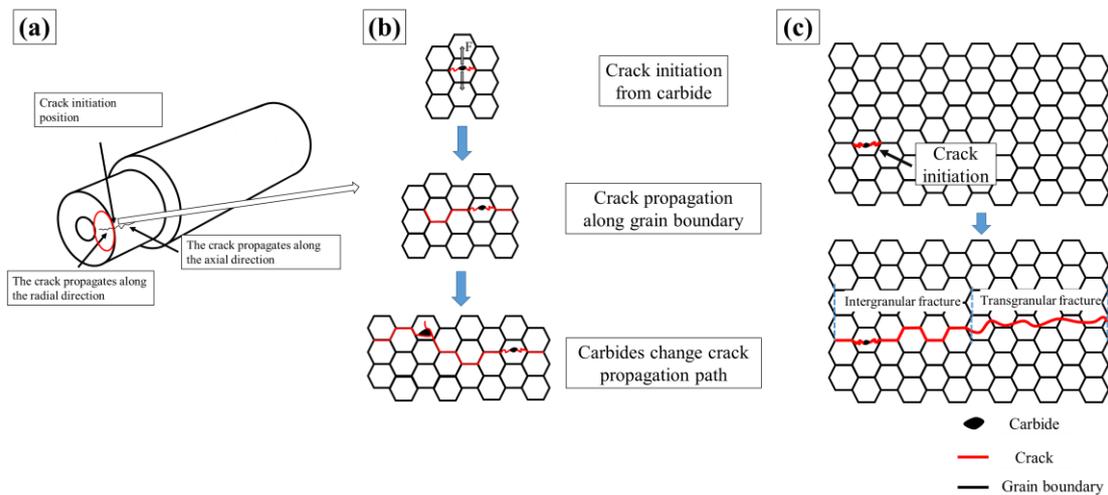
The crack initiation and propagation process of the impact piston is shown in Figure 12. The von Mises stress on the outer edge of the impact end of the piston is relatively high. As there are some brittle carbides in this region, these carbides will crack under the high stress, so the crack initiates at the carbides in the carburized layer. After the crack initiation, it will propagate vertically to the piston because of periodic tensile stress during the impact. In the acicular martensite region, the crack propagates along the grain boundary. When the crack propagates to the acicular martensite boundary, its size is much larger than 51.2 μm and the crack enters the propagation stage. In the plate martensite region of the carburized layer, the fracture mode is an intergranular fracture. In addition to the tensile stress, carbides also affect the crack propagation path. Finally, under the combined action of tensile stress and carbide, the crack propagates along the path with the lowest energy required.

Figure 12 Schematic diagram of crack initiation and propagation, a) Crack initiation and propagation on impact surface, b) The flow chart of crack initiation and propagation mechanism in carburizing layer, c) Flow chart of crack propagation from surface to interior

The piston's failure is mainly caused by higher von Mises stress on the outer edge and carbides in the carburized layer. The crack initiation is related to the high Mises stress, and crack propagation is related to the maximum tensile stress. Compared with the piston's vertical impact on the bit, the piston's inclined impact will cause more serious damage to the impact surface. Therefore, the clearance between piston and cylinder should be reduced as far as possible in the process of machining and assembling.
