Forensic investigations on earthquake damaged domestic and historical masonry structures in Himachal Pradesh region of India

Ashwani Kumar Sharma^{1*}, Ashutosh Kumar², Vasilis Sarhosis³

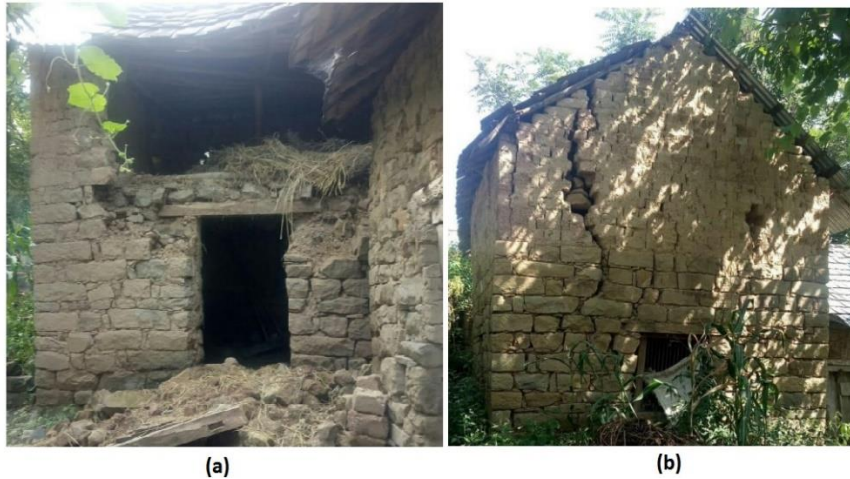
Fig 3: **a** Out of plane failure of wall, **b** development of cracks from openings

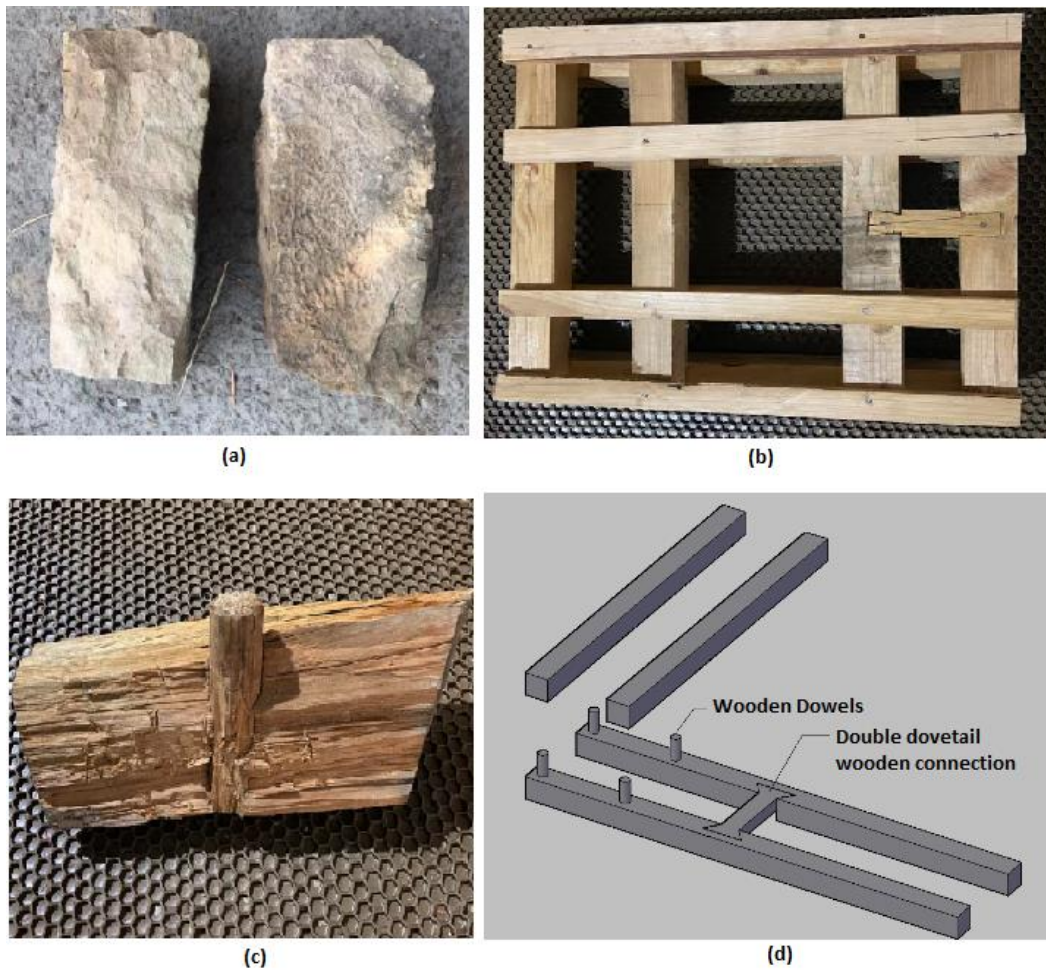
Figure 6 shows the samples collected during the site visit and a model of a typical connection of the timber elements. Figure 6(a) shows the stones collected from a deteriorating masonry structure. It is to be noted that the walls of the building use two horizontal beams in composite action which are connected by double dovetail timber connection and their thickness is approximately 100 mm. The connections between the beams were made in the middle length of wall and at every 1.8 m after grooving to restrict horizontal movement. This wooden connection in between the composite section of wall resists local degree of freedom of the beam components. Figure 6(b) shows a model describing double dovetail timber connection in the wooden framed structure which is made by a local mason who has constructed more than 70 Kath-kuni style structures. The timber beams of cross-section 40 mm × 40 mm were used in this model and double dovetail connection has length of 100 mm and thickness of 10 mm. The scaled down model also describes the corner connection of two parallel timber beams the beams of transverse walls. Two perpendicular beams were connected by timber dowels by drilling a hole through two beams at the corner, as shown in Figure 6(c). The diameter of these dowels was generally kept as 50 mm. In case of

seismic event, dowels provided lateral stiffness to resist lateral drift between two adjacent layers of the wall. Figure 6(d) shows the overall arrangement of timber beams and connection in the structure.

Fig 6: **a** Rubble stone collected from the site, **b** model of wooden double dovetail connection made by local mason, **c** wooden dowel in a timber beam obtained from the site **d** Modelling of connections in wooden frame present in Kath-kuni walls.

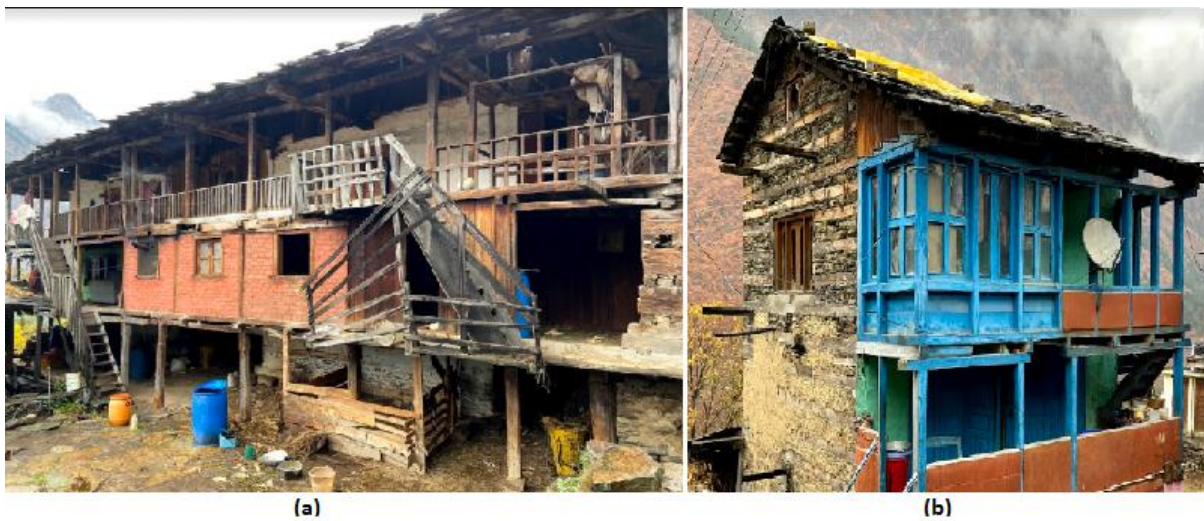
Fig 8: Residential Kath-kuni structure

Domestic Kath-kuni style structures are used by local people since several generations as shown in Figure 8. They were usually 1-3 stories where the ground storey was meant for cattle and served as storage purpose. The first storey was for living and dining and the topmost storey was often used as a place for worship and kitchen. The sloped roof was made of timber truss on which slate tiles were resting while the other structural configurations remains the same as discussed in the earlier section. The lateral dimensions of the buildings were usually dependent on the number of family members living and financial resources of the residents. Figure 8(a) shows the repair of the traditional structures with modern construction materials i.e. brick and cement mortar. Such repair practice may have negative impact on seismic resilience of the building as one portion of the structure becomes stiffer compared to the rest altering the global stiffness compatibility of the structure.

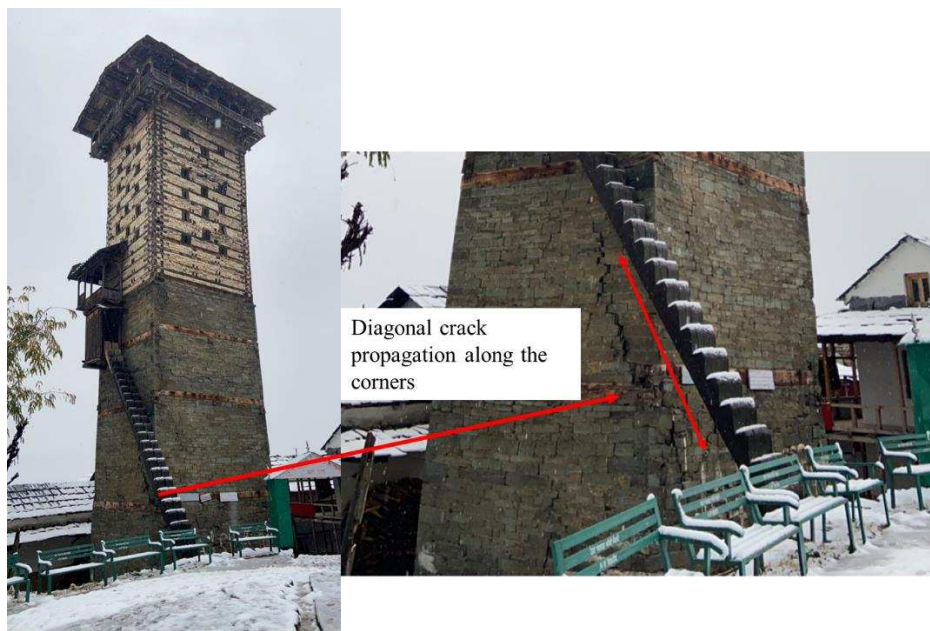
Fig 9: Chennai Kothi heritage tower

Figure 9 shows a 30 m high classical tower type Kath-Kuni architecture located at Chenni Kothi village of Kullu district. The structure is believed to be more than 500 years old and survived most of the disastrous earthquakes. This ancient tower was once the palace of the Queen but now transformed into a religious place. It has a symmetrical plan and walls with a narrow opening for windows and doors. The average width of the tower was 5 m. The structure was 4 storied having cantilevered balcony in all the directions. The length of the cantilever varied from 1.2 m to 1.5 m. The tower had initially 9 stories and during the seismic event of 1905 Kangra earthquake, the top two stories collapsed. The heavy mass lumped at such height and with lack of maintenance caused the historical structure to fail under the seismic event. Irrespective of the cultural and heritage value of the structure, there was no maintenance work done and there is also no documentation of the damage happened to the structure. During 2015 Gorkha earthquake, there was the same direct economic and historical loss in case of emergency measures taken by local people after the seismic event by clearing the parts of the collapsed structure which should be recycled and reused or preserved (Coningham et al. 2019). Figure 9 also highlight a wide visible crack just below the stairs of the structure which propagates towards the corner of the building. The length of the crack was measured as 2 m. This damage pattern may be attributed to the stress concentration near of corners of the wall and their inability to bear the shear stresses. Also, the possibility of rotation of the building was not observed

because of the intact rocky bearing strata. The maintenance, retrofitting and rebuilding work of such ancient marvel should be done by skilled engineers.

was recorded during the 1905 Kangra earthquake that collapsed the top 2 stories of the Chenni Kothi heritage tower.
