Dhimish, Mahmoud and KETTLE, JEFF (2021) Impact of Solar Cell Cracks Caused During Potential-Induced Degradation (PID) Tests. IEEE Transactions on Electron Devices. pp. 604-612. ISSN: 0018-9383

Impact of Solar Cell Cracks Caused During Potential Induced Degradation (PID) Tests

Mahmoud Dhimish, *Member, IEEE*, Jeff Kettle, *Member, IEEE*

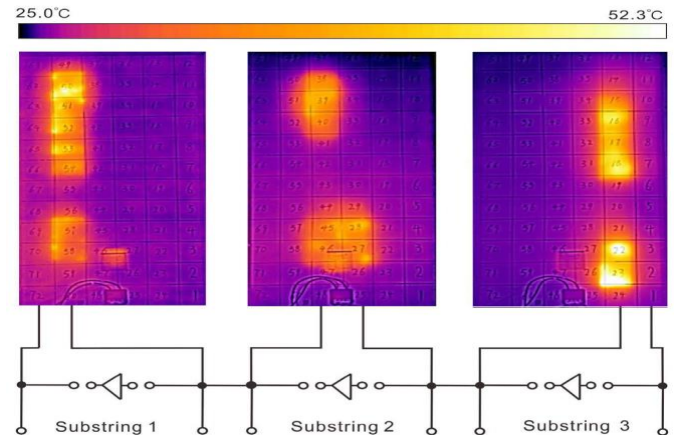
Fig. 1. Thermographic image of three substrings of module 3 under reverse 160 V bias [6].

modules, as presented in Fig. 1 for three different PV modules connected in series. This study showed that the PID resulted in a reduction of the current density and the open-circuit voltage. Improved testing has been the focus of much recent research; for example, in [7], authors have presented an approach to test the reversible and irreversible PID testing to bifacial PERC solar cells. Other researchers [8, 9] have reported that cracks in solar cells can accelerate PID due to the localized heat caused by the cracks. This work was supported by studies conducted using electroluminescence (EL) imaging before and after PID testing. This affirmed that cracks could lead to hotspots in the solar cells, and as a result, PID is expected, yet there were no discussions on the type/size of cracks and their expected impact upon PID.

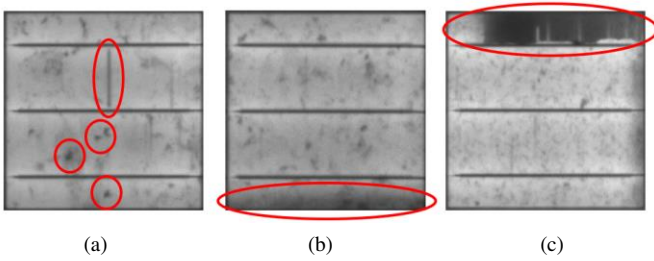
In Fig. 2, the EL image of solar cells affected by the typical cracks and/or structural defects is presented. These have been categorized into 3 groups by these authors; in Fig. 2(a), the cell is affected by minor cracks, whereas Fig. 2(b) shows that the cell has a dark area on the bottom edge. The last image, Fig. 2(c), presents a solar cell affected by a breakdown area.

Fig. 2. PV module affected by cracks or structural defect. (a) Minor cracks, (b) Dark area, (c) Breakdown the area.

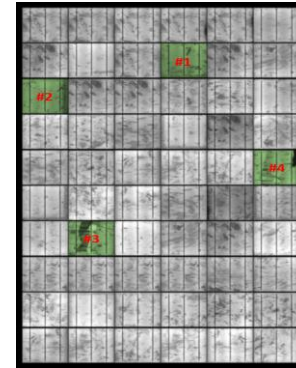
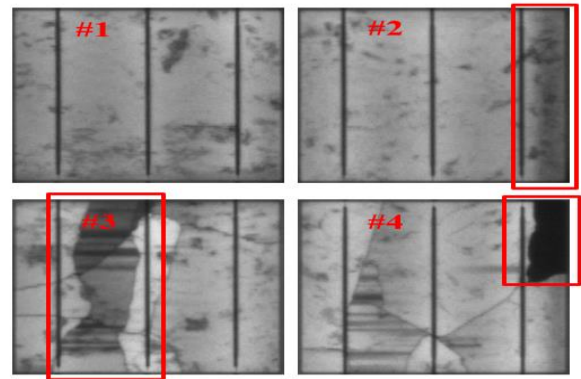
We have examined several solar cell samples categorizing different cracks shapes on distribution as well as structural defects. The EL image of the tested cells is shown in Fig. 4. According to Fig. 4(b), the solar cell sample (#1) is affected by minor defects/cracks across the cell. It was evident by previous research that such cracks do not reduce the output power of the solar cell. While solar cell samples (#2 and #3) are affected by cracked areas along with dark areas (labelled by the triangle), this type of crack has not been fully understood, and there is no information on whether it could lead to PID in the solar cell.

The last solar cell sample (#4) is affected by a breakdown region (labelled by the triangle). There are some proposals in the literature on whether this area can lead to PID or breakdown in the busbar; however, experimentation results have not yet been proclaimed. Hence, our results on examining these defects in the solar cells would significantly contribute to understanding the variations of the cracks along with their relationship with solar cell PID.

Fig. 4. (a) EL image of the PV module before the dismantling process, (b) After the dismantling process, the EL image of the tested solar cell samples, the first sample (#1), has a minor defect/crack across the cell. In contrast, samples (#2 and #3) are affected by a dark area with additional cracks in the cell. The last sample (#4) is affected by a breakdown region, as evidence by the solid black area.

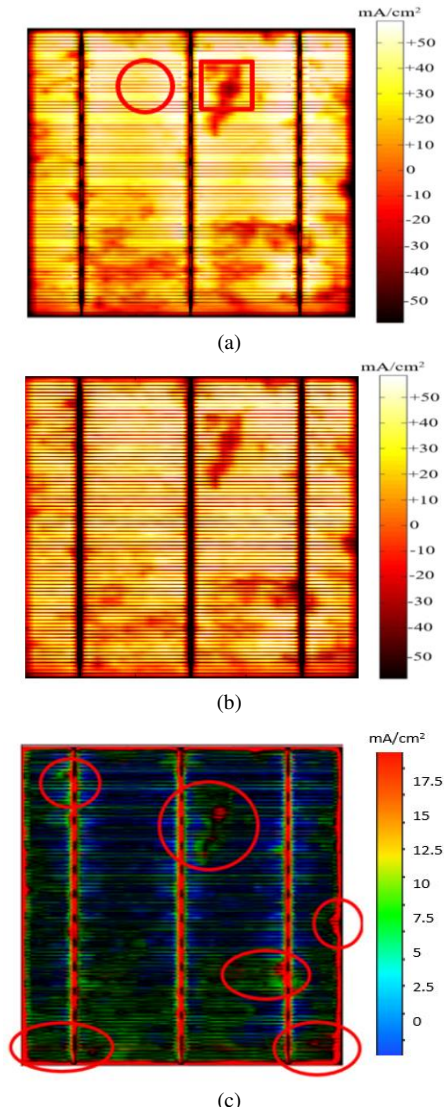
The image of the J_{sc} before and after the PID test is shown in Fig. 6(a) and Fig. 6(b), respectively. The difference between the before/after images is shown in Fig. 6(c). The most significant defects/cracks in the solar cell sees the biggest drop in J_{sc} . For example, on, the area labelled by the circle has no losses in the J_{sc} , 38 mA/cm². However, for the cracked/fractured area, labelled by the rectangle, the J_{sc} drop is approximately equal to -10 mA/cm² (27% relative reduction). This would correspond to a hotspot in an operational PV module, potentially leading to greater module defects as time progressed.

Following the observation of sample #1, minor cracked/defective areas in a solar cell are unlikely to cause a major and immediate PID. This consequence was concluded by observing that the pattern of Fig. 6(a) and Fig. 6(b) are almost equal. There are moderate differences between the J_{sc} before and after the PID, as shown in Fig. 6(c). We have labelled the key areas that exhibit a reduction in (leakage) current after the PID testing was completed. The blue regions in Fig. 6(c) correspond to a negligible change in degradation (no difference in the J_{sc}).

Fig. 6. J_{sc} for Solar cell #1. (a) before the PID test, (b) after the PID is completed, (c) Difference in the J_{sc} before and after the PID test.

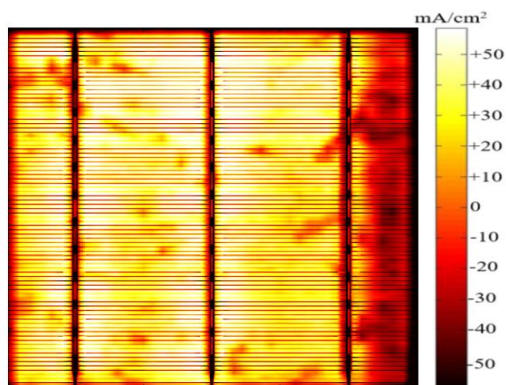
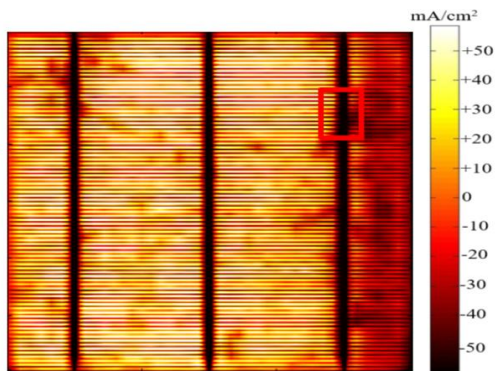
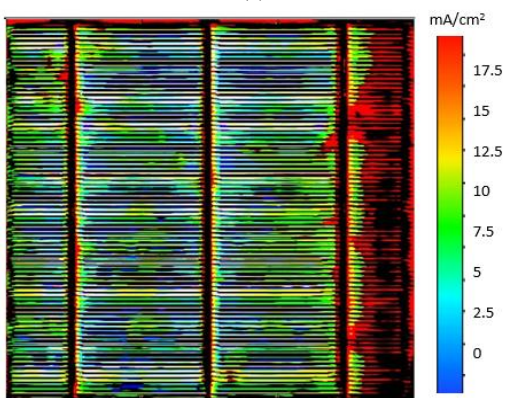
Now consider the behavior of solar cell sample #2, where the LBIC images before the PID test began is shown in Fig. 7(a). The dark area on the right-hand side of the solar cell clearly exhibits a drop in the J_{sc} . In agreement with the earlier data, the J_{sc} reduced significantly after the PID test was completed (Fig. 7(b)). Remarkably, the images indicate that the dark area is likely to be causing a more severe PID to the cell. There is a noticeable expansion of the dark regions across the right-hand side where the original EL image has an initial dark area.

The difference between the J_{sc} before and after the PID test is shown in Fig. 7(c). There is a significant drop in the current on the right-hand side of the solar cell, which is the same area that had the initial shading/defect. This confirms that such dark areas in the original EL images can be classified as high-risk regions for PID degradation in solar cells.

Fig. 7. J_{sc} for Solar cell #2. (a) before the PID test, (b) after the PID is completed, (c) Difference in the J_{sc} before and after the PID test.

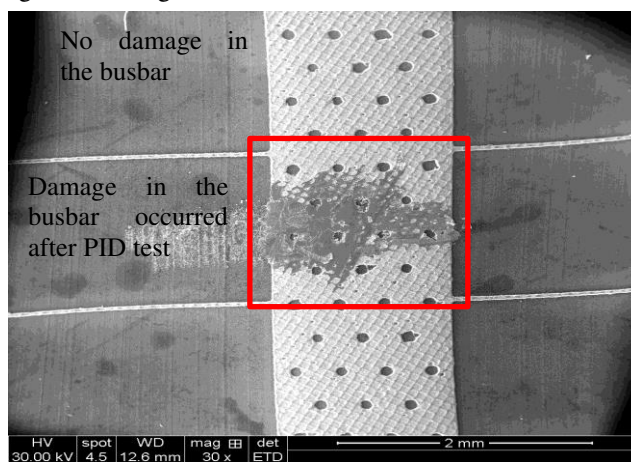
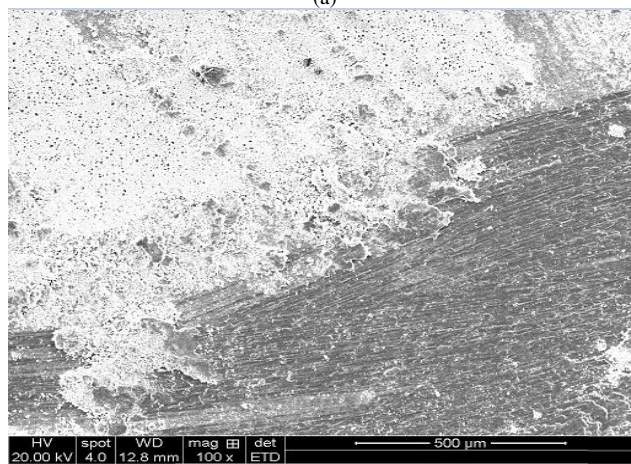
We have taken the SEM image of the labelled area in Fig 7(b) for further examination. The output image of the inspection is shown in Fig. 8(a). We have witnessed that after performing the PID test, the dark area (potential crack) damaged the busbar, this is evident by the front surface view.

In Fig. 8(b), we have observed at the back surface of the busbar. The PID test initiated further damage to the rear surface of the solar cell sample. There are a number of ‘pits’ in the contacts and material migration from the contact areas. As a result, we prove that it is likely to have a critical PID for a solar cell that comprises entirely/partially dark regions in the original EL image.

Fig. 8. SEM for solar cell #2. (a) front surface, (b) Back surface.

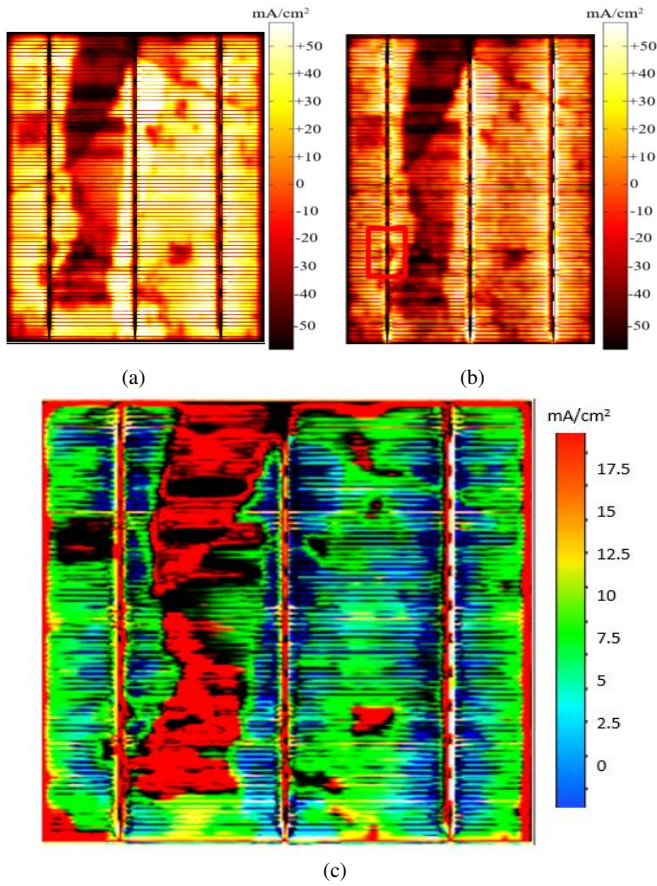
Now, considering solar cell sample #3 which was also imaged before and after PID testing. The J_{sc} before the PID test is shown in Fig. 9(a), whilst after the PID test is performed, a large reduction in the J_{sc} was observed, particularly in the dark area on the left-hand side of the EL image, and in the LBIC image, which is shown in Fig. 9(b).

The difference between the J_{sc} before and after the PID test is shown in Fig. 9(c). We can remark that there is negative current (leakage) in the areas where the dark (crack) is present. This result reinforces our earlier conclusion that cracks can lead to greater decreases in current density, indicative of regions where the solar cell operation has completely broken down. Hence, hotspots are expected to appear these locations if the cell is operated under field conditions, which would lead to further degradation.

Fig. 9. J_{sc} for Solar cell #3. (a) before the PID test, (b) after the PID test is completed, (c) Difference in the J_{sc} before and after the PID test.

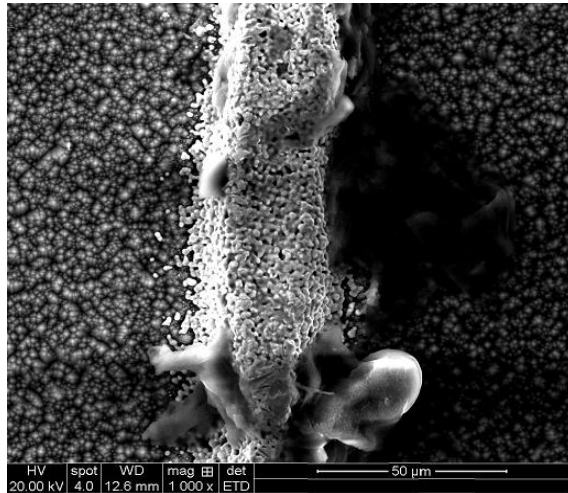
In contrast, we have further investigated the labelled area in Fig. 9(b), using an SEM. The result of the SEM inspection is displayed in Fig. 10. By inspection of the busbar's metallic (solder) joint to the solar cell surface, it is evident that the solder has migrated and deformed around the solder joint. This microscopic observation leads to understand why some solar cells, after PID tests, demonstrate significant decreases in the output current; clearly these changes lead to the development of hotspots and open circuits forming at the solder joints.

Fig. 10. SEM image for the front surface of the labelled area in Fig. 9(b).

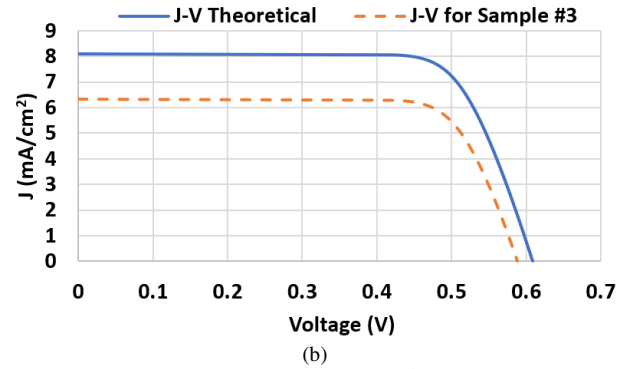
As the solar cell exhibits significant losses in the J_{sc} we have decided to test the cell under standard test conditions (illumination of 1000 W/m^2 and cell temperature 25 degrees), as shown in Fig. 11(a). The resultant current-voltage (J-V) curve compared with the theoretical values (taken from the solar cell datasheet) is shown in Fig. 11(b). The current density at short circuit conditions dropped by 20.5%, calculated using (1), whereas 4.9% was the drop in the V_{oc} calculated using (2). This concludes the fact that dark areas in EL images likely means that the cells are being impacted with severe PID.

$$\text{Drop in } J_{sc} = \frac{\text{Theoretical } J_{sc} - \text{Measured } J_{sc}}{\text{Theoretical } J_{sc}} \times 100 = \frac{38.1 - 30.3}{38.1} \times 100 = 20.5\% \quad (1)$$

$$\text{Drop in } V_{oc} = \frac{\text{Theoretical } V_{oc} - \text{Measured } V_{oc}}{\text{Theoretical } V_{oc}} \times 100 = \frac{0.61 - 0.58}{0.61} \times 100 = 4.9\% \quad (2)$$

Fig. 11. (a) The solar cell is exposed to 1000 W/m^2 illumination, (b) Measured J-V curve under STC conditions.

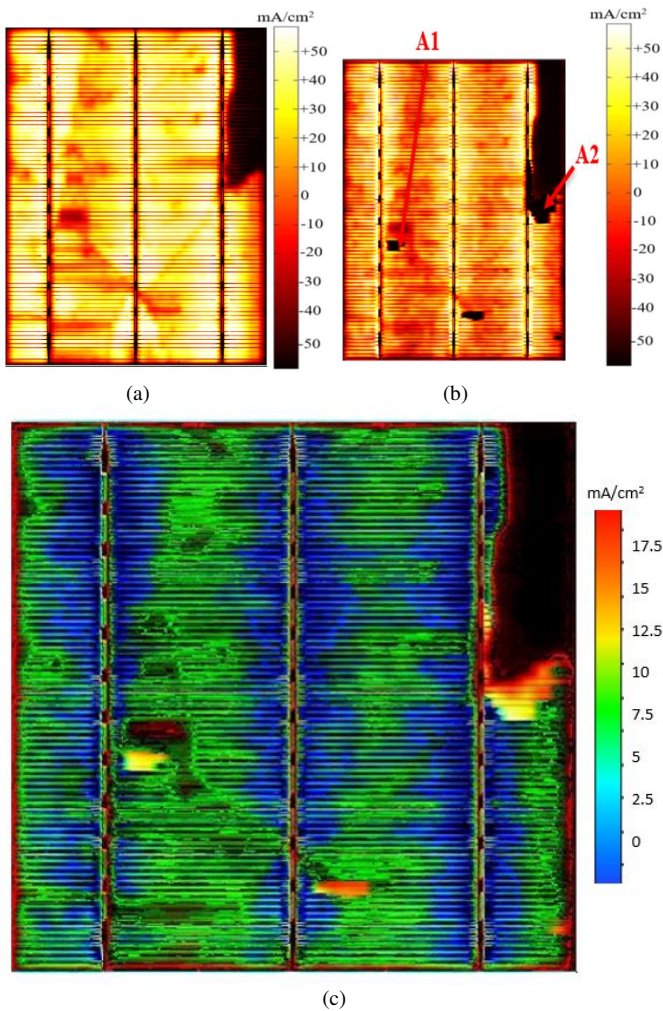
In In Fig. 12(a), we show the results of the J_{sc} for the last solar cell sample #4, which exhibited the largest number of cracks at the outset. We can notice in the initial EL image that the black area represents a complete breakdown in the cell. After the PID test was completed, the image (Fig. 12(b)) confirms an expansion of the breakdown area in the cell (labelled as A1 and A2). In Fig. 12(c), the difference in the J_{sc} before and after the PID test is presented. The expansion in the defect is evident indicating complete breakdown of $\sim 15\%$ of the cell. The cause of this breakdown is likely to be due to localized heating of the silicon material leading to expansion and greater stress on the cracked surface. It is worth noting that, if the solar cell sample were still exposed in the field, these additional breakdown regions would appear after a longer period, for example after months of operation, due to the lower stress conditions.

Fig. 12. J_{sc} for Solar cell #4. (a) before the PID test, (b) after the PID is completed, (c) Difference in the J_{sc} before and after the PID test.

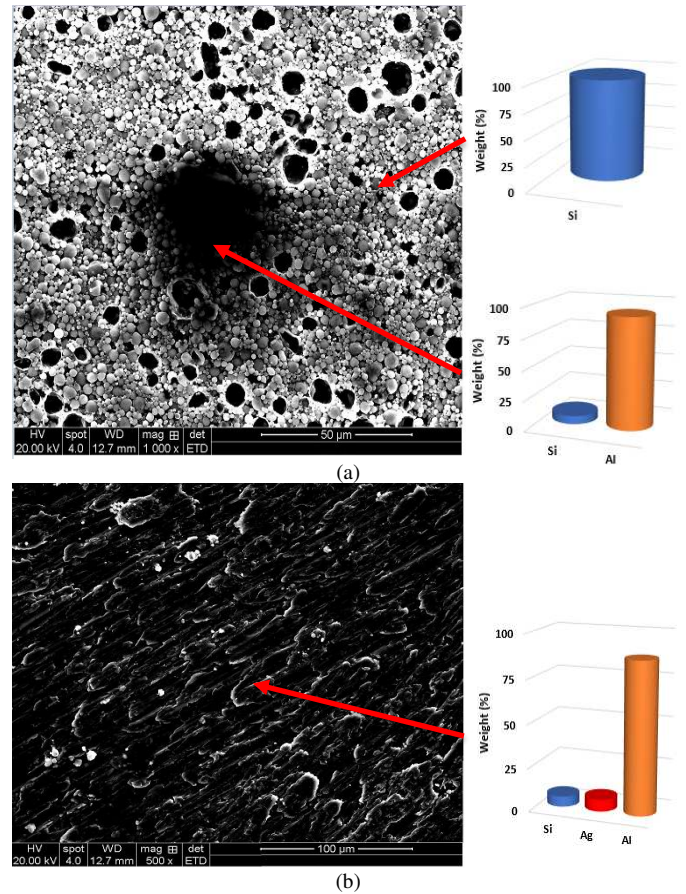
The breakdown areas were analyzed using a SEM. For example, the output SEM image for A1 is shown in Fig. 13(a). It appears that the crack has initiated a significant breakdown in the cell (the black area in the middle of Fig. 13(a)) and hundreds of similar potential breakdown blocks in the surrounding area. The white areas in the image represent as Silicon using Energy-dispersive X-ray spectroscopy (EDX). In comparison, the black area corresponds to aluminum (Al), indicating that a large defect in the solar cell, and the solar cell rear contact (made of Al) is only visible. Additionally, the SEM image for A2 is shown in Fig. 13(b); only 6% silicon was found in this area, along with 7% silver (Ag) due to the expansion of the busbar material and 87% of Al. Accordingly, this part of the solar cell has a complete breakdown, not generating any photocurrent.

In reviewing the abovementioned observations, the breakdown area in the solar cell sample #4 leads to a drop in the J_{sc} after the PID test was completed and a further breakdown area adjacent to the initial breakdown. These observations suggest the following:

Fig. 13. (a) SEM image for the front surface of area A1, (b) SEM image for the front surface of area A2.

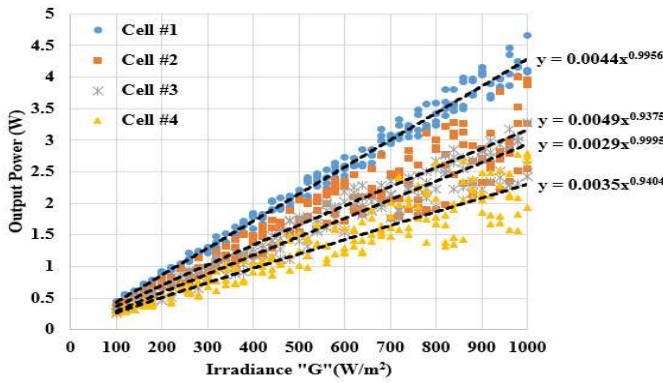
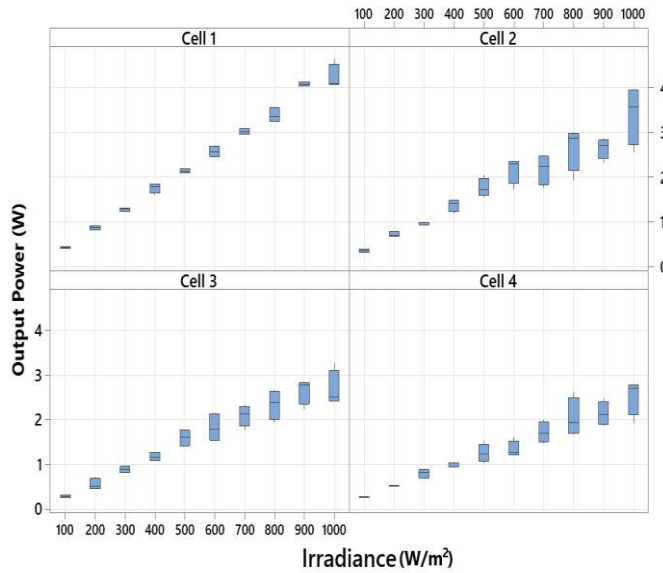
For sample #1, affected by minor cracks, the cell generated more output power, with an average power output of 2.36 W. Cells #2 and #3 show similar levels of cracking (as demonstrated by the dark areas in the EL image); so, their output averaged power at 1 Sun irradiance equals 1.81 W and 1.62, respectively. Finally, the maximum drop in the averaged power was observed for the last solar cell sample #4, which exhibited the most severe cracking and showed an output power of only 1.32 W.

Fig. 14. (a) Output power of the cells under illumination from 100 to 1000 W/m², and cell temperature is 25 degrees, (b) Boxplot of the output power vs irradiance.

This data is supportive that as the crack size increases in solar cells, PID testing has a greater affect the output power performance. Furthermore, if we consider Fig. 14(b), the measured power has a more pronounced distribution away from the mean as the irradiance level increases. For example, the distribution of the measured output power at 1000 W/m² is $\pm 15\%$ from the actual median value, while it is only equal to $\pm 2\%$ at 100 W/m².

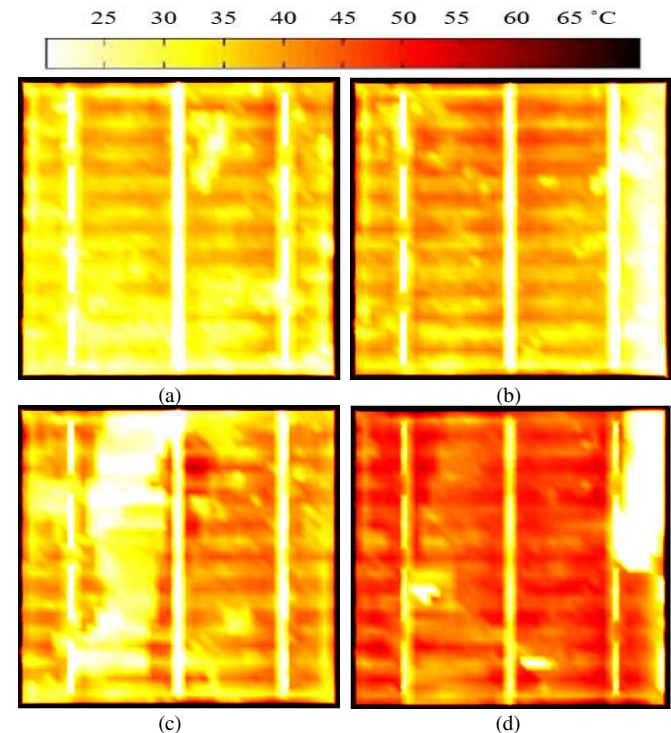
The results of the experiment are presented in Fig. 15. We can remark that the cell's temperature of cell #1 is uniformly distributed and at nearly STC condition, 25 degrees. For cell #2 and cell #3, it is evident that there is a localized increase in the temperature, which reaches as high as 40°C in the areas where a crack (dark) appears. Considering Fig. 15(c), we can recognise that in the middle busbar, there is a minor hotspot is now affecting the cell; this is because of the expansion of the crack after the PID was performed.

Because cell #4 has the large breakdown region (as shown in the earlier EL image in Fig. 4), a rapid increase (60°C) of the cell temperature is observed. This is because a reverse-biased voltage is expected in this region, hence, a hotspot in the cell has now been developed. In summary, the main effects of the cracks themselves on hotspot temperatures are,

Fig. 15. Thermal image of the solar cell samples (125 × 125 mm) at 1000 W/m². (a) Solar cell #1, (b) Solar cell #2, (c) Solar cell #3, (d) Solar cell #4.

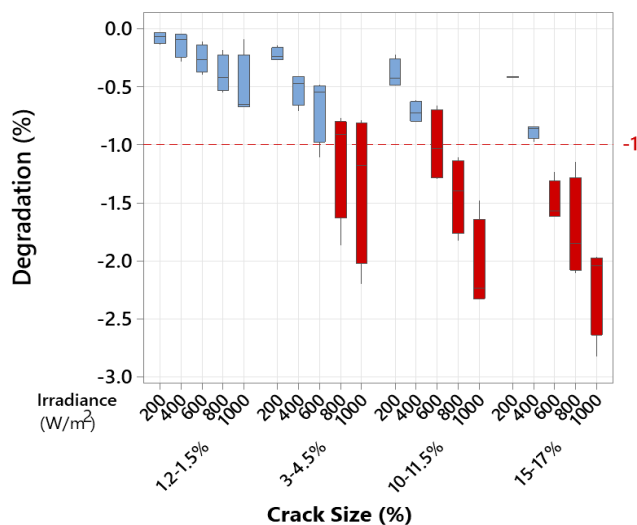
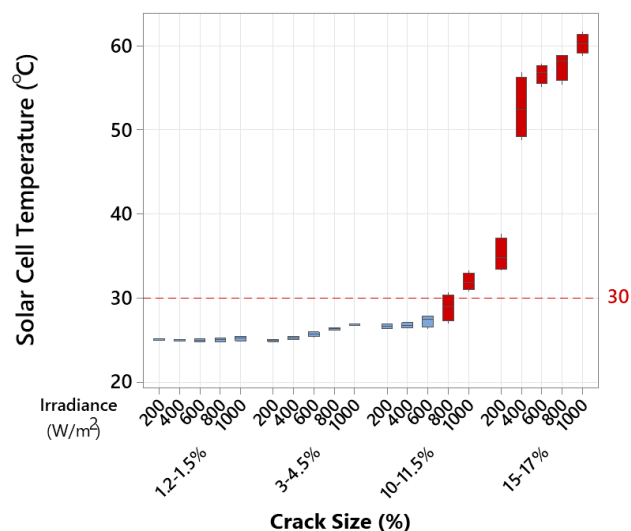
To consolidate the results, we have determined the crack size of each tested solar cell using the EL and LBIC images and assigned them into four categories, 1.2-1.5%, 3-4.5%, 10-11.5%, and 15-17%. The degradation rate for each category has been calculated by dividing the measured power by the theoretical power and the results are presented in Fig. 16(a). According to the largest study to date on PV degradation, [19], the median degradation is -0.5%/year for a PV system, while for a standalone solar cell sample is -1.0%. Accordingly, in Fig. 16(a), we have labelled in "red" all calculated degradation rates that were observed below -1.0%. As a result, we found no significant degradation in the cell with 1.2-1.5% crack size, while for all other considered crack sizes, a significant degradation is observed.

Similarly, we observed the thermal performance (cells temperature) under varying solar irradiance (see Fig. 16(b)). The results show that for the crack sizes from 1.2-11.5%, it is unlikely the cell develops a hotspot (nearly all measurements are below the standard baseline of 30°C, IEC61215/61646). In contrast, if the crack size is in the range between 15-17%, a hotspot is expected to develop and has an increase in the cell's temperature to approximately 60°C.

Fig. 16. Irradiance spectrum of the crack size vs. (a) Degradation, (b) Temperature.
