Impact of Solar Cell Cracks Caused During Potential Induced Degradation (PID) Tests

Mahmoud Dhimish, *Member, IEEE*, Jeff Kettle, *Member, IEEE*

Abstract— Potential-induced degradation (PID) of photovoltaic (PV) modules is one of the most severe types of degradation in modern modules, where power losses depend on the strength of the electric field, the temperature and relative humidity and the PV module materials. Understanding how module defects impact PID is key to reducing the issue. This work investigates the impact of cracks and fractural defects in solar cells and their impact on PID. We have tested using electroluminescence (EL) imaging how solar cells with varying levels of cracks/defects impact PID and our results indicate that such defects have a sizeable influence on the PID. We also confirmed the strong relationship between the size of the initial defect/crack and the presence of hotspots. As the crack (dark) area increased, there was a further increase in the cell's temperature under standard test conditions. In this work, it is observed that minor cracks in solar cells have no considerable PID effect for the solar cells providing some reassurance that quality contro

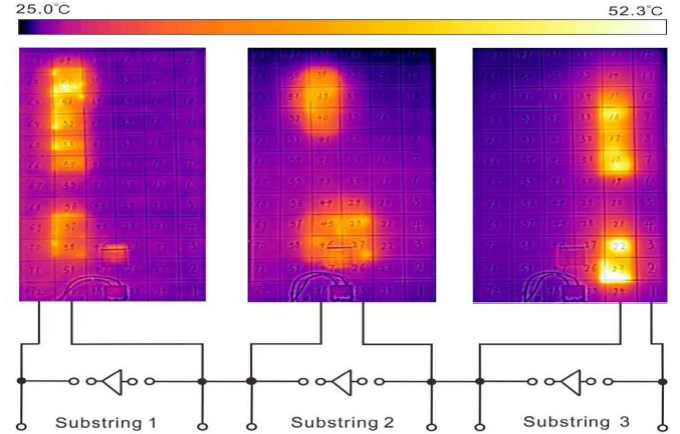
In a recent study, [6], a PV module subjected to a reverse bias of 160 V voltage was shown to exhibit severe PID, leading to the formation of hotspots which appeared on the

Fig. 1. Thermographic image of three substrings of module 3 under reverse 160 V bias [6].

modules, as presented in Fig. 1 for three different PV modules connected in series. This study showed that the PID resulted in a reduction of the current density and the open-circuit voltage. Improved testing has been the focus of much recent research; for example, in [7], authors have presented an approach to test the reversible and irreversible PID testing to bifacial PERC solar cells. Other researchers [8, 9] have reported that cracks in solar cells can accelerate PID due to the localized heat caused by the cracks. This work was supported by studies conducted using electroluminescence (EL) imaging before and after PID testing. This affirmed that cracks could lead to hotspots in the solar cells, and as a result, PID is expected, yet there were no discussions on the type/size of cracks and their expected impact upon PID.

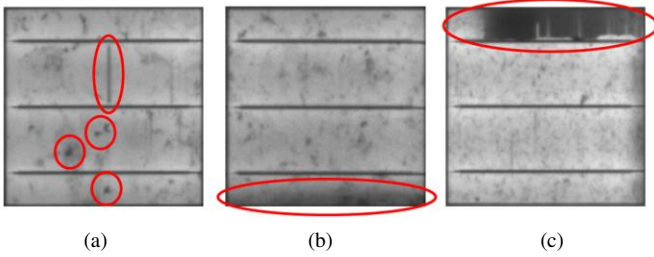
In Fig. 2, the EL image of solar cells affected by the typical cracks and/or structural defects is presented. These have been categorized into 3 groups by these authors; in Fig. 2(a), the cell is affected by minor cracks, whereas Fig. 2(b) shows that the cell has a dark area on the bottom edge. The last image, Fig. 2(c), presents a solar cell affected by a breakdown area.

Fig. 2. PV module affected by cracks or structural defect. (a) Minor cracks, (b) Dark area, (c) Breakdown the area.

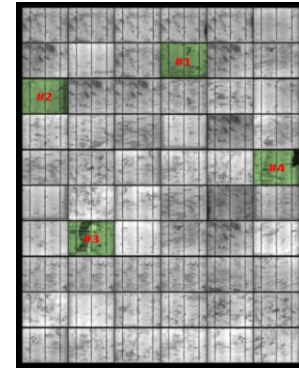
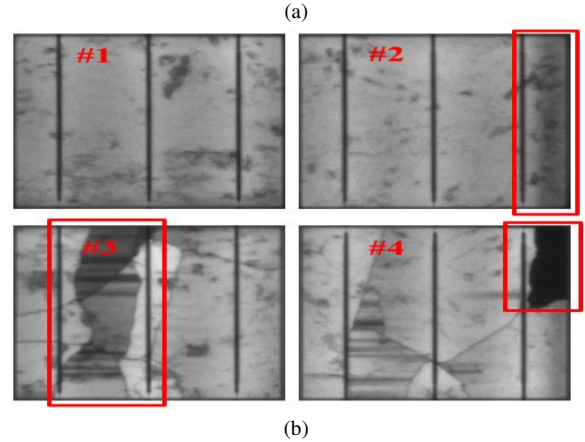
We have examined several solar cell samples categorizing different cracks shapes on distribution as well as structural defects. The EL image of the tested cells is shown in Fig. 4. According to Fig. 4(b), the solar cell sample (#1) is affected by minor defects/cracks across the cell. It was evident by previous research that such cracks do not reduce the output power of the solar cell. While solar cell samples (#2 and #3) are affected by cracked areas along with dark areas (labelled by the triangle), this type of crack has not been fully understood, and there is no information on whether it could lead to PID in the solar cell.

The last solar cell sample (#4) is affected by a breakdown region (labelled by the triangle). There are some proposals in the literature on whether this area can lead to PID or breakdown in the busbar; however, experimentation results have not yet been proclaimed. Hence, our results on examining these defects in the solar cells would significantly contribute to understanding the variations of the cracks along with their relationship with solar cell PID.

Fig. 4. (a) EL image of the PV module before the dismantling process, (b) After the dismantling process, the EL image of the tested solar cell samples, the first sample (#1), has a minor defect/crack across the cell. In contrast, samples (#2 and #3) are affected by a dark area with additional cracks in the cell. The last sample (#4) is affected by a breakdown region, as evidence by the solid black area.

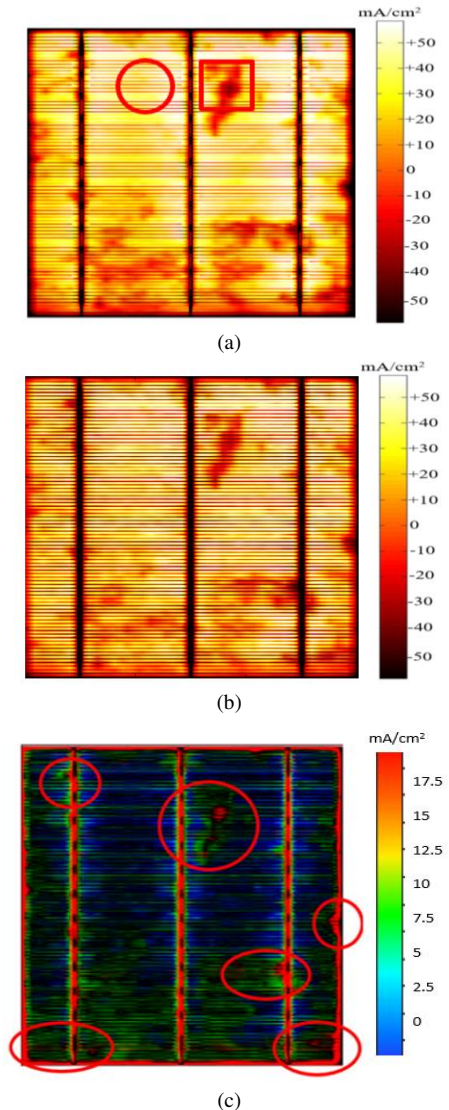
The first solar cell sample (EL image shown in Fig. 4, #1) was observed before and after the PID test. This solar cell possessed only minor defects/cracks across its surface. We investigated the short circuit current density, as the drop in the open-circuit voltage is not significant during the testing response (fraction of 10 mV) is expected to drop [17, 18] after the PID testing is performed.

The image of the J_{sc} before and after the PID test is shown in Fig. 6(a) and Fig. 6(b), respectively. The difference between the before/after images is shown in Fig. 6(c). The most significant defects/cracks in the solar cell sees the biggest drop in J_{sc} . For example, on, the area labelled by the circle has no losses in the J_{sc} , 38 mA/cm². However, for the cracked/fractured area, labelled by the rectangle, the J_{sc} drop is approximately equal to -10 mA/cm² (27% relative reduction). This would correspond to a hotspot in an operational PV module, potentially leading to greater module defects as time progressed.

Following the observation of sample #1, minor cracked/defective areas in a solar cell are unlikely to cause a major and immediate PID. This consequence was concluded by observing that the pattern of Fig. 6(a) and Fig. 6(b) are almost equal. There are moderate differences between the J_{sc} before and after the PID, as shown in Fig. 6(c). We have labelled the key areas that exhibit a reduction in (leakage) current after the PID testing was completed. The blue regions in Fig. 6(c) correspond to a negligible change in degradation (no difference in the J_{sc}).

Fig. 6. J_{sc} for Solar cell #1. (a) before the PID test, (b) after the PID is completed, (c) Difference in the J_{sc} before and after the PID test.

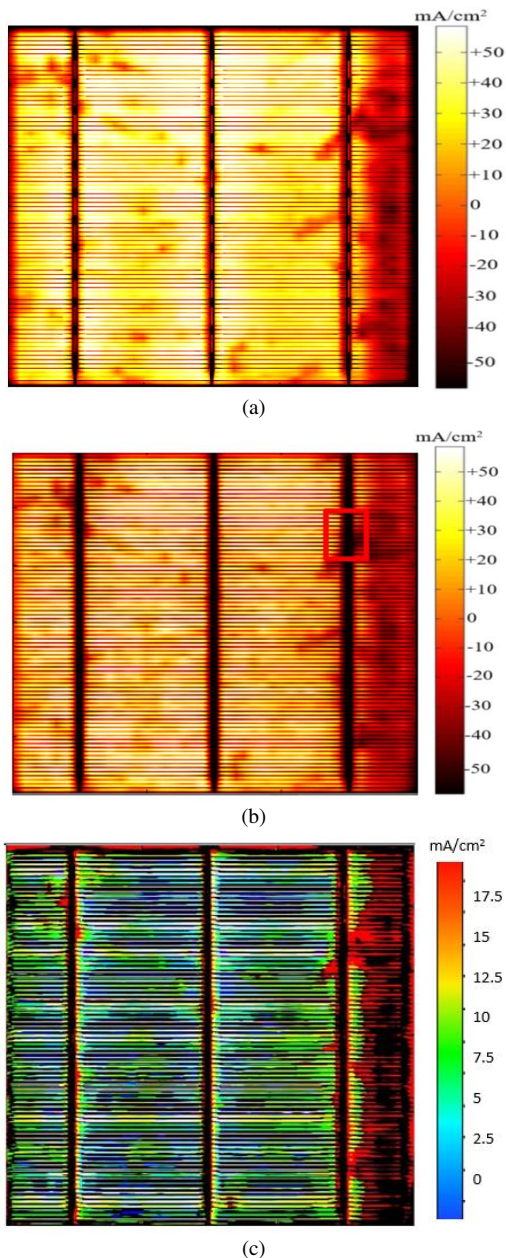
Now consider the behavior of solar cell sample #2, where the LBIC images before the PID test began is shown in Fig. 7(a). The dark area on the right-hand side of the solar cell clearly exhibits a drop in the J_{sc} . In agreement with the earlier data, the J_{sc} reduced significantly after the PID test was completed (Fig. 7(b)). Remarkably, the images indicate that the dark area is likely to be causing a more severe PID to the cell. There is a noticeable expansion of the dark regions across the right-hand side where the original EL image has an initial dark area.

The difference between the J_{sc} before and after the PID test is shown in Fig. 7(c). There is a significant drop in the current on the right-hand side of the solar cell, which is the same area that had the initial shading/defect. This confirms that such dark areas in the original EL images can be classified as high-risk regions for PID degradation in solar cells.

Fig. 7. J_{sc} for Solar cell #2. (a) before the PID test, (b) after the PID is completed, (c) Difference in the J_{sc} before and after the PID test.

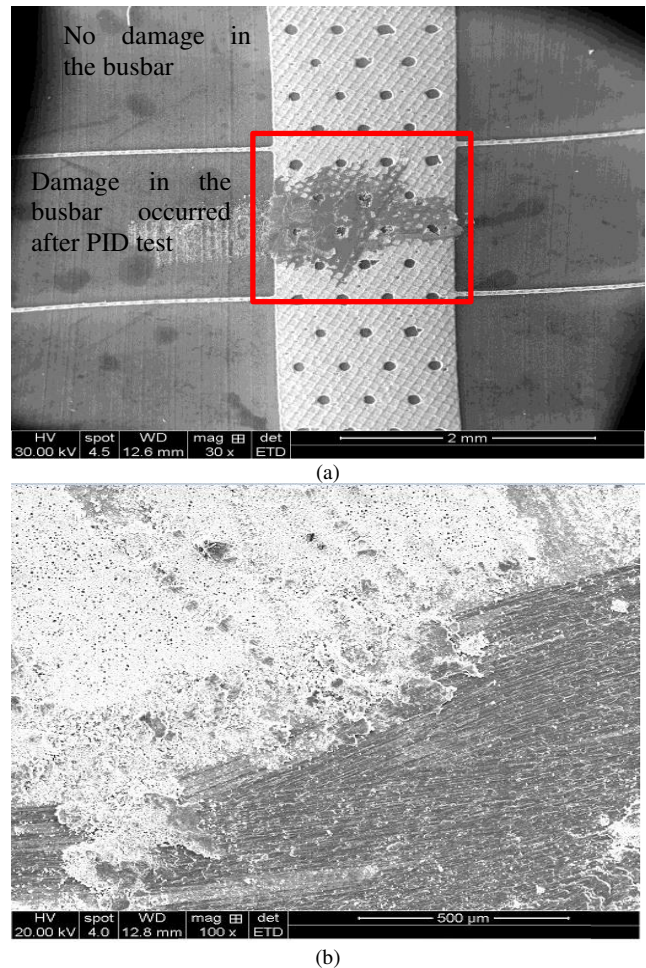
We have taken the SEM image of the labelled area in Fig 7(b) for further examination. The output image of the inspection is shown in Fig. 8(a). We have witnessed that after performing the PID test, the dark area (potential crack) damaged the busbar, this is evident by the front surface view.

In Fig. 8(b), we have observed at the back surface of the busbar. The PID test initiated further damage to the rear surface of the solar cell sample. There are a number of 'pits' in the contacts and material migration from the contact areas. As a result, we prove that it is likely to have a critical PID for a solar cell that comprises entirely/partially dark regions in the original EL image.

Fig. 8. SEM for solar cell #2. (a) front surface, (b) Back surface.

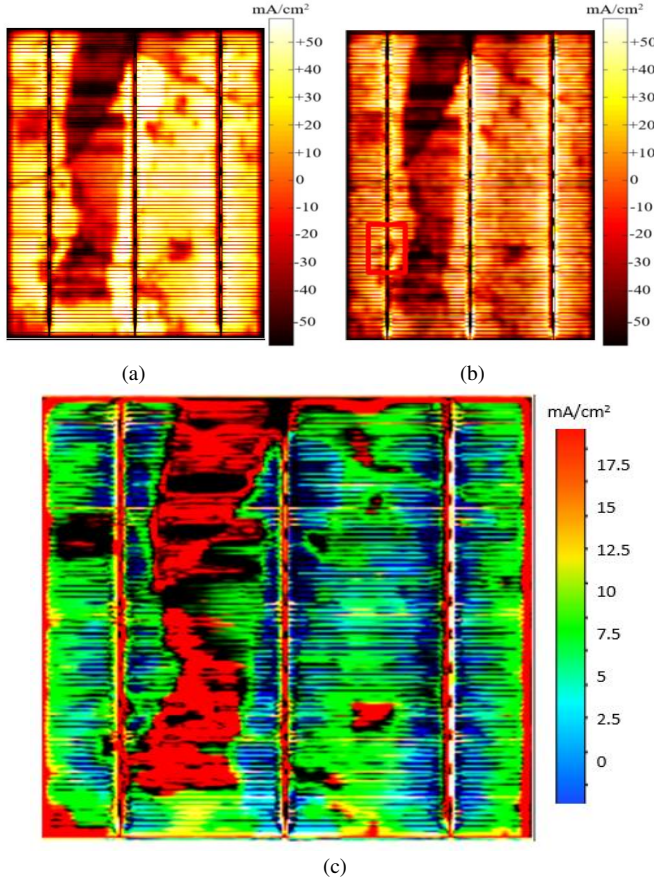
Now, considering solar cell sample #3 which was also imaged before and after PID testing. The J_{sc} before the PID test is shown in Fig. 9(a), whilst after the PID test is performed, a large reduction in the J_{sc} was observed, particularly in the dark area on the left-hand side of the EL image, and in the LBIC image, which is shown in Fig. 9(b).

The difference between the J_{sc} before and after the PID test is shown in Fig. 9(c). We can remark that there is negative current (leakage) in the areas where the dark (crack) is present. This result reinforces our earlier conclusion that cracks can lead to greater decreases in current density, indicative of regions where the solar cell operation has completely broken down. Hence, hotspots are expected to appear these locations if the cell is operated under field conditions, which would lead to further degradation.

Fig. 9. J_{sc} for Solar cell #3. (a) before the PID test, (b) after the PID test, (c) Difference in the J_{sc} before and after the PID test.

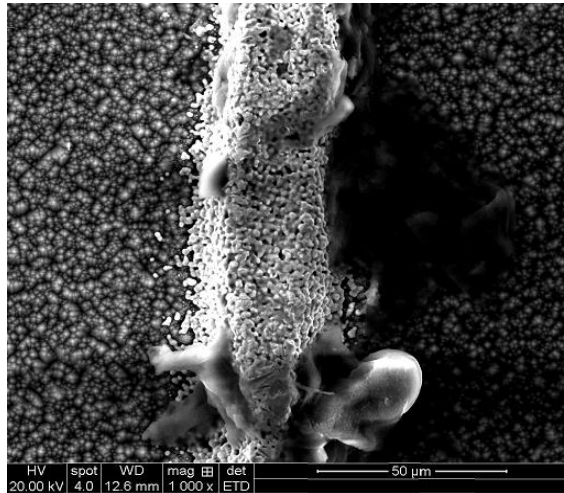
In contrast, we have further investigated the labelled area in Fig. 9(b), using an SEM. The result of the SEM inspection is displayed in Fig. 10. By inspection of the busbar's metallic (solder) joint to the solar cell surface, it is evident that the solder has migrated and deformed around the solder joint. This microscopic observation leads to understand why some solar cells, after PID tests, demonstrate significant decreases in the output current; clearly these changes lead to the development of hotspots and open circuits forming at the solder joints.

Fig. 10. SEM image for the front surface of the labelled area in Fig. 9(b).

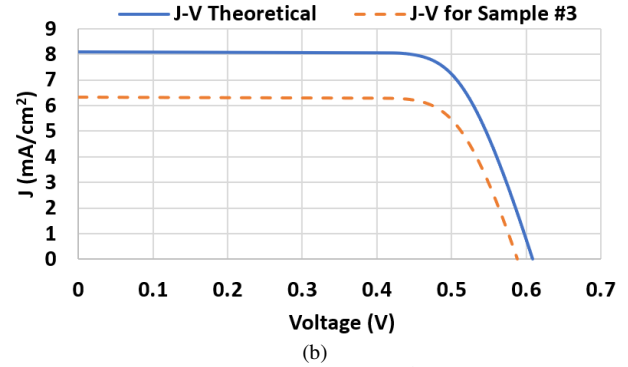
As the solar cell exhibits significant losses in the J_{sc} we have decided to test the cell under standard test conditions (illumination of 1000 W/m² and cell temperature 25 degrees), as shown in Fig. 11(a). The resultant current-voltage (J-V) curve compared with the theoretical values (taken from the solar cell datasheet) is shown in Fig. 11(b). The current density at short circuit conditions dropped by 20.5%, calculated using (1), whereas 4.9% was the drop in the V_{oc} calculated using (2). This concludes the fact that dark areas in EL images likely means that the cells are being impacted with severe PID.

$$\text{Drop in } J_{sc} = \frac{\text{Theoretical } J_{sc} - \text{Measured } J_{sc}}{\text{Theoretical } J_{sc}} \times 100 = \frac{38.1 - 30.3}{38.1} \times 100 = 20.5\% \quad (1)$$

$$\text{Drop in } V_{oc} = \frac{\text{Theoretical } V_{oc} - \text{Measured } V_{oc}}{\text{Theoretical } V_{oc}} \times 100 = \frac{0.61 - 0.58}{0.61} \times 100 = 4.9\% \quad (2)$$

Fig. 11. (a) The solar cell is exposed to 1000 W/m² illumination, (b) Measured J-V curve under STC conditions.

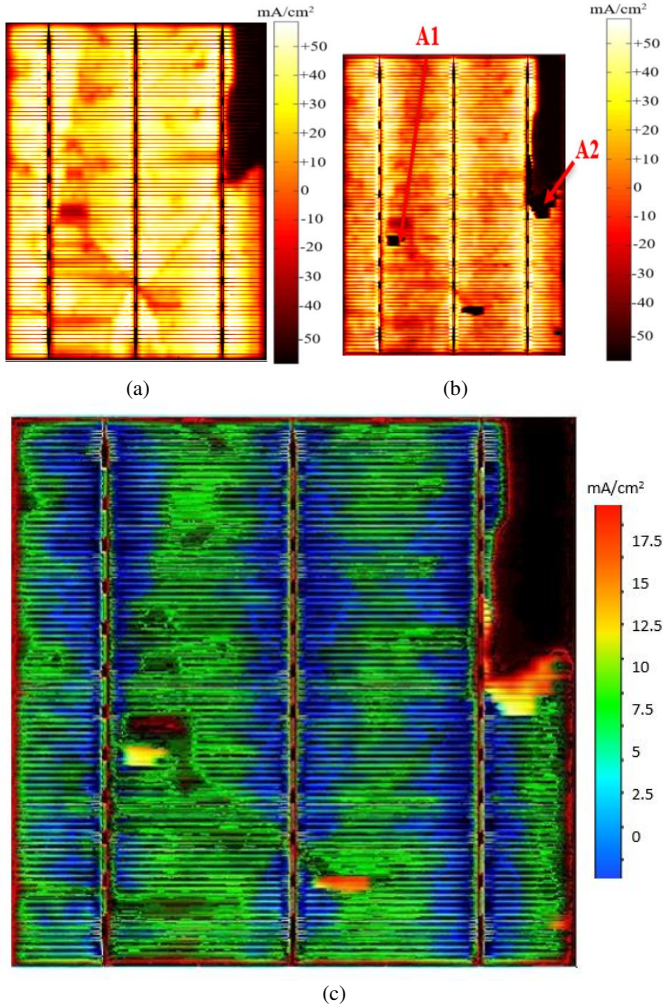
In In Fig. 12(a), we show the results of the J_{sc} for the last solar cell sample #4, which exhibited the largest number of cracks at the outset. We can notice in the initial EL image that the black area represents a complete breakdown in the cell. After the PID test was completed, the image (Fig. 12(b)) confirms an expansion of the breakdown area in the cell (labelled as A1 and A2). In Fig. 12(c), the difference in the J_{sc} before and after the PID test is presented. The expansion in the defect is evident indicating complete breakdown of ~15% of the cell. The cause of this breakdown is likely to be due to localized heating of the silicon material leading to expansion and greater stress on the cracked surface. It is worth noting that, if the solar cell sample were still exposed in the field, these additional breakdown regions would appear after a longer period, for example after months of operation, due to the lower stress conditions.

Fig. 12. J_{sc} for Solar cell #4. (a) before the PID test, (b) after the PID test, (c) Difference in the J_{sc} before and after the PID test.

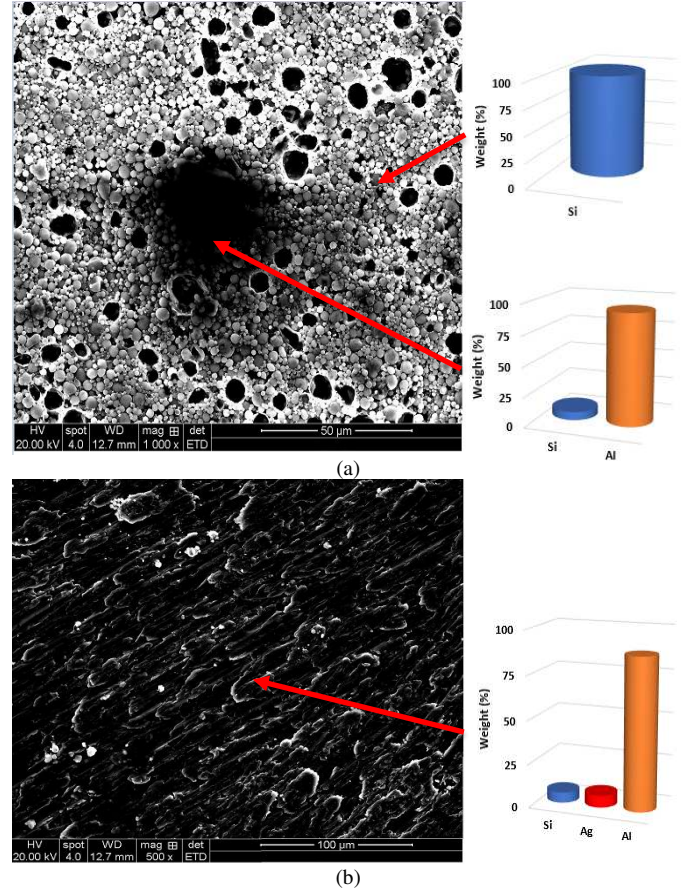
The breakdown areas were analyzed using a SEM. For example, the output SEM image for A1 is shown in Fig. 13(a). It appears that the crack has initiated a significant breakdown in the cell (the black area in the middle of Fig. 13(a)) and hundreds of similar potential breakdown blocks in the surrounding area. The white areas in the image represent are measured as Silicon using Energy-dispersive X-ray spectroscopy (EDX). In comparison, the black area corresponds to aluminum (Al), indicating that a large defect in the solar cell, and the solar cell rear contact (made of Al) is only visible. Additionally, the SEM image for A2 is shown in Fig. 13(b); only 6% silicon was found in this area, along with 7% silver (Ag) due to the expansion of the busbar material and 87% of Al. Accordingly, this part of the solar cell has a complete breakdown, not generating any photocurrent.

In reviewing the abovementioned observations, the breakdown area in the solar cell sample #4 leads to a drop in the J_{sc} after the PID test was completed and a further breakdown area adjacent to the initial breakdown. These observations suggest the following:

- 1) Breakdown in EL images are likely to span different breakdown regions after field operation.
- 2) Solar cells with this type of structural defects are indeed affected by PID.

Fig. 13. (a) SEM image for the front surface of area A1, (b) SEM image for the front surface of area A2.

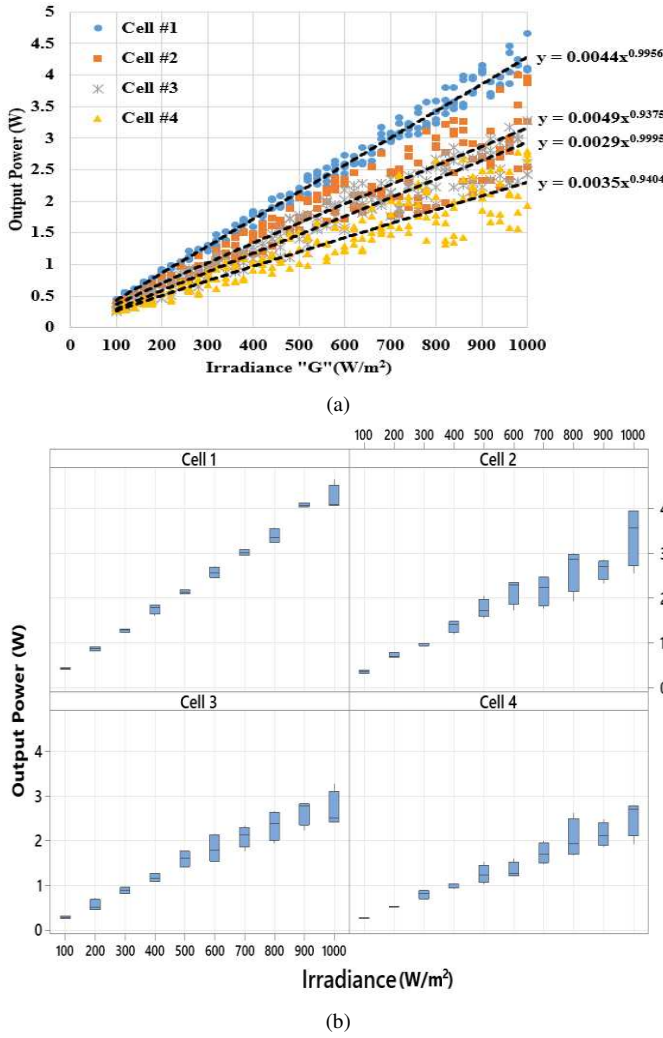
The solar simulator was used to test the performance of the cells, and the output power at maximum power point vs irradiance is presented in Fig. 14(a). The irradiance ranges from 100 (0.1 Sun) to 1000 (1 Sun) W/m^2 , while the cell's temperature was maintained at the standard test condition, 25°C.

For sample #1, affected by minor cracks, the cell generated more output power, with an average power output of 2.36 W. Cells #2 and #3 show similar levels of cracking (as demonstrated by the dark areas in the EL image); so, their output averaged power at 1 Sun irradiance equals 1.81 W and 1.62, respectively. Finally, the maximum drop in the averaged power was observed for the last solar cell sample #4, which exhibited the most severe cracking and showed an output power of only 1.32 W.

Fig. 14. (a) Output power of the cells under illumination from 100 to 1000 W/m², and cell temperature is 25 degrees, (b) Boxplot of the output power vs irradiance.

This data is supportive that as the crack size increases in solar cells, PID testing has a greater affect the output power performance. Furthermore, if we consider Fig. 14(b), the measured power has a more pronounced distribution away from the mean as the irradiance level increases. For example, the distribution of the measured output power at 1000 W/m² is $\pm 15\%$ from the actual median value, while it is only equal to $\pm 2\%$ at 100 W/m².

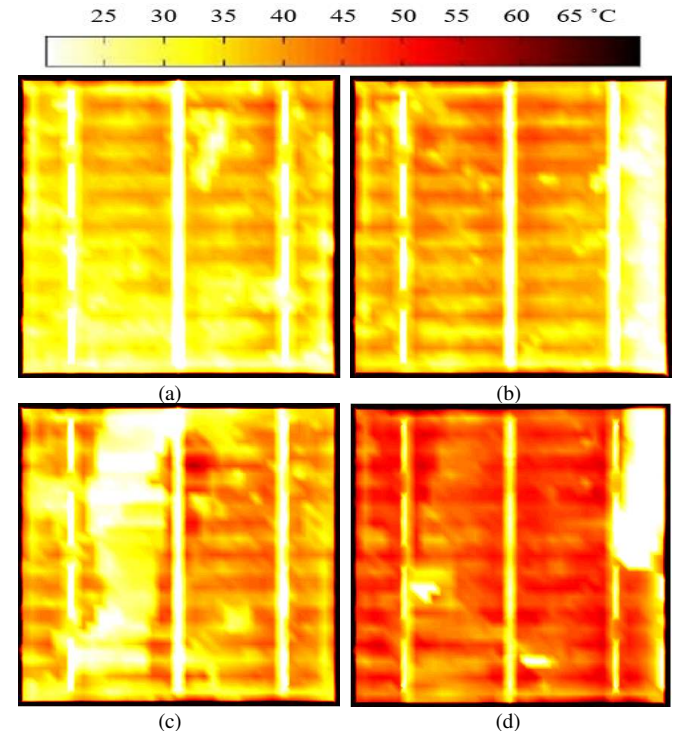
The results of the experiment are presented in Fig. 15. We can remark that the cell's temperature of cell #1 is uniformly distributed and at nearly STC condition, 25 degrees. For cell #2 and cell #3, it is evident that there is a localized increase in the temperature, which reaches as high as 40°C in the areas where a crack (dark) appears. Considering Fig. 15(c), we can recognise that in the middle busbar, there is a minor hotspot is now affecting the cell; this is because of the expansion of the crack after the PID was performed.

Because cell #4 has the large breakdown region (as shown in the earlier EL image in Fig. 4), a rapid increase (60°C) of the cell temperature is observed. This is because a reverse-biased voltage is expected in this region, hence, a hotspot in the cell has now been developed. In summary, the main effects of the cracks themselves on hotspot temperatures are,

- 1) A larger crack (dark) will drive the affected cell considerably into reverse bias.
- 2) An increase of the shading effectively decreases the photo-illuminated region leading to a reduction in the cell current. These two effects run counter to each other and lead to the development of the hotspot.

Fig. 15. Thermal image of the solar cell samples (125 × 125 mm) at 1000 W/m². (a) Solar cell #1, (b) Solar cell #2, (c) Solar cell #3, (d) Solar cell #4.

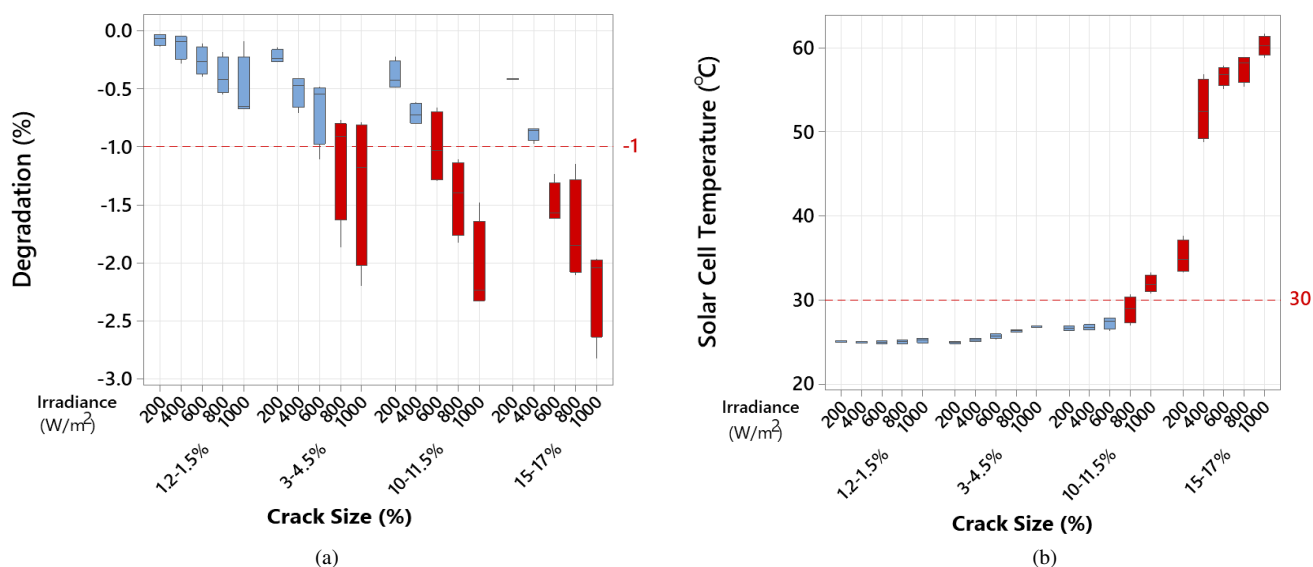
To consolidate the results, we have determined the crack size of each tested solar cell using the EL and LBIC images and assigned them into four categories, 1.2-1.5%, 3-4.5%, 10-11.5%, and 15-17%. The degradation rate for each category has been calculated by dividing the measured power by the theoretical power and the results are presented in Fig. 16(a). According to the largest study to date on PV degradation, [19], the median degradation is -0.5%/year for a PV system, while for a standalone solar cell sample is -1.0%. Accordingly, in Fig. 16(a), we have labelled in "red" all calculated degradation rates that were observed below -1.0%. As a result, we found no significant degradation in the cell with 1.2-1.5% crack size, while for all other considered crack sizes, a significant degradation is observed.

Similarly, we observed the thermal performance (cells temperature) under varying solar irradiance (see Fig. 16(b)). The results show that for the crack sizes from 1.2-11.5%, it is unlikely the cell develops a hotspot (nearly all measurements are below the standard baseline of 30°C, IEC61215/61646). In contrast, if the crack size is in the range between 15-17%, a hotspot is expected to develop and has an increase in the cell's temperature to approximately 60°C.

Fig. 16. Irradiance spectrum of the crack size vs. (a) Degradation, (b) Temperature.
