This is a repository copy of *Characterisation of the surface topography, tomography and chemistry of fretting corrosion product found on retrieved polished femoral stems*.

Bryant, M orcid.org/0000-0003-4442-5169, Ward, M, Farrar, R et al. (4 more authors) (2014) Characterisation of the surface topography, tomography and chemistry of fretting corrosion product found on retrieved polished femoral stems. *Journal of the Mechanical Behavior of Biomedical Materials*, 32. pp. 321-334. ISSN 1751-6161

**CHARACTERISATION OF THE SURFACE TOPOGRAPHY, TOMOGRAPHY AND
CHEMISTRY OF FRETTING CORROSION PRODUCT FOUND ON RETRIEVED
POLISHED FEMORAL STEMS**

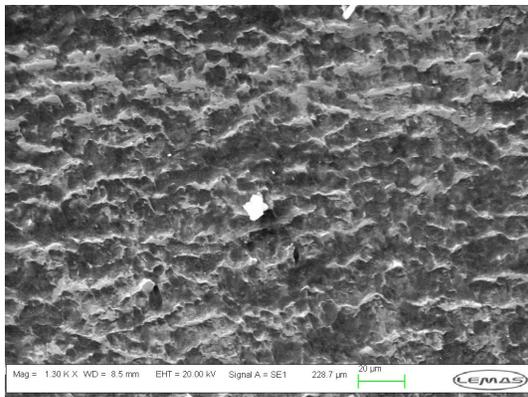
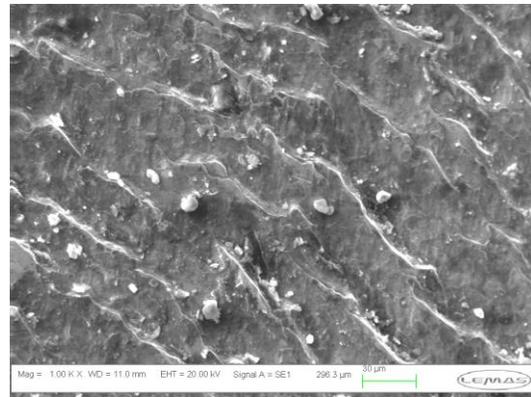
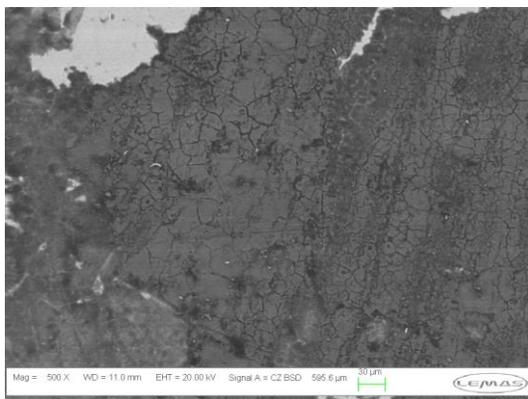
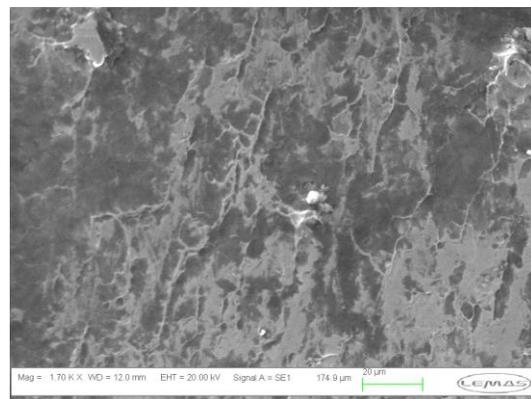
SEM/EDX analysis was conducted on sectioned femoral stems in order to fully characterise the surface morphology of retrieved femoral stems, in an attempt to understand the mechanisms of failure (Figure 8). At high magnification, clear ploughing and plastic deformation of the surface could be seen, with retention of debris within the valleys of the troughs (Figure 8a-b). Spot EDX analysis was conducted on the debris seen in Figure 8b, suggesting that the debris was Cr, O and C rich. However it is not known if this is fragmented PMMA bone cement with a Cr_2O_3 transfer film or Cr_2O_3 resulting from fretting corrosion at the interface. Attack which had characteristics of a more corrosive attack, in the absence of any micro-motion, was seen towards the distal regions of the retrieved femoral stems.

Figure 8 – SEM images of (a) plastically deformed surfaces in Gruen Zone 7 (b) surface morphology in Gruen zone 2 demonstrating the retention of debris within the grooves valleys of the plastically deformed surfaces (c) areas of black deposit seen in Gruen zone 2 and 6. Note the crazy paving like structure of the film on the surface (d) corrosion attack in Gruen zone 4. Note the loss of material in the absence of any indication of directionality on the surface.

The deposited layers were also observed using the ESEM. These were seen to comprise of smooth plaques with an irregular size and shape as shown in Figure 8c. The areas with surface deposits demonstrated a semi-conductive nature, suggesting build-up of a non-conducting film. EDX mapping was further utilised, demonstrating that the surface deposit was rich in Cr, O and N (Figure 9). Traces of Co, and Mo were also seen to be present in the surface deposit though not in the same quantities observed in the clean bulk material.

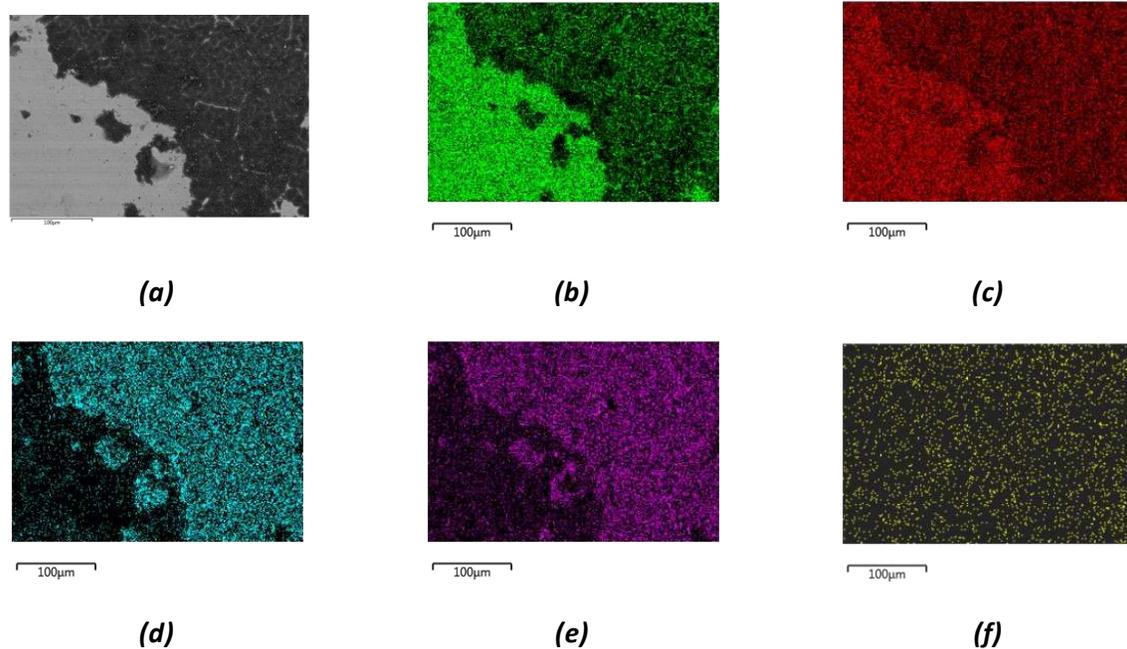
Figure 9 – EDX mapping of (a) Electron image (b) Co (c) Cr (d) C (e) O (f) N the deposit commonly seen on femoral stems demonstrating moderate to high fretting-corrosion grading.

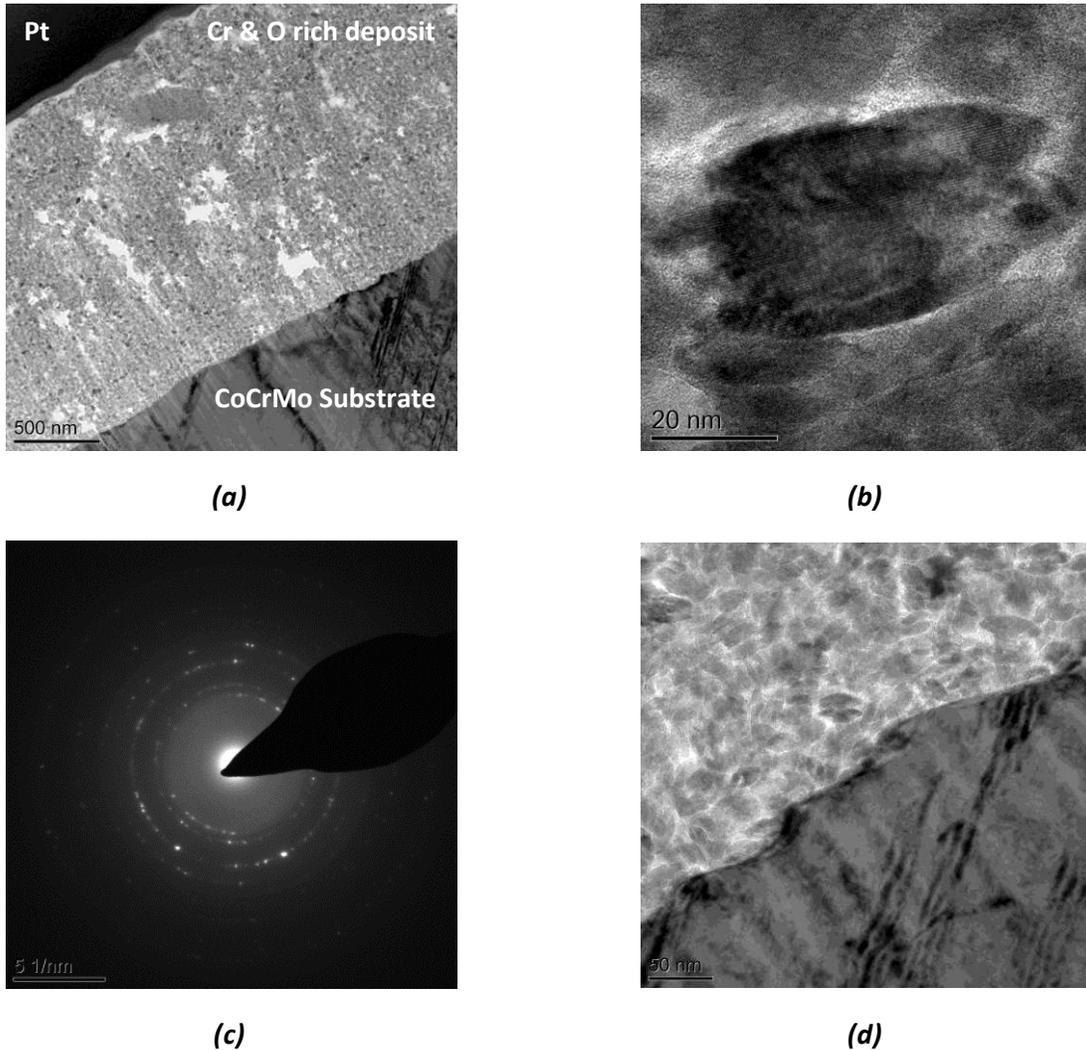
FIB/SEM preparation techniques, along with TEM and EDX analysis proved a useful tool when identifying the exact morphology and chemistry of the deposits found on top of the retrieved femoral stems. Figure 10a illustrates the thickness and morphology of the film found on the surface of the retrieved femoral stems under TEM conditions. A thick surface film, in the region of $1\mu\text{m}$, was seen on the surface of the retrieved metallic femoral stem in the regions of high fretting-corrosion. It is interesting to note the heterogeneous nature of the film present on the surface which contains large voids surrounded by densely packed nano-sized particles. At higher magnifications, TEM analysis indicated that the particles found in surface film commonly consisted of two seemingly ellipsoid shapes joined together, surrounded by an organic amorphous matrix (Figure 10b). Figure 10c shows a selected area electron diffraction pattern taken from the surface film. Analysis of the diffraction pattern indicated the presence of Cr_2O_3 particles within the deposited layer. The interface between the metallic stem and deposit found on the femoral component was also analysed in order to assess whether any localised chemical or crystalline reorientation had occurred due to chemical dissolution or mechanical wear. At higher magnification, the metallic surface showed signs of a ‘saw tooth’ like morphology (Figure 10d), a result of fretting-corrosion. Although TEM analysis demonstrated the presence of stacking faults and annealing twins, no localised

reorientation of the metallic lattice was observed for samples that had been subjected to wear and corrosion. This due to the nature and magnitude of the slip mechanism and magnitude of shear stresses acting at the metallic interface [20].

Figure 10 – Cross-sectional TEM images of (a) black deposit seen on retrieved femoral stems (b) Cr₂O₃ particles seen within the surface deposit (c) annotated diffraction pattern associated with the Cr₂O₃ film and (d) the metal-deposit interface. No localised re-orientation of the CoCrMo crystalline structure was seen.

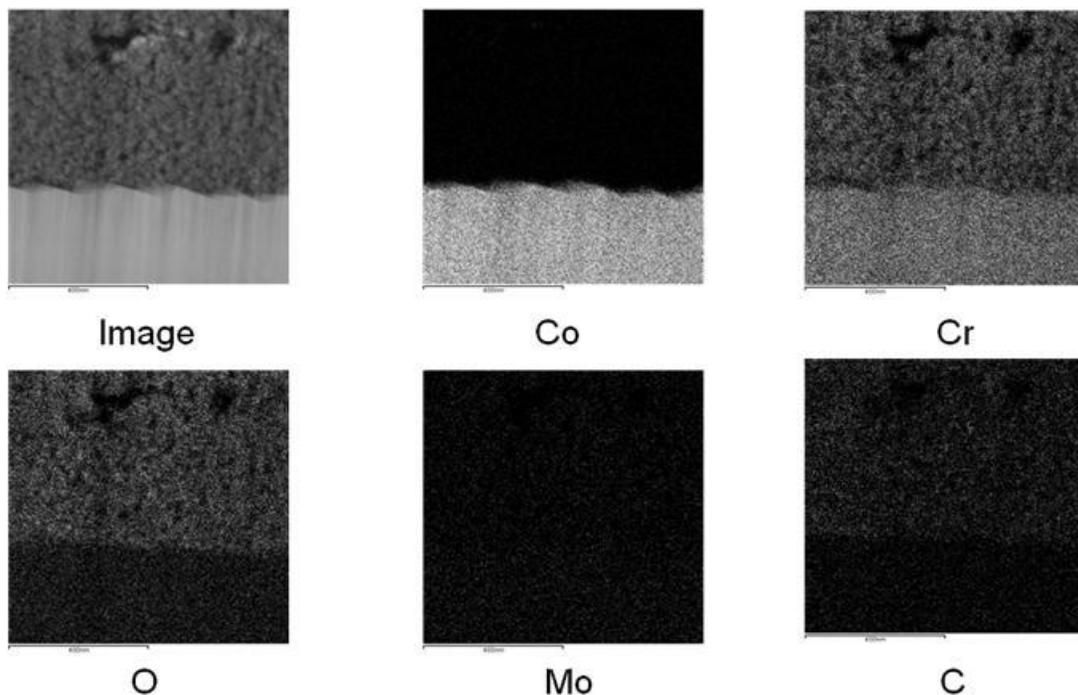
Scanning (S)TEM/EDX mapping of the substrate and surface film was utilised in order to identify the chemical composition of the surface film. Figure 11 shows the EDX maps that were obtained for the

retrieved sample with the surface film present. It is interesting to note that the film present on the femoral stems mainly consisted of Cr, O and trace amounts of C whilst Mo was seen to be relatively well dispersed within film and the underlying material (although the generally weak signal in the Mo map makes it difficult to accurately assess its dispersion). However a clear and distinct difference in Co content at the interface between the film that had formed and the metallic substrate was seen. Co was not seen to be present in the surface film formed in-vivo.

Figure 11 - TEM/EDX mapping of the substrate and deposited film. EDX analysis indicated the surface deposit was rich in Cr, O. Traces of C were also seen in the surface deposit.

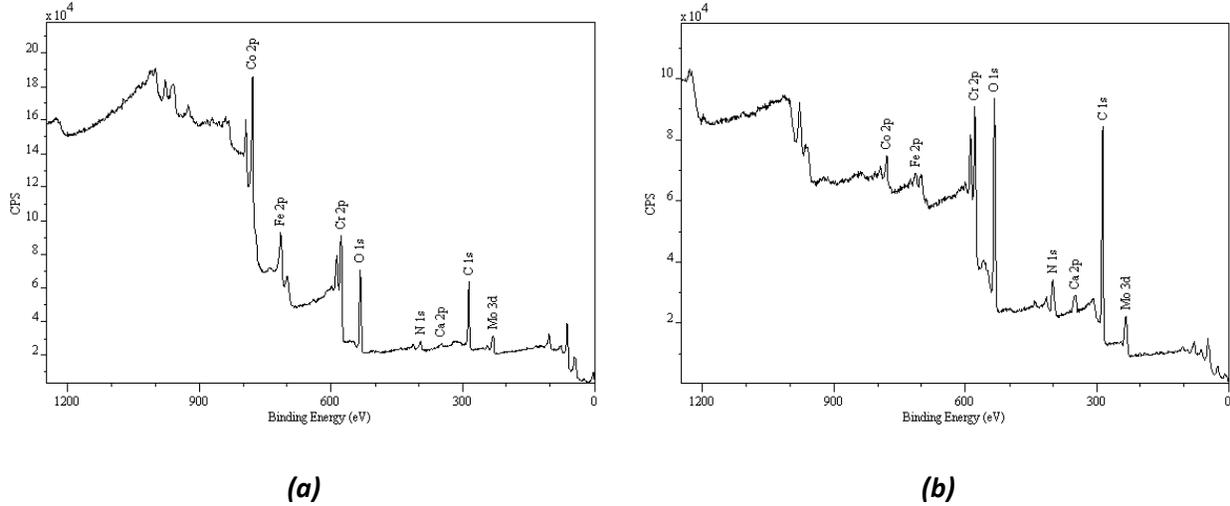
XPS was further utilised in order to investigate the exact chemical composition of the surface film. After the initial surface etch had been applied, general surface scans were conducted on areas clean and free from fretting-corrosion or deposited layers and areas demonstrating the deposited layer. Figure 12 demonstrates the survey spectra that were recorded from a clean and soiled area of a retrieved Ultima TPS femoral stem with the related chemical compositions in Table 1. C, O and N were present at both sites. However an increase in C, O, N and Ca was seen in the areas of deposit. Decreases in the atomic percentage (at%) of metallic elements (Fe, Co, Cr, Mo) were seen with the areas of surface deposits.

Figure 12 – General XPS survey spectra obtained for the (a) clean (b) deposited areas

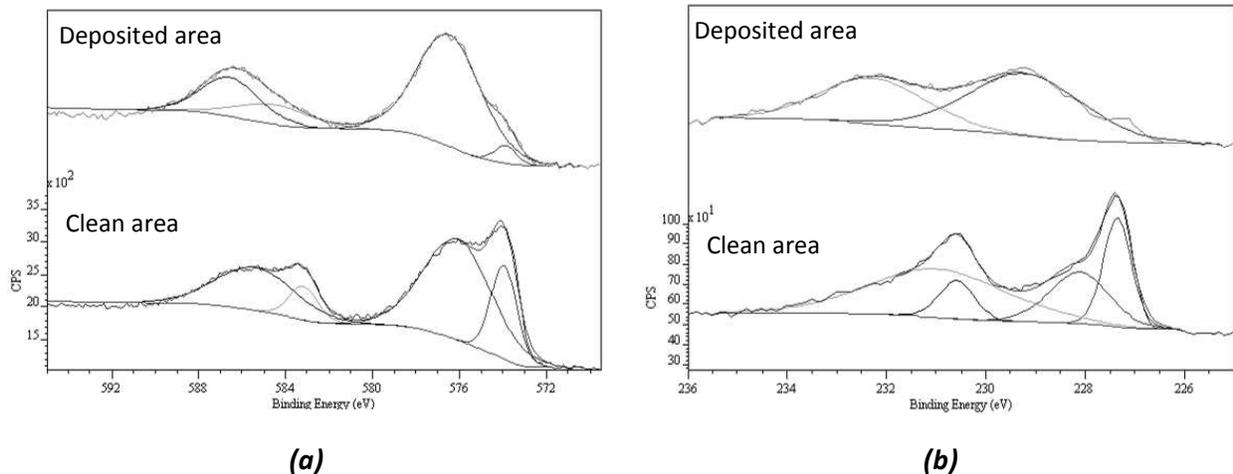
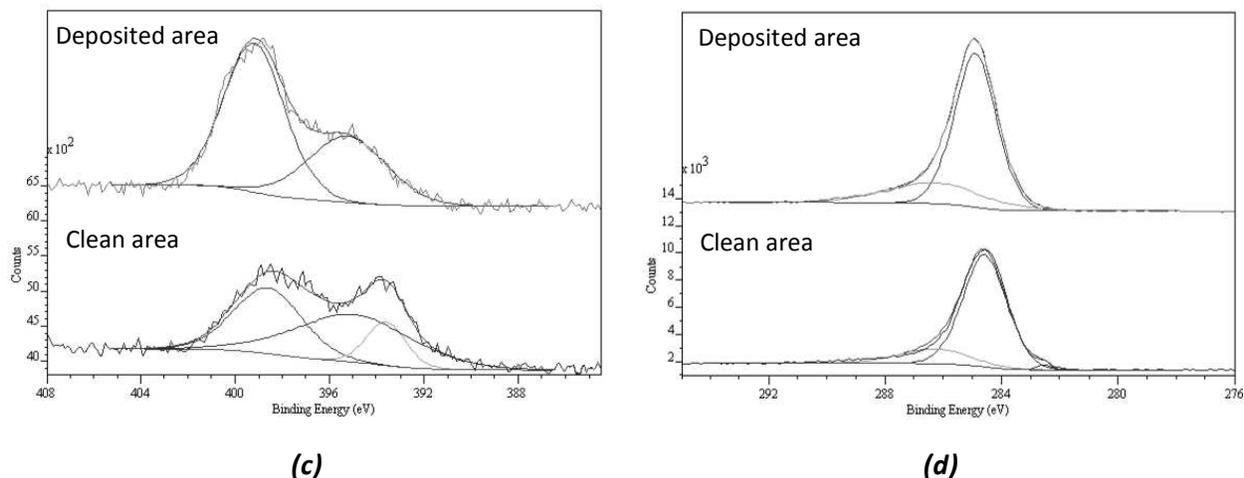
deposit, no difference in the chemical speciation was seen for Co, Ca and O. Differences in chemical state were seen for Cr, Mo, N and C. Figure 13 demonstrates the high resolution Cr, Mo, N and C XPS spectra obtained for both the clean and areas containing the deposit.

Curve fitting of the high resolution Cr 2p spectrum demonstrated that metallic Cr and Cr₂O₃ was seen in both areas with peaks being resolved at 573.98 and 583.188eV and 576.06 and 585.36eV respectively. However the intensity of the peaks were seen to change depending on the area analysed, with deposited areas demonstrating an intense peak of Cr₂O₃ peaks when compared to the clean areas which presented dominant Cr metal peaks. A difference in Mo spectrum was also seen. For the spectra obtained from clean unworn areas, peaks were obtained at 227.35 and 230.99eV and 228.11 and 230.58eV demonstrating the presence of metallic Mo₂C and Mo respectively. For the deposited area, peaks were only observed, at relatively low intensity, at 229.20 and 232.27eV indicating the presence of MoO₂. Traces of N were seen in both areas of the analysis. In each case, peaks were resolved at 395.25 and 399.19eV demonstrating the presence of nitride and organic N. An increase in organic N was seen in deposited areas demonstrating that the film formed on the surface is a complex mixture of organic and metallic materials. Differences were also seen in the carbon spectra, with peaks being resolved at 284.88 and 286.27eV suggesting elemental C and C with N. An addition peak was seen on the C 1s spectra indicating the presence of carbides, likely to M₇C₃.

Figure 13 – Curve fitted, high resolution XPS spectra obtained for (a) Cr 2p (b) Mo 3d (c) N 1s and (d) C 1s

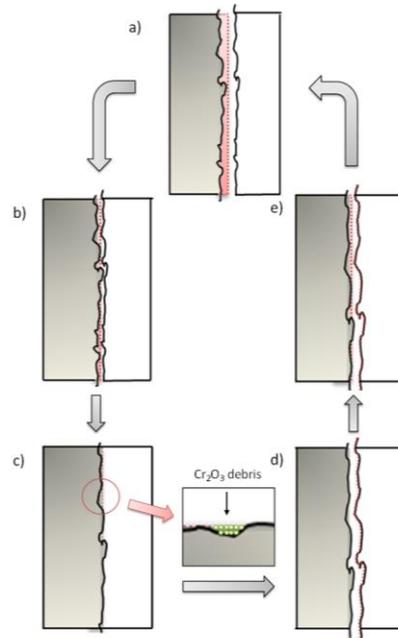
schematically demonstrates the depassivation and repassivation of the CoCrMo surface over one loading cycle. At the initial stages of loading (Figure 15a) the film, substrate, counter substrate and points of contact are elastically deformed. As the load is increased, the yield point of the passive film, CoCrMo substrate and PMMA bone cement is exceeded and rupture of the oxide film occurs (Figure 15b). This results in the CoCrMo substrate being exposed to the solution resulting in oxidation of the metallic substrate along with plastic deformation of the surface. At point d, maximum load has been applied and held, the stem-cement interfaces are held together with the PMMA bone cement protecting most of the ruptured sites in the oxide film from the electrolyte. It is thought that the transfer of the metal oxide occurs when the CoCrMo and PMMA bone cement surfaces are in contact resulting in compressed Cr_2O_3 debris, a common finding in fretting systems (Feng and Barrans, 1956; Geringer et al., 2005; Waterhouse, 1972). As the load is removed the surfaces gradually become separated until the contact area is sufficiently reduced to expose the ruptured oxide film and substrate to the electrolyte resulting in the further dissolution and repassivation of the oxide film (Figure 15d-e) until the surface is sufficiently protected by the oxide film to retard further oxidation.

Figure 15 – Schematic representation of the fretting-corrosion process taking place at the stem-cement interface and a mechanism for metallic debris from the metallic stem to the counterpart (Bryant et al., 2013d)
