# **Characterisation of white etching crack damage in wind turbine gearbox bearings**

**T. Bruce, E. Rounding, H. Long\*, R. S. Dwyer-Joyce**

**Leonardo Centre for Tribology, Department of Mechanical Engineering, The University of Sheffield, United Kingdom**

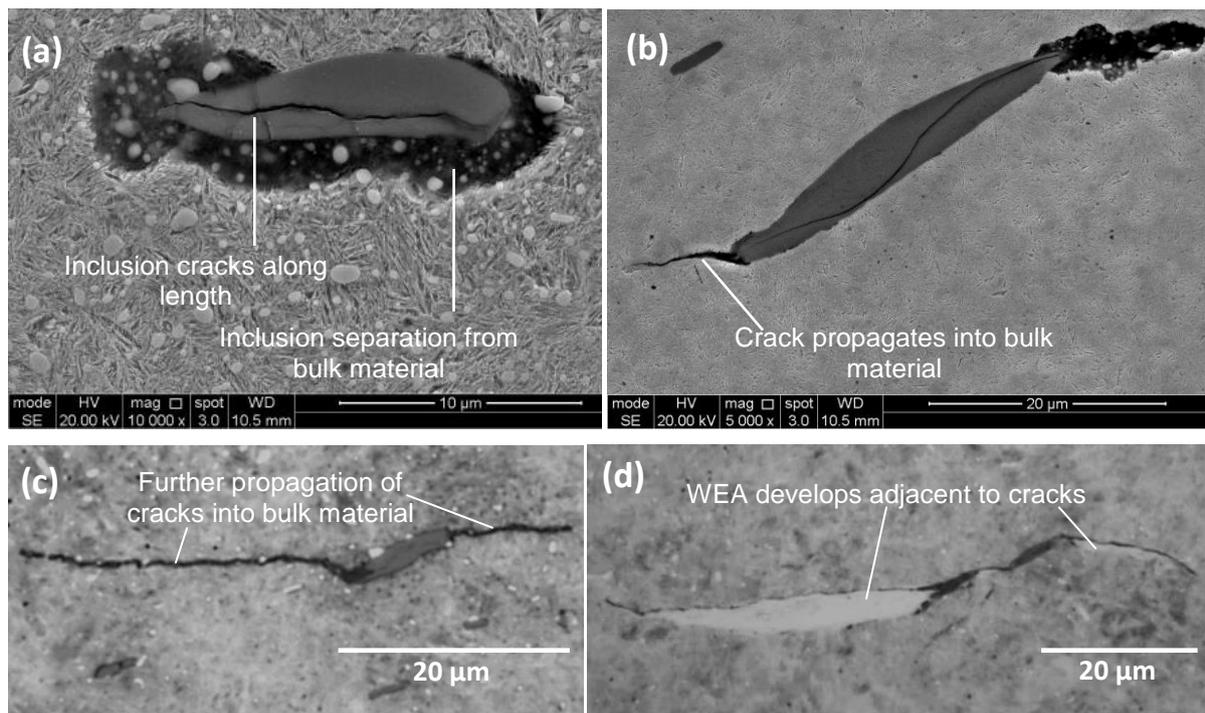
**Figure 1: WEA development at MnS inclusions**

A three-stage process for MnS initiated WEC formation has been proposed [19] and is illustrated in Figure 1, by using the evidence found in this study. Firstly, the inclusion fractures along the length of its major axis; Figure 1(a). Separation of the inclusion from the bulk material may or may not occur. Secondly the crack propagates into the bulk material surrounding the inclusion; Figure 1 (b-c). Finally, white etching areas (WEAs) develop along the cracks; Figure 1 (d). This process is similar to that proposed in [19], but with more extensive cracking in images Figure 1 (c) and (d).

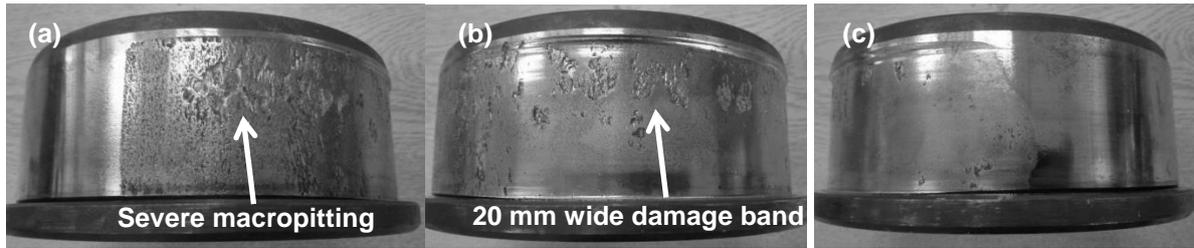
Wear was evident for approximately 55% of the inner raceway circumference, but within this region the coverage and type of damage changed. Outside this region there was little to no evidence of wear. The variation in damage has been described by three distinct phases as illustrated in Figure 2.

- **Phase 1:** Damage covered most of the raceway width for approximately 20% of the circumference. There was severe macropitting with evidence of material removal from the surface.
- **Phase 2:** There was a transition to decreasing area of damage coverage. Damage was mainly evident on one side of the raceway towards the non-flanged side of the ring. The wear damage was intermittent but well defined at a width of around 20 mm for approximately 35% of the bearing circumference. Within the main 20 mm band of damage there was severe macropitting. There were also smaller wear scars outside of this band around the centre of the raceway.
- **Phase 3:** Non-damaged phase. Over the remaining 45% of the raceway circumference there was very little evidence of damage detectable by eye.

Figure 2: Photographs of raceway damage (a) Phase 1 (b) Phase 2 (c) Phase 3

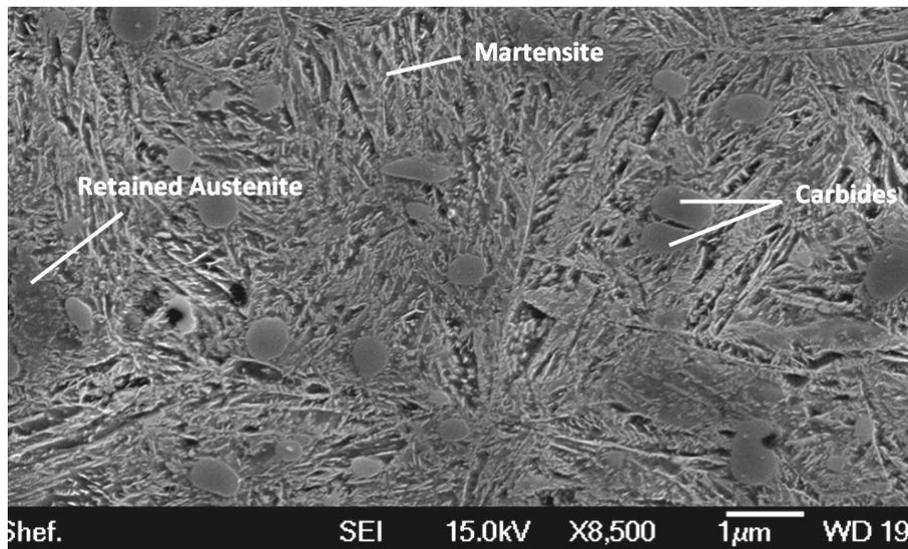
Figure 3: Bearing steel microstructure

From analysing several SEM images such as Figure 3 it has been observed that the predominant fibrous regions are martensite, separated by the darker non-fibrous regions of retained austenite and interspersed with spheroidal carbides. The steel is produced by rapid quenching from above the eutectoid temperature, before tempering at 160 °C. This creates a microstructure containing martensite, about 6 % volume of retained austenite and 3 - 4 % of cementite particles [14]. There were many MnS inclusions throughout the microstructure and their chemical composition was confirmed using Energy Dispersive X-ray Analysis (EDAX) as shown in Figure 4.

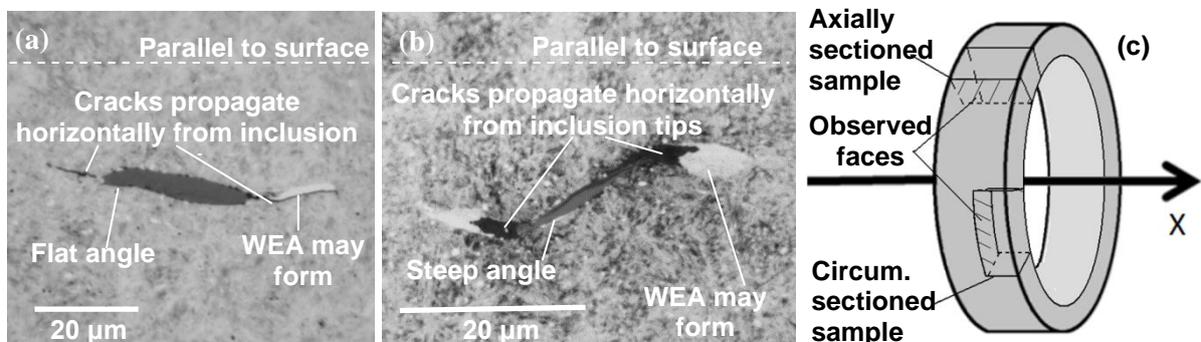
As previously mentioned, the rolling process used during manufacture of the bearing raceways determines the orientation of the MnS inclusions in the steel matrix. In this bearing, inclusions were orientated with their major axis close to parallel with the bearing surface when viewed in an axial cross section as shown in Figure 5a. They were also elongated to a lesser extent when observed in circumferential sections and were generally angled at approximately 30 degrees from the surface tangent as shown in Figure 5b. MnS inclusions were consistently orientated in this manner, regardless of their location in the bearing raceway. As a result, it was necessary to prepare specimens sectioned both axially and circumferentially, in order to determine whether cracks form preferentially in either direction. A summary of the specimens investigated and the damage found at each location is provided in Table 2. 112 damage initiating inclusions were found during sectioning and their properties catalogued will be described in section 4.

Figure 5: Inclusion orientation in inner raceway a) Typically MnS inclusion viewed axially b) Typical MnS inclusion viewed circumferentially c) Specimen orientation (not to scale)

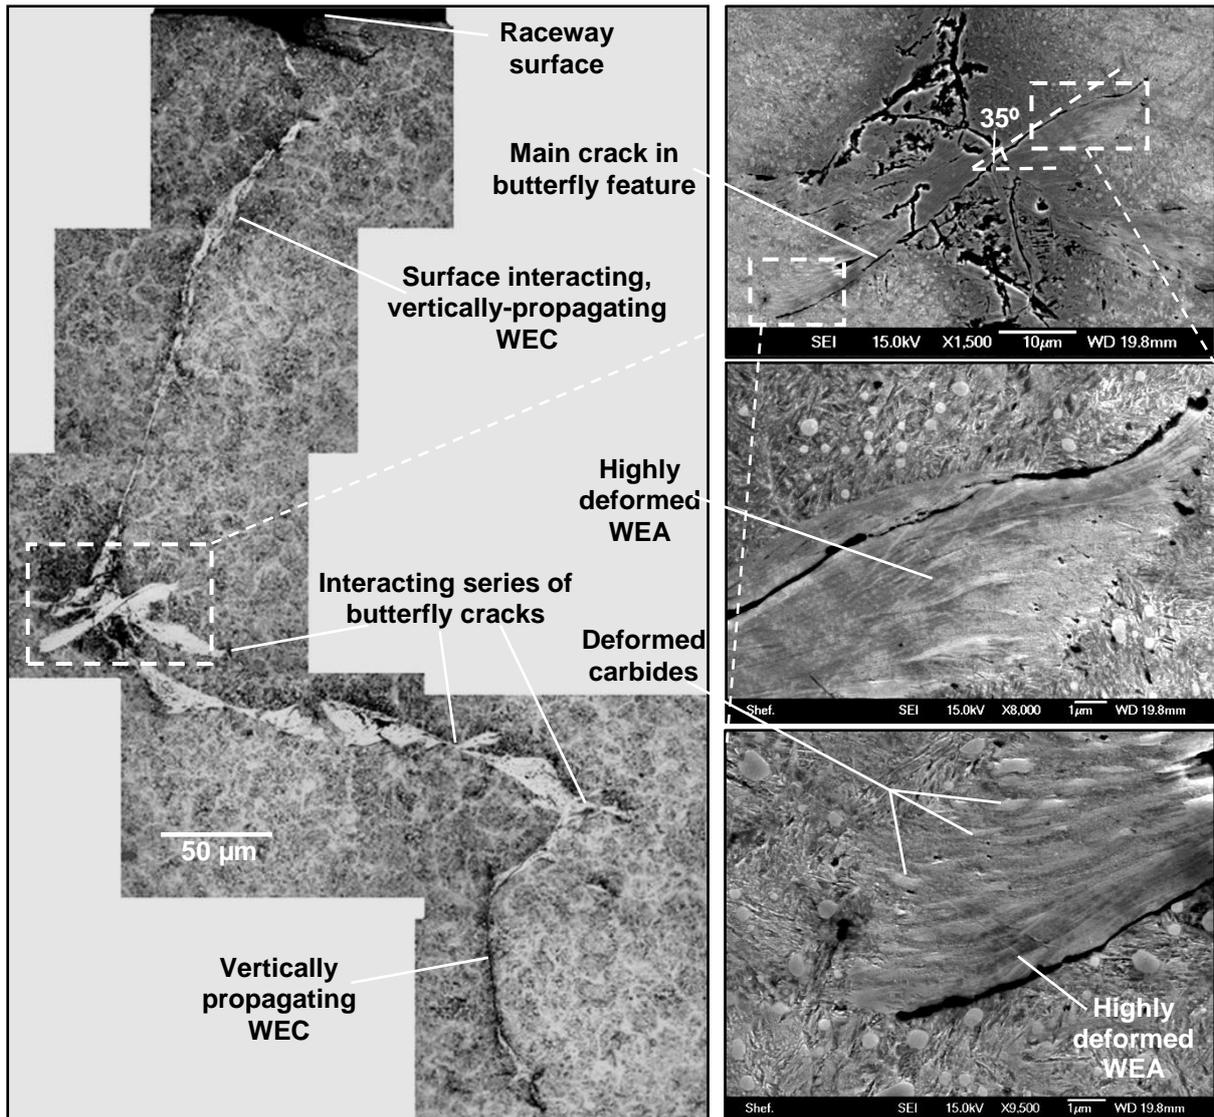
Figure 6: Series of butterflies and connected WECs

It has become apparent that there has been some confusion over the definition of the term “butterfly” in the literature. The term was originally introduced in order to explain features that appeared to resemble a butterfly, with four “wings”, symmetrically propagating from a central point as shown in detail in Figure 6, which gives an example of a series of linked butterflies and connected WECs that propagate to the raceway surface. Highly magnified SEM images of the largest butterfly are presented showing the severe elongation of carbides in the vicinity of the WEA. It is clear that there is no obvious inclusion initiating any of the butterfly features in Figure 6. The butterflies presented in this image clearly have 4 “wings”.

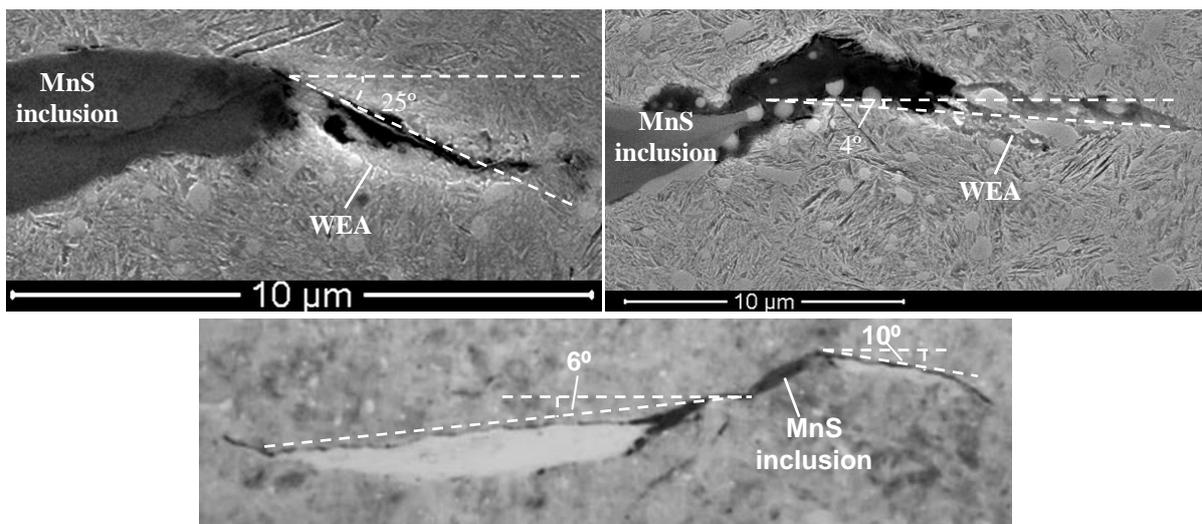
Of the 112 catalogued inclusions, 89 inclusions were connected to WEAs. All 89 inclusions had either one or two WEAs that tended to propagate at much shallower angles than traditional “butterfly wings”. Most WEA initiating cracks propagated close to horizontally from the inclusion, with the steepest angle not exceeding 30 degrees. It is suggested that WEAs linked to inclusions are not “butterfly wings”. Examples of these inclusion-initiated WEAs are shown in Figure 7. The features are thought to be distinct from the butterfly features and should be treated as such, so they will not be referred to as “butterflies” in this study, but as WEA-interacting MnS inclusions.

Figure 7: Examples of WEA-interacting MnS inclusions

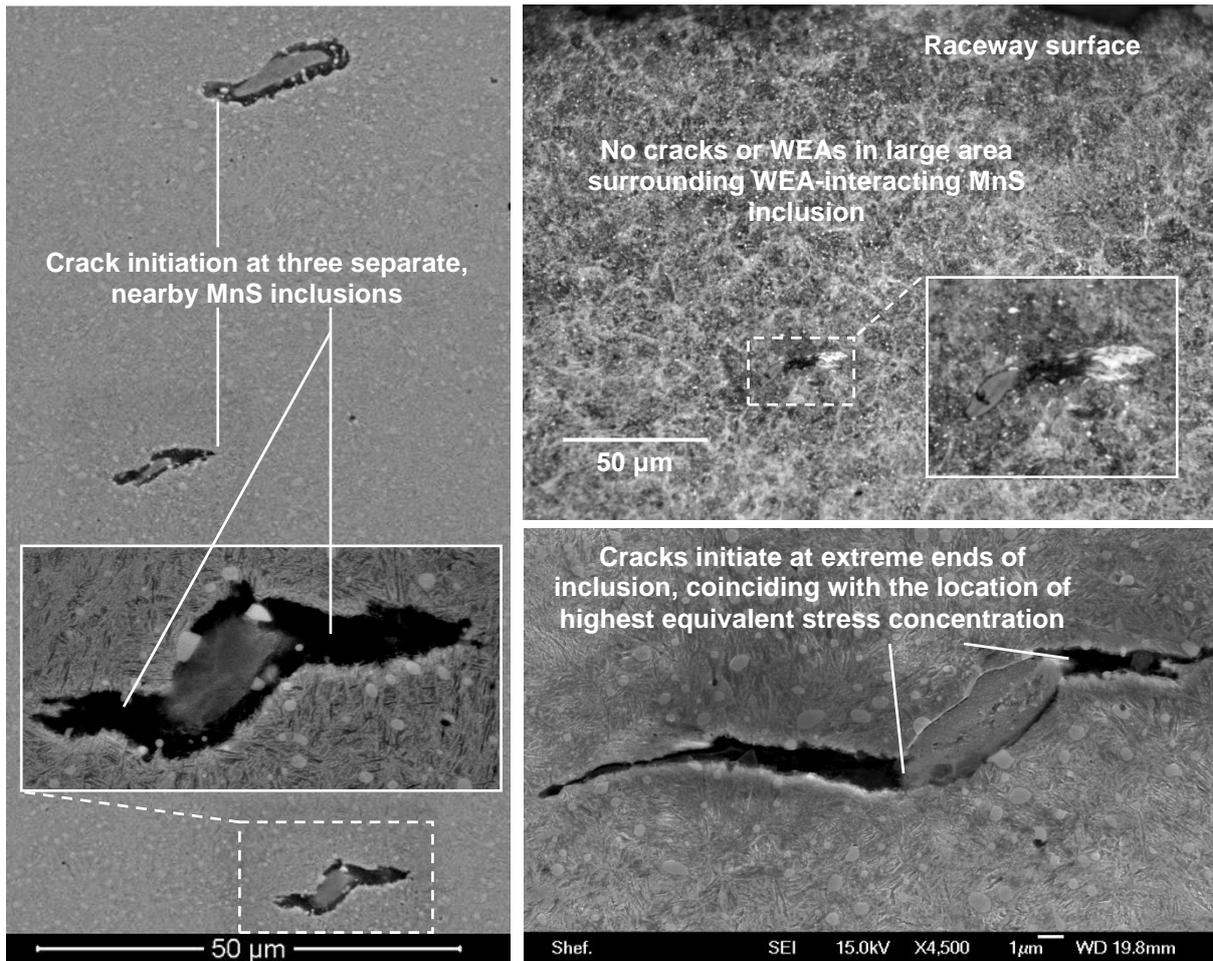
**Figure 8: Subsurface inclusion initiated WEAs**

Figure 8 presents evidence that such damage is initiated at MnS inclusions. Figure 8a shows three nearby inclusions, which have each independently initiated cracking. They are not part of an extended crack network and no other cracks are visible on this plane, therefore crack initiation must have begun at the inclusions themselves. Figure 8b shows a typical WEA, initiated at an inclusion, around 150 microns below the raceway surface. Again the feature does not appear to be linked to any extended crack network. Since all 112 damage initiating inclusions did not appear to be part of a larger crack network, the evidence that the damage was initiated at the inclusions is conclusive. Figure 8c shows typical cracks formed at the ends of damaged inclusions. The location of crack initiation at the inclusion tips, and at the highest radius of curvature, coinciding with the location of maximum equivalent stress concentration around the inclusion [26], suggesting that it is high stress levels that have initiated cracking.

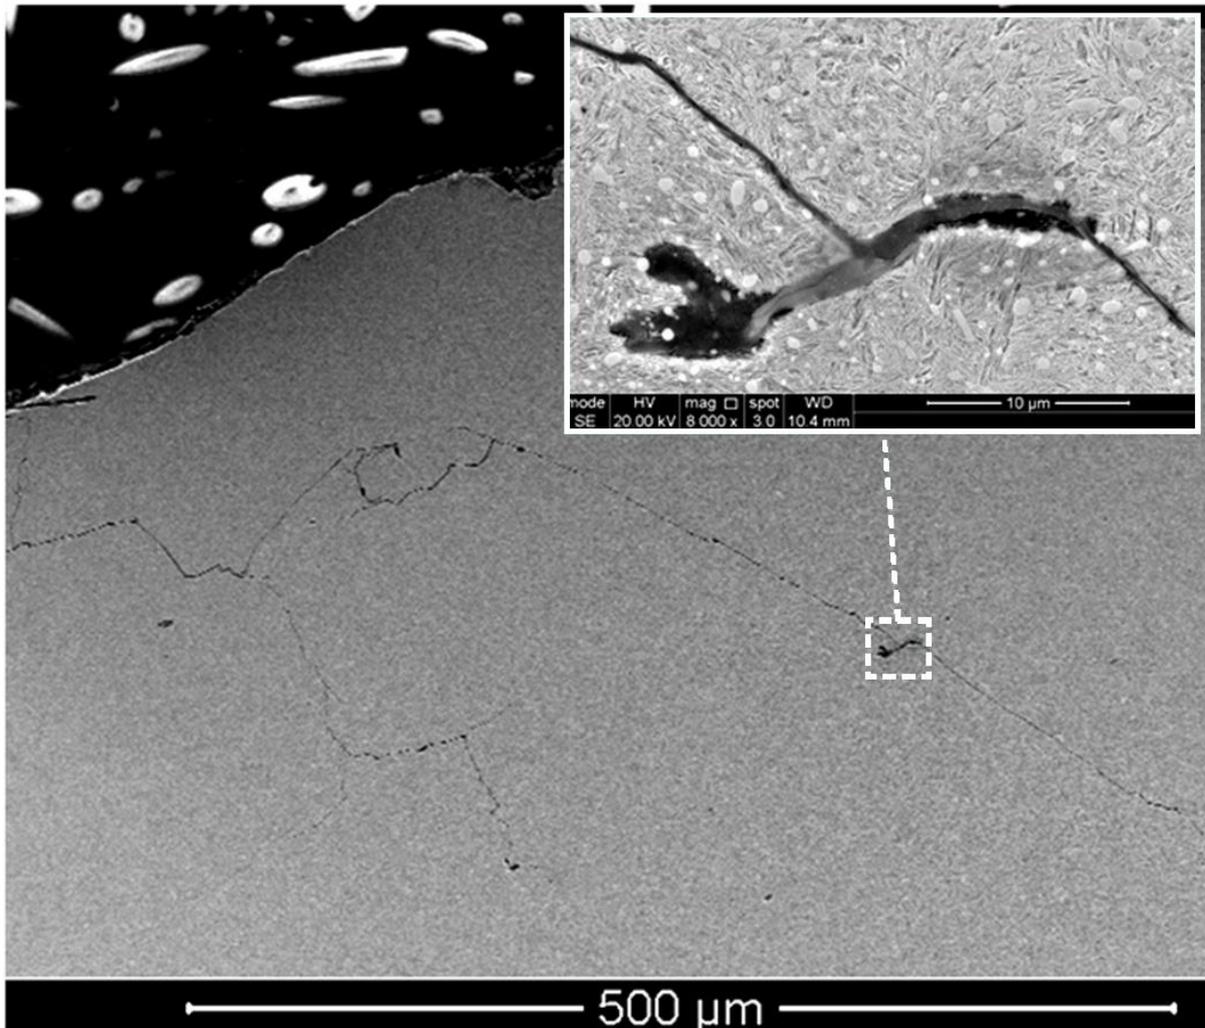
It has been reported [27] that MnS inclusions may act as “virtual cracks”, which due to their low strength may propagate actual cracks. An example of a MnS inclusion acting as a virtual crack is presented in Figure 9, where the inclusion that is intersected by a large crack network, diverts a crack by a distance of approximately 10 microns. This finding supports the theory that cracks preferentially propagate along MnS inclusions, rather than the surrounding matrix and shows that they are a "weak spot" within the steel microstructure.

Figure 9: Crack "deflection" by MnS inclusion

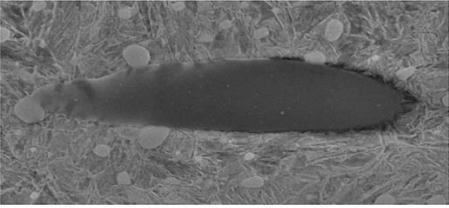
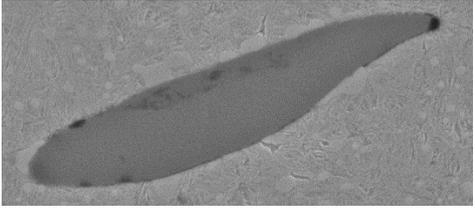
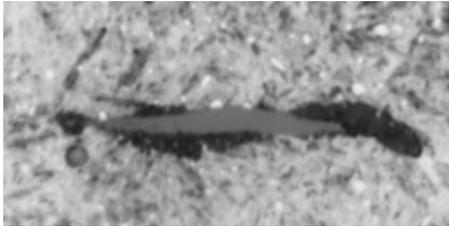
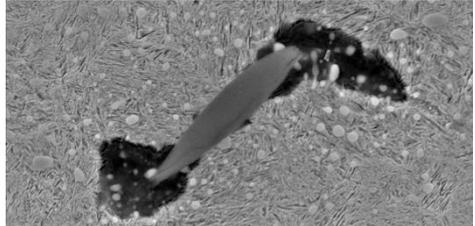
**Figure 10: Damage initiation and propagation at MnS inclusions**

The observed damage at MnS inclusions found during sectioning is summarised in Figure 10. Inclusions are initially undamaged and well-bonded to the matrix (stage 0). The first sign of damage may be internal cracking of the inclusion (stage 1a) and/or separation of the inclusion from the steel matrix (stage 1b). Cracking may be initiated into the steel matrix (stage 2), possibly from propagation of the stage 1a internal crack, from stage 1b type separation, or from the inclusion tip that may act as a stress concentration point. WEAs then form at stage 1b separation (stage 3a) or, at stage 2 type propagated cracks (stage 3b). Further propagation of cracks and sometimes, of their attached WEAs, may then take place (stage 4), leading to the propagation of what has been termed white etching cracks (WECs), far away from the MnS inclusions. The likelihood of each damage type occurring and the possible relationships between each are investigated in section 4.

<b>Axial cross-section shape</b>	<b>Circumferential cross-section</b>
<b>Stage 0</b> Undamaged inclusion

<b>Stage 1a</b> Inclusion internal cracking

<b>Stage 1b</b> Separation of inclusion from matrix
