Zeng, P, Rainforth, WM and Stewart, TD (2017) Characterisation of the wear mechanisms in retrieved alumina-on-alumina total hip replacements. *Wear*, 376–37 (Part A). pp. 212-222. ISSN 0043-1648

# Characterisation of the wear mechanisms in retrieved alumina-on-alumina total hip replacements

P Zeng<sup>1</sup>, W M Rainforth<sup>1</sup> and T D Stewart<sup>2</sup> 1. Department of Materials Science and Engineering, University of Sheffield, Sheffield S1 3JD, UK 2. School of Mechanical Engineering, University of Leeds, Leeds LS2 9JT, UK

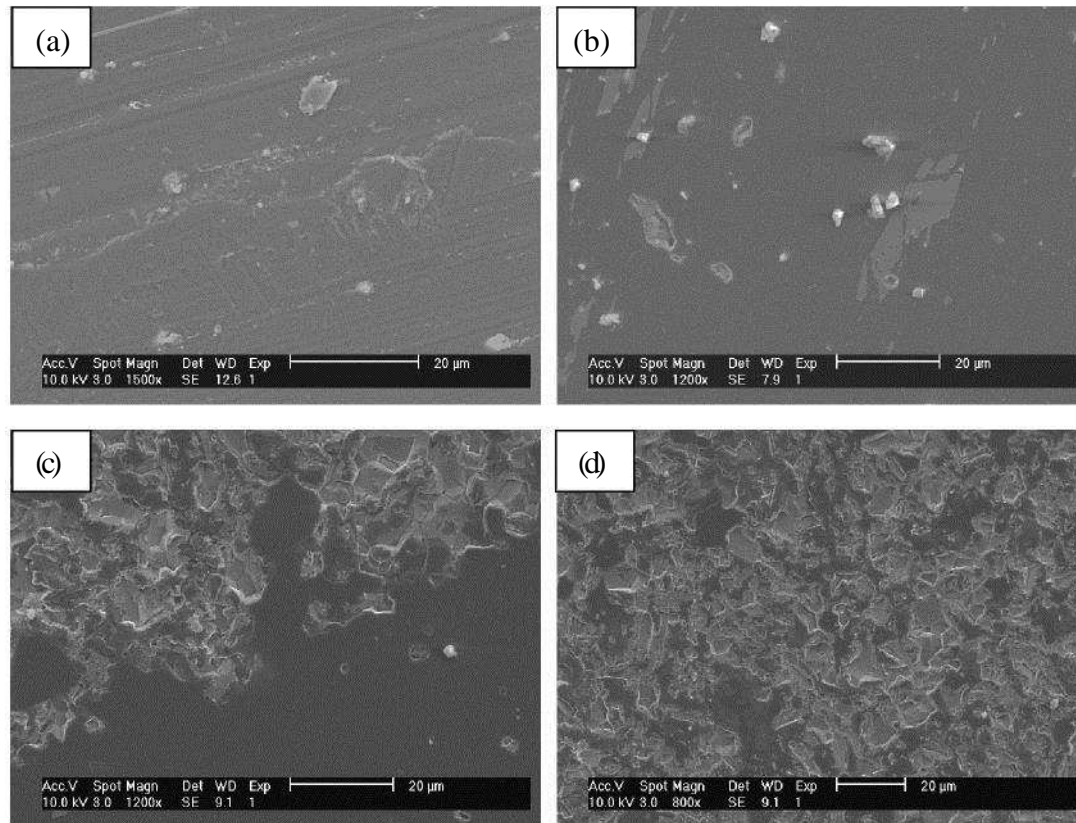
Fig. 3 shows SEM images of the worn surface from a retrieved in vivo alumina femoral head (head #7 in table 1). In the mild wear zone (Fig. 3a), parallel grooves due to the original polishing process could be observed. Wear debris was present on the surface inside the grooves. Evidence of surface deformation could also be observed, as arrows shown in Fig. 3a. In the wear transition zone, occasional surface pits due to grain pull out were seen in an otherwise smooth surface. Wear debris was widely observed, with some having a ‘smear’ appearance, arrowed in Fig. 3b. A sharp boundary between the mild/transition wear and the stripe wear is shown in Fig. 3c. Intergranular fracture was observed along the stripe boundary. In the stripe wear zone, as shown in Fig. 3d, a rough surface was seen with clear fracture facets,

indicating predominantly intergranular fracture, but also some transgranular fracture. In addition, there were areas that had a ‘smeared’ appearance, presumably formed through the compaction of wear debris. Plastic deformation was also observed around the surface pits.

**Fig. 3 SEM images of the retrieved in vivo alumina femoral head, showing (a) the mild wear zone, (b) the wear transition zone, (c) the stripe boundary zone and (d) the stripe wear zone. Arrows in (a) and (b) are explained in the text.**

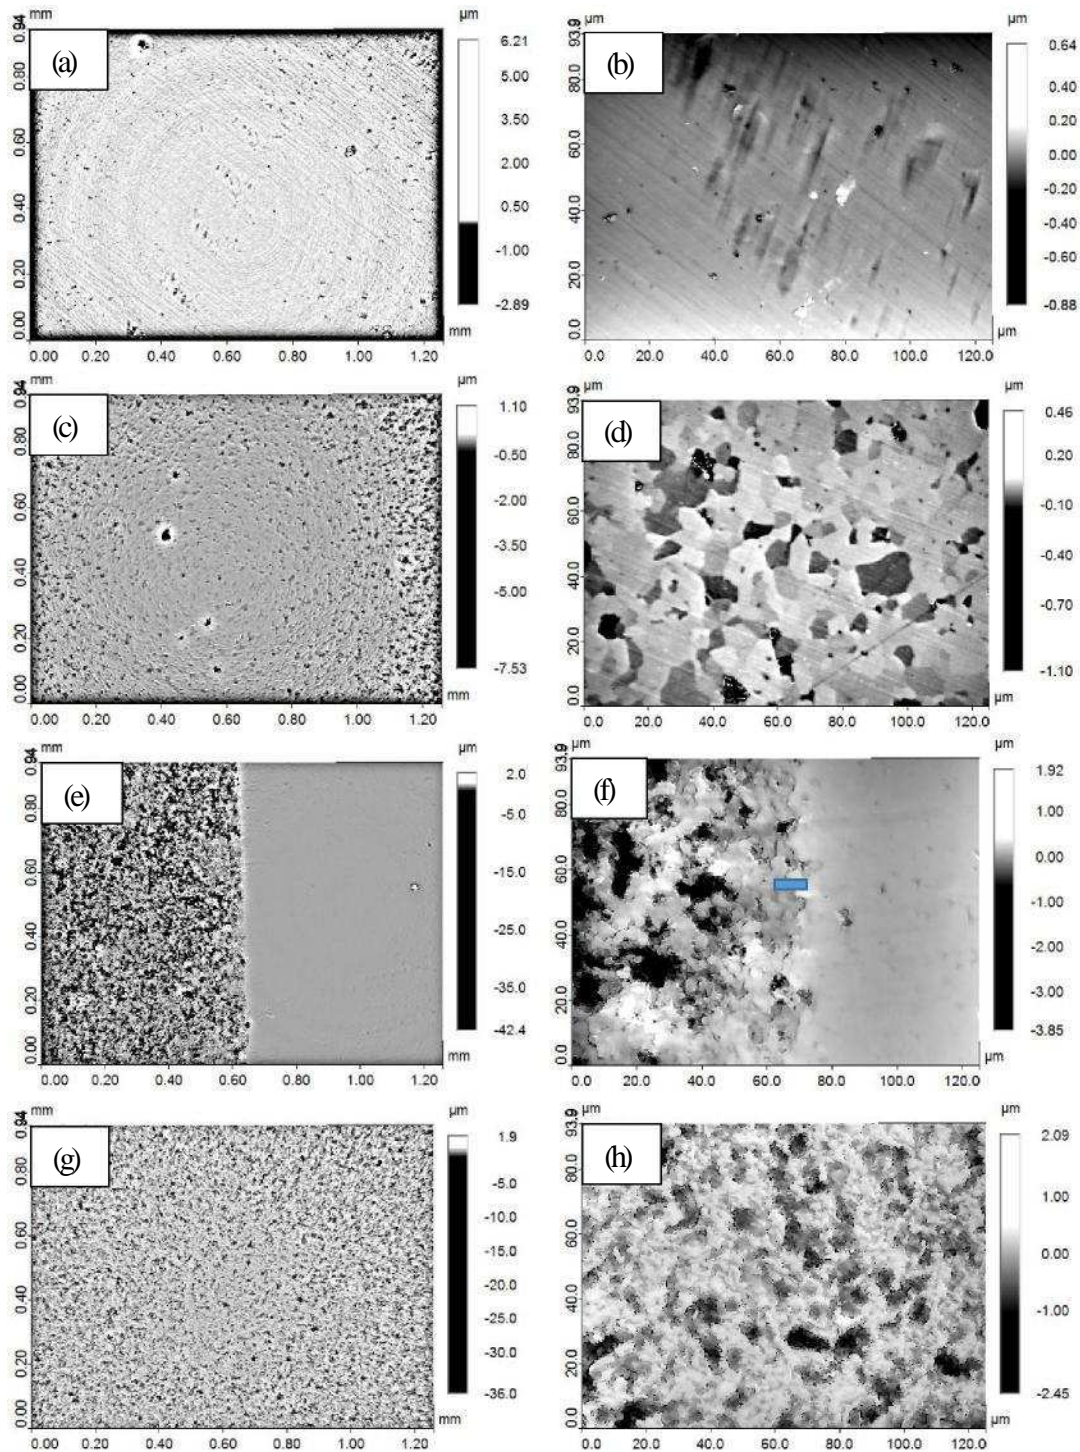
Fig. 4 shows the surface topography of the retrieved in vivo alumina femoral heads (representative of heads #1, #2, #3, #4 and #6 in table 1). Fig. 4a shows a low magnification image of the mild wear zone from the retrieved in vivo alumina femoral head, taken at the pole of the head. The parallel lines in the image were believed to be original polishing marks (note the concentric rings are an artefact caused by flattening the image of a strongly curved surface). A higher magnification image (Fig. 4b) shows the original polishing marks with some mechanical damage that had left small gouges in the surface, together with occasional wear debris standing proud of the surface.

**Fig.4 Surface topography of four wear zones of the retrieved in vivo alumina femoral head. The mild wear zone (a) and the magnified image (b); the wear transition zone (c) and the magnified image (d); the stripe boundary zone (e) and the magnified image (f); the stripe wear zone (g) and the magnified image (h). The rectangle in (f) indicates the location of TEM cross-section.**

In the wear transition zone, a pitted surface could be seen (Fig. 4c). A magnified image (Fig. 4d) revealed grain relief on the surface, indicating the wear rate differed from grain to grain. An abrupt boundary could be seen at the boundary to the stripe

boundary, as shown in Fig. 4e. Dramatic changes were seen, with surface pitting due to grain pull out visible along the stripe boundary (Fig. 4f). The location of the TEM cross-section is shown in Fig. 4f, which is discussed later. In the stripe wear zone, a highly pitted surface was observed (Fig. 4g). Magnified image (Fig. 4h) shows grain pull out and smearing of the wear debris.

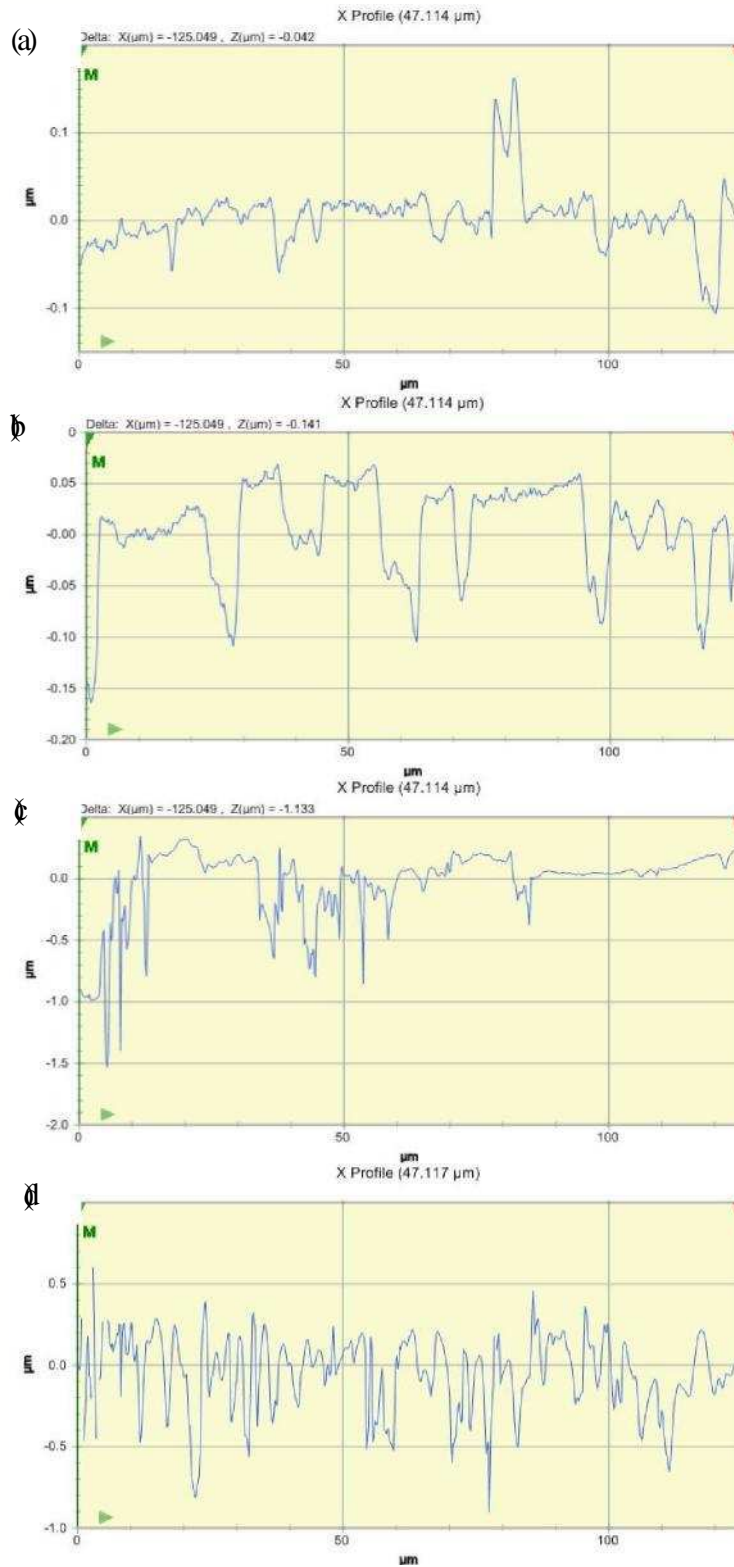
The surface profile of the alumina femoral heads in different wear zones is shown in Fig.5 (representative of heads #1, #2, #3, #4 and #6 in table 1). In the mild wear zone (Fig. 5a), a smooth surface with occasional peaks (which were believed to be wear debris) could be seen. A mean roughness (Ra) of 59 nm was measured in this region. Fig. 5b gives a surface profile in the wear transition zone, indicating grain relief, i.e. individual grains were wearing at different rates. Interestingly, a mean roughness of 32 nm was measured, which indicates a smooth surface in the wear transition zone, in the agreement with the SEM observations. In the stripe boundary zone (Fig. 5c), an abrupt change from mild/transition to severe wear could be seen. An Ra roughness of 250 nm was measured. Fig. 5d, which shows the surface profile in the stripe wear zone, which exhibited a rough surface with a measured Ra of 251 nm.

A negative Ssk could be seen in all regions, indicating the dominance of valleys in the profile, which of course is associated with grain pull-out. A value of Sku > 3 is normally taken to indicate inordinately high peaks or deep valleys. The values of Sku in Table 2 indicate inordinately deep valleys in all cases. However, these were surprisingly larger for mild and wear transition zones, perhaps because in the wear transition zone and the stripe wear region the valleys had been filled by wear debris.

**Fig.5 Surface profiles of the retrieved in vivo alumina femoral head in the mild wear zone (a), the wear transition zone (b), the stripe boundary zone (c) and the stripe wear zone (d).**

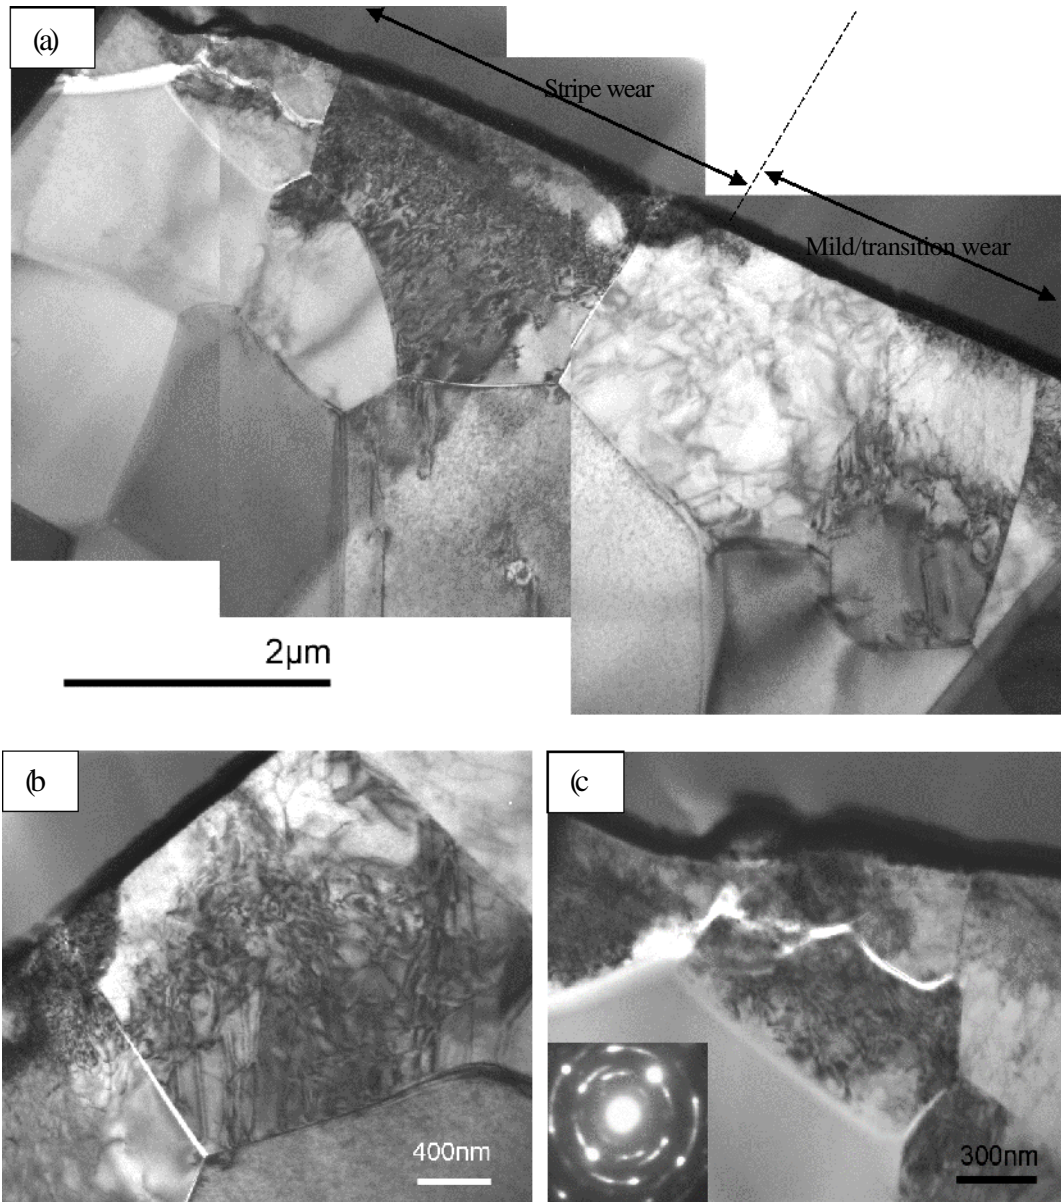
Fig. 6 shows TEM images of the site-specific cross-section of a retrieved in vivo alumina femoral head (head # 7 in Table 1) from the stripe boundary zone (as indicated in Fig. 4f). Fig. 6a is a plan-view with stripe wear zone on the left side and mild/transition wear zone on the right side, as indicated. A high dislocation density could be seen in the surface grains in both wear zones. It is important to note that the dislocation slip was limited in the outermost grains and was not observed in the grains below. Intergranular fracture was seen between grains in the stripe wear zone and the mild/transition wear zone, as shown in Fig. 6b. In the stripe wear zone, not only intergranular fracture, but also transgranular fracture could be observed (Fig. 6c). The inset diffraction pattern from the top region indicated substantial arcing in the diffraction spots for a particular plane, typical of misorientations arising from high dislocation density sub grain boundaries. The difference between the stripe wear zone and the mild/transition zone appeared to be that in the former, grains had been lost

from the surface from fracture, while in the latter, cracking had occurred, but it had not yet led to loss of surface grains. However, given the amount of damage observed in the mild/transition region, it is clear that grain pull out was imminent.

**Fig.6 Site-specific TEM cross-section of the retrieved in vivo alumina femoral head from the stripe boundary zone. (a) A plan-view; (b) intergranular fracture between grains in the mild/transition wear zone and the stripe wear zone; and (c) intergranular fracture and transgranular fracture in the stripe wear zone, with diffraction pattern from the top surface inset.**

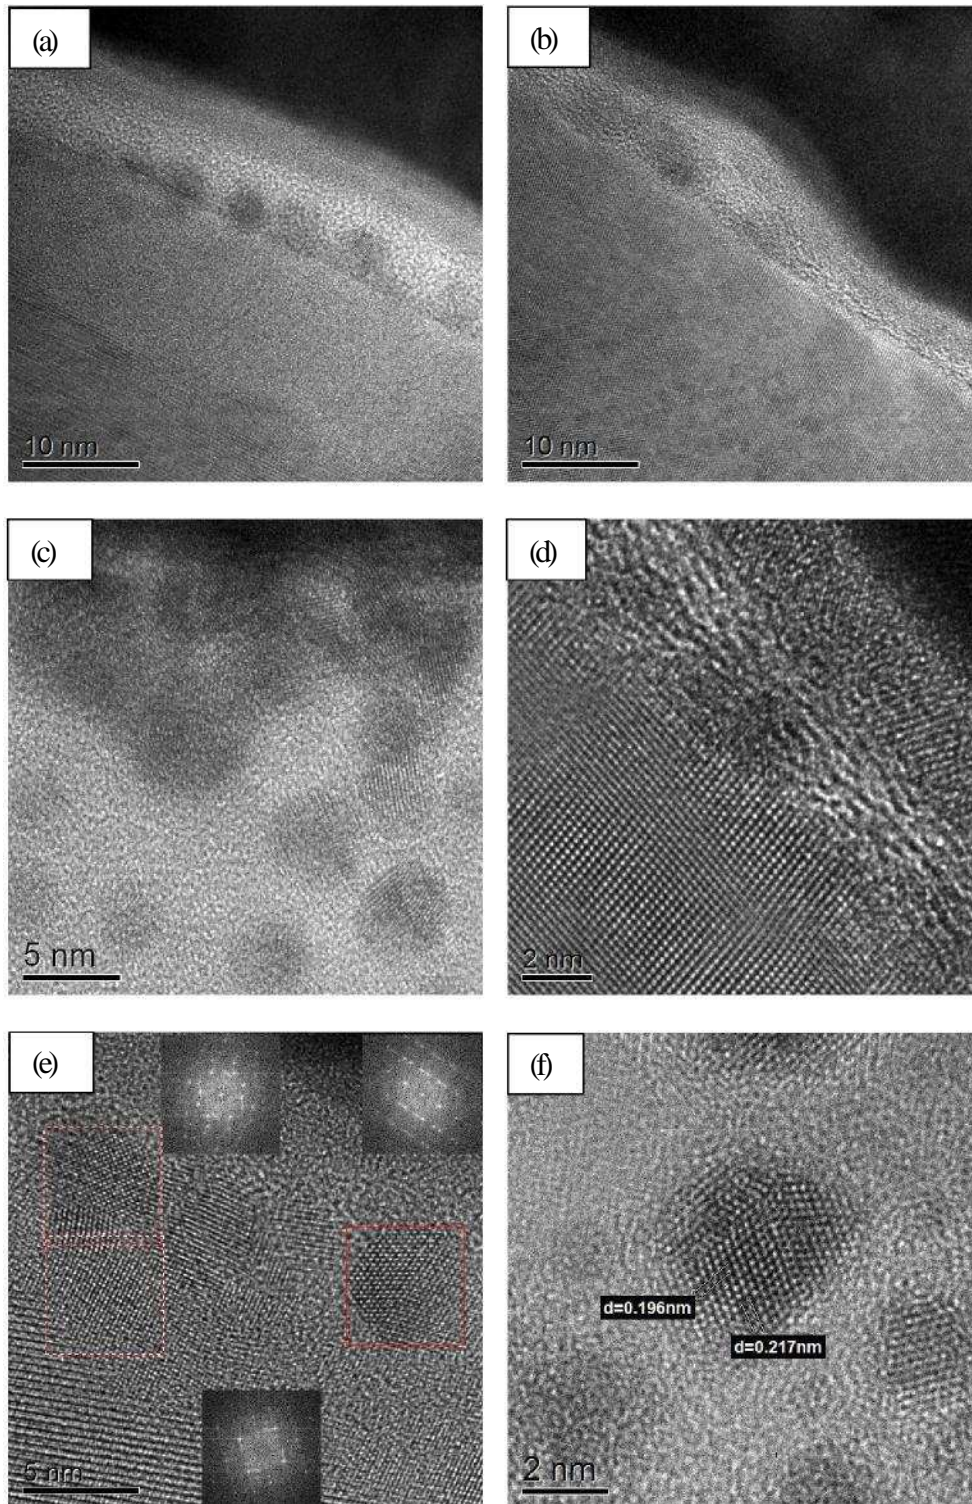
**Fig.7 HRTEM images of the cross-section from the stripe wear zone in the mild/transition side. (a) In the mild wear region shows a thin amorphous layer with nano-crystals embedded, as well as a thin hydroxide layer. (b) In the wear transition region shows only a thin amorphous layer with nano-crystals embedded. (c) A thick amorphous layer with nano-crystals ranged from 2-5 nm. (d) A thin amorphous layer less than 2 nm. (e) Detail of nano-crystals in the amorphous layer, insets are FFT of selected nano-crystals. (f) Detail of a nano-crystal in the amorphous layer with d-spacing of 0.196 nm and 0.217 nm, respectively.**

High resolution TEM (HRTEM) images of the site-specific TEM cross-section from the stripe boundary zone are shown in Fig. 7 and Fig. 8. HRTEM images of the top surface in the mild wear zone are shown in Fig. 7. An amorphous layer of about 9 nm thick was seen, Fig. 7a, that was embedded with nano-crystals ranged from 2 nm to 5 nm in diameter. Below this, a layer ~ 10 nm thick was observed, that clearly had a different structure to that of the substrate. Fast Fourier Transfer (FFT) of the HRTEM image of this region suggested that the layer might be caused by the formation of aluminium hydroxide.

Fig. 7b shows the surface structure from a region of the wear transition zone. A thinner (~2 nm) amorphous layer was observed with no suggestion of aluminium hydroxide being present. However, nano-crystal particles were observed embedded in the amorphous layer. A thicker (~20 nm) amorphous layer could also be seen, as shown in Fig. 7c. Again, nano-crystals in the range of 2 nm to 5 nm were observed. Fig. 7d shows a HRTEM image showing a thin amorphous layer (< 2 nm) on the worn surface. Fig. 7e and f give magnified images of the nano-crystals observed. FFT of the three chosen nano-particles are shown in the inset, indicating two of the three particles were alumina particles with d spacing measured of 0.196 nm and 0.217 nm, representing (1011) and (0001) planes of alumina respectively (while the third was a gold particle from gold coating). Furthermore, d spacing of a nano-particle was measured, as indicated in Fig. 7f. Therefore, it can be concluded that the nano-particles in the amorphous layer were mainly alumina nano-crystals wear debris particles.

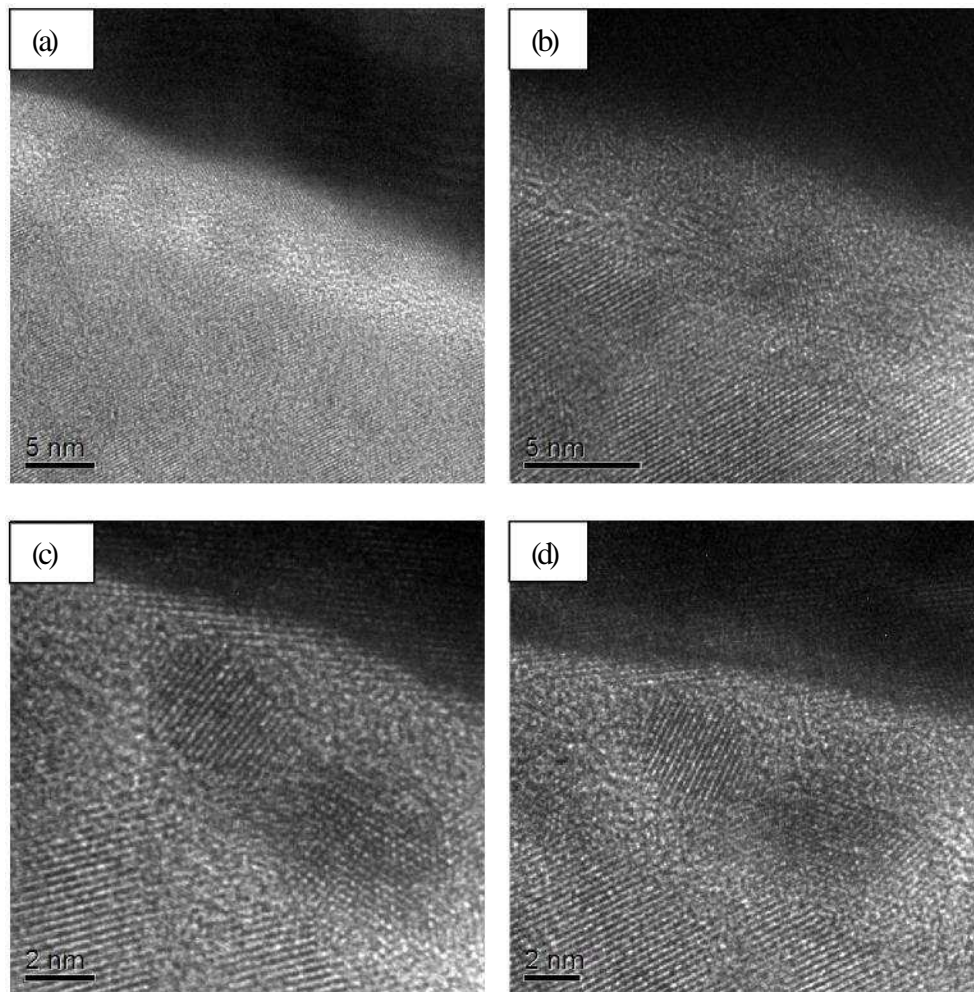
Fig. 8 gives HRTEM images of the top surface in the stripe wear zone. Compared with the observation in the mild/transition wear zone, a thinner amorphous layer was seen (~ 2 nm to 5 nm). A mixture of alumina nano-crystals and gold nano-particles could be seen by FFT and d spacing measurement (Fig. 8b-d).

**Fig. 8** HRTEM images of the cross-section from the stripe wear zone in the stripe wear side. (a) A thin amorphous layer is shown. (b)-(d) show a mix of alumina nano-crystals and gold nano-crystals.

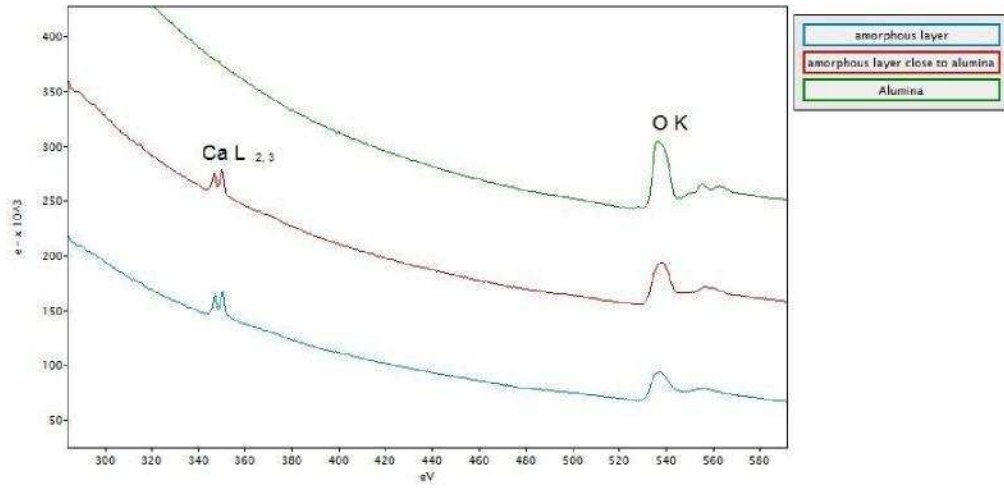
Fig. 9 compares three normalised electron energy loss (EEL) spectra taken from the amorphous layer, the amorphous layer close to alumina matrix and the alumina matrix. Ca  $L_{2,3}$  –edges were observed in the amorphous layer, suggesting the amorphous layer was the result of the tribochemical reaction between the body fluid and the alumina

surface. The O K-edge was seen in all the spectra, however, O K-edge near edge structure characteristic of alumina was only seen in the alumina itself.

**Fig.9** Normalised experimental EEL spectra from the amorphous layer (bottom), the amorphous layer close to alumina matrix (middle) and alumina matrix (top).
