Yeo, S.Y., Hsu, M-F., Komatsu, K. et al. (2 more authors) (2016) Shaking Table Test of the Taiwanese Traditional Dieh-Dou Timber Frame. *International Journal of Architectural Heritage*, 10 (5). pp. 539-557. ISSN 1558-3058

**Shaking table test of the Taiwanese traditional Dieh-Dou timber frame**

This paper attempts to explore the dynamic behaviour of traditional Dieh-Dou timber structure under different combinations of structural forms and vertical loads. Using time-history record (TCU 084) from the Chi-Chi earthquake, two semi full-scale specimens (Symmetric and Asymmetric) were tested. Results showed that the Symmetric specimen tends to be damaged more easily and faster than the Asymmetric one. Damage pattern generally begins from the bottom Dou members and subsequently spreading upwards to the upper Dou, horizontal Gong members and adjoining Shu members. Friction force between the contact surfaces is crucial towards the maintenance of overall structure. Increase vertical loadings have significant effect on the natural frequencies and global stiffness of the structure. Using the Single-Degree-Of-Freedom (SDOF) system, the derived stiffness is generally in good agreement with th

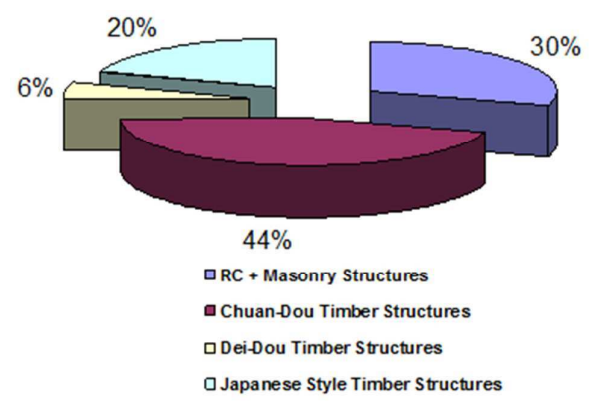
1  
2  
3 Findings from the above reports revealed that Chuan-Dou type accounted for 44% of the total number of  
4 damaged historic timber buildings; whilst the Dieh-Dou type was noted to have a lower damage percentage of  
5 6%, comparatively (Figure 2). In view of the above, a series of research was initiated to investigate the seismic  
6 capacity of the Taiwanese traditional timber structures, placing priority on the Chuan-Dou type due to its higher  
7 damage counts.  
8  
9

Figure 2. Damage percentage overview of the historic buildings in Taiwan after Chi-Chi earthquake (Data source originates from CCA 2000a and further analyzed by Chang 2005)

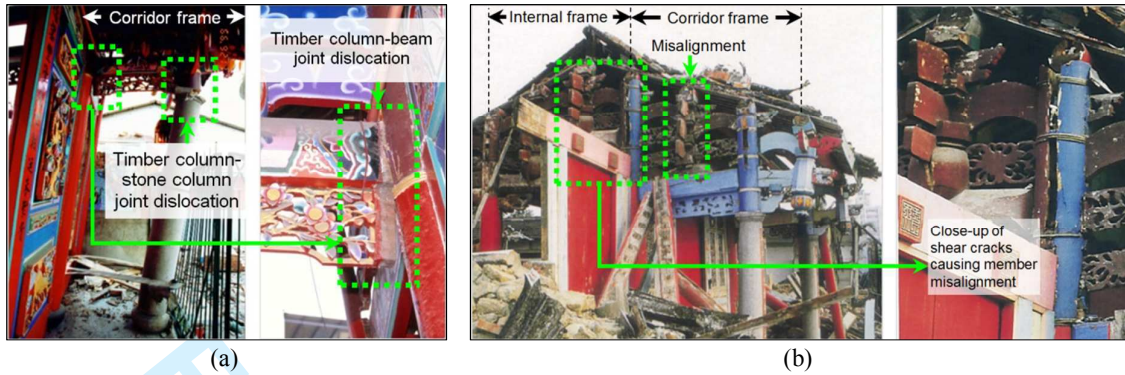
20 observed (Figure 3(b)). In addition, the corridor frame region (Figure 3(a)) of the Dieh-Dou frame was more  
21 prone to damage than the internal frame region (Figure 4). As the corridor frame is usually designed as the main  
22 entrance and exit zone of the entire building, hence in this paper, first priority is placed on the study of the  
23 damage behaviour of the corridor frame as this is the critical region in the safety design of escape route of the  
24 entire building, particularly when earthquake occurs.  
25  
26  
27  
28  
29  
30  
31  
32  
33  
34  
35  
36  
37

(a)  
 (b)  
 Figure 3. Typical damages observed in Dieh-Dou timber frame after the Chi-Chi earthquake: (a) Joint dislocation between the timber column-beam region and timber column base-stone column; (b) Shear crack causing misalignment of bracket complexes (NCKURDF 2001)

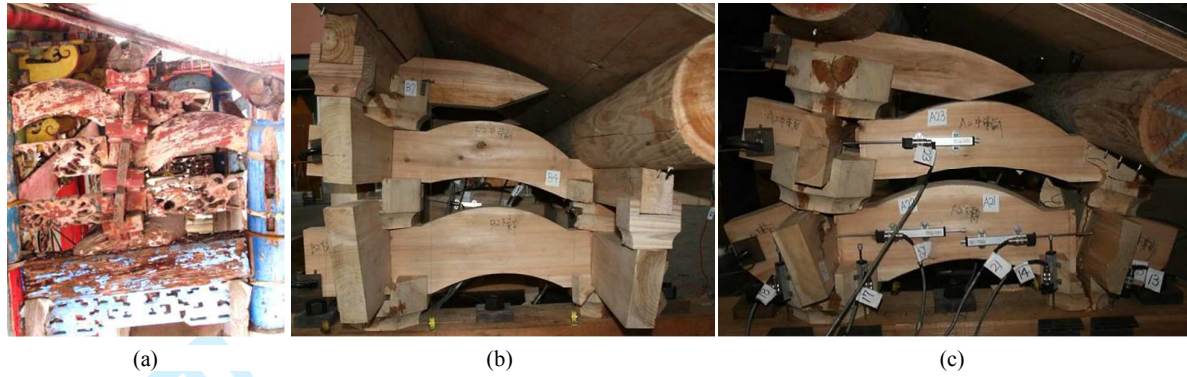
1  
2  
3 experiments begins from the bottom Dou members and subsequently spreading from the front section and  
4 extending upwards to the upper Dou, horizontal Gong members and traverse tie members (Shu). Detachment of  
5 Dou dowel, shear failure of Dou and joint detachment between bracket complex and wood crushing were  
6 observed in both specimens. Figure 9(a) shows the damage pattern of a Dieh-Dou timber frame during Chi-Chi  
7 earthquake. The damage patterns obtained from the experiments are similar to the damage seen from the Chi-  
8 Chi earthquake (Figure 9(b) and 9(c)).

Figure 9. Comparison of the final damage pattern between (a) the front corridor Dieh-Dou timber frame observed during Chi-Chi Earthquake (D'Ayala and Tsai 2008); (b) the Symmetric specimen when subjected to 26kN/80% intensity (0.64g) test and; (c) the Asymmetric specimen under 26kN/100% intensity (0.80g) test

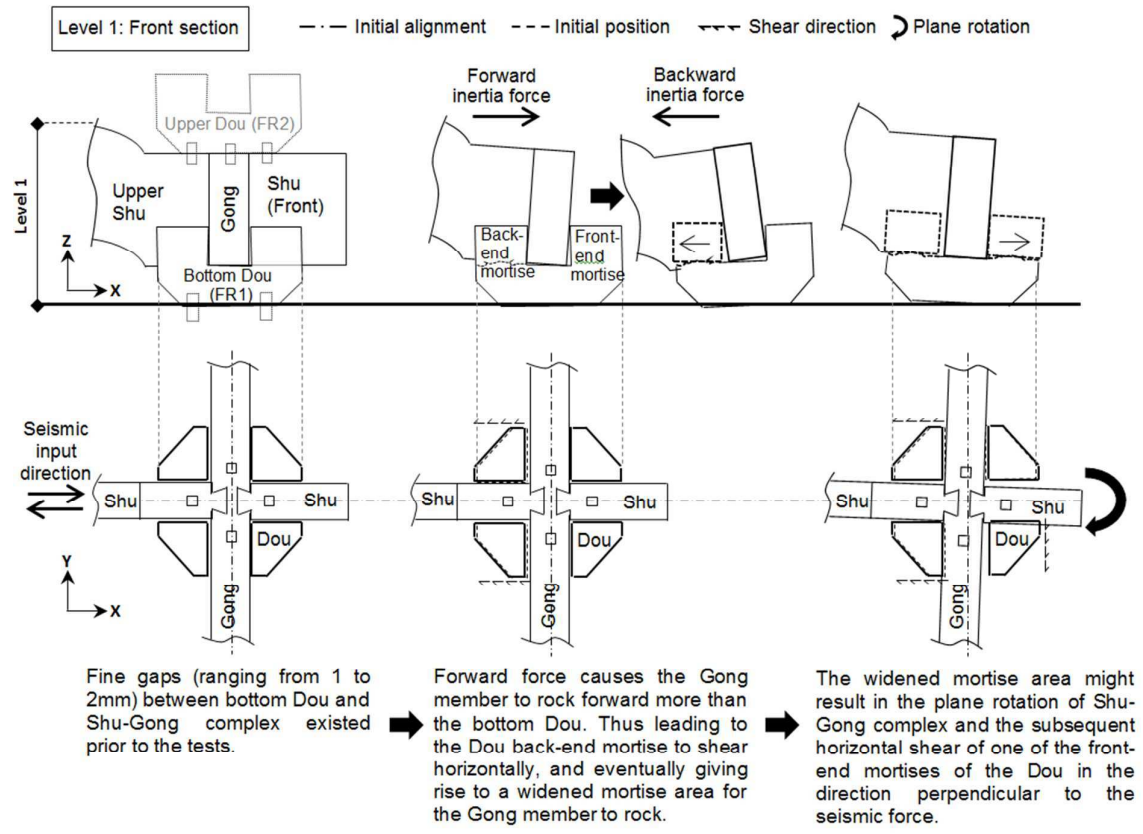
9  
10  
11  
12  
13  
14 Being the critical linker between each level, the Dou member is found to be the first structural member to be  
15 damaged in both systems. This could be due to the fact that most of the force is often been channelled in and out  
16 of the Dou member. At times when high seismic force happens, the overall magnified force might cause the Dou  
17 member to be fractured more easily during the course (Figure 10).

18  
19  
20  
21 When the two back-end mortises of the Dou were fractured severely, the widen mortise region might offer more  
22 room for plane rotation of the Shu-Gong complex, and subsequently, causing the front-end mortise to shear  
23 horizontally in the direction perpendicular to the seismic force.

24  
25  
26  
27 Dovetail connection damage of the Shu-Gong complex for both systems was generally observed from high  
28 seismic tests of 80% onwards. Such phenomenon occurred when the cruciform mortise area of the Dou member  
29 was severely damaged, subsequently losing its restraint. From the video footages, differential uplift between the  
30 Shu-Gong complex tends to happen when the complex is constantly subjected to back and forth rocking force  
31 (perpendicular to the grain direction of the Gong member) and strong impact vertical forces. As a result of this  
32 strong rocking force, the Gong member was eventually ripped apart particularly at the dovetail connection.  
33 Hence the above observation suggests the structural importance of the bottom Dou member towards the  
34 maintenance of overall structural stability. As long as the general cruciform mortise area of the Dou is intact, the

Figure 10. Failure mechanism of the Dou under the 42% and 60% intensity tests

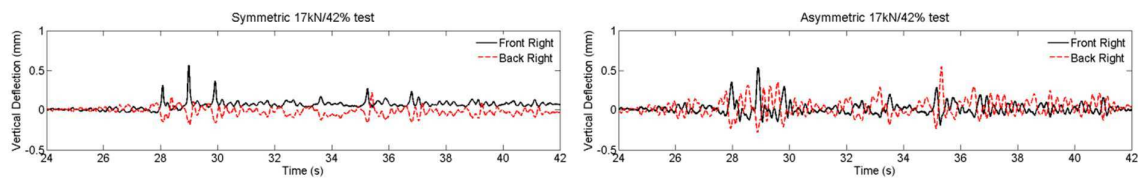
By taking the mean vertical deflection measured between the two bottom Dou members, the rocking behaviour under various loadings are evaluated, as shown in Figure 17. Taking the 17kN/42% loading test as an example, results shown that the front Dou members (black solid line) of the Symmetric specimen have a larger rocking angle than the back Dou members (red dotted line) (Figure 18). In the case of Asymmetric specimen, although the deflection intensity for the front and back members is not very distinct, slightly larger rocking angle is generally observed for the front members compared to the back members. This observation is in agreement with the damage pattern observed for both systems as the front Dou member of Symmetric specimen tends to be damaged much earlier than the Asymmetric one.

The above rocking behaviour might be due to the geometric of the specimens. In both specimens, the front bottom Dou has a smaller base than the back bottom Dou. Hence the greater surface contact at the back as compared to the front might give rise to higher rotational rigidity, as shown in Figure 17. Also, the geometry of the specimen with respect to the location of the gravity center of the roof load tends to make the entire structure rock forward. As a result, the stronger forward force caused more damage to the front structures. The above results also matched with the observations in Table 3 and 4.

- 23 4. The rocking angle of front structures is observed to be greater than the back, and that the Symmetric  
24 specimen tends to have a larger rocking angle than the Asymmetric set. This could be due to the lesser  
25 surface contact at the front bottom Dou as compared to the back where the contact surface of back bottom  
26 Dou is much wider, thus giving rise to a higher rotational rigidity. Hence more structural strengthening is  
27 recommended on the bottom Dou and front section members for future repair.  
28  
29

Figure 18. Rocking behaviour of the Dou members of both specimens under 17kN/42% seismic tests
