Assessment and Retrofitting of an Existing Steel Structure subjected to Wind-Induced Failure Analysis

C. Maraveas^{1,2*} and K.D. Tsavdaridis³

¹C. MARAVEAS & ASSOCIATES P.C. - Consulting Engineers, Greece

The "Dimitrios Vikelas" athletic centre in Ermoupolis of Syros (Greece) is selected and it consists of two buildings. Building B has a steel superstructure that was constructed approximately 35 years ago. It was initially used as a boat shelter and no design calculations were available, possibly constructed as a pre-engineered structure. It contains steel columns with varying cross-section heights. The spans are bridged via trusses and I-beams. Significant geometrical inconsistencies are noted among the existing steel connections and failures have been resulted due to buckling in several beams and bracings during the service life of the athletic centre. The current study presents an investigation performed in order to diagnose structural problems and propose strengthening and intervention measures.

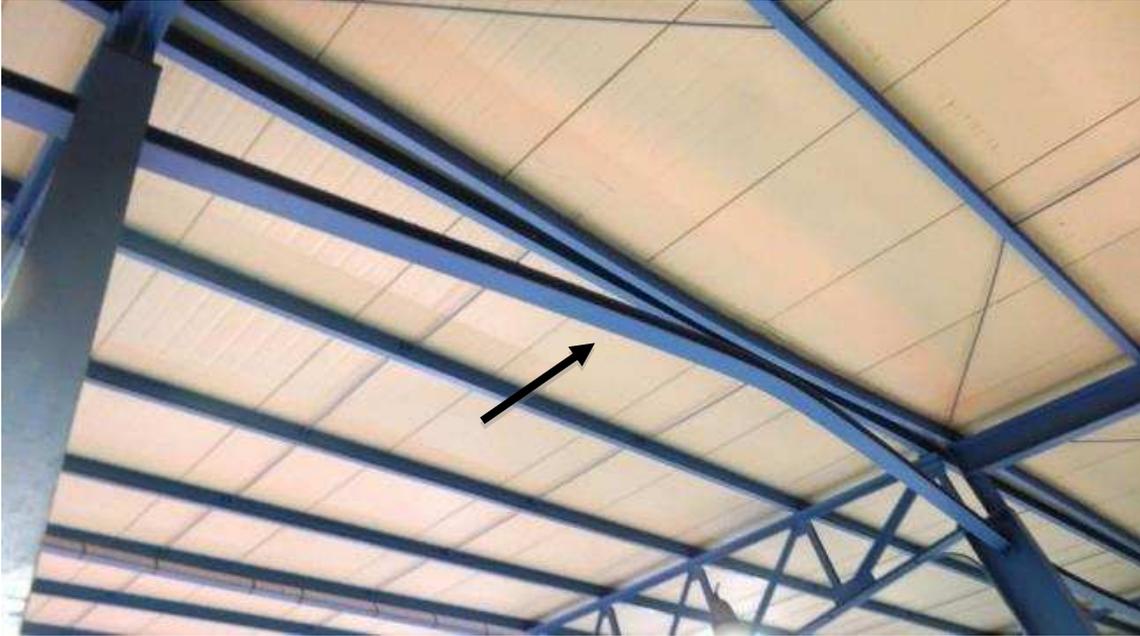
a) Extended buckling deformation of the corroded Λ -type vertical bracings to the south (Fig. 4a) as well as of the connecting beams between the IPE360 columns at +8.70 m (Fig. 5).

Fig. 5. Steel elements with major second-order deformations.

- d) Replacement of distorted members such as H-type connecting beams in Section 1-1 of Fig. 16, Fig. 17.
- e) Replacement of vertical elements at the end of the IPE360 column (Fig. 17), which is predicted to provide a stiffer beam-column connection.

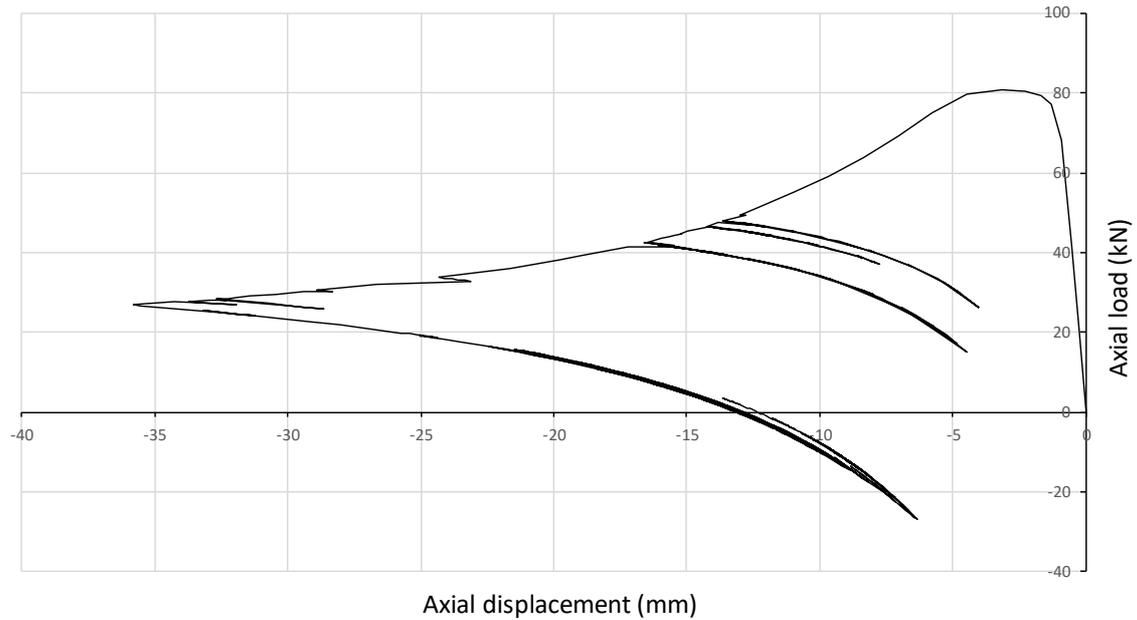
The buckling response, as shown in Fig. 14, was identified after importing the exact function of the axial displacement from the wind history analysis into Abaqus as a boundary condition amplitude. The maximum buckling capacity attained is greater than 81 kN (greater than 71 kN from Fig. 13). Nevertheless, buckling phenomena have occurred due to a significant shortening of the beam. In addition, the axial stiffness of the buckled beam is confirmed using the post-buckling curves. In particular, the stiffness (which is detected at the onset of a new compression region) is nearly equal for all subsequent loading paths after the first buckling occurrence (axial displacement of 3 mm).

Fig. 14. The response of the corroded buckled bracing, as determined using Abaqus.

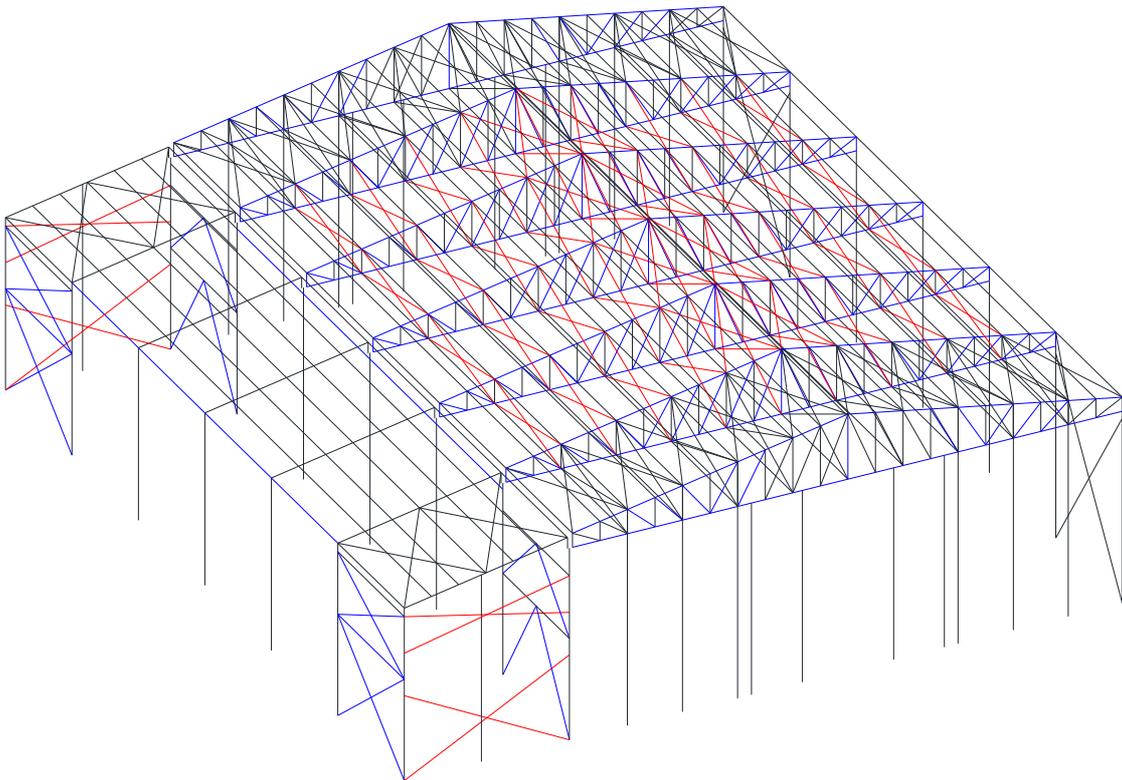
Fig. 16. Three-dimensional view of the structural modifications (blue for replacement or strengthening, red for member addition).

a) Addition of horizontal X-bracings near the roof ridge (roof plan view in Fig. 16, Fig. 17).

Fig. 16 shows the type and extent of interventions recommended for the main steel structure. Replacement and strengthening of the truss roof are illustrated in blue, while red is

used to indicate member additions. The same conventional symbolism has been adopted for Fig. 17. Some serviceability constraints (e.g., equipment, etc.) prevent the use of a more orthodox and appropriate X-bracing configuration in the east and west views (outer red vertical bracings in Fig. 16).

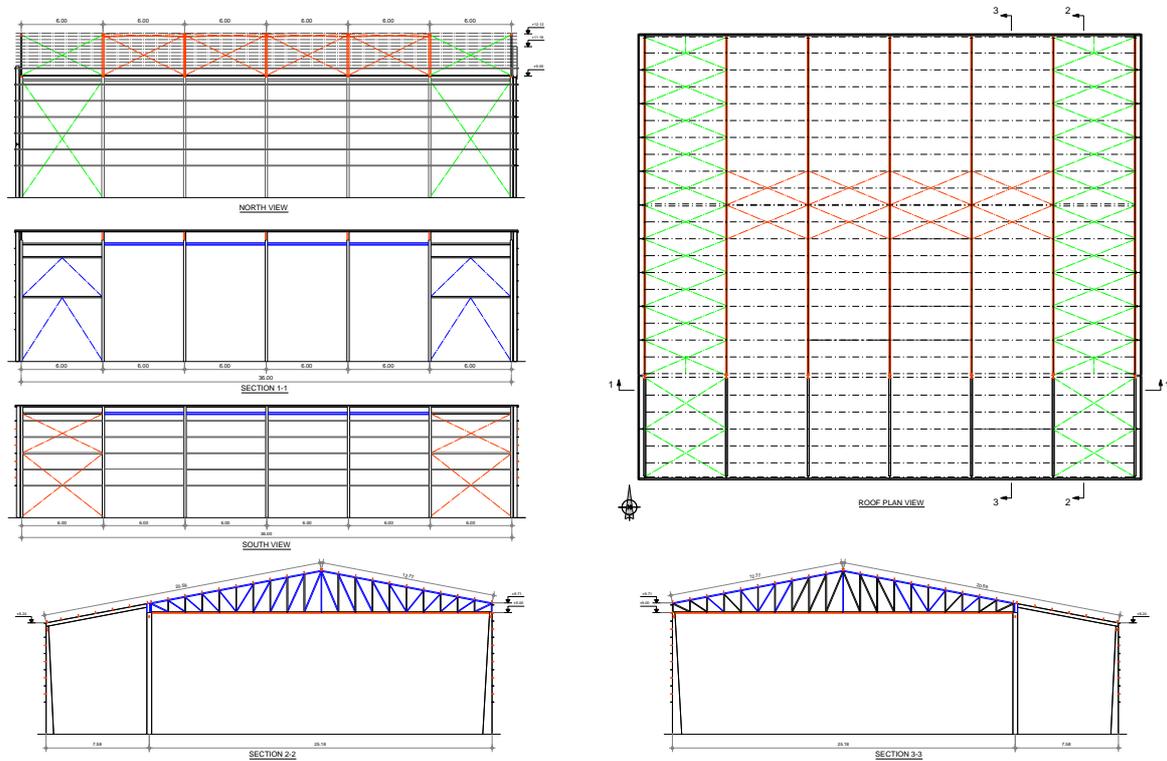
Fig. 17. Schematic view of the strengthened structure (green for existing bracings, red for proposed modifications, and blue for strengthening).

- c) Replacement of insufficient vertical bracings using the same or different configurations (examples from the south and north sides of the building as well as Section 1-1 can be observed in Fig. 16, Fig. 17).

- f) Strengthening the cross-sections of the main chords of the lattice roof using thin-walled hollow sections. Strengthening of specific truss members by adding second angle sections [Sections 2-2 and 3-3 in Fig. 17 and details in Fig. 18(b)].

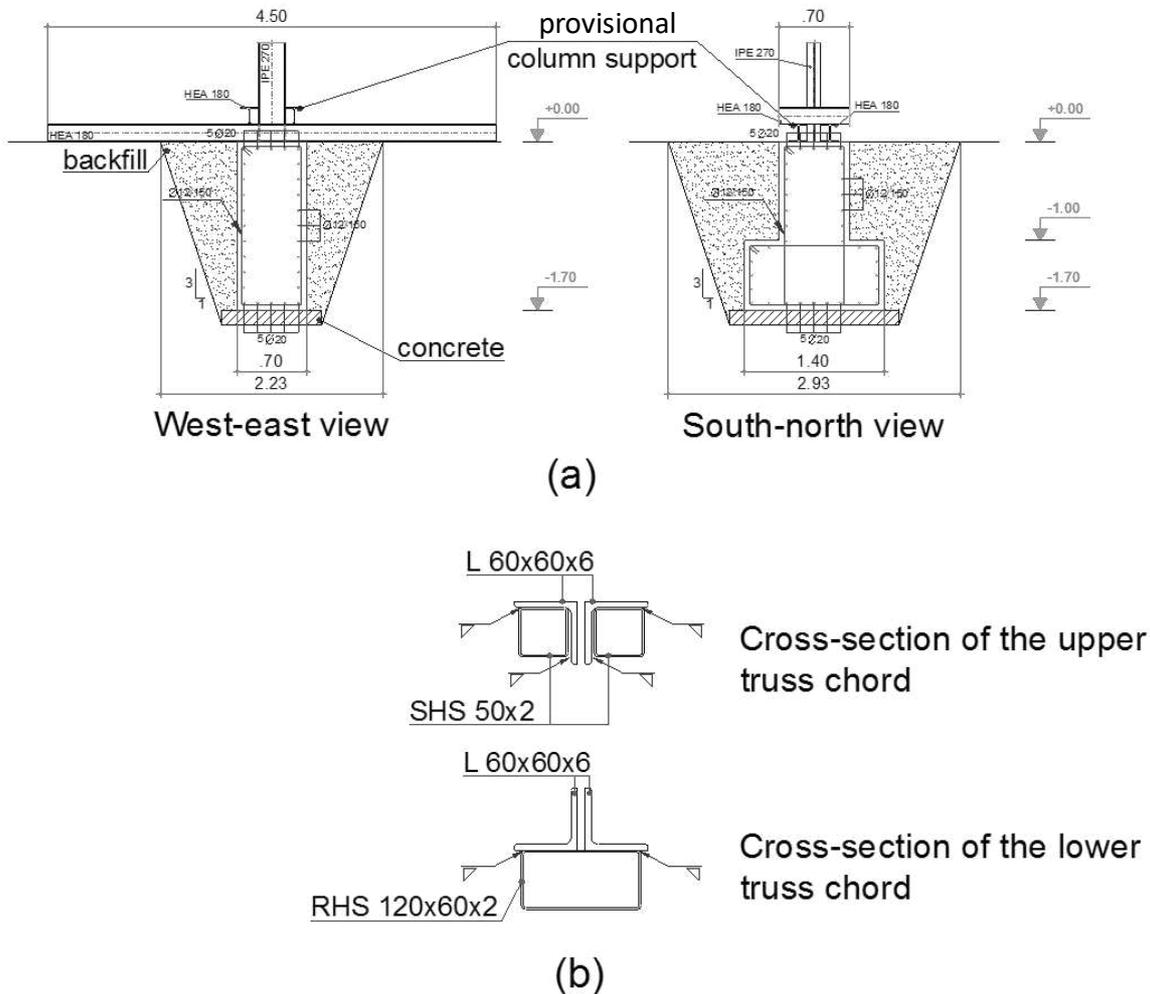
Fig. 18. Schematic view of strengthening details for a) the foundation and b) the truss chords.

A detailed schedule of strengthening of the truss chords (point “F” of the strengthening proposals) is attached in Fig. 18(b). The new hollow sections will be properly welded under the existing angle members since the purlins and the web members used for the upper and lower chords of the truss, respectively, preclude any other recommendation. Finally, it is
