Sharma, AK, Kumar, A and Sarhosis, V (2021) Evaluating the Seismic Performance of Domestic and Historical Masonry Structures in Himachal Pradesh Region of India. In: Kolathayar, S and Chian, SC, (eds.) Lecture Notes in Civil Engineering. Virtual Conference on Disaster Risk Reduction (VCDRR 2021), 15-20 Mar 2021, Online. Springer, pp. 477-490. ISBN: 978-981-16-4616-4. ISSN: 2366-2557. EISSN: 2366-2565.

Forensic investigations on earthquake damaged domestic and historical masonry structures in Himachal Pradesh region of India

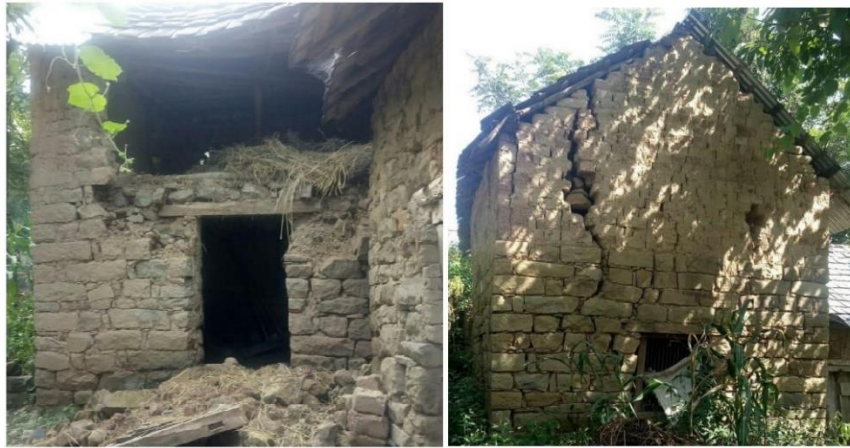
Fig 3: **a** Out of plane failure of wall, **b** development of cracks from openings

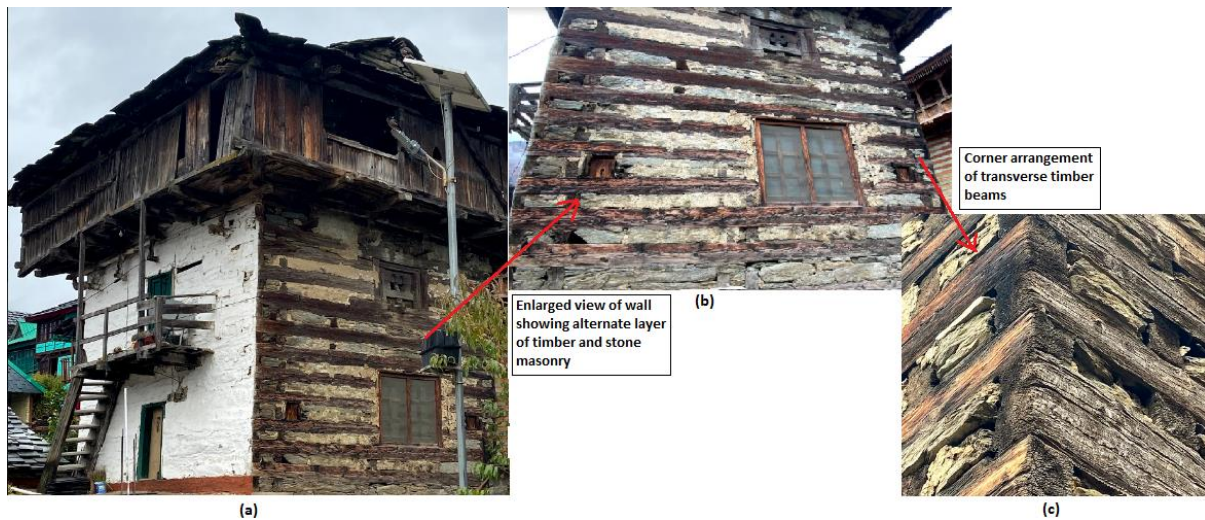
Most of the low-rise buildings (e.g. 1-3 stories) were constructed using rubble stone masonry. Figure 5(a) shows a 300 year old structure based on the Kath-Kuni architectural style and a typical arrangement of stones and timber members along the wall. Drystone-timber composite masonry walls were the main load-bearing system in the Kath-Kuni architecture. Wall openings were supported by wooden lintel beams. Buildings had alternate layers of complete dry-stone masonry and composite layers of timber as shown in Figure 5(b). These two different layers

Fig 5: **a** Kath-kuni tower-like structure, **b** Enlarged view of Kath-kuni side wall **c** Corner details showing interlocking of transverse timber beams

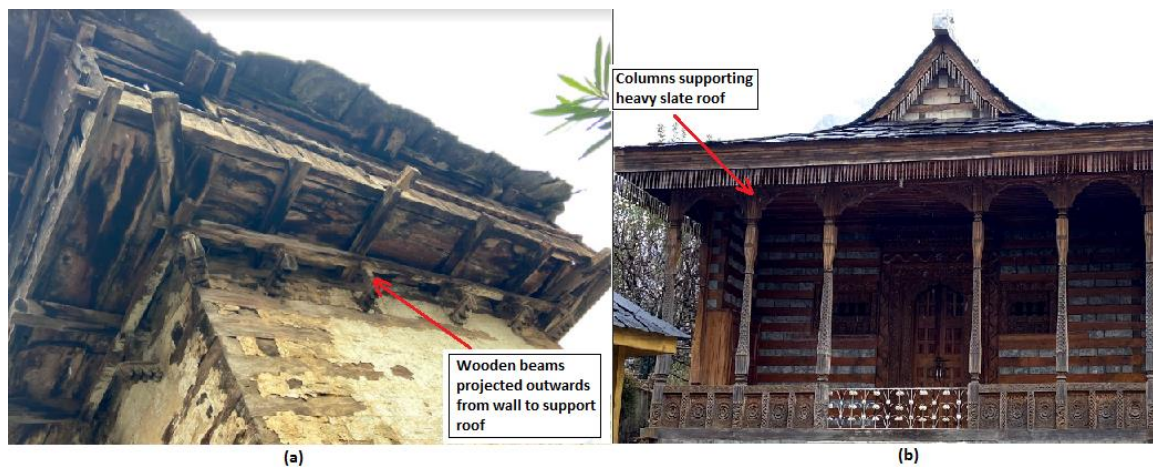
However, the top floors of these buildings were cantilevered and made of timber (Figure 7a). The space available at the top floor was for lightening during the winter season. Herein, overhang beams were projected from walls to support the loads of balcony where columns made of timber were used to distribute loads of a thick sloped roof

as shown in Figure 7(b). It has to be pointed out that a column discontinuity existed in the structure. This reduces the ability of the upper portion of the structure to withstand the lateral forces during a seismic event. Also, the roofing material consisted of slates that are abundantly available in the region while proper anchorage to the roof to the walls was not observed. The non-uniform mass distribution and heavy weight of slates covering the roof will attract greater inertia forces that need to be resisted in case of an earthquake event. The poor connectivity between the walls and the top portion of the building will reduce the ability of the upper portion of the structure to withstand the lateral forces during the earthquake. Furthermore, age-related deterioration of the structural members and lack of proper maintenance could further reduce the seismic resilience. The failure of the top 2 stories of 500 years old building is the evidence describing the seismic vulnerability of the structure (discussed in the Section 5).

Fig 7: **a** Cantilevered balcony in old kath-kuni buildings, **b** Cantilevered balcony having columns to support slate roof.

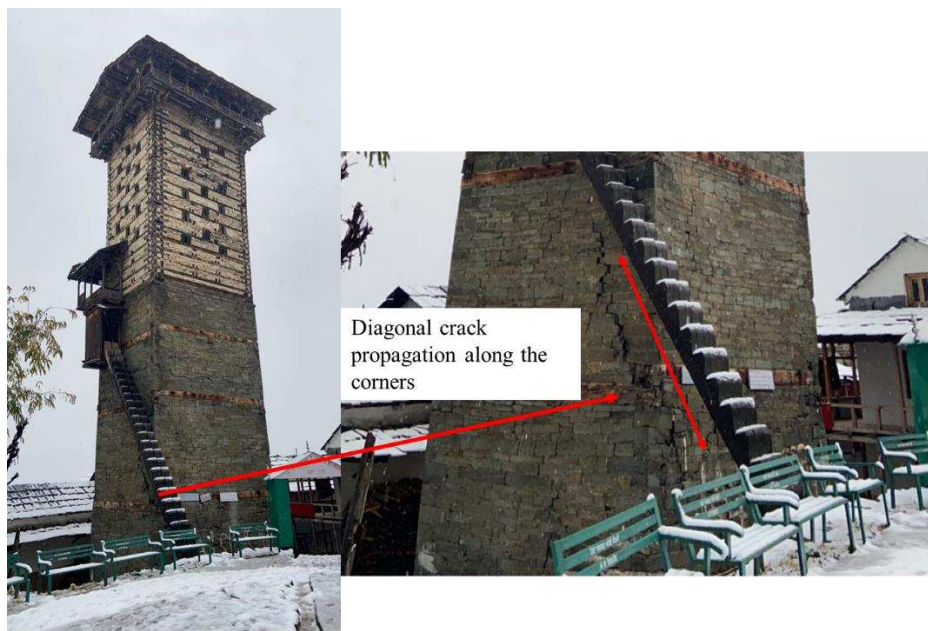
Fig 9: Chennai Kothi heritage tower

Figure 9 shows a 30 m high classical tower type Kath-Kuni architecture located at Chenni Kothi village of Kullu district. The structure is believed to be more than 500 years old and survived most of the disastrous earthquakes. This ancient tower was once the palace of the Queen but now transformed into a religious place. It has a symmetrical plan and walls with a narrow opening for windows and doors. The average width of the tower was 5 m. The structure was 4 storied having cantilevered balcony in all the directions. The length of the cantilever varied from 1.2 m to 1.5 m. The tower had initially 9 stories and during the seismic event of 1905 Kangra earthquake, the top two stories collapsed. The heavy mass lumped at such height and with lack of maintenance caused the historical structure to fail under the seismic event. Irrespective of the cultural and heritage value of the structure, there was no maintenance work done and there is also no documentation of the damage happened to the structure. During 2015 Gorkha earthquake, there was the same direct economic and historical loss in case of emergency measures taken by local people after the seismic event by clearing the parts of the collapsed structure which should be recycled and reused or preserved (Coningham et al. 2019). Figure 9 also highlight a wide visible crack just below the stairs of the structure which propagates towards the corner of the building. The length of the crack was measured as 2 m. This damage pattern may be attributed to the stress concentration near of corners of the wall and their inability to bear the shear stresses. Also, the possibility of rotation of the building was not observed

because of the intact rocky bearing strata. The maintenance, retrofitting and rebuilding work of such ancient marvel should be done by skilled engineers.

was recorded during the 1905 Kangra earthquake that collapsed the top 2 stories of the Chenni Kothi heritage tower.
