Observations from the March 2021 Thessaly Earthquakes: an earthquake engineering perspective for masonry structures

Abstract

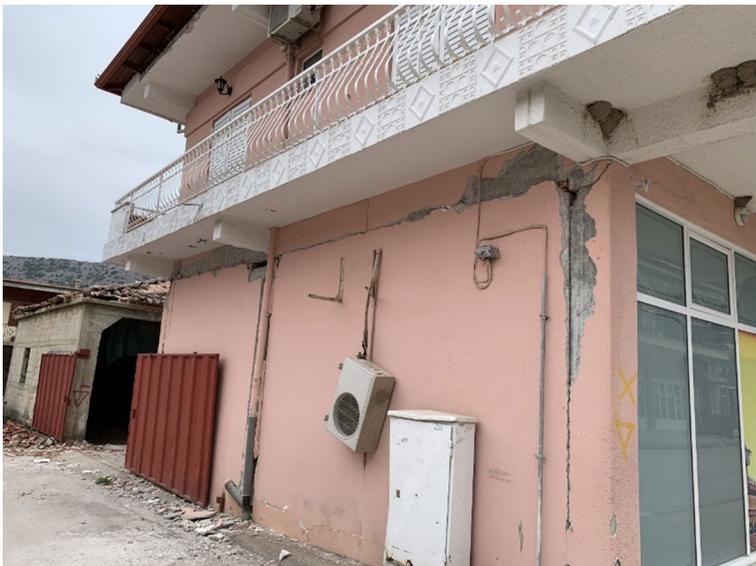
Fig. 8 Damage of infill walls in a RC building due to out of plane bending and shear damage in the column due to in plane infill behaviour in Damasi

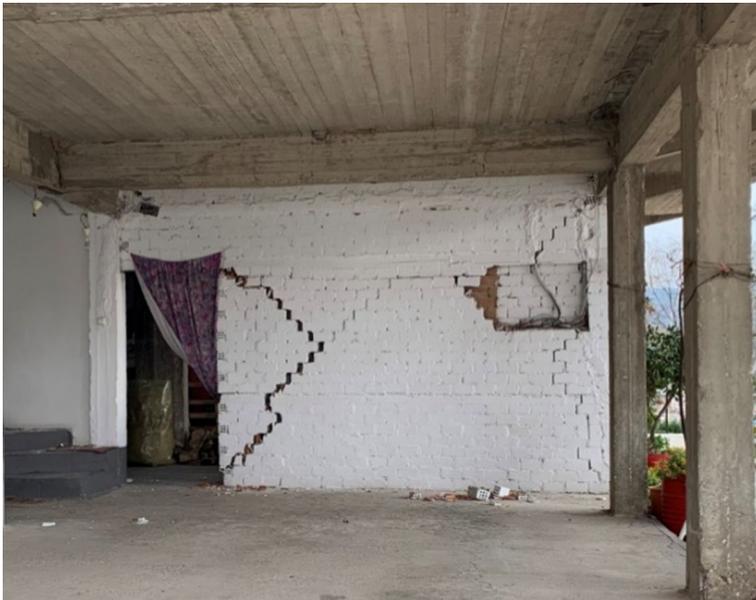
Figure 9 shows another example of in-plane shear failure of a poorly confined masonry wall in Mesochori. Cracking in masonry presents a diagonal shear crack formed in a zig-zag pattern.

Fig. 9 In plane shear failure of poorly confined masonry wall due to door opening in Mesochori

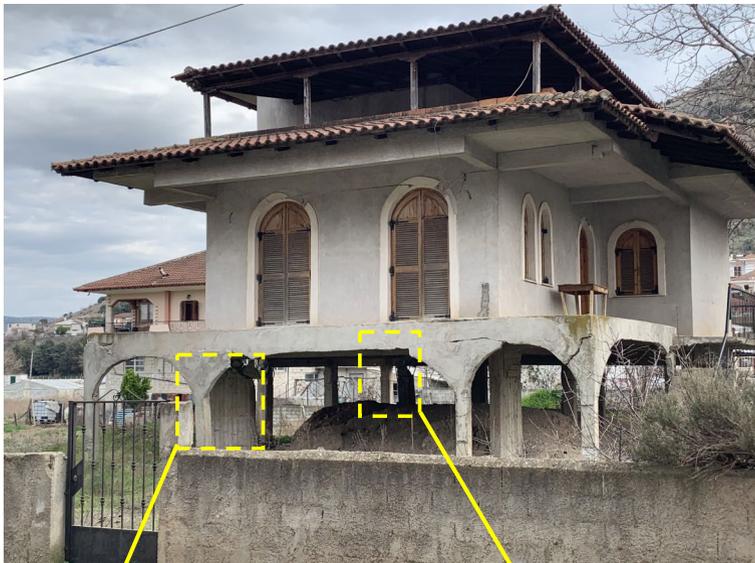
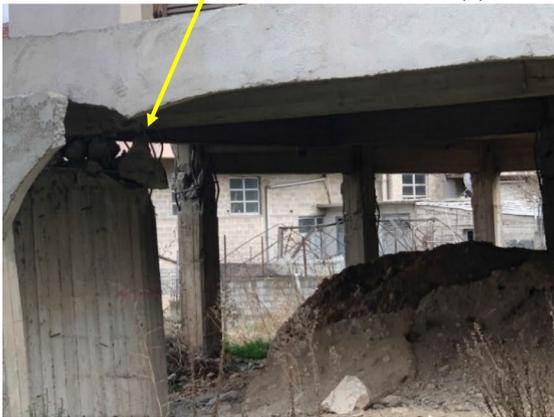
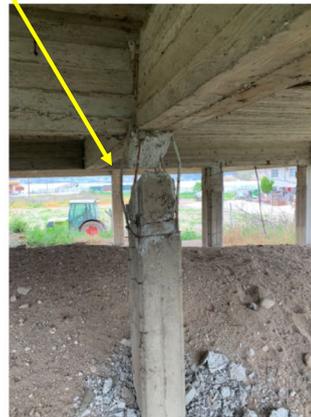
Severe damages to RC buildings were observed mainly in soft-storey ground floors (called pilotes in Greek, see Fig. 10a). These are buildings mainly designed and constructed before 1985. The lack of shear reinforcement accompanied with loss of stiffness due to open ground floors led to shear failures of columns and beam to column joints, see Fig. 10. Lack of appropriate horizontal reinforcement (stirrups) resulted in buckling of the longitudinal rebars of the columns (Fig. 10c). The strong beams remained undamaged, while severe damage and plastic hinges developed at the top of the columns. In other cases, where not enough reinforcement installed, diagonal shear cracking was observed in shear walls, see Fig. 11.

Fig. 10 Strong beam-weak column of a residential building in Damasi

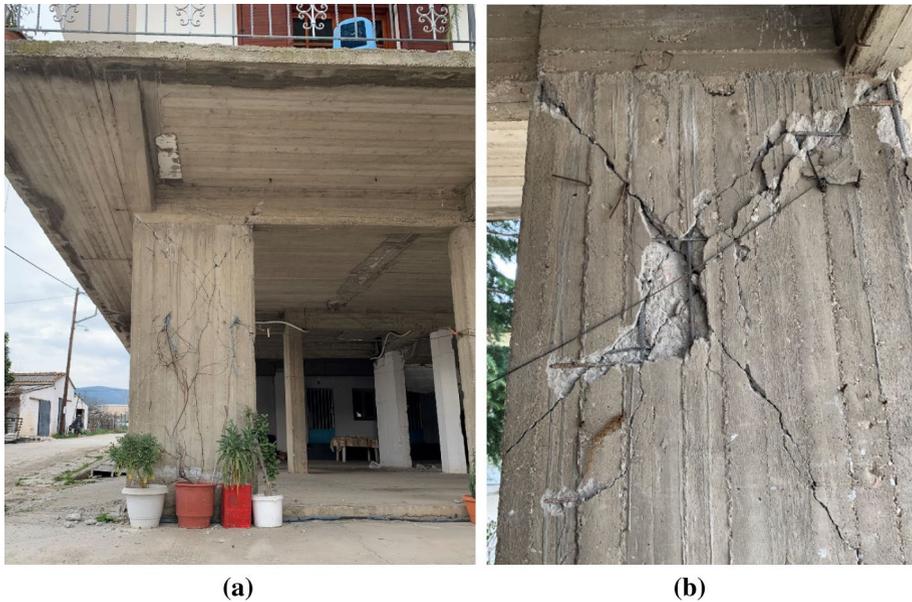
Fig. 11 “X” shaped failure of a shear wall located near the top in a RC building **a** face of the shear wall; **b** back of the shear wall at the corner of the building

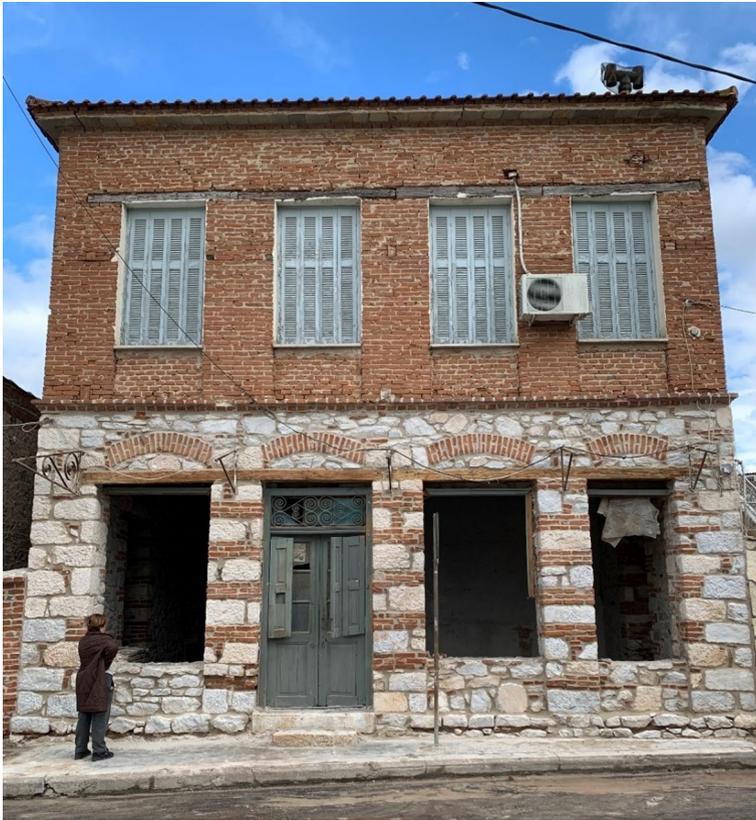
Fig. 12 Masonry house with large openings and wooden lintels above openings in Tyrnavos. The ground floor is made of stone masonry while the first floor is made of clay bricks

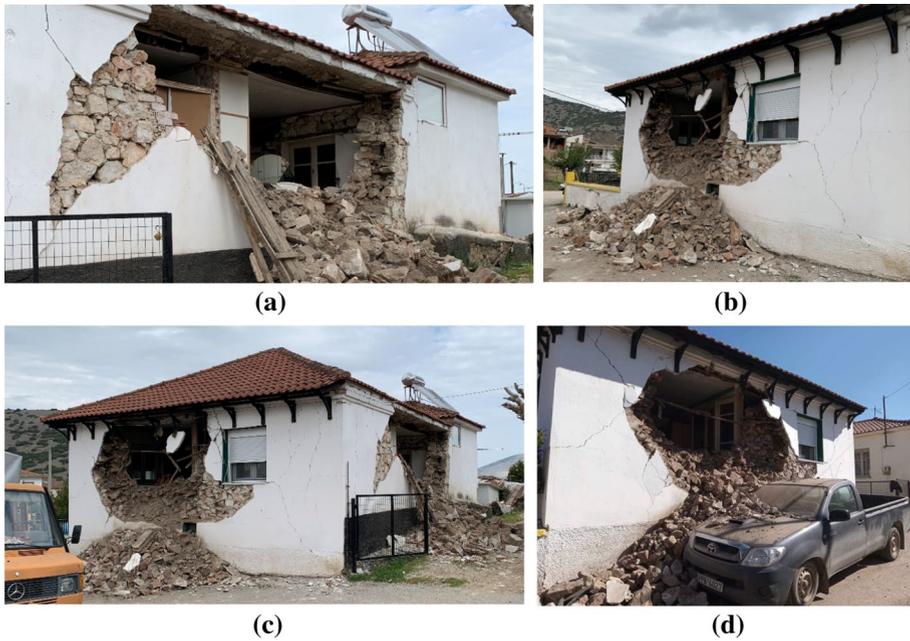
buildings in Damasi and Mesochori. Figure 13 shows some examples of out-of-plane failure of masonry walls. It is evident from Fig. 13 that, although the thickness of the walls is adequate, these were constructed using mud as mortar, which is of very low strength and thus vulnerable to earthquake shaking (Lourenço 1998). Despite the fact that Fig. 13 does not show a serious damage in the form of partial or total collapse, parts of the wall falling on the street causes many other secondary issues, such as blocking the passage of large rescue vehicles and damaging civilian cars.

Fig. 13 Out of plane collapse of masonry walls in Damasi, Greece

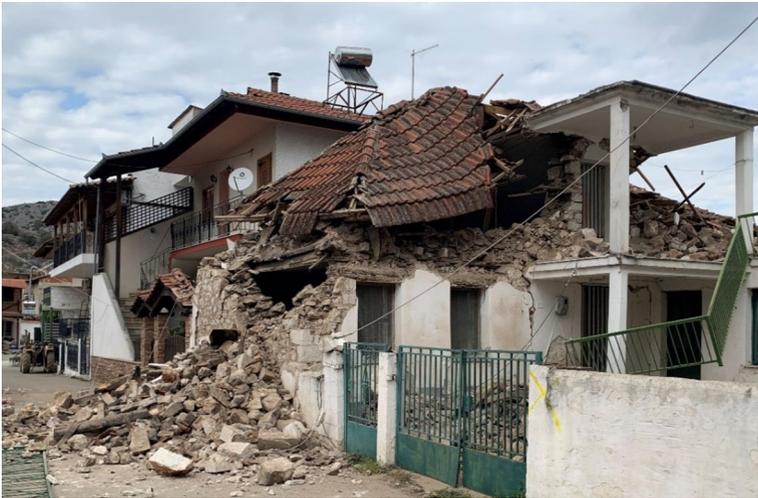
Fig. 15 Out of plane collapse due to poor connection between the roof and the underlying masonry and no rigid top floor, Damasi, Greece

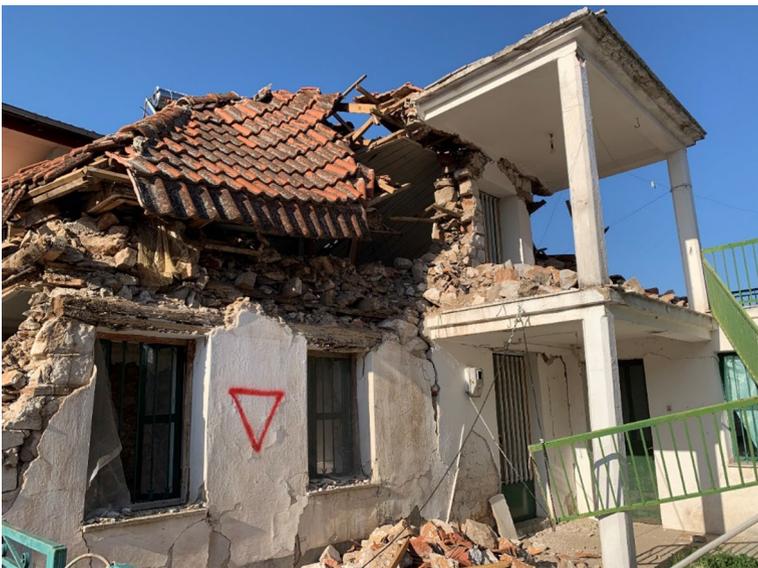
Fig. 16 Pounding failure due to different dynamic characteristics of structural components

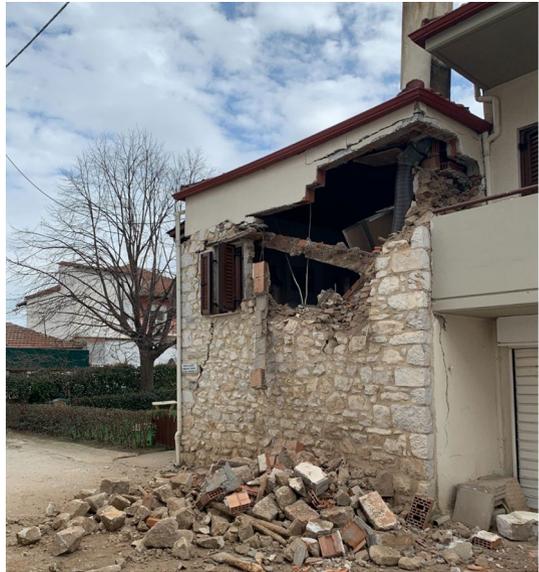
Fig. 17 Lack of an effective ring beam

layers of clay masonry units with a stronger mortar, which is a rather unfortunate design choice. The higher masonry ring beam may have caused redistribution of vertical compressive stresses and some parts of the masonry wall below, could result in becoming unloaded and prone to being unstable during the earthquake. In addition, the high stiffness of the masonry ring beam, which is able to carry large axial and bending forces has modified the natural vibration mode of the masonry walls and generated local high stresses in the masonry walls below the ring beam (Borri et al. 2016; Faella 2020). From Fig. 17, the lack of anchoring of the ring beam with the load bearing walls to resist loads from horizontal direction and the lack of strengthening of the wall are the main causes of the partial collapse.

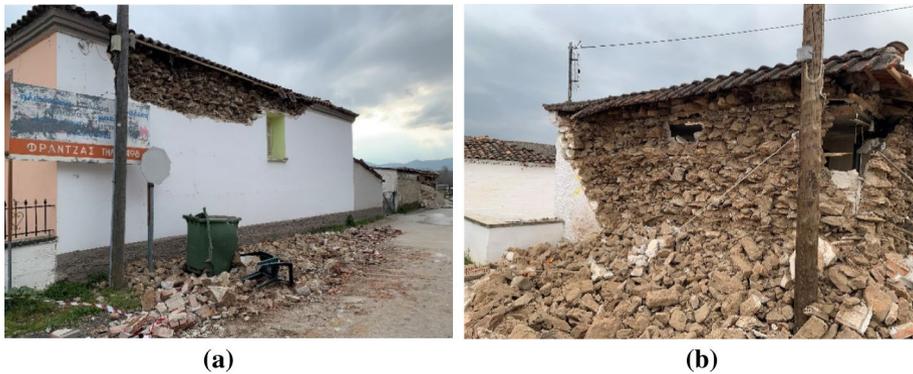
Another type of damage observed was that of bulging and delamination of the walls due to their outward buckling. The main reason for delamination was the absence of through stones or connection between the two-leaf walls as well as due to weak bonding between the outer wall and fill material. Delamination was mainly observed at the upper part of the walls. Since the space between the interior and exterior walls was filled with small stones and rubble bonded with mud mortar, connection between the two walls was inadequate. Figure 18 shows examples of delamination of masonry walls in buildings found in Meschiori. It is worth mentioning that delamination was formed in a trapezoidal shape. In some cases, delamination was observed only at the masonry walls (Fig. 18a), while in others it was a combination of the masonry walls and wall to wall intersections (Fig. 18b).

Fig. 18 Delamination of **a** the upper part; and **b** entire wall of a masonry buildings in Mesochori

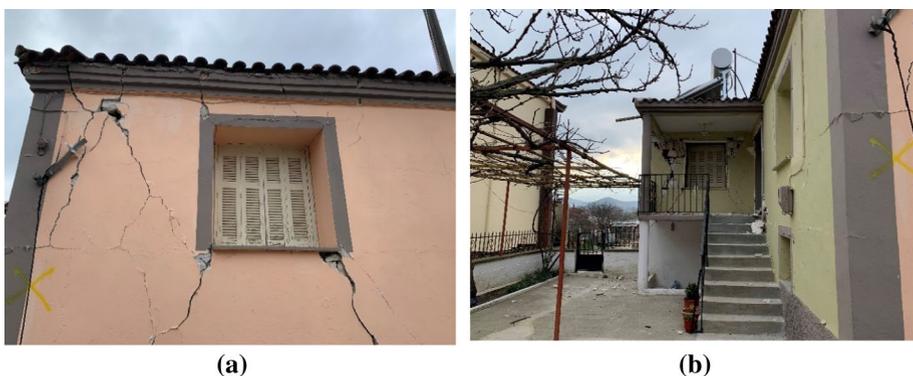
triangular sections of the cross-diagonal crack become unstable, and eventually it may lead to collapse with aftershocks. Typical, examples of diagonal shear cracks in load-bearing walls caused by the earthquake in Thessaly are shown in Fig. 19.

Fig. 19 Shear cracks due to diagonal tension in domestic masonry buildings in Mesochori

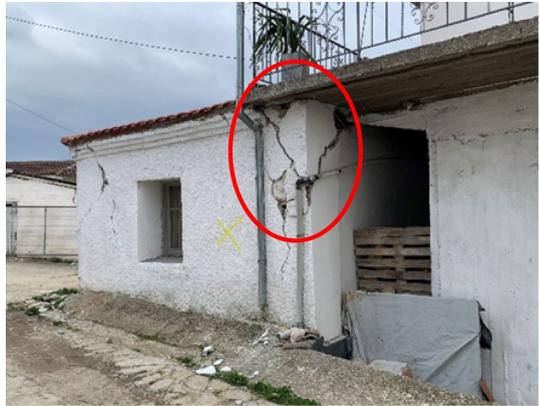
Figure 20 also shows pounding of the RC building slab into the masonry wall of the adjacent building. The RC slab of the reinforced concrete building penetrated in the corner of the masonry buildings at the wall to roof connection and created damage.

Fig. 20 Pounding between adjacent RC and masonry buildings

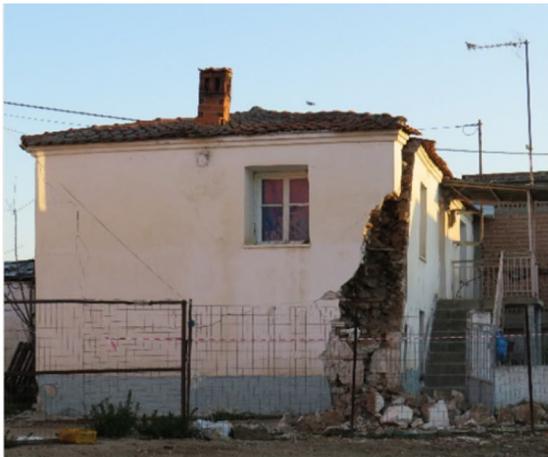
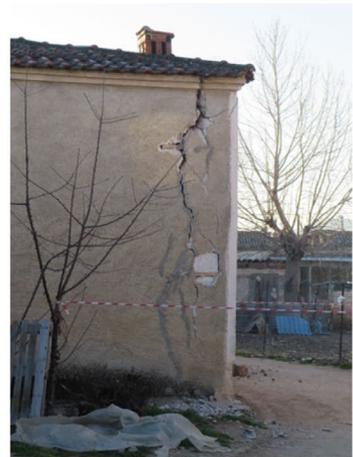
In addition, it was observed that severe vertical cracks and gaps formed and propagated along the height of bearing wall intersections, see Fig. 21a and b. Such damage was attributed to the lack of the horizontal diaphragms. Structural integrity formed due to the inadequate connections between the bearing walls at the wall intersections and between the bearing walls and the roof. From Fig. 21 the lack of diagonal shear cracks is evident which denotes that the walls acted independently along the in-plane and out-of-plane direction under the earthquake.

Fig. 21 Vertical cracks at corners of the buildings denotes the lack of diaphragmatic action of the roof and floor systems (Lekkas et al. 2021a, b)

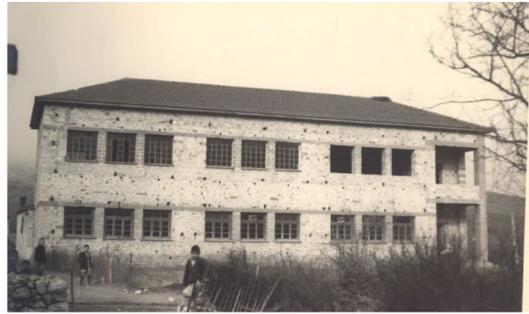
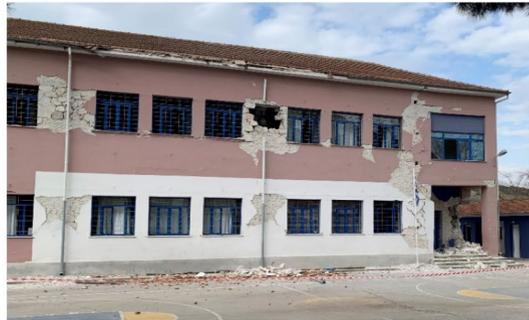
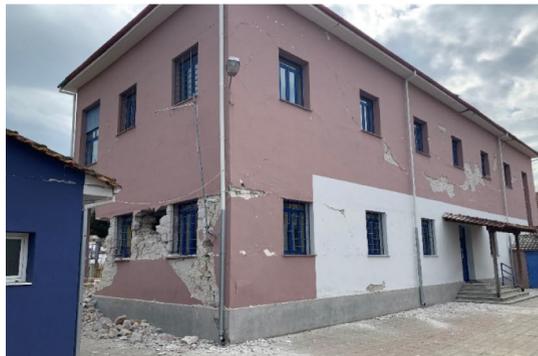
walls, lintels above window and door openings, beams, or bands at various heights etc. The failures observed in school buildings in Thessaly follow the typical damage typology of the masonry residential buildings. The extent of damage in the school of Damasi which was built in 1938 is shown in Fig. 22. Sixty-three students and their ten teachers were fortunately unharmed when some masonry walls locally collapsed. From Fig. 22, it can be observed that parts of the load bearing walls of the building failed in the out of plane direction while some diagonal shear cracks are evident between the window openings of the ground floor. Also, the front face of the school suffered more damage compared to the back side. This was due to the fact that more openings existed at the front of the school in which classes were located as opposed to the back side of the school in which there was the corridor to the classes. In the interior of the building, major diagonal shear failure at the masonry walls as well as separation of coating material from the masonry walls and overturning of chairs, desks and equipment occurred. The structure

Fig. 22 **a** Front view of the school from the 1940s; **b** front view of showing shear cracks and out of plane failure of the masonry walls; **c** rear view showing extensive shear failure of the piers between openings

was characterised as unsuitable and was demolished a couple of weeks after the first strong earthquake.

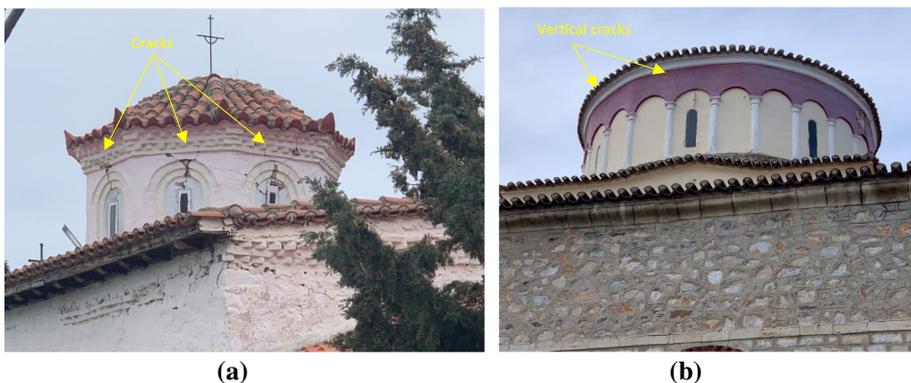
Fig. 23 Vertical cracks in arches and domes: **a** profitis Ilias in Tyrnavos; **b** Panagia Faneromeni in Tyrnavos

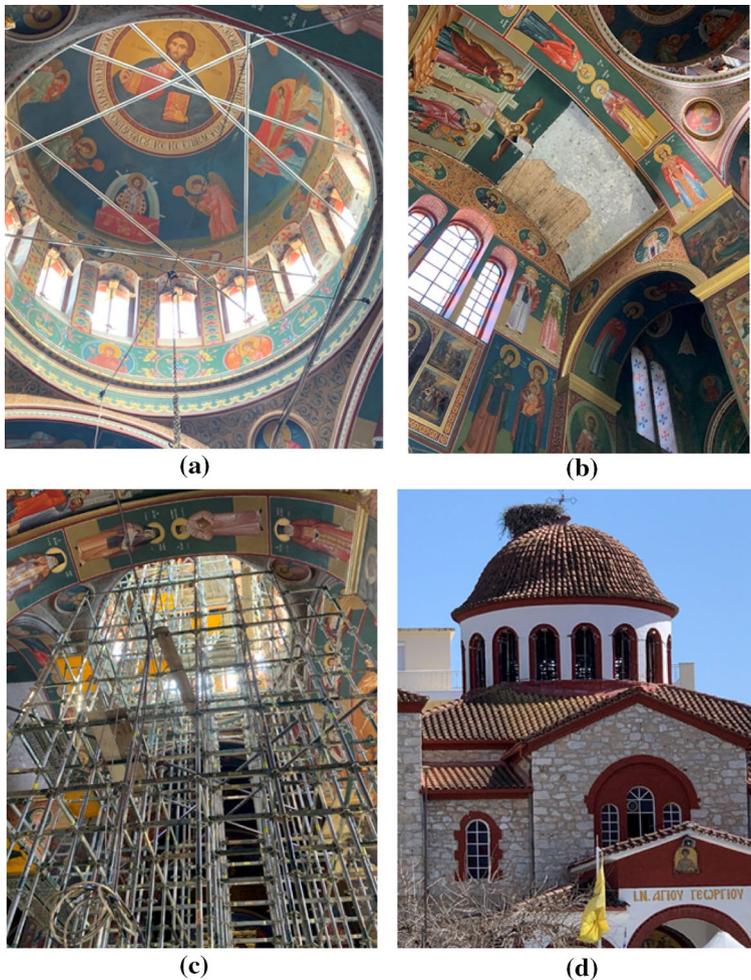
Fig. 24 Church of Agios Georgios in Tyrnavos: **a** Lateral springing thrust of the arches resulted in shear cracks in the slender piers supporting the wooden dome; **b** non-structural damages; **c** scaffolding for supporting of the arch dome; **d** external view

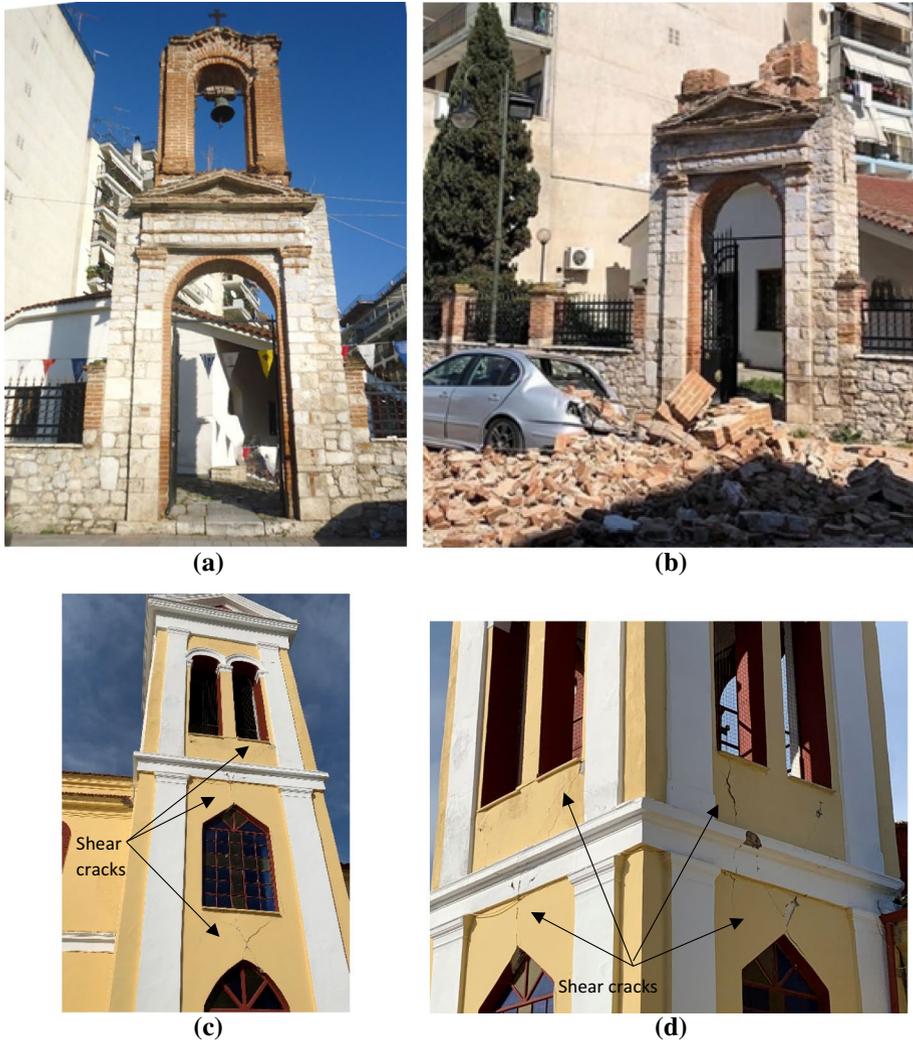
Fig. 25 **a** Bell tower of church of Agios Ioannis in Tyrnavos before the 3/3/2021 event (source: Tirnavospress.gr); **b** out of plane failure after the earthquake; **c** and **d** shear diagonal cracks between openings at the bell tower of the church of Agia Paraskevi in Tyrnavos

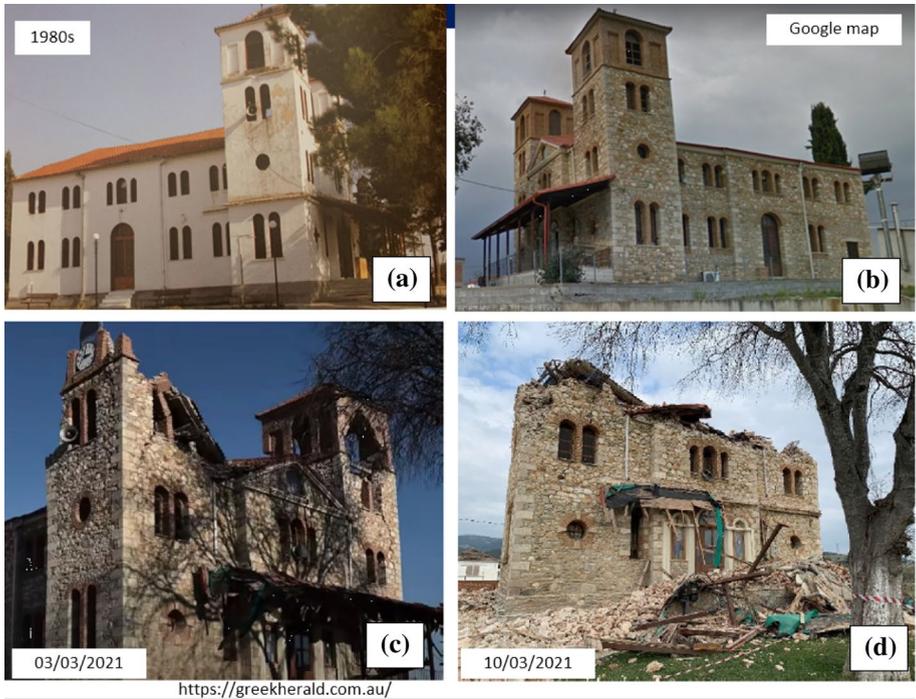
Fig. 26 Church of Agios Dimitrios at Mesochori **a** view from the 1980s; **b** before the earthquake; **c** after the main event of 3/3/21; **d** after the aftershocks on 10/03/21

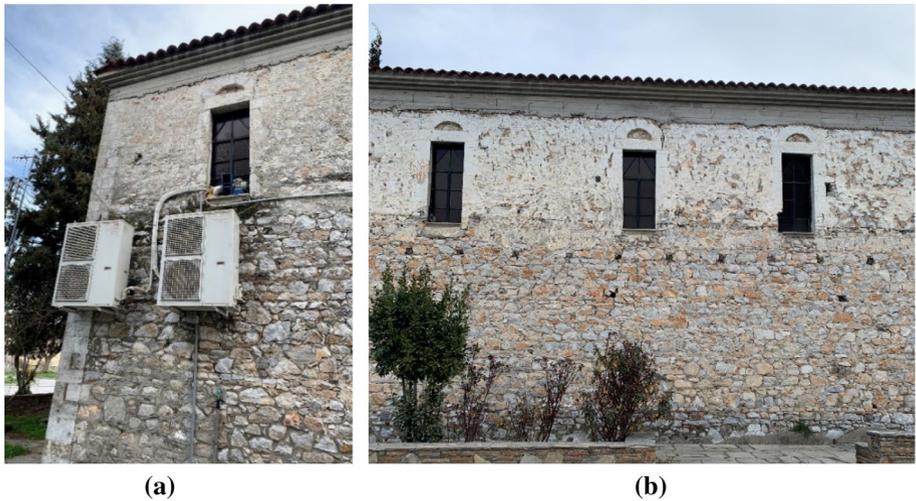
Figure 27 is an example of an effective retrofitting scheme to improve connection of the roof and the walls applied to a church in Tyrnavos. The reinforced concrete ring beam effectively kept the connectivity of the peripheral walls of the building and the roof together. In order for the retrofitting scheme to be effective, reinforced concrete ring beams should be introduced to avoid excessive increase in weight and stiffness

Fig. 27 Example of good quality RC ring beam which ensured connectivity of walls in a church in Tyrnavos

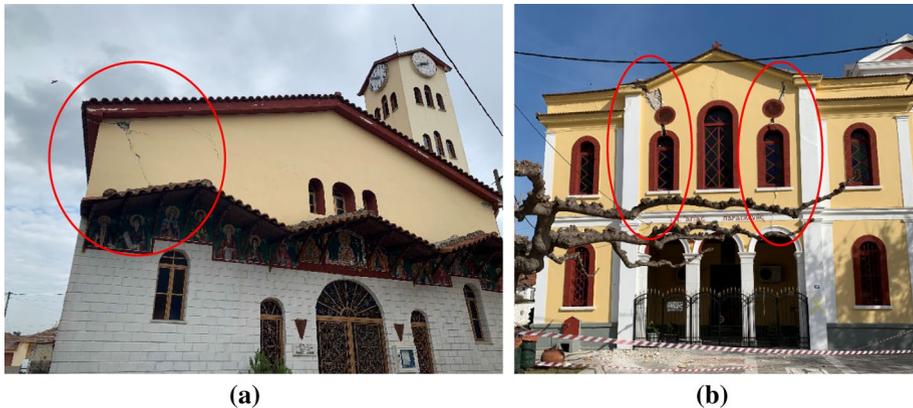
On the other hand, Fig. 28a shows a corner failure of the load bearing walls of a church due to out of plane movement which can lead to façade separation, while in Fig. 28b shear cracks occurred due to the large openings. Such cracks propagated from the window and door openings to the roof.

Fig. 28 Damages (within the red ellipses) in the corner and perimeter wall of churches at **a** Damasi (church of Agios Nikolaos); and **b** Tyrnavos (church of Agia Paraskevi)

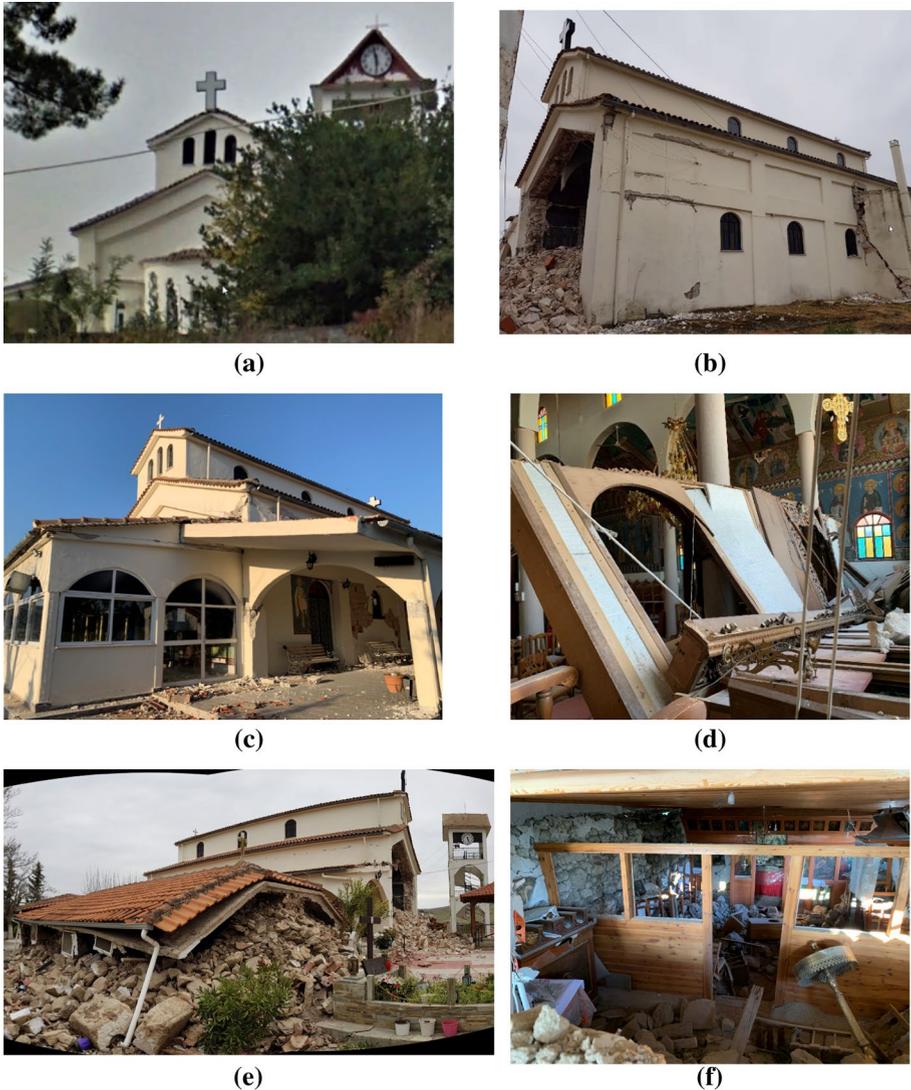
Figure 29 shows the Church of St Nicolas in Koutchocheron. As we can see from Fig. 29b the eastern wall of the church collapsed in an out of plane mode. This may be attributed, among others, to the existence of three large openings at the altar (Fig. 29a), a not so typical architectural feature (most Greek Churches have one opening at the altar only). Also, Fig. 29c shows an extension of the church with a RC covered walkway in contact with the southern wall of the church for operational reasons. Diagonal “X” shaped cracks of the infill walls of the walkway as well as separation of the newer walls with the existing ones of the church occurred during the earthquake. Several non-structural damages were also observed in Fig. 29d. Finally, Fig. 29e and f shows the total collapse of the older, Agios Nikolaos chapel (built in late 1700s), next to the newer church. The chapel was made of stone masonry connected with low in bond strength mud mortar. Also, the timber roof simply resting on top of the perimeter walls without any capacity of resisting any out of plane actions of the upper part of the walls but rather transfer horizontal forces which led to collapse of the walls.

Fig. 29 Church of Agios Nikolaos at Koutchochero: **a** before the earthquake (picture taken from Google maps-street view), **b** North side of the church after the earthquake of March 2021; **c** west side of the church; **d** non-structural damages inside the church; **e** older, Agios Nikolaos chapel; **f** interior of the chapel of Agios Nikolaos
