# Analysis of Early-Retrieved Dual-Mobility Polyethylene Liners for Total Hip Replacement

Mackenzie Smeeton <sup>1,\*</sup>

**Abstract:** Despite their emerging use, the in vivo behaviour of dual-mobility (DM) total hip replacements (THR) is not well understood. Therefore, the purpose of this study was to assess the articulating surfaces of 20 early-retrieved DM polyethylene liners (mean length of implantation  $20.0 \pm 18.8$  months) for damage to improve the current understanding of their in vivo functional mechanisms. The internal and external surfaces of each liner were visually and geometrically assessed, and the material composition of embedded debris particles were further characterized. Scratching and pitting were the most common modes of damage identified on either surface, and a high incidence of burnishing (50%) and embedded debris (65%) were observed on the internal and external surfaces, respectively. Embedded debris particles were commonly titanium- or iron-based, although other materials such as cobalt-chrome and tantalum were also identified. The geometric assessment demonstrated highly variable damage patterns across the liners, with the internal surfaces common

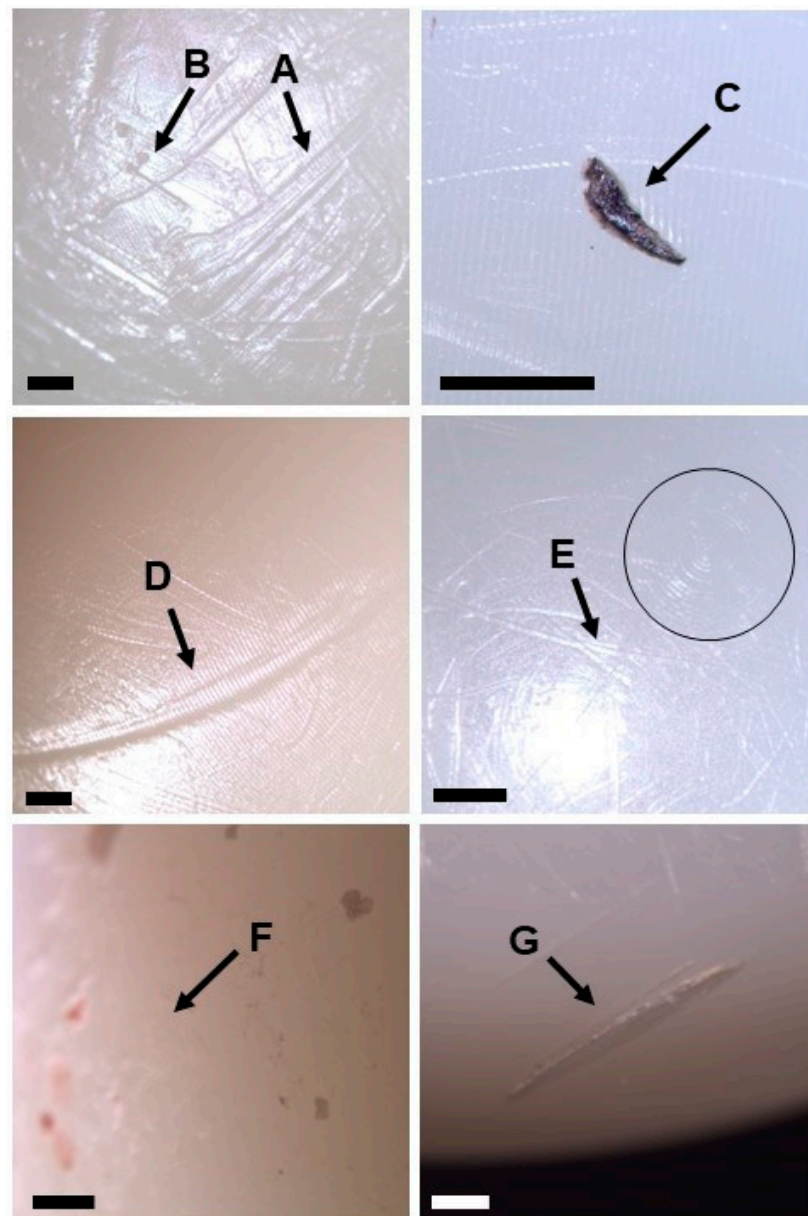
The frequency of each damage mode identified amongst the collection of retrieved liners is summarized in Figure 1, and examples of these are shown in Figure 2. With regard to the internal surface of the polyethylene liner, the most frequently observed modes of damage were scratching (100%), pitting (85%), and burnishing (50%). Additionally, embedded debris was identified on the internal surfaces of five liners (25%), and abrasion was observed on two liners (10%). There were no signs of delamination or deformation on the internal surfaces of any samples assessed in this study.

For the external surfaces, the most frequently observed modes of damage included scratching (100%), pitting (90%), and embedded debris (65%). Abrasion and delamination were identified on 45% of the samples, whilst burnishing (15%) and delamination (10%) were less common.

**Figure 2.** Examples of the damage modes observed, which include scratching (A), pitting (B), embedded debris (C), deformation (D), burnishing (E) next to an area of visible machining marks within the black circle, abrasion (F), and delamination (G). Scale bar represents a unit of 1 mm.

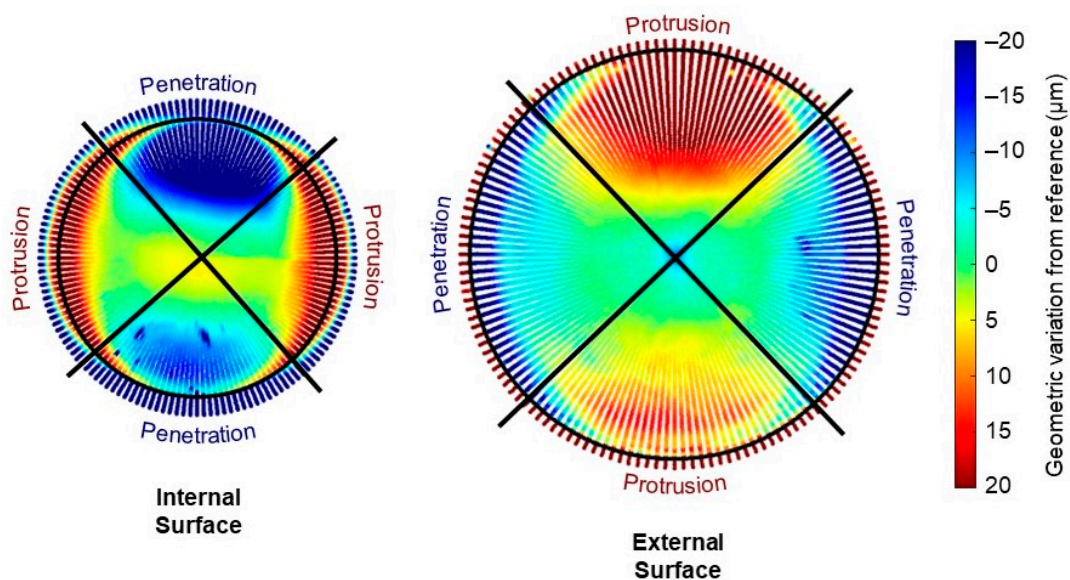
Highly variable damage patterns were observed among the collection of retrievals. The surfaces of seven (35%) liners showed diametrically opposed regions of penetrative and protruding geometric variation, which were visible on both the internal and external surfaces, as exemplified in Figure 3, which would suggest the liners had become more elliptical in shape.

**Figure 3.** Diametrically opposed regions of penetrative and protruding geometric variance on both the internal and external surfaces of one sample.

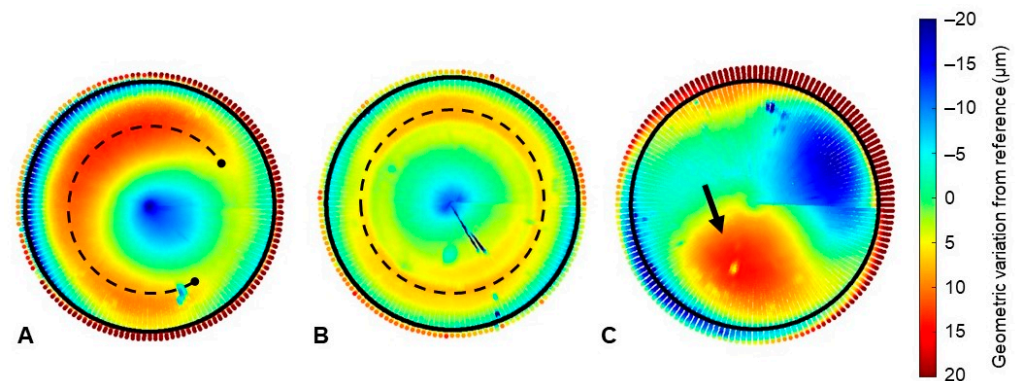
The most common damage pattern observed on the internal surfaces was asymmetric, crescent-shaped regions of penetrative geometric variation (Figure 4A), which was identified on eight samples (40%). Additionally, circumferential stripes were identified on the internal surfaces of four liners (20%, Figure 4B), whilst circular or elliptical regions of geometric variation were observed on three samples (15%, Figure 4C). No obvious damage was present on the remaining six samples (30%).

**Figure 4.** Examples of the damage patterns present on the internal surfaces of retrieved DM liners, including crescent-shaped (A), circumferential (B), and circular (C) regions of penetrative geometric variance as highlighted by the black dotted lines (A,B) or arrow (C).

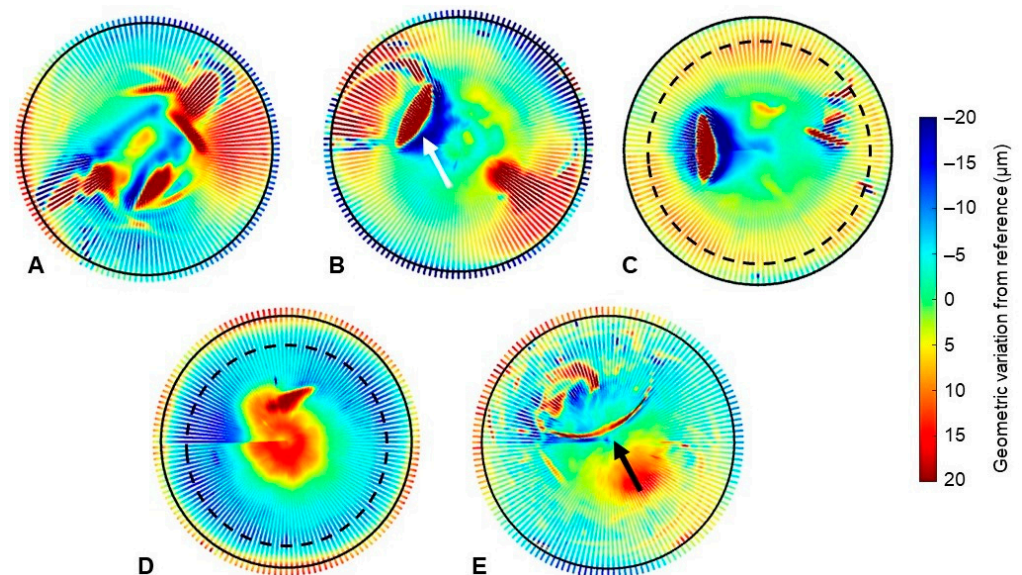
With regard to the external surfaces, moderate-to-deep pitting was observed on 15 samples (75%), as exemplified in Figure 5. The shape, location, and severity of the damage varied, although similar stripe wear patterns appeared in the equatorial region of four samples (30%, Figure 5D,E). Additionally, circumferential stripes of penetrative ( $N = 3$ , 15%) and protruding ( $N = 2$ , 10%) geometric variation was observed among the samples. A C-shaped indentation was observed on one sample, and minimal damage was observed on the remaining four liners.

**Figure 5.** Examples of the damage patterns present on the external surfaces of retrieved DM liners, including moderate-to-deep pitting (A), stripe wear (B), circumferential stripes of penetrative (C) or protruding (D) geometric variance as highlighted by the black dotted line, and a C-shaped surface indentation (E).

In addition, analysis of the retrieved liners revealed more damage at the external surfaces in comparison to the internal surfaces. Regions of discrete, localised, and severe damage were frequently identified on the external surfaces, as evidenced by the visual inspection (i.e., increased incidence of abrasion, delamination, and deformation) and geometric assessment (i.e., increased incidence of deep pitting). Due to the unexplainable nature of this damage, it is hypothesised that this was caused, at least in part, by *ex vivo* factors such as contact with surgical instrumentation during the revision process. This aligns with the material characterisation results, whereby a high proportion of the embedded debris identified on the external surfaces contained traces of iron, which could not be attributed to any of the implant surfaces. It is recommended that retrieved DM components are handled with caution in future analyses to prevent this type of damage, that the condition of these implants is well documented at the time of revision, and that damage characterisation studies are performed to assess the effects of implant removal on surface damage to DM polyethylene liners.

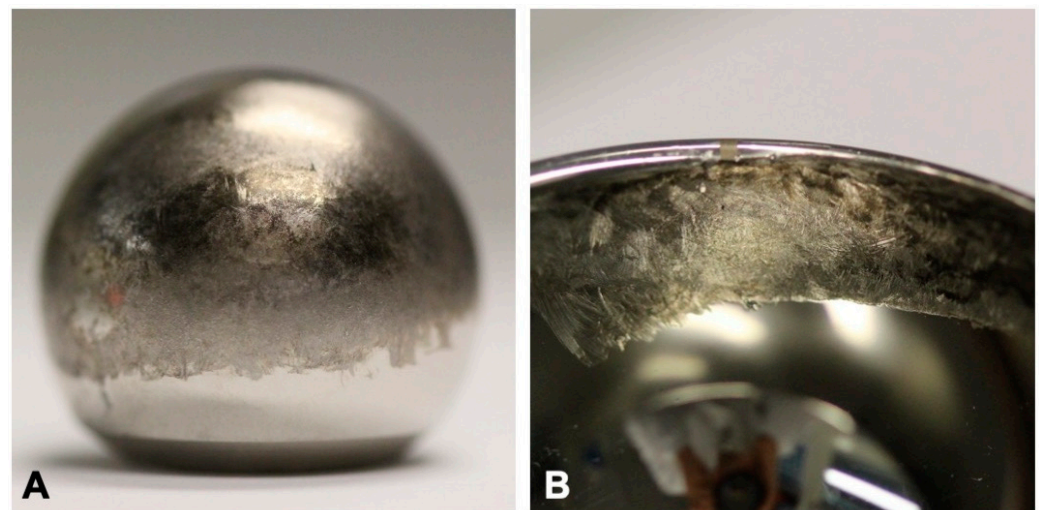
for less than 12 months and therefore represent early failures. Despite their enhanced stability, two implants (10%) failed due to dislocation or instability. This may be attributed to pre-existing patient comorbidities which increased their inherent risk of dislocation, although these details were unavailable in the present study. Additionally, two implants (10%) failed due to intra-prosthetic dislocation at 1 and 13 months following the operation. In one case, there was also clear evidence of metal-on-metal articulation between the femoral head and acetabular shell, as shown in Figure 6. Interestingly, both implants were modern DM systems with crosslinked polyethylene liners, and therefore, these results contradict the theory that new-generation DM designs have eliminated the incidence of intra-prosthetic dislocation as reported in several systematic reviews [19,25]. Due to the limited sample size in this study, it is difficult to conclude whether intra-prosthetic dislocation indeed remains a prevalent complication of DM-THRs. However, this observation highlights the importance of enhanced monitoring of these implants as their use continues to increase.

**Figure 6.** Surface damage evident of metal-on-metal articulation between the femoral head (A) and acetabular shell (B) of one component which failed due to intra-prosthetic dislocation.
