Gonçalves, M.C.C., Alsters, R., Curtis, D. et al. (2025) Analysis of tool wear in micromilling Ti6Al4V and its impact on generated surface integrity. *Wear*, 570. 205955. ISSN: 0043-1648

Analysis of tool wear in micromilling Ti6Al4V and its impact on generated surface integrity

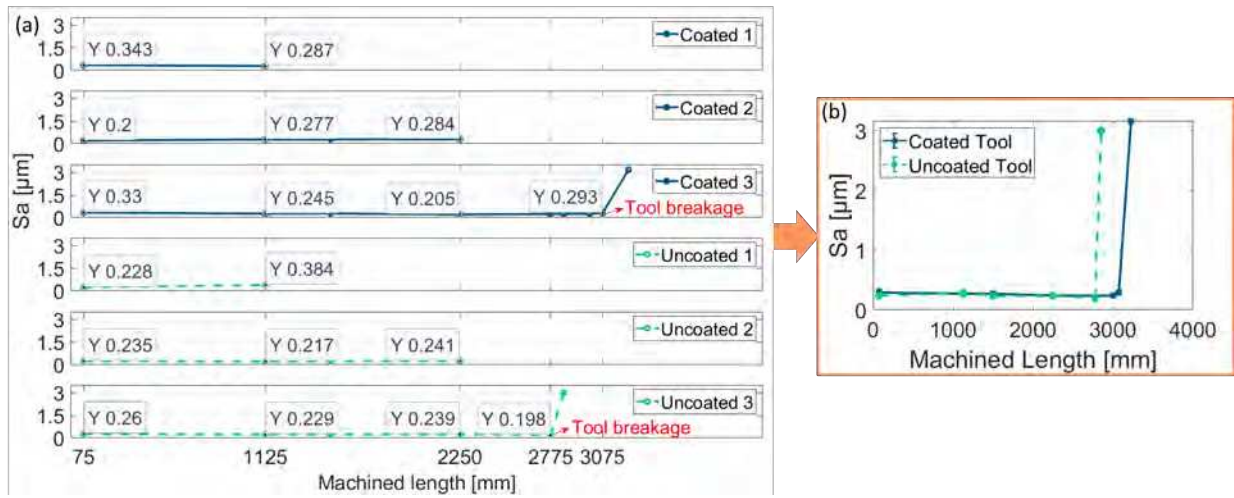
Figure 3 shows that there was no significant change in the S_a results due to tool wear up until the point that the tool broke and started rubbing against the surface, which caused the S_a values to increase to up to 3 μm . Similarly, the use of a coating had no significant impact on surface roughness in the applied machining parameters. Excluding the tool failure point, the average S_a value was 0.27 ± 0.05 μm for the coated tools and 0.25 ± 0.05 μm for the uncoated tools, indicating that tool coating results were essentially the same for both tool types. Although there was no significant change in the surface roughness for either the coated or uncoated tool up until the breakage point, the coated tool presented

Figure 3: S_a results for each experiment performed and as a comparison of the coated and uncoated tools per machined length.

a longer tool life, reaching its failure at 3075 mm machined, while the uncoated tool broke at 2775 mm machined.

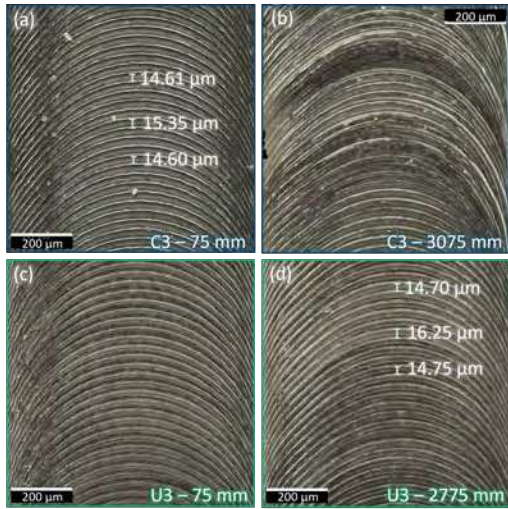
By analysing the two-dimensional images of the slots obtained in Alicona (Figure 5) it is possible to observe some small chips attached to the machined surface, and Figure 5 also shows that, as the machined length increases, the feed marks on the surface becomes slightly more asymmetrical due to tool wear. In addition, the feed mark spacing behaves as expected, at around 15 µm, matching the feed per tooth used (Figure 5).

Figure 5: Comparison of the slot surfaces at a low machined length and before the tool failure.

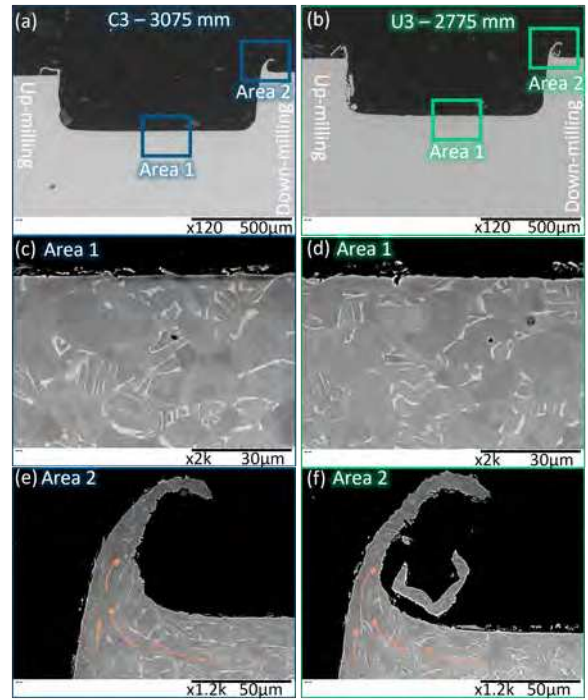
the workpiece microstructure by adjusting the imaging brightness and contrast, as shown in Figure 6. This figure presents the slot profile for both coated and uncoated tools near tool failure (Figures 6(a) and 6(b)) with highlights at the regions that were zoomed in for microstructure analyses. It is possible to see from Figures 6(c) and 6(d) that the microstructure on the bottom machined surface did not significantly differ from the bulk material (shown in Figure 2), even near tool failure. This suggests that, despite the shearing process inherently involving material dragging and plastic deformation, no signs of material dragging or plastic deformation were observed in the bottom slot subsurface microstructure. In contrast, the microstructure at the top burr shows grains distorted outward, as highlighted by the orange arrows in Figures 6(e) and 6(f), which is caused by the material near the interface being pushed or extruded away.

Figure 6: Subsurface evaluation for the coated and uncoated tools before failure.

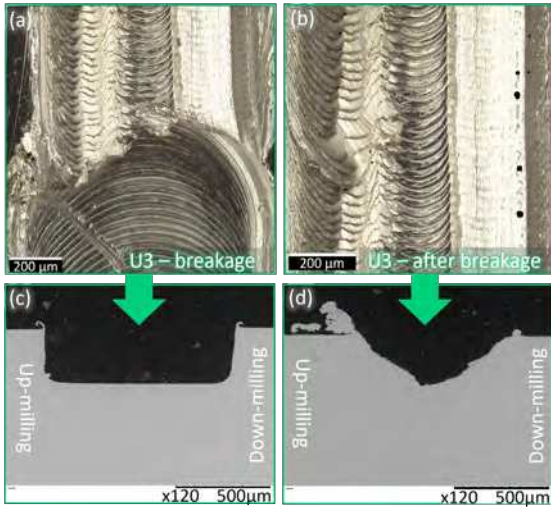
From the surface analyses presented in Section 3.1, it was possible to observe that the tool breakage occurs abruptly. The tool breakage point was particularly evident in the U3 test, as shown in Figure 7, where the top and side views of the slots are compared near tool failure and after it. Unlike what was observed in the microslot subsurface, when the broken tool rubs against the surface, the workpiece material experiences severe plastic deformation, with the formation of a heat affected zone (HAZ) and deformed grains below it (Figure 8). This deformation occurs because the friction between the broken tool and the workpiece generates significant heat, and without proper shearing, this heat leads to ex-

Figure 7: Top and side views of the slots for test U3 near and after tool catastrophic failure.

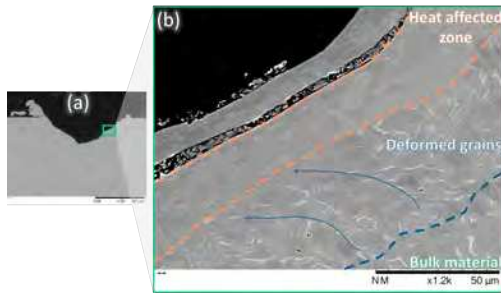
Figure 8: Subsurface microstructure of the broken slot for test U3.

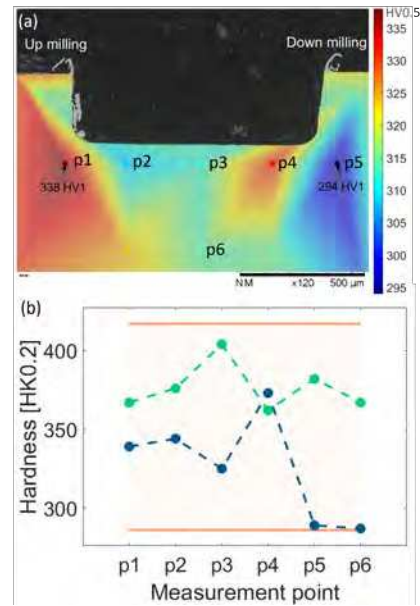
The microhardness results are presented in Figure 9. All hardness measurements were performed on the U3 experiment at the machined length of 2775 mm. The heatmap in Figure 9(a) shows the microhardness variation along the slot using a colour scale, based on the measurement points (p1–p6 in the figure) from the Vickers hardness test. The Knoop method was also applied for measuring the hardness in the slot profile, and its results can be seen in Figure 9(b). In Figure 9(b), the orange lines depict the variation in Knoop hardness of the bulk material, with the average of 346.8 ± 42.4 HK0.2 out of five measurements. It can be observed that hardness measurements from the subsurface were similar to those of the bulk material, reflecting their similar microstructures. Since no plastic deformation was observed in the slot subsurface due to the shearing process, it is expected that the hardness of the slot subsurface would be similar to that of the bulk material. The high standard deviation between measurements, observed consistently in both the bulk and slot subsurface, can be attributed to the variations in grain orientation and phase distribution within the material. This variability in hardness measurements is expected in the Ti6Al4V alloy, as it is an α - β alloy with differences in the crystal structures of each phase. Consequently,

Figure 9: Subsurface hardness measurements results: (a) Vickers hardness map including measurements points 1 to 6; and (b) Knoop results for measurements points 1 to 6.

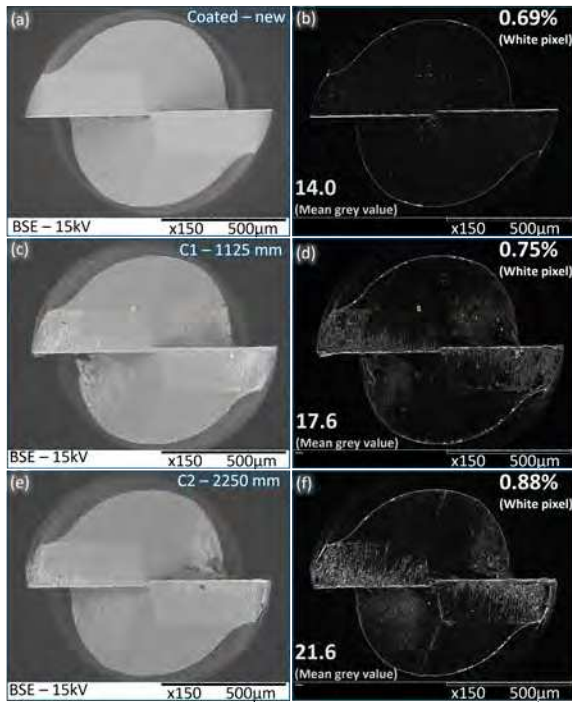
Figures 10 and 11 show the SEM images acquired for the coated and uncoated tools, respectively, and their corresponding filtered images with their white pixel percentage and mean grey value results. All conditions during SEM image acquisition were kept the same for all images, which allows for a comparison between the tools.

From Figures 10 and 11, the first evident observation is that the white pixel percentage is higher for the uncoated tool. This is due to changes in the reflection properties of the tool material without the coating. For this reason, the results can be compared between tools under the same coating conditions. When analysing the coated and uncoated tools separately, it is possible to observe that both the white pixel percentage and the mean grey value increase with tool wear in both cases, pri-

Figure 10: SEM images of the coated tools in different stages of machined length.

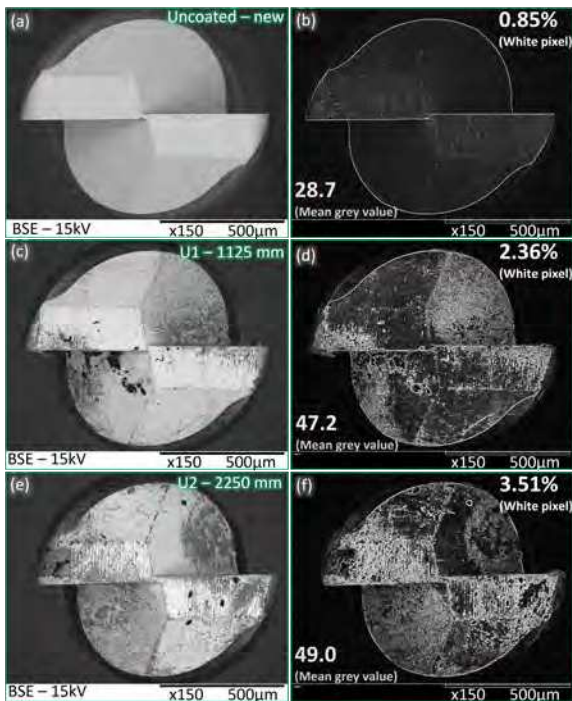
Figure 11: SEM images of the uncoated tools in different stages of machined length.

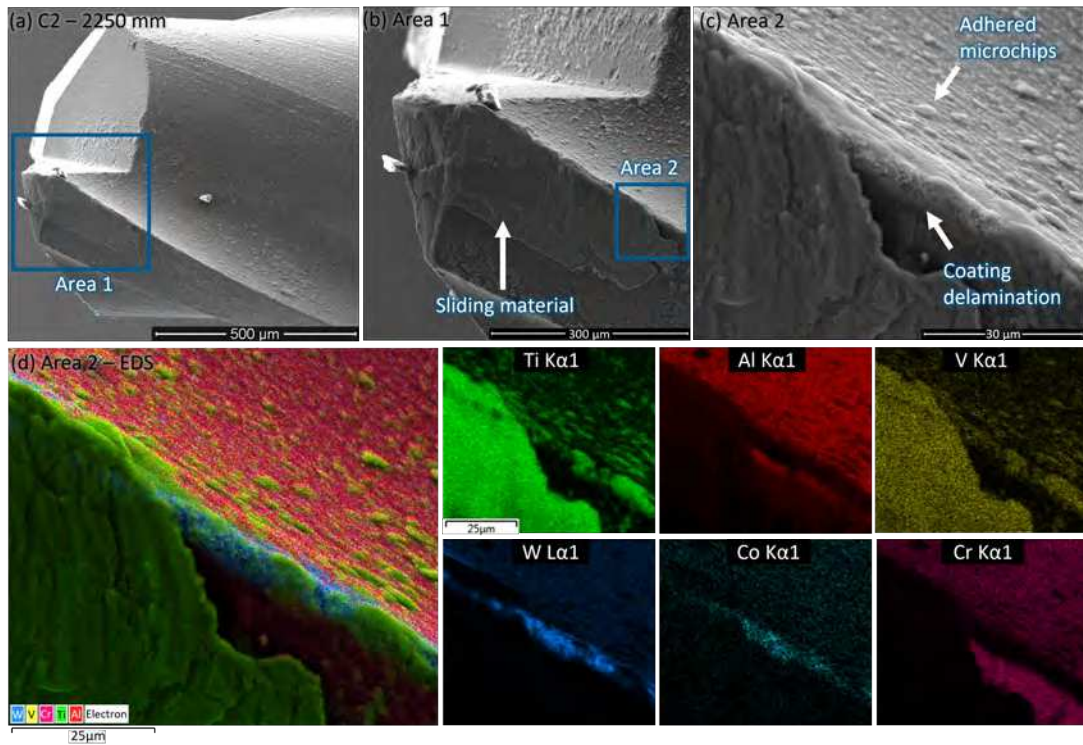
Detailed analysis of these tools in the flank face view are presented in Figures 12 and 13, showing an EDS of the cutting edge region, for the coated and uncoated tools, respectively. From the SEM images shown in Figures 12 (a), (b) and (c) it can be seen that Ti6Al4V chips and microchips are adhered along the coated tool. Also, there is a lack of coating in the edge of the tool, confirmed by the detection of the cemented carbide components (tungsten and cobalt) in the cutting edge from the EDS analysis presented in Figure 12 (d). Moreover, Figure 12 (d) shows the tool coating in red, made from Chromium and Aluminum, and adhered Ti6Al4V throughout. Similarly, Figures 13 (a), (b) and (c) show a worn uncoated tool edge near failure, where adhered material and abrasion can be observed. Figure 13 (d) presents the EDS analysis of the region near the cutting edge showing the Ti6Al4V material elements adhered to the cemented carbide tool. From these images, it can be seen that adhesive wear is predominant in both

tools, which can be addressed to a poor thermal diffusion in the tool-chip-workpiece interface. Additionally, besides material adhesion specially in the cutting edge and flank, the cutting edges of both tools did not present signs of severe degradation before its breakage point.

Figure 12: SEM images and EDS analysis of a coated tool tip at the machined length of 2250 mm.

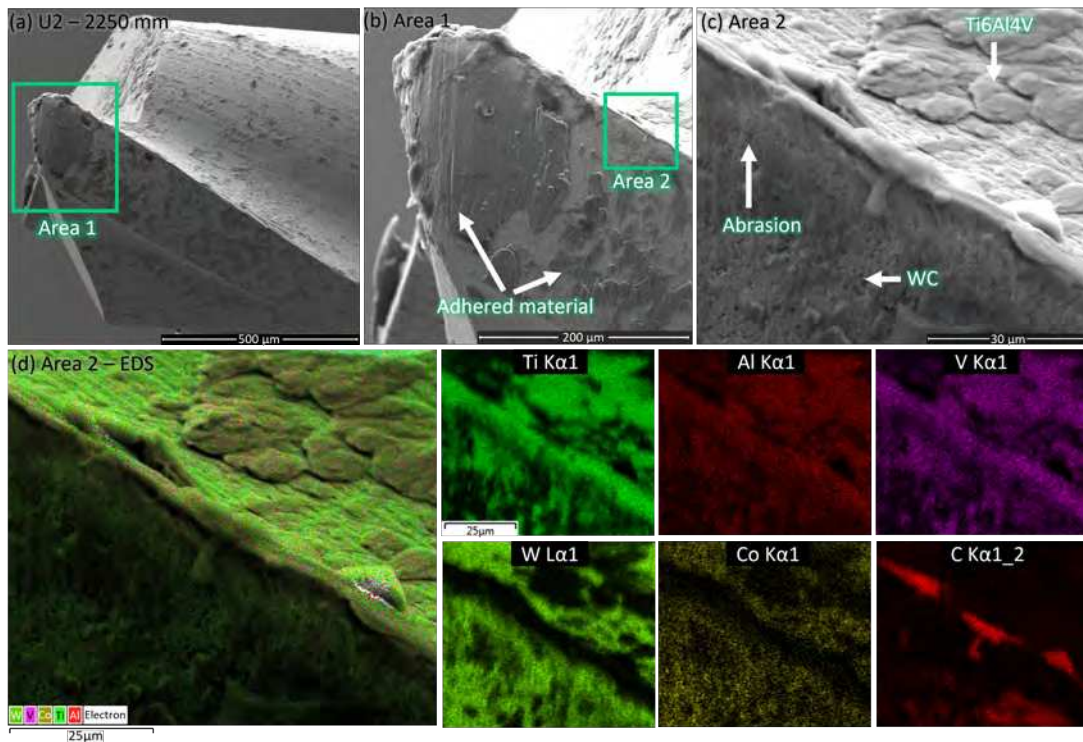
Figure 13: SEM images and EDS analysis of an uncoated tool tip at the machined length of 2250 mm.

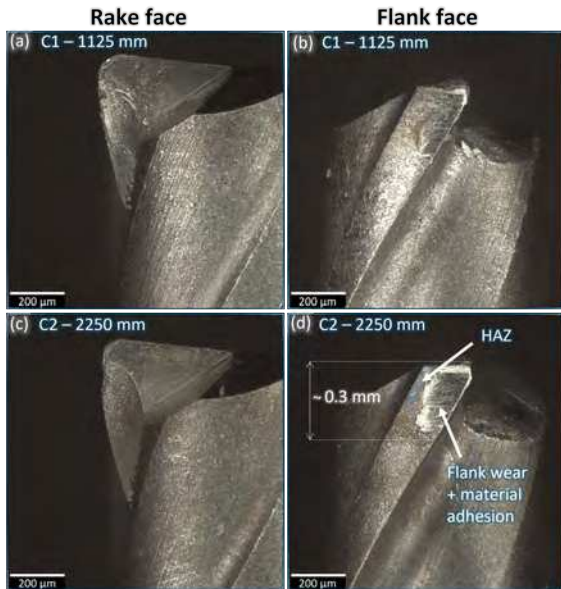
Another view of the tools is provided in Figures 14 and 15, which present the rake and flank face images of the coated and uncoated tools at different machined lengths, respectively. From the flank face view shown in Figures 14(b), 14(d), 15(b), and 15(d), it can be seen how the Ti6Al4V material smearing over the flank increases with the machined length. Besides that, HAZ and built-up edge formation were also observed on the tools, as indicated in Figures 14 and 15. When closely analysing the top view of the tools in the SEM (Figure 16), the sliding material over the flank can be observed, as indicated in the figure. The formation of BUE on the tool's cutting edge and chip formation on the primary relief face of the tool can also be observed by the perspective presented in Figure 16.

Figure 14: Rake and flank face of the coated tools in different stages of machined length.

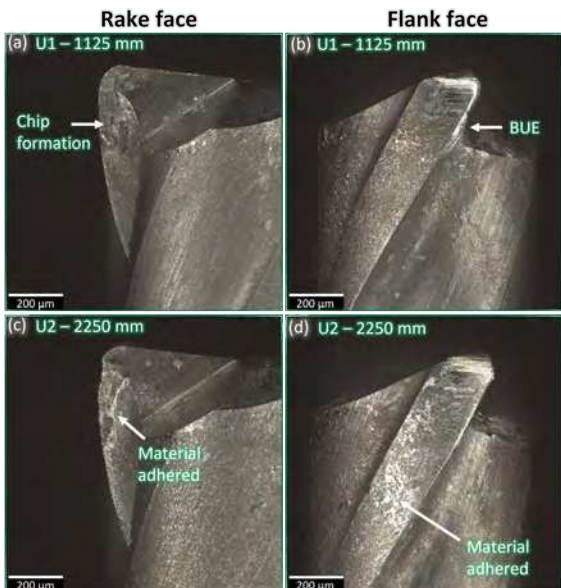
Figure 15: Rake and flank face of the uncoated tools in different stages of machined length.

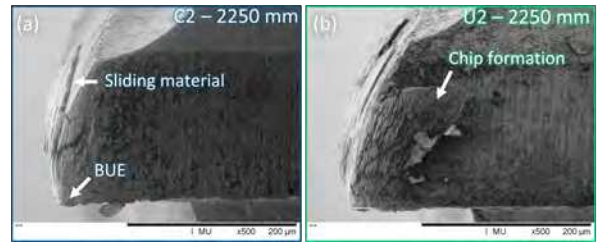
Figure 16: Close-up view of the tool tips for both coated and uncoated tools at a machined length of 2250 mm.
