Cuthill, F., Lopez Dubon, S., Vogel, C. et al. (3 more authors) (2025) Destructive testing and failure analysis of a full-scale composite tidal turbine blade. *International Marine Energy Journal*, 8 (3). pp. 279-285. ISSN: 2631-5548

# Destructive testing and failure analysis of a full-scale composite tidal turbine blade

Fergus Cuthill, Sergio Lopez Dubon, Christopher Vogel, Miguel Valdivia Camacho, Conchúr Ó Brádaigh and Eddie McCarthy

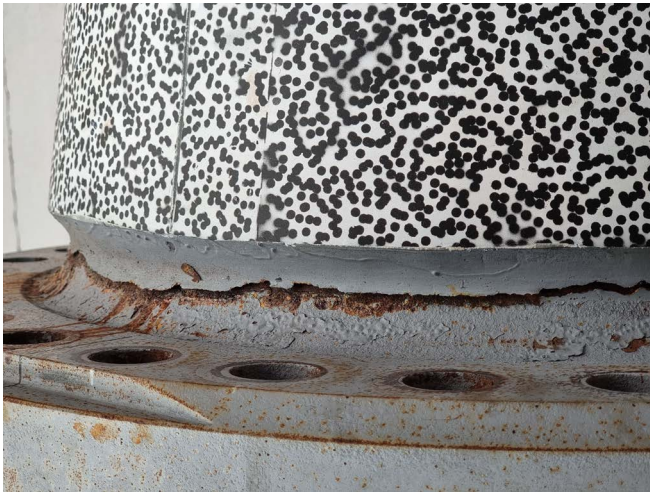
Fig. 6. Image of failed blade root showing crack from delamination extending around the circumference of root connection.

described in the timeline of blade testing above, the first detectable failure occurred at the root of the blade. The failure initially appeared as a debond between the glass fibre skin of the blade and the steel root connection, as shown in Fig 7. The failure occurred during a static test, targeting an actuator load of 220 kN at a loading rate of 1.467 kN/s; during the ramping, failure in the root occurred at 200.3 kN, with an average load drop of 5 kN on each of the 3 actuators. Nevertheless, the test was continued, as the load appeared to recover and stabilise after the initial failure; however, after a further failure at 206.2 kN, it was decided to stop the test for inspections. A graph showing the initial load drop for a single actuator can be seen in Fig 6. After the inspections identified the delamination root failure, the test was repeated, and the load of 220 kN was achieved and held for 150 seconds with no further failures detected. After this test, the decision was made to attempt to initiate a crack failure in the blade, as the first failure mode had been identified, and it was believed that pushing further would have resulted in further failures at the root with little extra information gathered about other areas of the blade.

The delamination that occurred between the steel root plug and the composite skin was the first failure mode that was detectable in the turbine blade, without artificial influence from stress holes/notching. However, this failure may have been influenced by the service and storage conditions of the blade; as can be seen in Fig 2, the root section of the blade was coated with rust after years of storage. This rust may have extended into the bonded area between the skin and the steel, resulting in reduced bond strength and the resulting failure. Rusting can be a major concern while a blade is deployed in the ocean, but regular inspection, with rust prevention techniques and coatings, may have prevented extensive rusting of this blade. After the root debond failure occurred, the blade was still capable of withstanding the design fatigue and ultimate load cases, so it is not expected that this failure would have been catastrophic for a blade in service, and it may have been repairable.

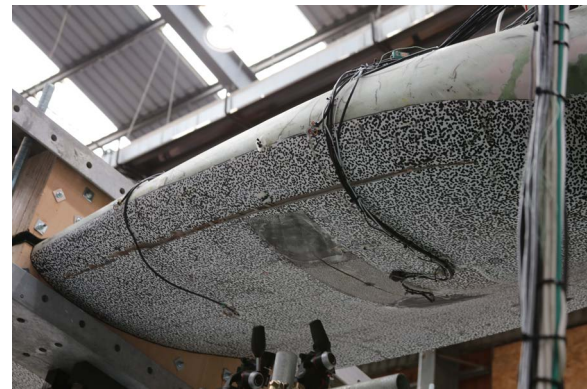
resulted in the control system increasing the oil flow required to deliver the additional displacement of the actuators. This resulted in an overshoot of the target load as seen in Fig. 9, with the test system reaching a limit state and shutting down. The seam failure near the leading edge of the blade is shown in Fig 10.

Fig. 10. Image showing blade seam failure at the overlap where the top and bottom skins of the material were bonded.

The most significant failure, relevant to the blade in service, is the debonding of the adhesive at the bond line along the leading edge of the blade. In the testing at FastBlade, however, this failure likely occurred due to the machined notch weakening the blade and altering the load path to the root as no significant strain was noted along the leading edge before the notches were cut in the blade. Manufacturing issues or debonding of the adhesive between the spar and skins could easily result in this load path through the skin being a likely failure mode for the blade. If this blade failed in this way during service, it is unlikely that any repair would be possible due to the difficulty in re-establishing a good bond between the skins and the inability to inspect or repair any bonding issues anywhere else in the blade.

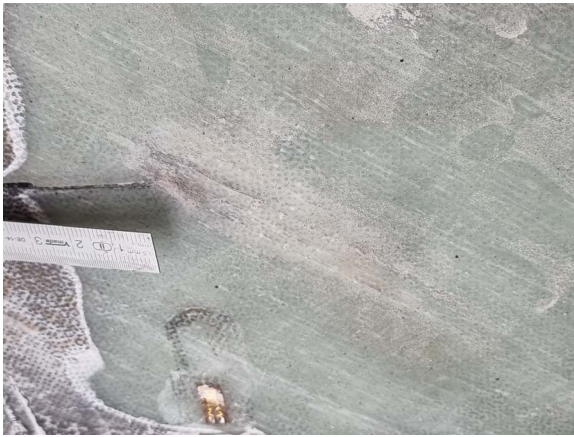
The crack propagation within the blade skin at the tip of the notches is a result of the extremely high strain levels detected, due to the stress concentration introduced during the testing. The failure in the composite surface is visible in Fig 11. It is possible that this sort of failure could propagate from areas on the blade, which already have defects such as manufacturing faults or impact damage during service. Failure, in this blade by this mechanism, however, appears to be unlikely due to the extreme nature of the notching that was required to initiate this failure. An entirely different load path through the skins was required, rather than through the carbon fibre spar, to achieve strain levels high enough to cause this failure.

Fig. 11. Visible cracking in composite surface running at 45° from the tip of the notch. Ruler and notch at image right orientated in chordwise direction.

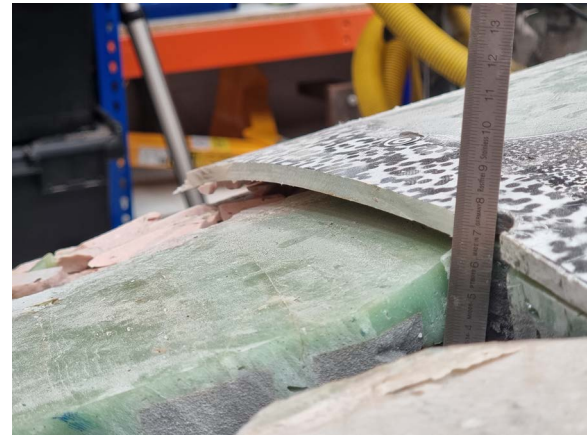
Fig. 12. Thick adhesive layers (green) averaging 10 mm thickness, showing debonding from the GFRP blade skin.

1) *Thick adhesive layers*: Thick adhesive layers, bonding the skin to ribs and spar, measured at more than 20 mm in some places and averaging over 10 mm. These layers were thicker than expected according to all the manufacturing documentation available. This may have resulted in different stiffness and performance compared to the expected GFRP and CFRP components. An image of the Spabond adhesive can be seen in Fig 12.

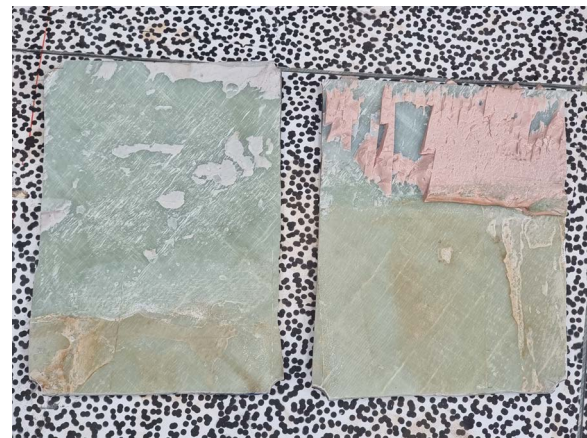
2) *Inadequate bonding between the Spabond adhesive and the skin*: As the panels of the blade were cut out for inspection, there appeared to be a very weak bond to the skin, with only a slight lever action with a pry bar causing the entire skin panel to release from the adhesive, inspecting the underside of the panel, it was clear that only about 10 % of the skin was adequately bonded to the internal structure. This can be seen in

Fig. 13. Cut away blade skin showing inadequate bonding between the blade skin and core structure.

Fig 13 where large areas of the GFRP skin panels do not show any indication of adhesive bonding.

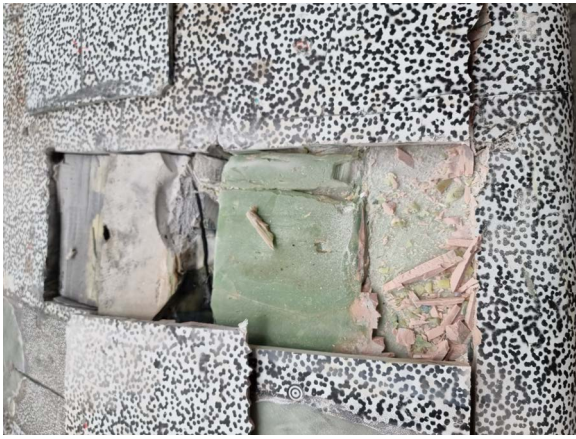
3) *Incorrect bond areas*: 3) Along the skin bond at the leading edge, the manufacturing drawings indicated a full structural bond throughout the entire overlapped area, however, when inspecting the failed edge, it was found that only approximately 50 % of the overlap was bonded, the rest appeared to be a non-structural filler. This was likely required due to issues encountered when attempting to assemble the blade but will have reduced the strength along the leading-edge bond significantly. A cutaway section of the blade from the leading edge bond to the carbon spar can be seen in Fig 14.

Fig. 14. Image showing a section of blade with the outer skin removed. From bottom to top: leading edge of blade, pink coloured filler at overlap seam, green Spabond adhesive, black carbon spar.

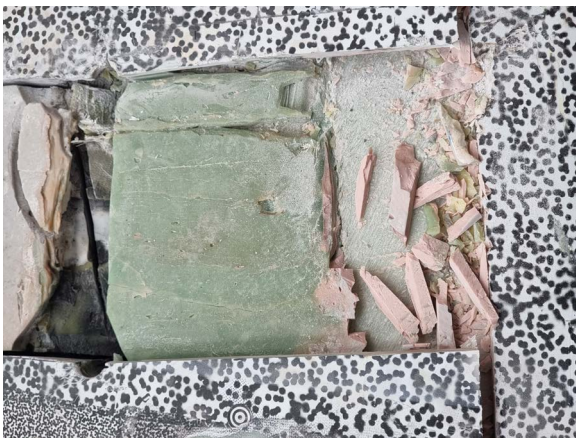
4) *Adhesive voids*: Where the adhesive is used in the blade, there are large voids where the adhesive has not fully spread to cover the area under the skin. Fig 15 shows this, where it appears that the adhesive was applied in lines, expecting the compression of the skin to spread the adhesive correctly. This likely resulted in reduced bond strength and stress concentration along the numerous additional bond edge voids.

Fig. 15. Section through blade skin showing voids in between adhesive bond lines. Adhesive thickness at this location is approximately 15 mm.
