Boyle, H. orcid.org/0000-0002-4935-6863, Norgren, S. orcid.org/0000-0003-1471-8307, Crawforth, P. orcid.org/0000-0002-1235-8494 et al. (3 more authors) (2023) Insights in  $\alpha$ -Al2O3 degradation in multilayer CVD coated carbide tools when turning IN718. In: Hanke, S., (ed.) Wear. 24th International Conference on Wear of Materials, 16-20 Apr 2023, Banff, Canada. Elsevier BV. Article no: 204786. ISSN: 0043-1648. EISSN: 1873-2577.

# Insights in $\alpha$ -Al2O3 degradation in multilayer CVD coated carbide tools when turning IN718

Henry Boyle <sup>a,\*</sup>, Susanne Norgren <sup>b,c</sup>, Pete Crawforth <sup>d</sup>, Katerina Christofidou <sup>a</sup>, Denis Boing <sup>b</sup>, Martin Jackson <sup>a</sup>

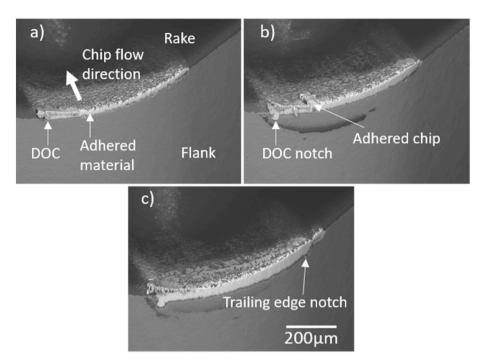
Fig. 3. BSE micrographs of tool wear developed during turning trial at each machined length a) 2 m b) 32 m c) 128 m

An example of the machining forces measured during the experiment is shown in Fig. 2. In all experiments performed the cutting force (Fc) was found to be the largest of all force components, followed by the passing force (Fp) and the feed force (Ff). The smooth gradient during the initial engagement indicates a stable entrance of the tool with no unexpected failure or abrupt wear, similarly there are no large variations during the cut either. The wear observed during the trials is shown after 2 m, 32 m and 128 m turned length in Fig. 3. After 2 m turned length, the workpiece material is adhered to the tool (Fig. 3a). By 32 m, the region covered by adhered material has increased significantly in thickness, a DOC notch and chip adhesion can also be observed (Fig. 3b). After 128 m (Fig. 3c) turned length, the thickness of the adhered material on the cutting edge has increased further. In addition, the DOC notch has continued to expand and a small trailing edge notch has started to develop (Fig. 3c).

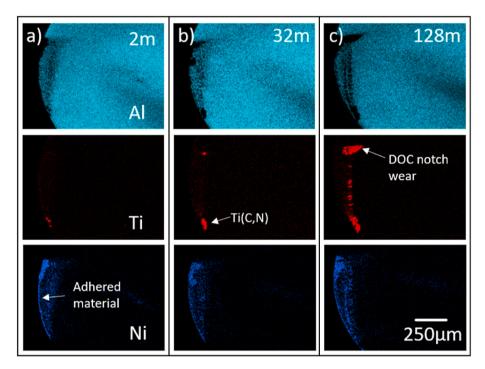
Fig. 4. X-EDS of adhered material on worn inserts for Al, Ti and Ni at different machining times a)  $2\ m$  b)  $32\ m$  c)  $128\ m$

Fig. 4 shows X-EDS mapping of the elements Al, Ti, and Ni on the damaged tools after each machined length. The Al signal indicates the alumina coating and so is the majority of the signal seen on the rake of the tool. Ni indicates adhered workpiece material, which has formed or adhered in the tool/chip contact zone. The Ti signal indicates that the Ti (C,N) layer of the coating has now been exposed as the alumina coating has been removed. Fig. 4a shows a small notch/chipped region that has formed after 2 m of turning towards the trailing edge of the tool. The wear may be concentrated in this region as the chip is at its thinnest, meaning the chip compression ratio is higher, and so more work hardening and grain refinement of the workpiece material can be expected. After 32 m (Fig. 4b), the wear in this region continues to expand as the alumina layer is removed, there is also additional exposure of the Ti(C, N) layer around the DOC notch. By 128 m, (Fig. 4c), the alumina layer has worn further in the regions previously displaying wear. Furthermore, the alumina coating wear around the DOC has become significantly enlarged and elongated. Several additional areas of alumina coating failure have also appeared towards the rear of the contact zone as the chip begins to deflect.

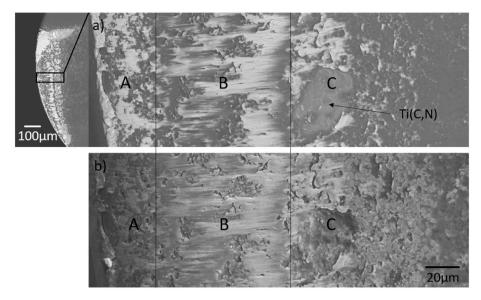
Fig. 5. BSE micrograph of worn unetched sister insert showing adhered material after a machined length of 128 m

In Fig. 5a it is revealed that the strong signals of Ti observed in Fig. 4 are areas where the alumina coating has delaminated; Fig. 5b shows the rough topography of the fractured surface that remains. Three distinct wear zones can be seen in the worn surface. Zone A is the sticking zone, an area that appears to correspond to the edge radius of the tool. Zone B

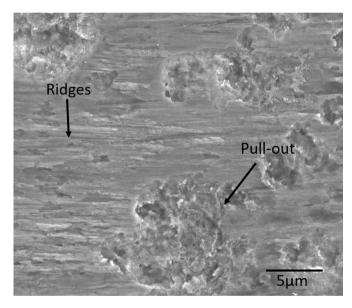
**Fig. 6.** SE micrograph showing worn surface of etched alumina after 128 m machined length in zone B.

In order to explore the wear mechanisms that alumina is subjected to it is necessary to remove the adhered material using etching techniques. The worn alumina surface of the etched sister insert in the sliding zone (zone B), after 128 m machined length, is presented in Fig. 6. The worn surface exhibits two characteristic distinct wear types: the first type is identified by ridges that have formed on the tool surface, indicative of plastic deformation in the alumina due to slip, which appears to correspond to the smeared material observed in Fig. 5. Plastic deformation of alumina has been widely reported during dry steel turning [16–18,22]. Although no temperature measurements were made during this experiment (since longitudinal turning operations do not permit the use of a thermal camera), maximum rake face temperatures in orthogonal dry Ni-based superalloy turning have been reported to be in the region of 1000 °C [27], which is comparable to those achieved during dry steel turning [28]. Therefore, the likelihood for activation of different slip systems in the alumina coating is expected to be similar. The effect of coolant on the maximum temperature remains disputed as an exact measurement of surface temperatures in the tool-chip contact zone is often not feasible. Thermal modelling suggests that a temperature decrease of between 31 and 38 °C could be expected when using an 80 bar coolant pressure supply when turning IN718 using similar processing parameters to those used in the study [29]. As such, the impact of coolant on maximum temperatures in the contact zone is considered to be minimal.

The second observable wear type shown in Fig. 6 is grain pull-out of the alumina coating. It is hypothesised that coating pull-out is largely controlled by an adhesive wear dominated mechanism that occurs when the bond formed between the alumina and workpiece material has a stronger bonding energy than the intergranular bonding energy of the alumina grains. This in contrast to the observations made during steel turning experiments in which no grain pull-out is observed in the sliding zone [16–18,22].

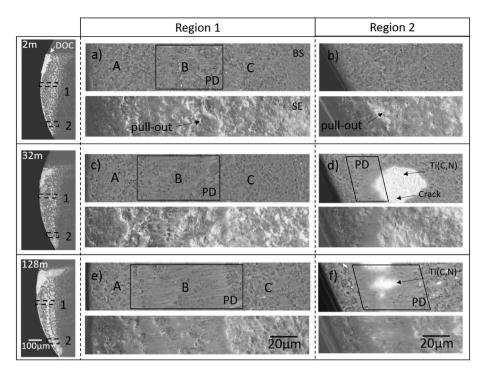
Fig. 7. SEM backscattered electron micrographs showing alumina wear unetched (BSE imaging) and etched (SE imaging) sister inserts compared at different machining times a) region 1 at 2 m b) region 2 at 2 m c) region 1 at 32 m d) region 2 at 32 m e) region 1 at 128 m f) region 2 at 128 m

Despite the short time in cut, Fig. 7a demonstrates there is evidence of plastic deformation in region 1 (shown as PD) after a machined length of 2 m, which corresponds to the sliding zone (zone B). In the area displaying plastic deformation there are also indications of coating pull-out; to the left of this region there is an area characterised solely by coating pull-out. This area corresponds to the sticking zone (zone A). Towards the right of the plastically deformed region there are further areas displaying coating pull-out, which lie within the end of contact zone (zone C). In region 2, there appears to be less evidence of plastic deformation (Fig. 7b), although some coating pull-out has occurred.

After 32 m of cutting (Fig. 7c), the plastically deformed area has expanded towards the sticking zone (zone A), potentially due to the temperature increase caused by the longer time in cut. Significant grain pull-out is also observed within the plastically deformed area, as well as to the right in the end of contact zone (zone C). In region 2 after 32 m machined length (Fig. 7d), there is a large delaminated region to the right of the plastically deformed area. The overlap between these two regions appears gradual, demonstrating further plastic deformation of the alumina layer occurred after the delamination event.

After a machined length of 128 m (Fig. 7e), the plastically deformed regions of alumina have increased both towards and away from the cutting edge. It appears as if this wear behaviour has resulted in a smoother topography. Areas exhibiting coating pull-out can be observed within the plastically deformed region, as well as in the sticking zone (zone A) and the crater zone (zone C). In region 2 (Fig. 7f), it appears as if the continued alumina wear via plastic deformation has led to the Ti (C,N) layer becoming partly exposed. This appears to be as a result of a more gradual wear than was observed in Fig. 7d, since the revealed Ti(C,

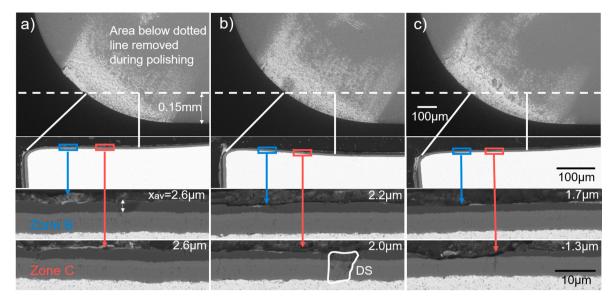
Fig. 8. Cross sections of inserts taken from plastic deformation region and pull-out region at different machining times a) 2 m b) 32 m c) 128 m

Cross sections of the worn tools were metallographically prepared to investigate variations in alumina coating thickness. This was done by polishing away approximately 0.15 mm of material (as shown in Fig. 8). Two separate 50  $\mu$ m sample regions were chosen to be representative of the sliding zone (zone B), 100–150 µm from the tool edge, and the crater zone (zone C), 200-250 µm from the tool edge; the average coating thickness (x<sub>av</sub>) is shown for each sample region. After 2 m of cutting (Fig. 8a) it can be observed that both sample regions have a similar appearance in terms of both topography and thickness. A similar observation is made after 32 m of cutting (Fig. 8b), although in zone B, a dislodged section (labelled DS) is observed whereby both the alumina and Ti(C,N) layer have been removed. This may have been caused by the propagation of CVD cooling cracks within the coating during either polishing or machining. After 128 m (Fig. 8c), a noticeable difference in the two regions is revealed, with a large section of alumina ( $\approx$ 20 µm) in zone C being completely removed and the underlying Ti(C,N) layer exposed.
