Forensic investigation of failure in a full-scale composite tidal turbine blade

Miguel A. Valdivia-Camacho ^a, Fergus Cuthill ^a, Edward D. McCarthy ^a, Sergio Lopez Dubon ^a, Conchúr M. Ó Brádaigh ^b, Parvez Alam ^a,* ^{ID}

Tidal turbine blades endure uniquely harsh, shear-dominated loads that distinguish them from wind turbines, yet their failure mechanisms remain poorly understood. In this study, we report the first full-scale failure investigation of a tidal blade made of glass fibre reinforced polymer (GFRP), carbon fibre reinforced polymer (CFRP) and cast iron. The blade was subjected to 26 static tests and 17 fatigue tests using a bespoke laboratory setup with three hydraulic actuators and saddle fixtures. Strain gauges, displacement transducers, and digital image correlation (DIC) were coupled to track local deformation and damage. Artificial defects accelerated damage progression, yielding roughly 97,000 fatigue cycles before ultimate failure. Two dominant failure modes emerged: de-bonding between the pressure skin and root connection under quasi-static loading at 216% of design load, and bondline failure between pressure and suction skins under fatigue at 119% of design

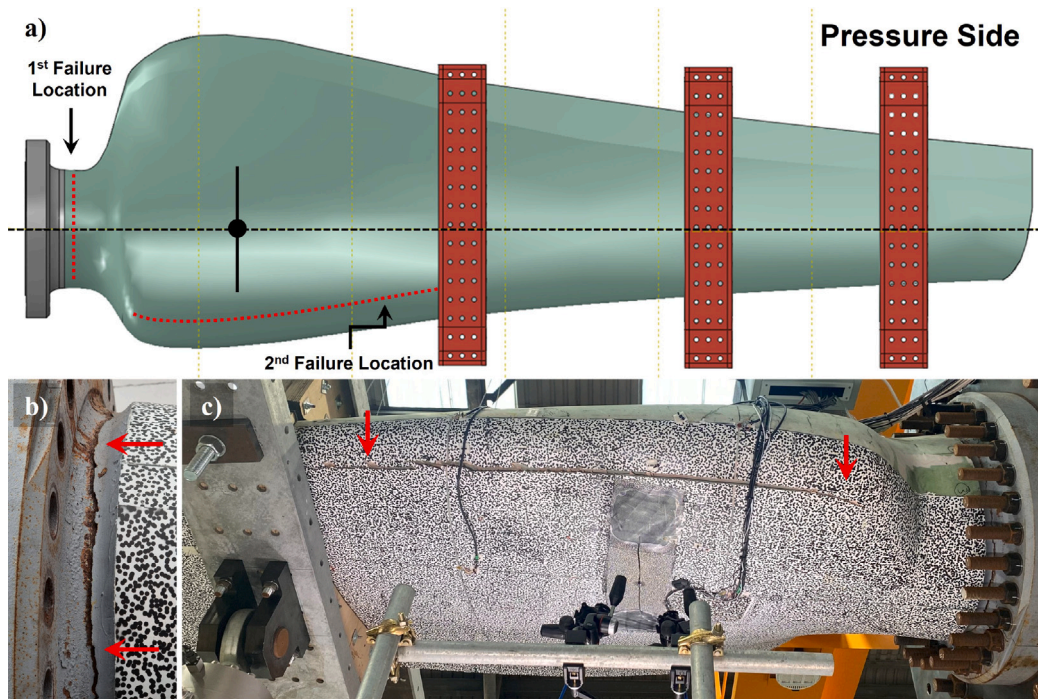
Subsequent damage was observed during failure event "B", the first to affect the blade itself. In this case, failure occurred at 617.65 kN after 327.4 s of ramp loading, despite a planned target of 660 kN. The failure was localised near the root section, as shown in Fig. 11b. This failure mode can be described as a root-skin interface debonding, confirming concerns on this adhesive joint raised in Zuo's and Hosseini-Toudeshky's studies on wind turbine blades [10,22].

Finally, failure event "C" marked the ultimate failure of the blade, after which the design load could no longer be sustained. This event occurred between static tests 24 and 25, during a fatigue test conducted slightly above the design fatigue load, with a mean actuator load of 47.5 kN and an amplitude of 27.5 kN. Fig. 11c highlights the final failure feature: pressure-suction skin interface debonding adjacent to the leading edge. Although prior studies have not reported this mode, Bir identified the leading edge as particularly vulnerable to impact in tidal blades [12], underscoring its critical role in structural integrity. Following these events, residual strength tests were conducted to quantify the degradation in stiffness. The next sections present additional analyses of the tests associated with these failure events.

Fig. 11. Diagram on the pressure side of the blade: (a) Location of both failure events; (b) First failure event; (c) Seconds and final failure event.

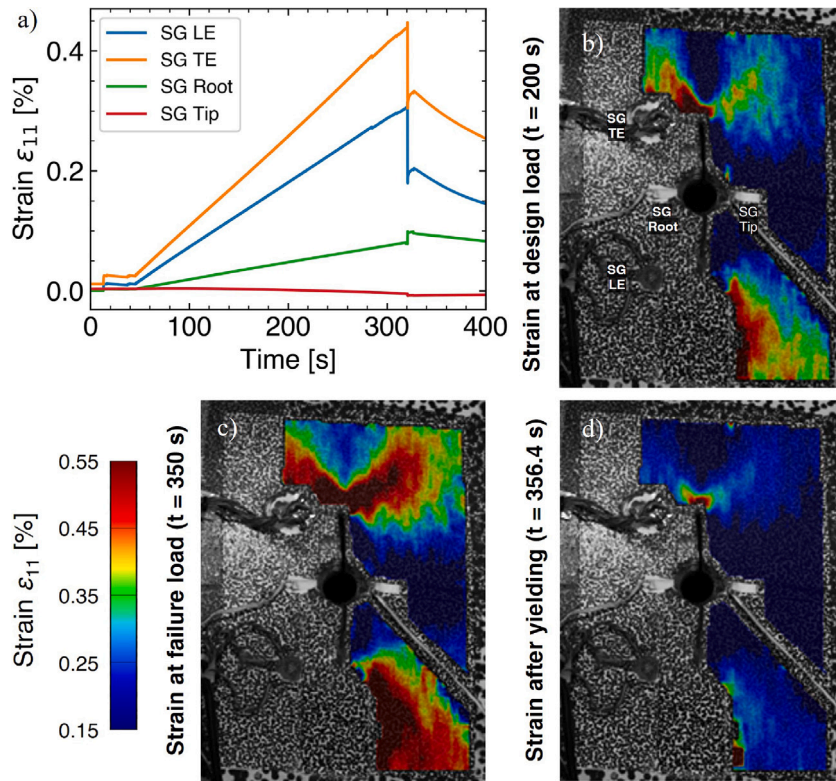
The resulting strain map from reaching the design load is shown in Fig. 16b. This distribution highlights the biaxial nature of the skin layout, with the prepreps oriented at +45 and −45 degrees. The average strain in this map is $(0.1614 \pm 0.1052)\%$, which increases in Fig. 16c to $(0.3591 \pm 0.1927)\%$ immediately before failure. Fig. 16d shows a decrease in strain surrounding the hole after the skin de-bonded from the root, even though the applied load increased by an additional 15 kN. This observation further supports the assumption that the first 1100 mm of the bottom skin stops effectively transferring load to the root, with the load now redirected through the internal components.

The hole and its notches are no longer the regions of highest stress concentration. Although the blade is designed to carry load primarily through the spar, the initial load path unexpectedly relied on the skin's bond to the root, likely due to large discontinuities between the skin and adjoining components. To address this, test case “D” introduced notches to deliberately weaken the spar box and encourage additional damage before complete skin de-bonding at the root. Moreover, the observed strain redistribution indicates a progressive shift in load path driven by damage evolution, underscoring the internal structure (ribs and spar) in sustaining load transfer even after partial skin detachment. This structural integrity can be observed in Fig. 17, where the longitudinal strain shows minor changes on top of the spar box.

Fig. 16. Hole analysis during root failure: (a) Strain gauges surrounding the hole; (b) Strain map at the design static load (283.29 kN); (c) Strain map at failure event; (d) Strain map of the structural response after failure event.

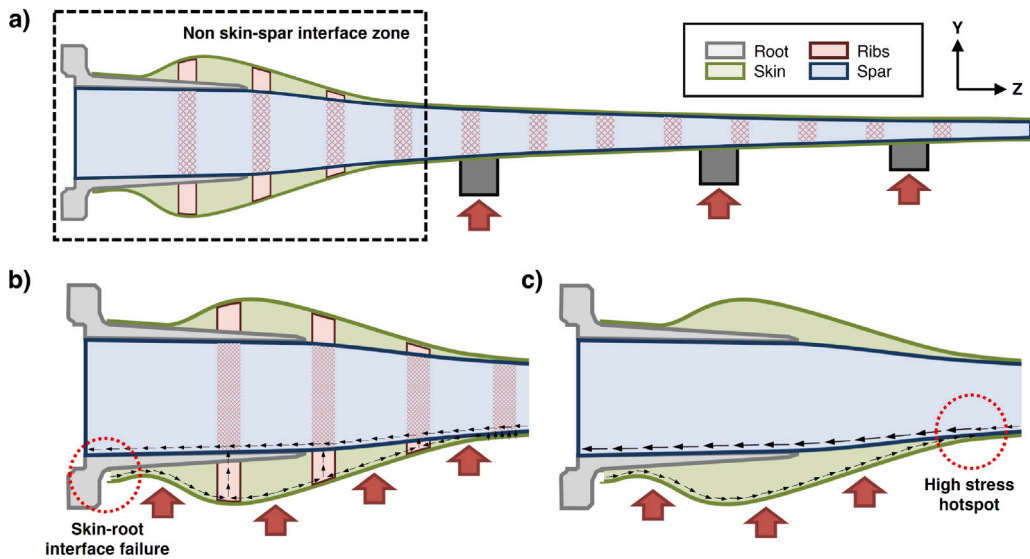
The observations translate directly to in-service blade behaviour and underscore the critical role of ribs in preserving short load-transfer paths. Fig. 18a shows a side view of the blade with its internal components. In the region close to the root, where no skin spar interface exists, the ribs alone carry the pressure load back to the root. If the skin–root interface fails, that load is rerouted to the nearest rib (Fig. 18b); without closely spaced ribs, stress concentrations form deeper along the blade where the spar and skin converge (Fig. 18c), placing excessive demand on the adhesive layer at that interface.

Fig. 18. Load routing diagram of the blade and its internal components: (a) Side view illustrating saddle load application; (b) Operational load path after skin-root debonding with closely spaced ribs; (c) Operational load path after skin-root debonding when ribs are absent.

Building on these insights, our study recommends a tidal specific optimisation that reflects shear dominated loading and the absence of a skin spar bond in the proximal region. The priority variables are rib spacing that could be denser near the root, geometry transitions, and regions without a skin spar interface; a variable rib thickness; rib material and lay up selection, including hybrid laminates; and rib flange length and bond detailing to control peel and shear at the skin and spar interfaces. We also recommend quality controls to minimise voids at rib to skin and rib to spar bonds.

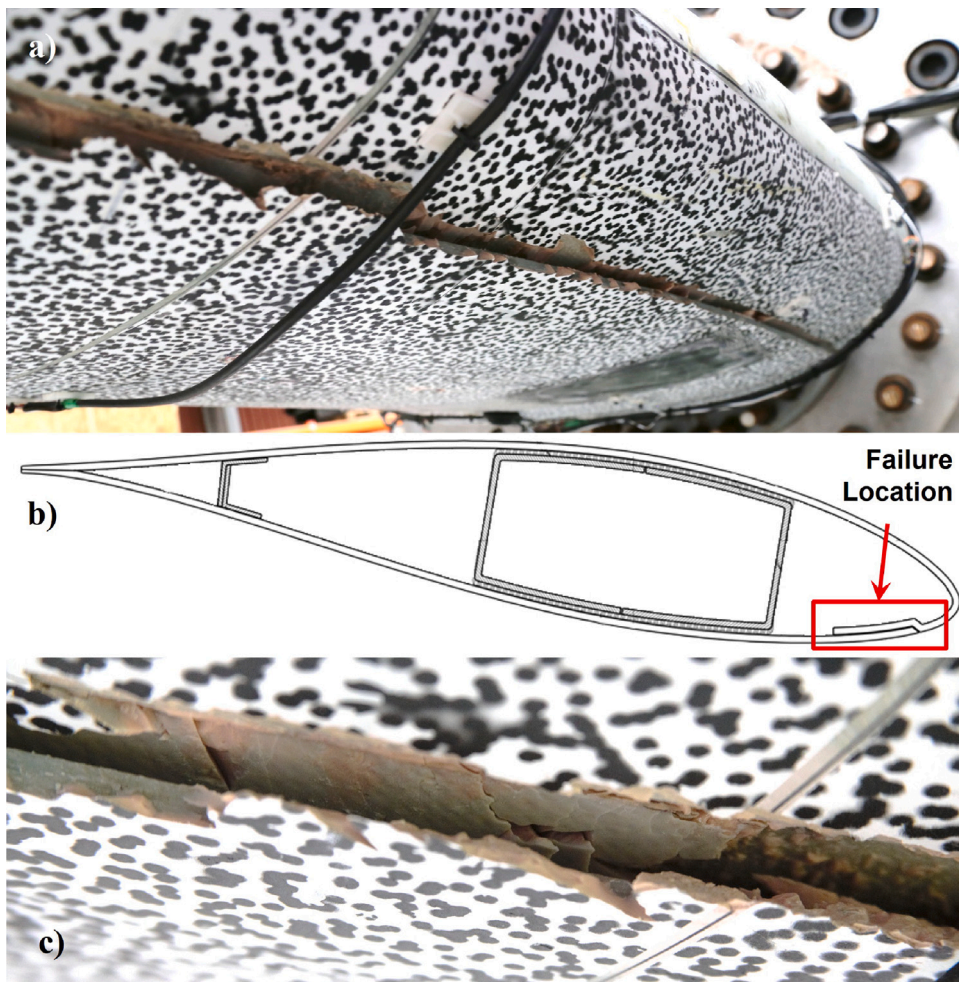
The final failure event shown in Fig. 19a occurred under test case “D” conditions, with a highly weakened spar box. The length of each notch extended past the location of the shear webs, effectively creating vertical notches on these components, each with a length of 100 mm. Surface micro-cracks were observed propagating in the +45 and -45 degree directions from both crack tips on the skin surface. Strain gauges also started to show a slow increase in their readings, but further inspection of the blade revealed no visible signs of major damage.

The failure feature initiated at the complex geometry transition from the circular root to the largest airfoil, matching Zuo’s observations of interface debonding locations under high shear [22]. Although this location lies closer to the leading edge region noted by Bir [12], the debonding occurred on the pressure side rather than the suction side reported by Lee and Overgaard [25,26], likely due to the artificial damage (drilled hole and notches) being introduced there. The large drop of load bearing capacity in the sparbox makes it unclear whether damage would have arisen naturally at this site without a considerable level of manufacturing defects.

Fig. 19. Final blade failure: (a) General view; (b) Failure feature in a section view diagram; (c) Detailed view along the skin seam of the blade.

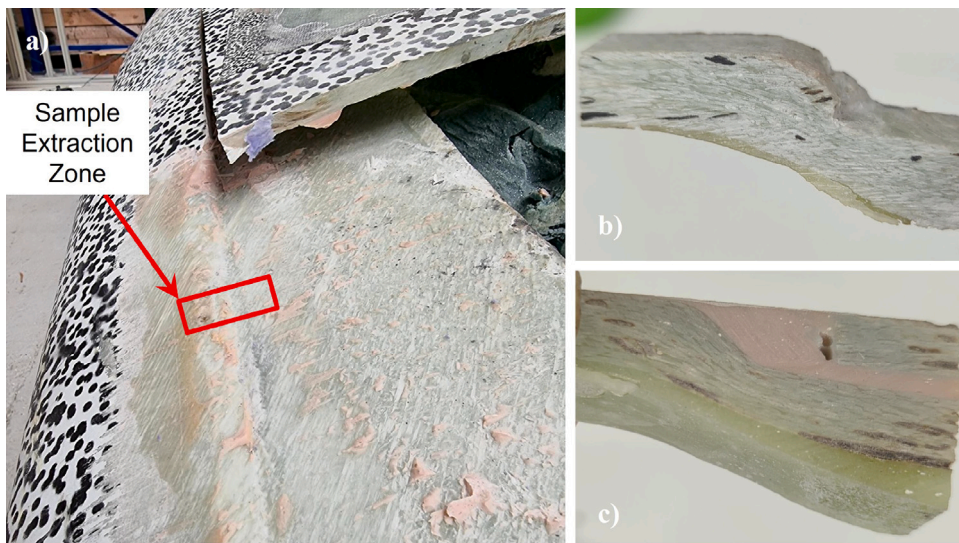
Fig. 25. Sample extraction at skin seam, (a) Full failure location extraction location; (b) Sample extracted at failure location; (c) Sample extracted at undamaged location.

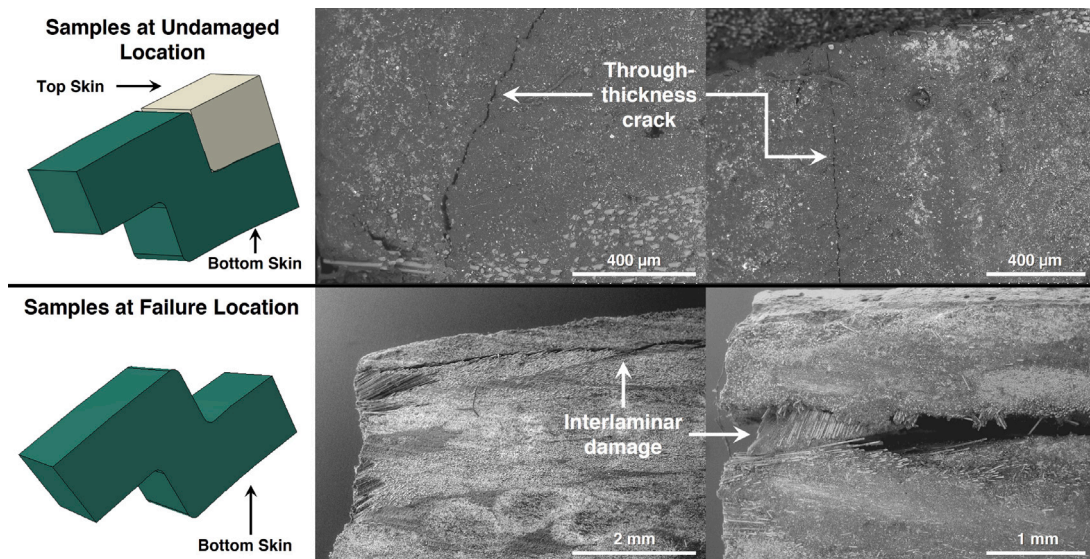
Fig. 26. Microscope images from different samples extracted at the skin seam along the blade.

present in the first ply of each sample, agreeing with near-surface delamination caused by buckling in [18]. It could be assumed that delamination was caused by buckling, rather than developing independently during the fatigue tests. This further emphasises that the bond between the plies is stronger than the adhesive holding the components together, making the bonding material one of the most critical components of the blade's structure.

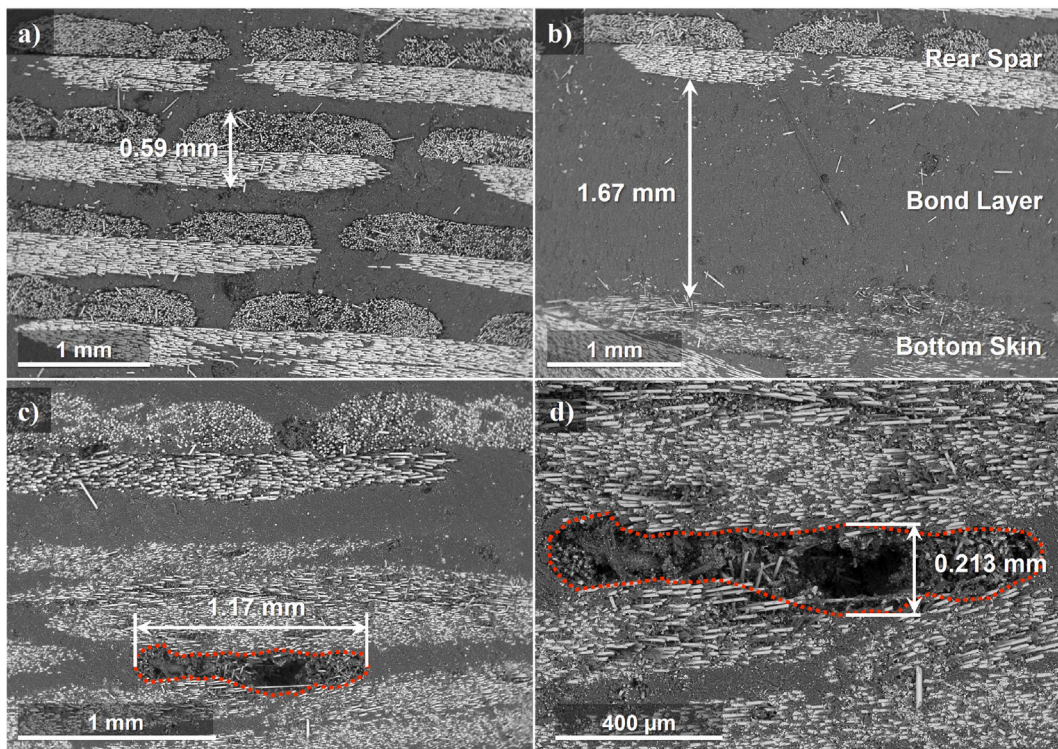
As mentioned in the previous section, the rear spar began to take a considerable portion of the load after the bond line had failed. For this reason, three cylindrical samples were taken at evenly spaced locations along the length of the blade and 200 mm from the trailing edge. Fig. 27a shows a microscope image of the GFRP plies laid up in the rear spar. In all the samples, the rear spar plies exhibited no signs of interlaminar or intralaminar damage. It was observed that the thickness of the bond layer between the skin and the spar is relatively large compared to these components, with Fig. 27b showing one of the samples where the bond layer is twice the thickness of one of the skin plies. This increased thickness raises the likelihood of large voids if not properly cured during the blade's assembly, which was observed at various locations across the blade. Smaller voids were found throughout the thickness of both the rear spar layup and the skin layup. The dimensions of one such void are shown in Figs. 27c and 27d, where at its thickest point, it accounts for 31% of the GFRP ply cured thickness.

Fig. 27. Microscope images from the trailing edge section: (a) undamaged individual biaxial GFRP plies in the rear spar; (b) interface zone between the bottom skin and the rear spar; (c) manufacturing defects in the bottom skin; (d) void between individual GFRP plies.
