Valdivia-Camacho, M.A., Cuthill, F., McCarthy, E.D. et al. (2025) Forensic investigation of failure in a full-scale composite tidal turbine blade. *Engineering Failure Analysis*, 182, Part B. 110076. ISSN: 1350-6307

Forensic investigation of failure in a full-scale composite tidal turbine blade

This study tested a 5.25 m composite blade that was part of a 500 kW DeepGen tidal turbine deployed in Orkney, UK in 2010, as seen in Fig. 1a. Only one full scale blade was tested, reflecting both access constraints from the lending organisation and the substantial time and resource demands of a full failure campaign. The manufacture of a full scale blade can cost hundreds of thousands, making destructive testing economically demanding. Information regarding its design, internal structure, manufacturing process, and material properties was limited by the involved companies. However, the material systems and assembly procedures are representative of tidal blades, as this design drew on proven wind industry materials at the time of manufacture. The outer geometry of the blade was mapped using a 3D scan and several NACA 62XXX profiles were matched accordingly. Fig. 1b shows a top view of the

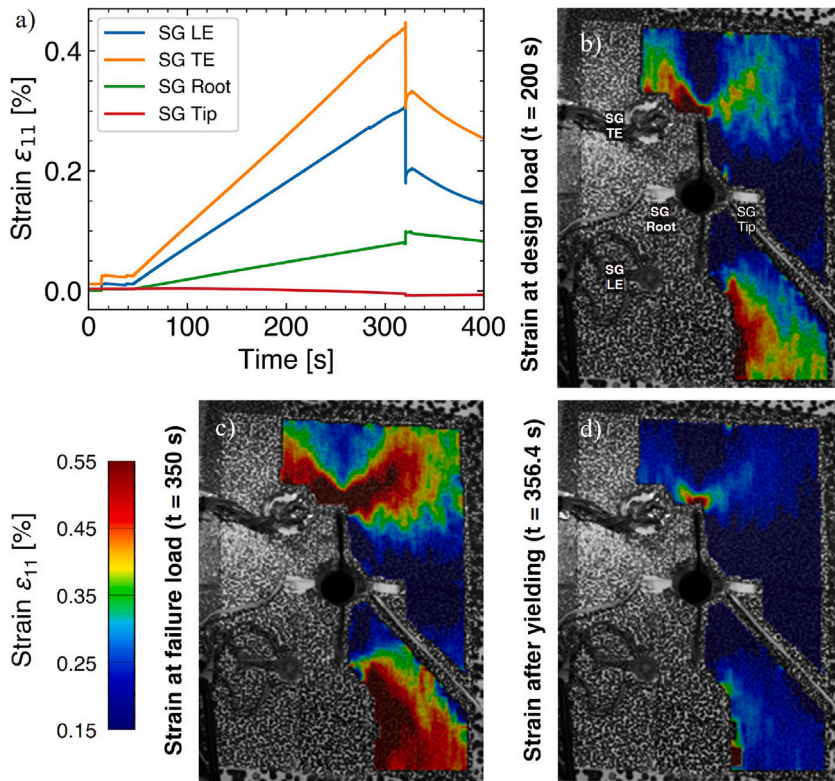
The resulting strain map from reaching the design load is shown in Fig. 16b. This distribution highlights the biaxial nature of the skin layout, with the prepregs oriented at +45 and -45 degrees. The average strain in this map is $(0.1614 \pm 0.1052)\%$, which increases in Fig. 16c to $(0.3591 \pm 0.1927)\%$ immediately before failure. Fig. 16d shows a decrease in strain surrounding the hole after the skin de-bonded from the root, even though the applied load increased by an additional 15 kN. This observation further supports the assumption that the first 1100 mm of the bottom skin stops effectively transferring load to the root, with the load now redirected through the internal components.

The hole and its notches are no longer the regions of highest stress concentration. Although the blade is designed to carry load primarily through the spar, the initial load path unexpectedly relied on the skin's bond to the root, likely due to large discontinuities between the skin and adjoining components. To address this, test case "D" introduced notches to deliberately weaken the spar box and encourage additional damage before complete skin de-bonding at the root. Moreover, the observed strain redistribution indicates a progressive shift in load path driven by damage evolution, underscoring the internal structure (ribs and spar) in sustaining load transfer even after partial skin detachment. This structural integrity can be observed in Fig. 17, where the longitudinal strain shows minor changes on top of the spar box.

Fig. 16. Hole analysis during root failure: (a) Strain gauges surrounding the hole; (b) Strain map at the design static load (283.29 kN); (c) Strain map at failure event; (d) Strain map of the structural response after failure event.

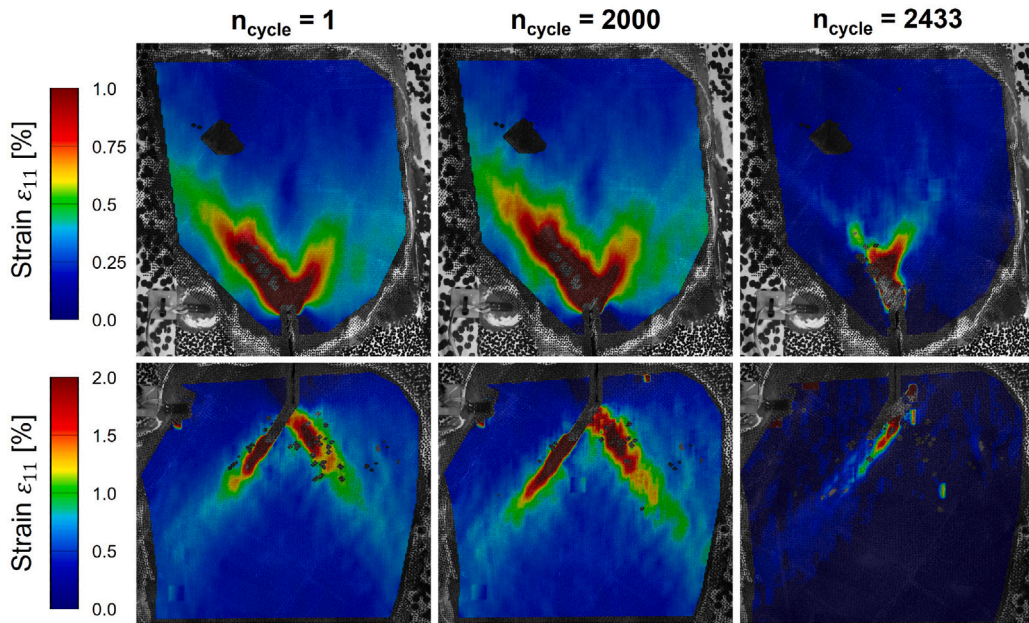
The DIC analysis of this fatigue test focused on the regions of interest surrounding the notch tips. Fig. 22 presents a direct comparison of these high-stress zones between the first cycle and the cycles close to the failure event. It was observed that cracks continued to grow from the notch tips in both the +45 and -45 degree directions, propagating along the fibres and exhibiting significant matrix cracking. The notch closer to the trailing edge exhibited a higher number of micro-cracks than the notch near the leading edge. This observation is corroborated in the first cycle, where the trailing edge notch region showed an average strain of $(0.375 \pm 0.335)\%$, which is lower than the average strain of $(0.539 \pm 0.321)\%$ in the leading edge notch region. This difference

shifted during the course of the fatigue test, as the statistics indicated a higher average strain of $(0.421 \pm 0.401)\%$ in the trailing edge notch region compared to the leading edge region, which showed $(0.194 \pm 0.145)\%$. Finally, after the blade failure, the DIC analysis revealed that the leading edge notch transitioned into a shadow-stress zone, with the average strain in that region dropping to $(-0.028 \pm 4.131)\%$, exhibiting a high standard deviation that suggests rigid body motion was considered as strain. In contrast, the region surrounding the trailing edge notch largely remained above 0.1% strain.

Fig. 22. DIC strain maps surrounding the hole notch close to the trailing edge (top) and close to the leading edge (bottom), at different cycles during the last fatigue test.

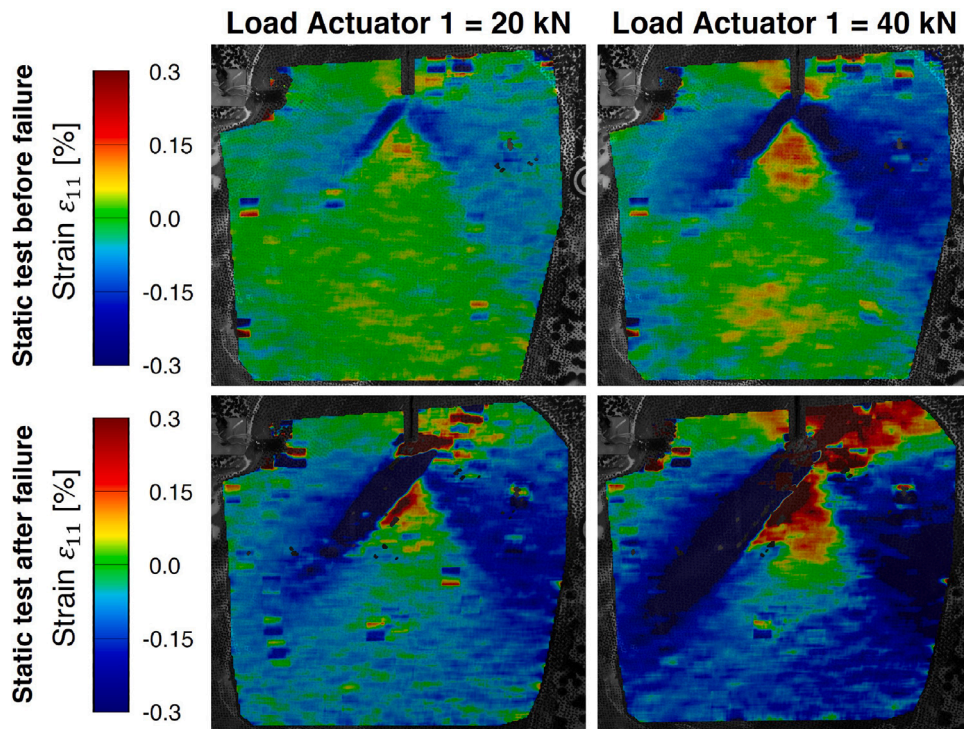
Fig. 24. DIC comparison of the region close to the leading edge notch between static tests before and after the fatigue test where final failure occurred.

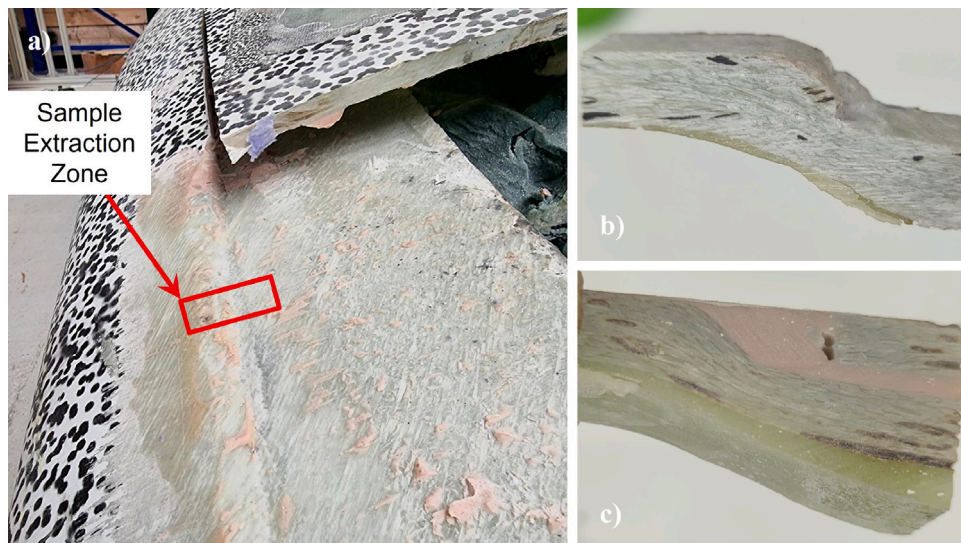
Fig. 25. Sample extraction at skin seam, (a) Full failure location extraction location; (b) Sample extracted at failure location; (c) Sample extracted at undamaged location.

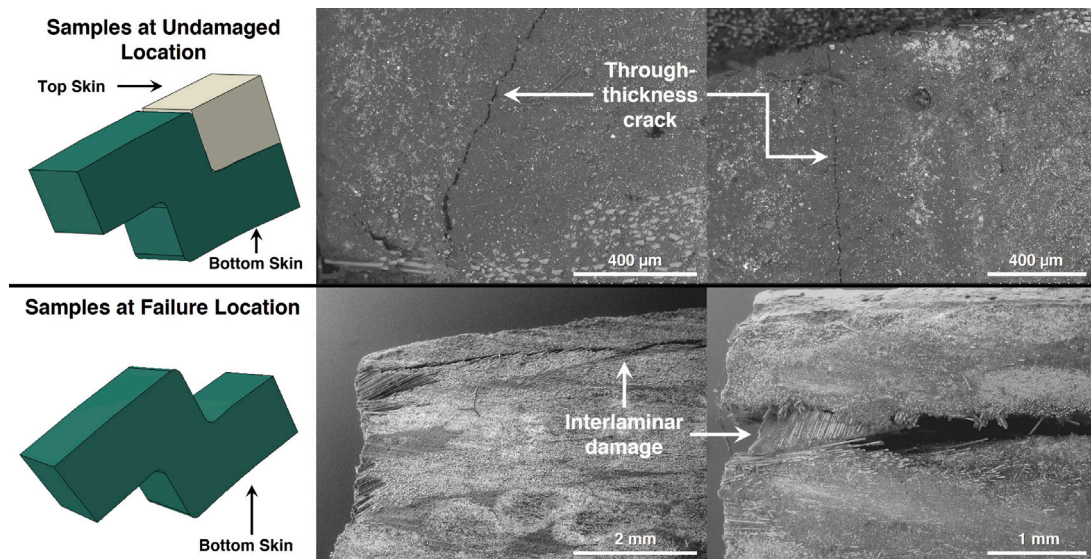
Fig. 26. Microscope images from different samples extracted at the skin seam along the blade.

present in the first ply of each sample, agreeing with near-surface delamination caused by buckling in [18]. It could be assumed that delamination was caused by buckling, rather than developing independently during the fatigue tests. This further emphasises that the bond between the plies is stronger than the adhesive holding the components together, making the bonding material one of the most critical components of the blade's structure.

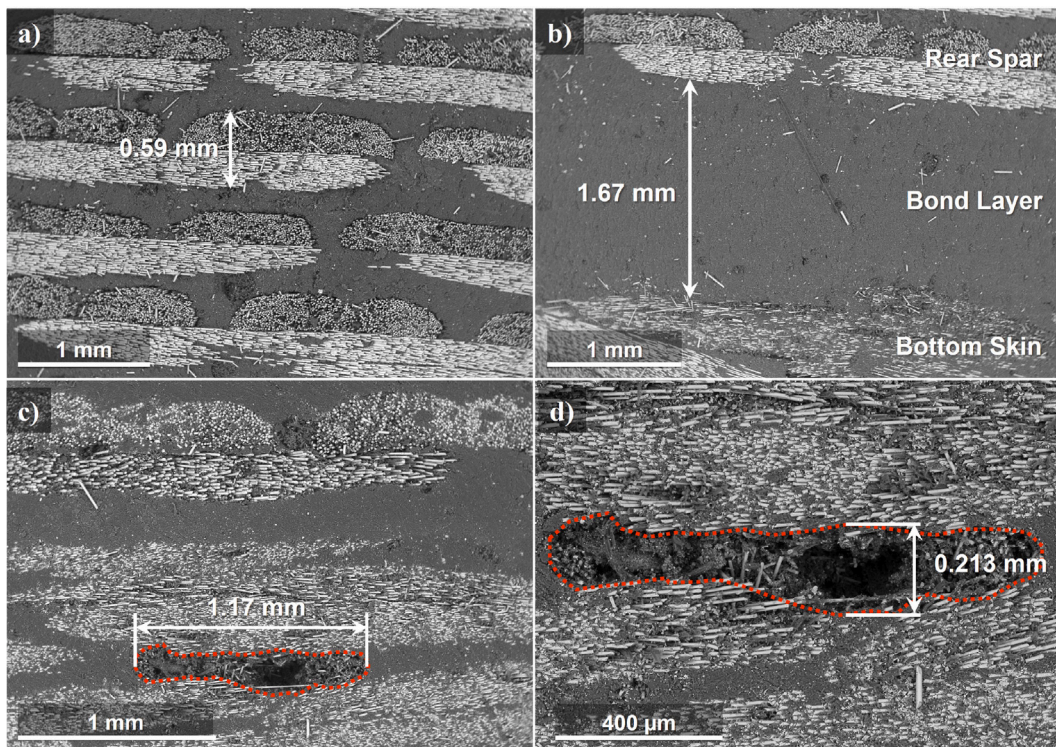
As mentioned in the previous section, the rear spar began to take a considerable portion of the load after the bond line had failed. For this reason, three cylindrical samples were taken at evenly spaced locations along the length of the blade and 200 mm from the trailing edge. Fig. 27a shows a microscope image of the GFRP plies laid up in the rear spar. In all the samples, the rear spar plies exhibited no signs of interlaminar or intralaminar damage. It was observed that the thickness of the bond layer between the skin and the spar is relatively large compared to these components, with Fig. 27b showing one of the samples where the bond layer is twice the thickness of one of the skin plies. This increased thickness raises the likelihood of large voids if not properly cured during the blade's assembly, which was observed at various locations across the blade. Smaller voids were found throughout the thickness of both the rear spar layup and the skin layup. The dimensions of one such void are shown in Figs. 27c and 27d, where at its thickest point, it accounts for 31% of the GFRP ply cured thickness.

Fig. 27. Microscope images from the trailing edge section: (a) undamaged individual biaxial GFRP plies in the rear spar; (b) interface zone between the bottom skin and the rear spar; (c) manufacturing defects in the bottom skin; (d) void between individual GFRP plies.

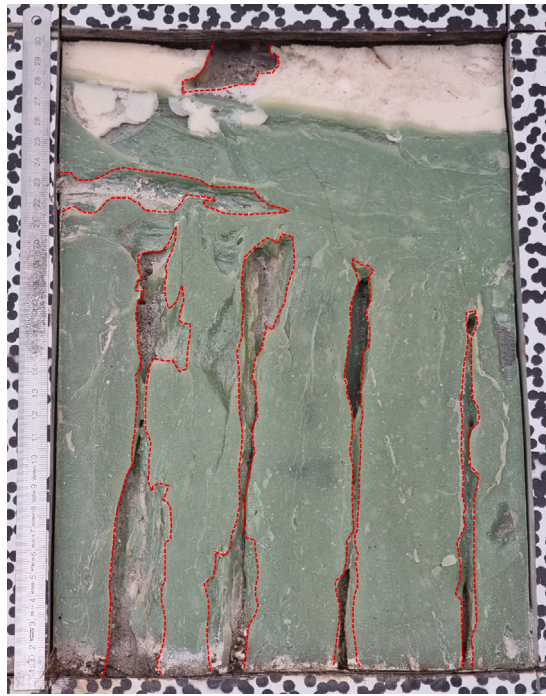
Prior work highlights adhesives as a critical concern for blade reliability, especially in the later years of service life. Voids arising from fast cure schedules and non-uniform heat distribution can accelerate adhesive fatigue [51]. Reviews of thin and thick composite joints show there is no single criterion for selecting bondline thickness because it depends on the adherend materials and their surface preparation [52]. For thicknesses above about 3 mm, damage mechanisms are less well understood since a plastic zone ahead of the crack tip can dominate crack growth; fillet joints can even fail differently across their width, with one side showing cohesive adhesive failure and the other side delaminating the CFRP [53]. Thickness also trades fracture toughness against shear response: increasing thickness may raise fracture toughness but can reduce shear stiffness and strength [54]. Architected joints with crack arrest features can improve damage tolerance, although these results are mainly for mode I loading [55]. Our tidal blade interfaces are governed primarily by mode II and mode III shear, and studies on single lap aluminium–epoxy joints report decreasing strength with increasing adhesive thickness under mode II conditions [56].

Fig. 28. Adhesive voids (highlighted with a red dashed line) in the interface between the filling foam and the skin layup.
