Formation Mechanism of Subsurface White Etching Area and White Etching Crack of Failed Bearings in Wind Turbine Gearbox

R. Dai and H. Long*

Bearings of some wind turbine (WT) gearboxes experienced premature failures due to bearing steel microstructural damage under rolling contact fatigue (RCF). However, the formation mechanism of the microstructural damage and its progression to the final bearing failure is still being debated. In this study, subsurface damage sustained in two bearing raceways of a failed gearbox from a field-operated WT is investigated. The study provides evidence of damage initiation and progression from non-metallic inclusions in the subsurface by using actually failed WT bearings as a case study. Damage characterisation has found various microstructural damage in the raceway subsurface including non-metallic inclusions, butterfly wing cracks, White Etching Areas (WEAs), and White Etching Crack (WECs). Complex interactions between cyclic rolling contact loading with inclusions and cracks are observed. Their roles in the formation of butterfly wing cracks, WEAs and WECs in the raceway subsurface are evaluated. It has been found that the butterfly wing cracks i

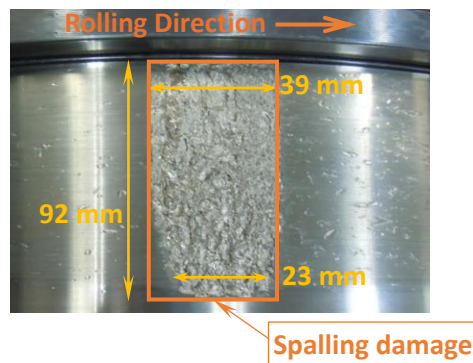
in Appendix Table A.1. Fig. 1 shows the failed inner raceway of the upwind and downwind planetary bearings of the gearbox, respectively. The damaged surface with spalling area and indenting area can be seen clearly on the raceway surface. Each raceway has a concentrated damage area, caused by the fixed loading zone of the raceway, as illustrated in Fig. 1a. For the planetary stage of the WT gearbox, the upwind bearing is located on the rotor side of the gearbox, facing the wind, and the downwind bearing is positioned next to the upwind bearing but on the higher speed side of the gearbox. The upwind bearing raceway in Fig. 1b shows severe spalling damage than that of the downwind bearing raceway in Fig. 1c. This is due to the different levels of the radial load acting on each bearing. It is known that in the WT gearbox the upwind planetary bearing normally undertook 40% to 60% more loads than the downwind bearing [36, 37]. Accordingly, the upwind bearing raceway shows a relatively larger area of surface spalling.

b Damaged raceway of upwind bearing

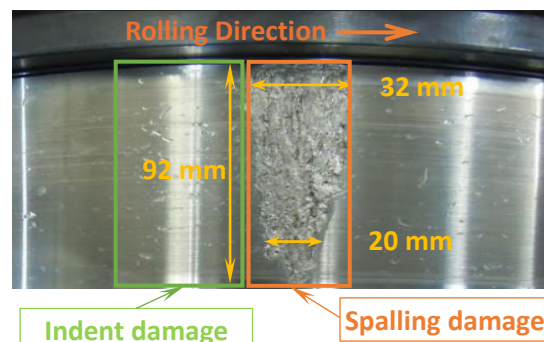
c Damaged raceway of downwind bearing

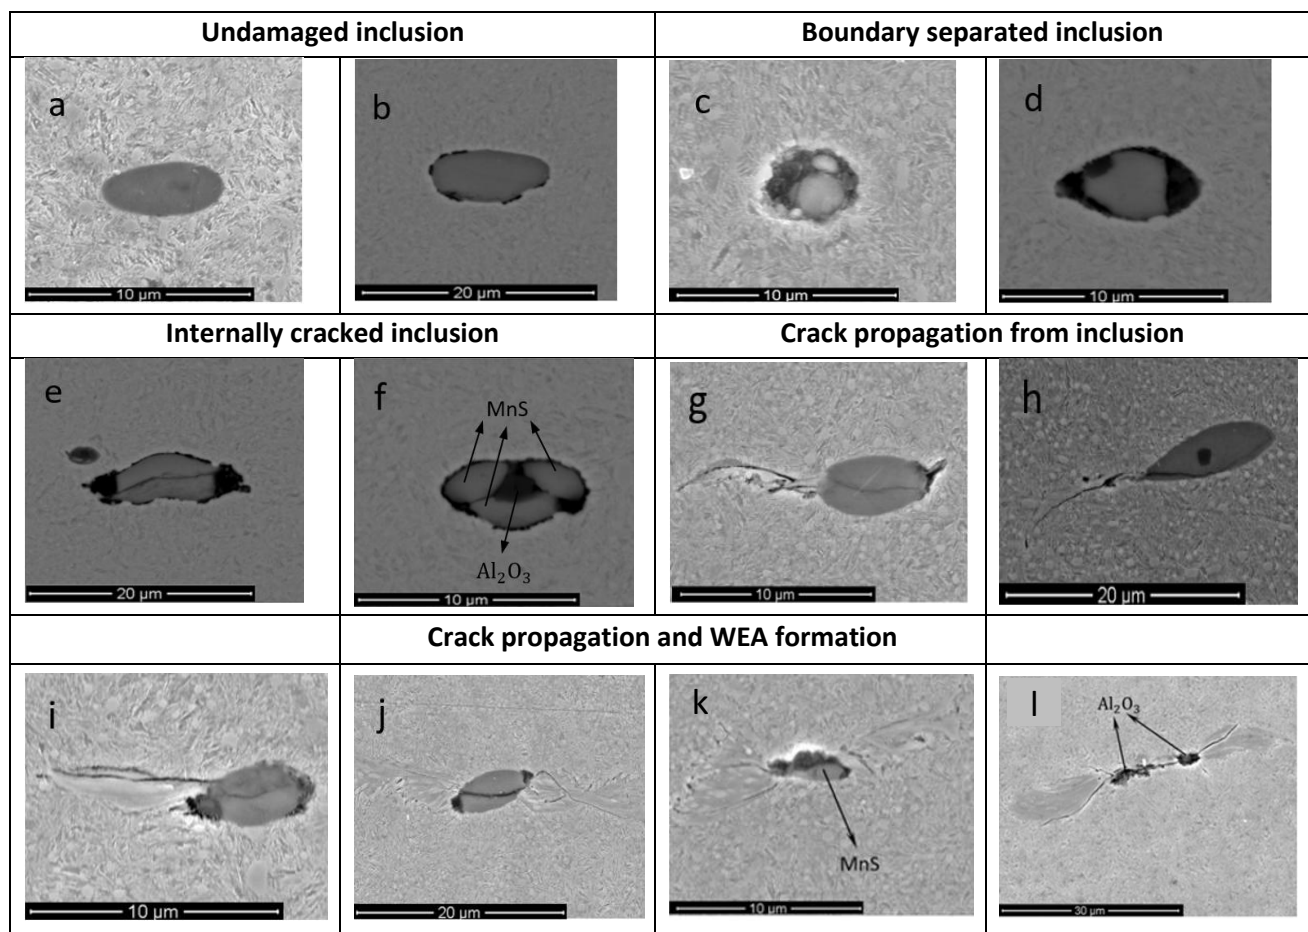
Fig.3 Different types of inclusion damage: (a) and (b) perfectly bonded inclusions; (c) and (d) boundary separation damage; (e) and (f) inclusions with internal cracks; (g) and (h) cracks propagated from inclusion into matrix; (i) (j) (k) and (l) butterfly cracks with WEA formation

The first damage type is the boundary separation of an inclusion, as shown in Fig.3c and Fig.3d. This type of the inclusion damage is most likely to occur during the steel heat treatment process because of differences in thermal expansion and contraction between the inclusion and steel matrix. In addition, the contact pressure acting on the raceway surface may also lead to boundary separation because the inclusion-matrix ionic bonds may be broken due to differences in deformation of the inclusion and steel. The second damage type is the internal cracking of an inclusion, as shown in Fig.3e and Fig.3f. The breakage of an inclusion is often caused by complex mechanisms. Firstly, the separation of the inclusion boundary from the steel matrix may occur due to the steel heat treatment or the loading from the rollers on the raceway. If the inclusion boundary is firmly connected to the steel matrix, energy from thermal expansion and contraction cannot be released through the debonding at the boundary. Hence, the relatively fragile inclusion may break internally itself because of its poor loading capacity. The other mechanism is related to the chemical composition of the inclusion. As shown in Fig.3f, in a compound inclusion of $\text{MnS}+\text{Al}_2\text{O}_3$, the MnS inclusion has been fractured into three pieces due to the Al_2O_3 particle located in the middle of the compound inclusion. Therefore, internal cracks may also initiate from the compound inclusions because of their fragile structures.

The third damage type is the internal crack propagation from an inclusion to the steel matrix, as shown in Fig.3g and Fig.3h. In this form of damage, the connection between the inclusion boundary and steel matrix is usually stable and firm. However, internal cracks of the inclusion may cause highly localised shear stress between the cracked surfaces during the subsequent RCF loading cycles. Therefore, the cracks may propagate from the inclusion into the steel matrix. Importantly, the cracks in the steel matrix caused by an inclusion are not only related to the internal cracks of the inclusion, but also influenced by any separated boundary or an excessive longitudinal ratio of the inclusion geometry. These factors also affect the maximum shear stress levels and cause the stress concentration localised at the inclusion when the raceway is subjected to a high contact pressure on the surface.

The fourth damage type is related to the WEAs at cracks around an inclusion, as shown in Figs.3i, 3j, 3k, and 3m. WEAs may form around the cracks due to sliding and impact loading between the fracture surfaces of these cracks [34]. Because the shape of the WEA damage is similar to butterfly wings, it is known as WEA “butterfly wing” damage. The investigation in [6] suggested that it was the final stage of the inclusion-initiated cracking. After the formation of WEAs at an inclusion, the local steel matrix transforms from martensite structure into a harder and more brittle ferrite structure. This undoubtedly provides favourable conditions for a rapid propagation of the cracks within the steel matrix under subsequent RCF cycles. Typically, the WEA associated cracks can propagate rapidly from the subsurface to the surface of the raceway and eventually cause the flaking of the surface material leading to spalling of the raceway.

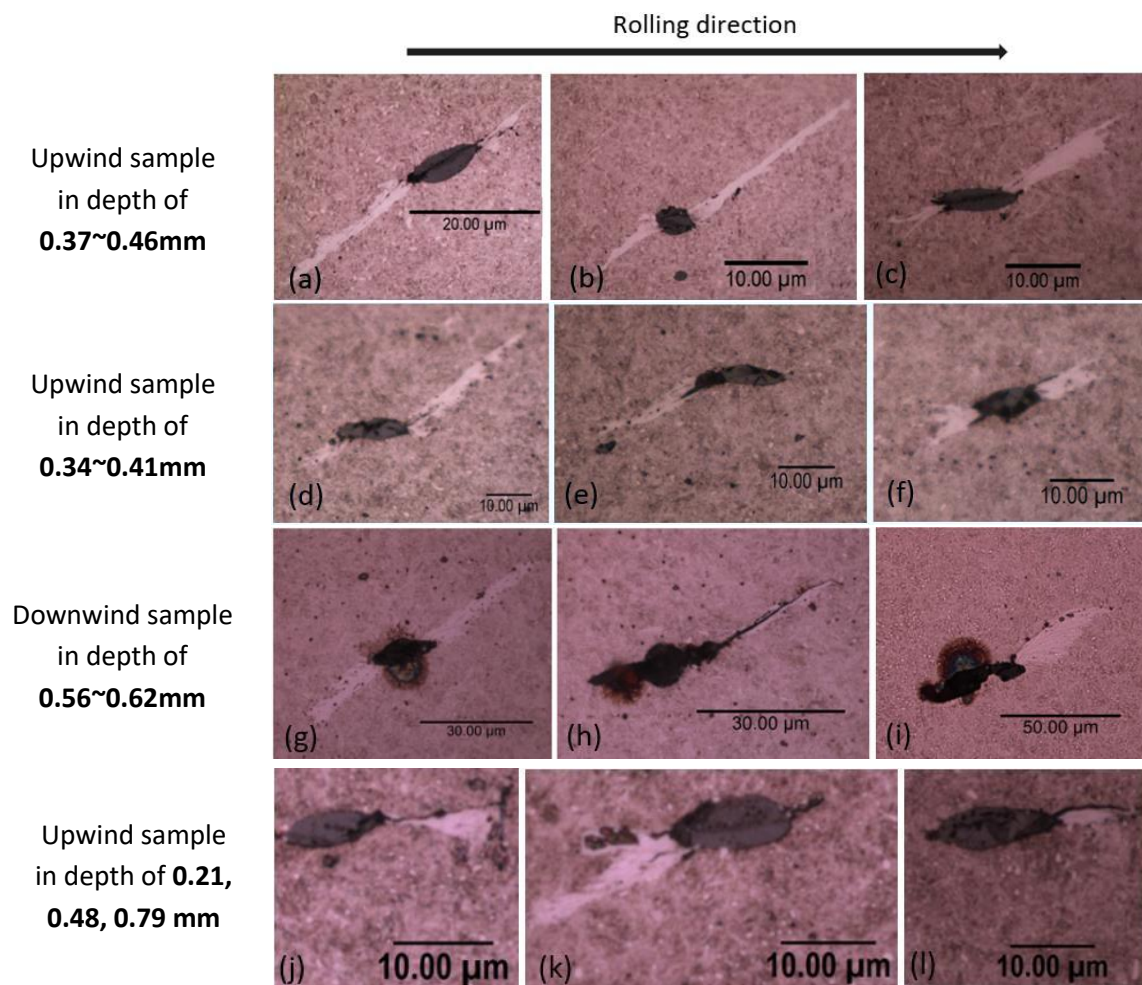
Fig.4 Butterfly wing cracks and WEAs at inclusions located at different depths in subsurface

To investigate factors affecting the propagation direction of butterfly wing cracks, Fig. 4 shows some examples of butterfly wing cracks and WEAs at inclusions from circumferential and axial samples. From Figs.4a,b,c, though these three butterflies are found at similar subsurface depths in the same sample, the geometry and inclined angles of their inclusion are completely different. However, the WEA decorated butterfly wings propagated from the inclusion are almost in the same direction, at an acute angle to the rolling direction. Similar observations can be found from different samples in Figs.4d,e,f and Fig.4g,h,i, when the butterflies are at the similar depths, their WEA decorated

butterfly wings propagate in the similar direction. However, when inclusions are located at different subsurface depths of 0.21, 0.48 and 0.79 mm, the WEA decorated butterfly wings propagate in different directions, as shown in Fig.4j,k,l.

Orientations of micro cracks of each butterfly at different subsurface depths can be different, as evidenced in Fig. 4. This is because the depth difference of inclusions results in the difference of the orthogonal shear stress distribution and variation around each inclusion. Therefore, under repeated rolling contact cycles, developed fatigue cracks at butterflies have diverse geometries and crack orientations. In the actual operation of a WT, a bearing raceway can be subjected to different levels of contact loading and surface traction; affecting crack propagations along both circumferential and

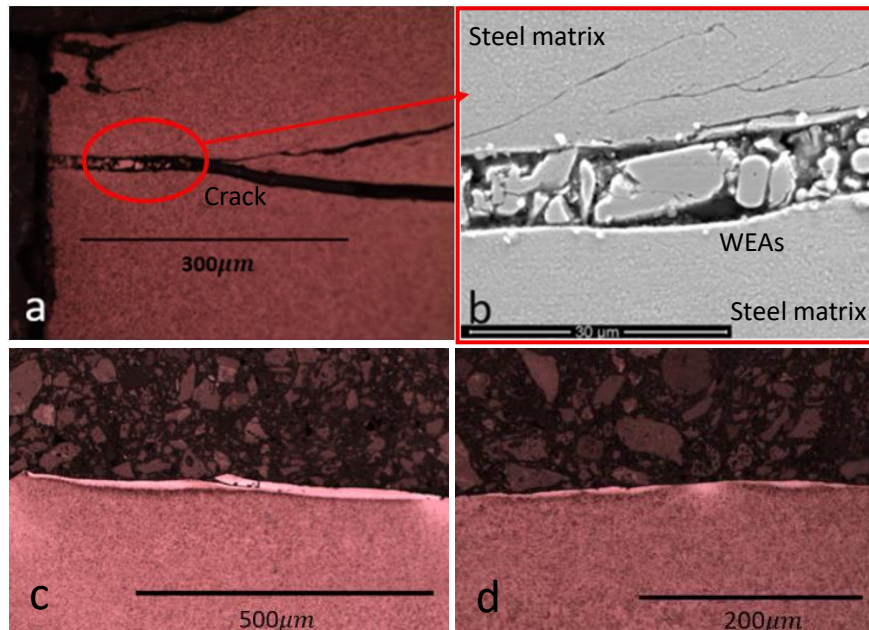
Fig. 7 White etching crack (WEC) networks: (a)(b) optical and SEM image of broken WEAs within crack from downwind axial sample; (c)(d) white surface flaking from upwind axial samples

Many investigations of the bearing premature failure showed that the bearing surface spalling was initially triggered by WECs from the subsurface areas [3, 8, 13, 35, 40]. Fig. 7a shows a WEC network observed from a downwind axial sample; some broken WEA particles are found entirely within the crack in the subsurface which is parallel to the raceway surface. The microstructure difference between the original steel matrix and WEAs is clearly shown in Fig. 7b. The broken areas surrounded by WEAs in the crack have smooth surfaces, which means no carbide can be observed. However, for the steel matrix above and below the crack, it exhibits a frosted texture because there are spherical carbide particles within the steel matrix. Two examples of the white structure flaking (WSF) observed from the spalled raceways are shown in Figs. 7c,d. The steel material above the WEC has already been flaked away, thus only the cracks with decorated WEAs remain on the observed sample surface; some of the WEAs are also broken and cracked, similar to that observed in Fig. 7a.

Fig. 7 shows examples when the steel material above the WECs has already flaked away, thus only the cracks with decorated WEAs can be observed; where some of the WEAs are also fractured. It can be seen that the WEA does have the finer grains compared with the original martensite matrix. This is because the hardness of WEAs is 30% to 50% higher than that of the martensitic structure [46], the ductility and toughness of WEAs are lower than the martensite, thus the WEAs are prone to be cracked and shattered. Under subsequent rolling contact loading cycles, the surface areas where flaking or spalling already occurred may be further hardened, causing further surface flaking and spalling damage. In addition, when the surface material has already flaked away, the damaged surface material may be directly in contact with the lubricant, which could lead to localised hydrogen embrittlement. Undoubtedly, both the strain hardening and hydrogen embrittlement may further reduce the ductility of the already damaged surface material. When higher contact loads occur, such as under impact loading, the secondary cracks may form beneath these spalled surface areas into deeper regions of the subsurface, accelerating crack propagation which leads to the final failure of the bearings.

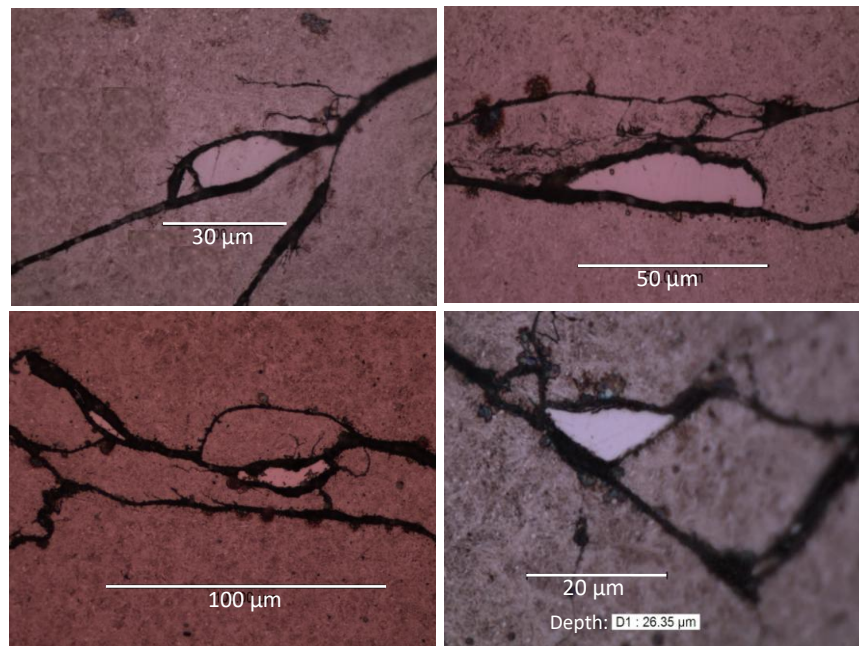
A large number of WEAs due to inclusions is observed in this study, and this type of WEAs is often accompanied by the micro cracks within the butterfly wings in the subsurface. However, WEAs without being attached to any inclusion are also observed in the raceway samples. These WEAs are often found in the subsurface crack networks and surrounded by longer cracks, examples of these WEAs are shown in Fig. 8. To confirm whether these WEAs are caused by inclusions, the current observation plane of the sample surface is subjected to an additional polishing process, followed by an etching process, aiming to investigate whether any inclusions still exist beneath the current observation plane. However, the crack network geometries remain unchanged after observing three different planes of the sample, indicating that these WEAs may not be caused by subsurface inclusions.

Fig. 8 Subsurface crack networks without attached to any inclusions

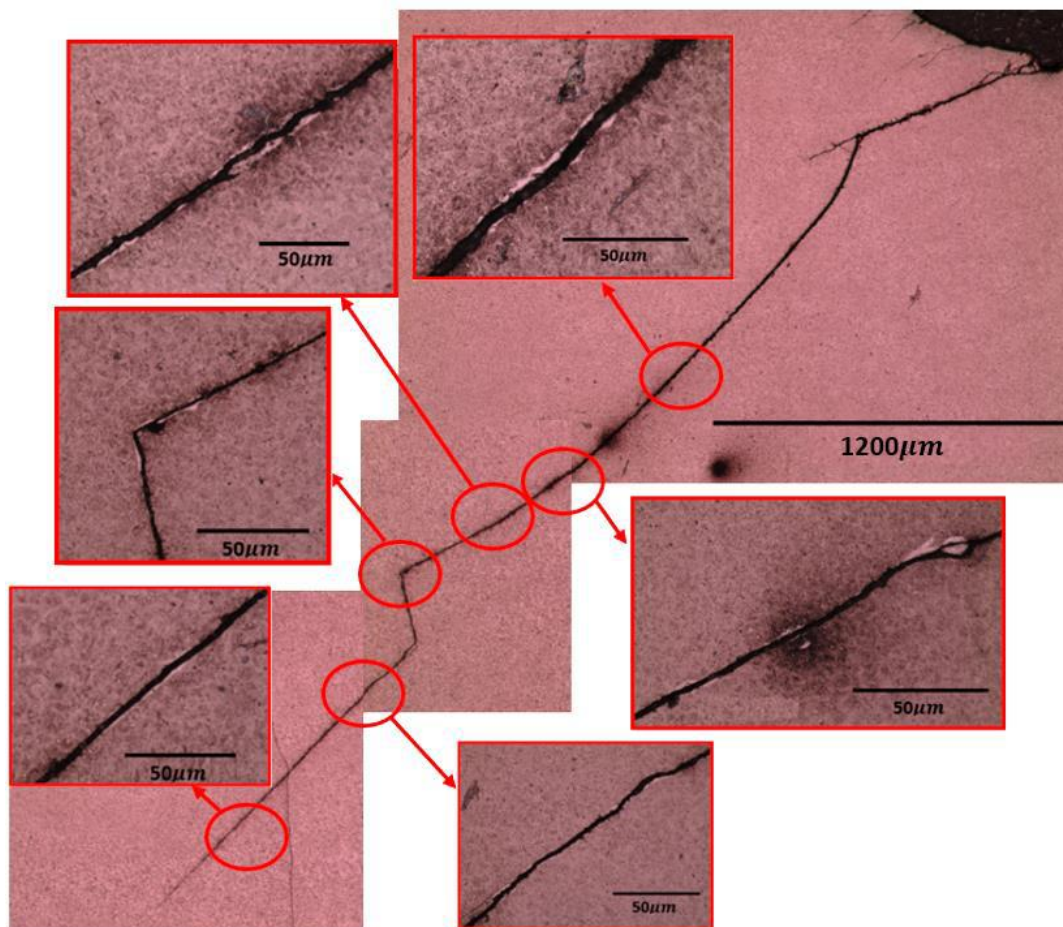
Fig. 9 shows a WEC network found from a downwind sample; no inclusions can be observed from the WEC and the crack has propagated to deeper region in the subsurface, approximately 5 mm below the spalled surface of the raceway, indicating there may be other possible factors contributed to the complex crack networks in the subsurface of the failed raceways.

Fig.9 WEC network propagated into deeper subsurface at 5 mm from the raceway contact surface

Similar to the subsurface micro cracks initiated from inclusions, the secondary cracks may also contain WEAs. The WEC crack network shown in Fig.9 is observed in the circumferential direction of the raceway. Because no inclusions can be found associated with the crack network, which has propagated into the deeper region below the spalled surface, this crack network is identified to be a secondary crack. At the depth of 5 mm where the crack network is propagated to, the stress magnitude caused by the contact pressure at the raceway is typically small. Therefore, the formation of WEAs in the WEC crack shown in Fig.9 could not be caused by the damage initiated at inclusions due to cyclic stress alternation. There may be three possible explanations for the WEA initiation process in the secondary cracks. Firstly, lubricant may leak from the contact surface into the subsurface alongside the secondary crack to the deeper region in the subsurface, resulting in the localised electrical current discharge and heating. Secondly, WEAs may easily form due to the localised shearing and heating if these areas are adiabatic, according to the ASB theory. Thirdly, the rubbing and squeezing between the cracked surfaces under cyclic rolling contact may lead to the accelerated recrystallisation of the steel matrix from martensite to ferrite. All these possible mechanisms suggest that the WEAs could have formed after the occurrence of the crack network, considering the subsurface depth of this crack network. Compared with the WECs observed in Fig.7, the area of WEAs of the WEC in Fig.9 is relatively small. This may be because the secondary crack network has occurred after the spalling of the raceway surface, thus the formation period of WEAs in Fig.9 is relatively short, when compared with the WEAs formed at subsurface micro cracks initiated from inclusions in Fig.7.

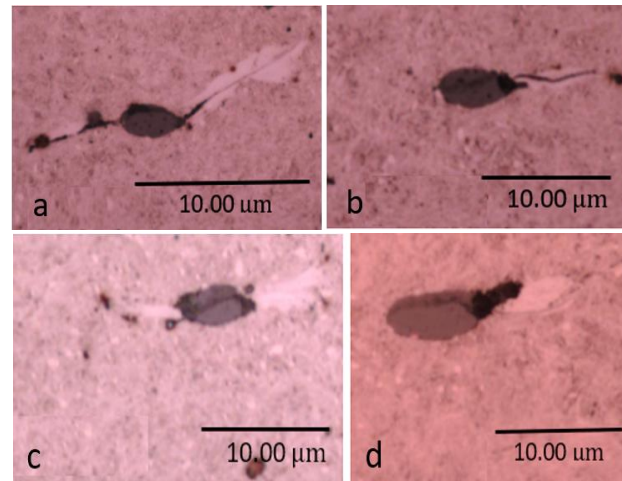
To ascertain the formation of the subsurface crack networks is initiated from the raceway subsurface, the subsurface microstructure of the raceway surface without flaking or spalling damage but only with indents, as shown in Fig. 1c, is also investigated. Away from the fixed loading zone of the raceway, no subsurface crack networks can be found beneath the surface without flaking or spalling damage. However, four butterfly wing cracks at inclusions in the subsurface are still detected in circumferential samples; all of them are caused by either boundary separation or internal cracking of the MnS inclusions, as shown in Fig. 10. This observation confirms that the subsurface crack networks are initiated from the damaged inclusions within the subsurface.

Fig.10 Butterfly wing cracks with WEAs at MnS inclusions of the subsurface of indented downwind raceway without surface flaking or spalling

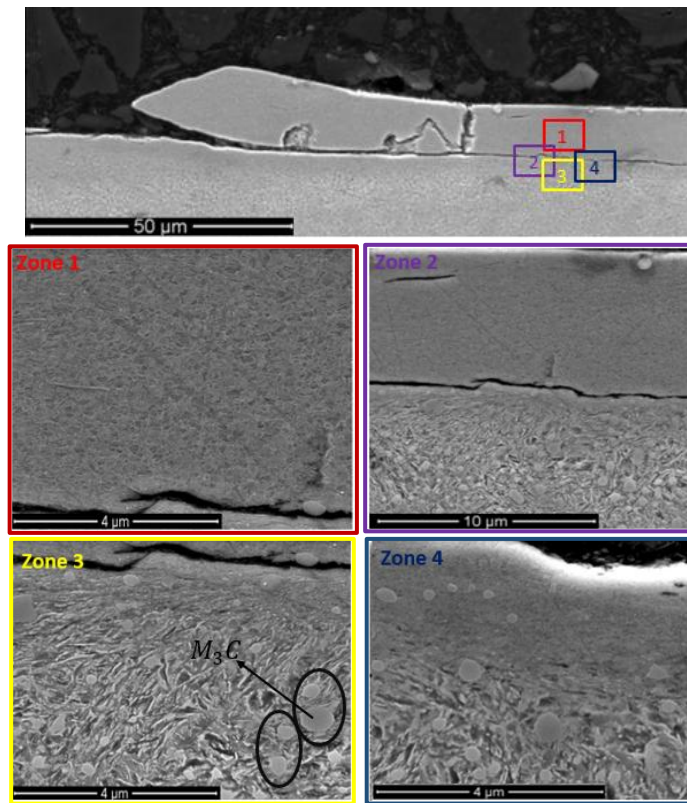
The microstructure of WEAs was identified as the nanocrystalline ferrite that was supersaturated with carbon [41, 42]; and the grain sizes of the WEAs were reported to be ranged from 20 to 30 nm [43]. To investigate the microstructure differences between WEAs and the original martensitic structure, a WEA on a crack in an axial sample from the surface flaking area is investigated by using SEM, as shown in Fig.14. Four regions are selected; Zone 1 is the WEA; Zone 2 shows the microstructures on both sides of the crack; Zone 3 is the original martensite structure of the steel; and Zone 4 is the microstructure of the transition zone from the martensite to the WEA which locates below the crack.

As can be seen from Zone 3, the martensite in the original structure has a needle-shaped structure. Because carbon is added during the steel manufacturing, some circular carbides, with the chemical composition M_3C , can also be observed around the acicular martensite. In general, the carbides will absorb some of Fe element to form Fe_3C , named as cementite. Comparing the images of four zones in Fig.14, it can be seen that the circular cementite disappears in the microstructure of the WEA in Zone 1. Although the cementite can still be found in the transition region of Zone 4, they become extremely rare in the WEA in Zone 1. This can be seen more clearly in Zone 2, where the distribution of cementite is mainly concentrated in the region below the crack.

Fig.14 Comparison of microstructures of WEA and original martensite

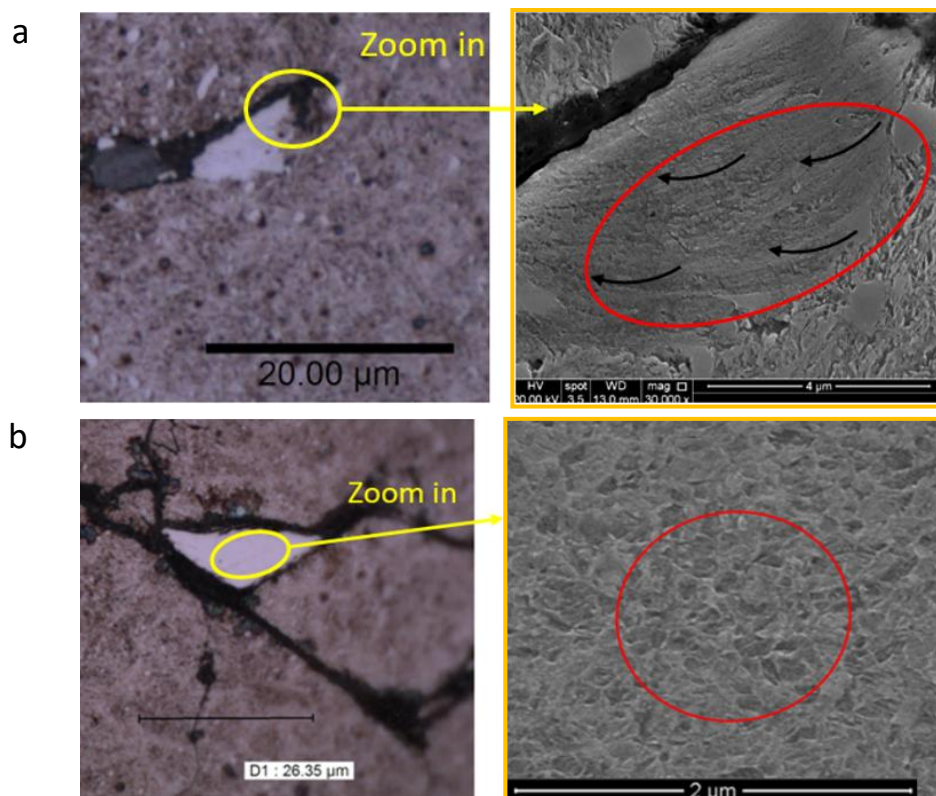
Fig.15 WEAs in butterfly wing cracks from circumferential samples of upwind raceway: (a) with elongated cementite; (b) without elongated cementite (the enlarged images are on the right)

elongated cementite can be broken up and dissolved during subsequent rolling contact loading cycles. From this study, elongated cementite elements can be observed in the butterfly wing cracks from a circumferential sample of the upwind raceway, shown in Fig.15a. However, in this study, not all the WEAs are found to contain the elongated grains in the microstructure. An explanation in [44] suggested that there might exist a thermal-mechanical mechanism that resulted in the dissolution of the cementite because an increase of temperature of the microstructure was observed during the WEA formation process. Furthermore, the interaction between the dislocated grain boundary and the cementite might also lead to the damage and dissolution of the cementite, as reported in [45].

From the microstructure of another circumferential sample of the upwind raceway shown in Fig.15b, a WEA is observed alongside a crack network in the subsurface area. From the SEM image shown on the right, it is clear that the microstructure of this WEA is the compact ferrite without the elongated grains, highlighted by a red cycle. Moreover, the boundaries of the grains in Fig.15b are clearer than those in Fig.15a. These differences may be because under the rolling contact loading, the triangular WEA in Fig. 15b, surrounded and in contact with three cracked surfaces of the crack network, is subjected to shearing deformation applied to the area in three different directions. Accordingly, the interactions between the grains in Fig.15b is multidirectional, which may be the main reason for the formation of dense ferrites. However, for the WEA in Fig.15a, it only has one surface interacting with the butterfly wing crack, under the rolling contact loading, the WEA is only subjected to one dimensional shear deformation affecting the formation of ferrite grains, mainly oriented along the crack direction of the butterfly wing. This confirms that the formation of WEAs is caused by a variety of mechanisms, not only due to the existence of damaged inclusions.
