Improving Rail Wear and RCF Performance using Laser Cladding

S. R. Lewis¹, S. Fretwell-Smith², P. S. Goodwin³, L. Smith², R. Lewis¹, M. Aslam², D. I. Fletcher¹, K. Murray⁴,
R. Lambert²

Laser cladding has been considered as a method for improving the wear and RCF performance of standard grade rail. This paper presents results of small scale tests carried out to assess the wear and RCF performance of rail which had been laser clad. Using the Laser Cladding process premium metals can be deposited on to the working surface of standard rail with the aim of enhancing the wear and RCF life of the rail. Various laser clad samples were tested using a twin-disc method. The candidate metals were clad on to standard R260 grade rail discs and were tested against a disc of standard wheel material. During the tests, wear rates and RCF initiation were monitored and compared to those of a standard rail disc. Six candidate cladding materials were chosen for this test: A multi-phase Manganese Steel Variant (MMV), Martensitic Stainless Steel (MSS), TWIP Steel, NiCrBSi, Stellite 12 and Stellite 6. The MSS, Stellite 6, and Stellite 12 samples showed reduced wear rates relative to the standard R260 Gra

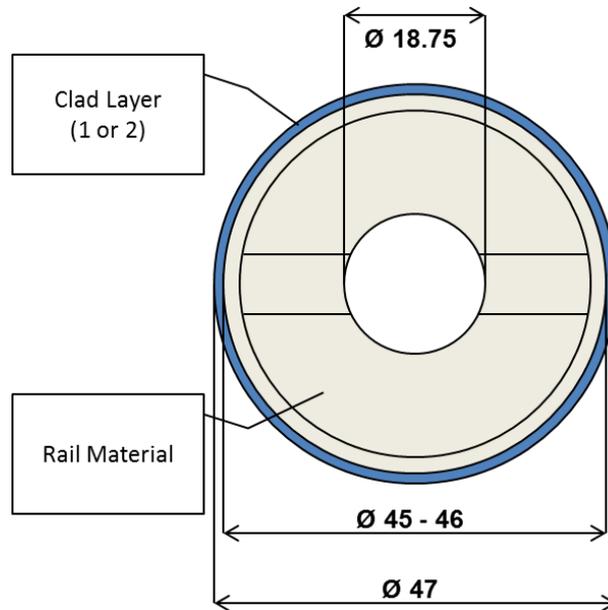
proven/expected wear and RCF resistance. Materials were deposited in nominally 1 mm thick layers. 1 or 2 layers were applied, as shown in Figure 1. The width of a deposited bead is typically 4mm and several beads are required to cover the 10 mm wide running band of a twin-disc specimen. Once the surface of a specimen is covered and the deposit cooled the surface has a “ploughed field appearance due to the adjacent beads of deposit. After the required number of layers are applied the discs then need to be ground to achieve the final test surface finish.

Figure 1. Schematic of a twin-disc specimen

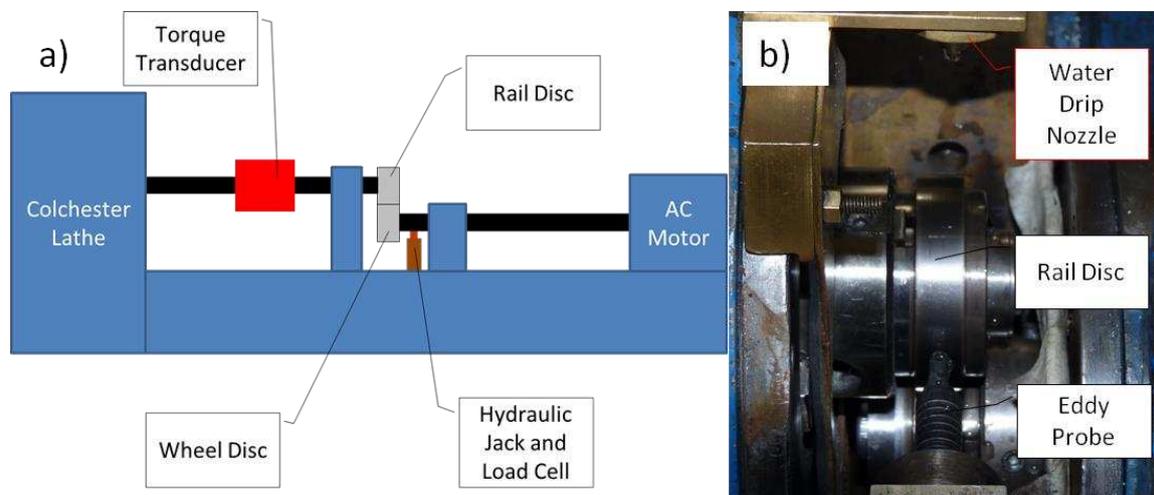
Two types of tests were carried out; one to look at wear and the other RCF. Before each test, the samples were cleaned in an ultrasonic bath with acetone. In the wear tests the discs were run for a total of 30,000 cycles in 5,000 cycle intervals. Wear was periodically measured by weighing the discs before the test start and after each subsequent 5000 cycles. The tests were intermittently stopped in order to monitor the evolution of the wear rates of the discs over time. The wear tests were designed to characterize the traction and wear properties of the laser clad samples under dry conditions. Some of the candidate cladding materials were known to work-harden, hence will not show a stable wear rate. Therefore monitoring the evolution of the wear rate allowed a better understanding of the wear characteristics of each material. Micro-hardness of the discs was also measured before and after each test. The RCF test samples were run for 500 cycles under dry conditions to build up plastic flow at the disc surface and initiate cracks. The discs were then run for 50,000 wet cycles [5]. The contact between the discs was wetted by dripping water at a rate of 1 drop per second onto the discs. The contact was wetted to accelerate the rolling contact fatigue process. Both types of test were performed at a slip of 1% and a maximum Hertzian contact pressure of 1500 MPa. An Ellotest B1 Eddy Current Crack Detector was used to show the presence of any fatigue cracks in the specimens during the RCF tests. A differential eddy current probe was offset 0.3 mm from the surface of the rail disc, see Figure 2b. This induces an eddy current in the surface of the disc. Any crack or fissure in the disc surface will disturb this eddy current and these

disturbances are sent back to the detector unit. The unit is calibrated with a reference disc which has a 5mm long wire eroded crack in its surface parallel to the discs axis of rotation.

Figure 2. a) Schematic of twin-disc machine b) Eddy current probe secured close to rail disc

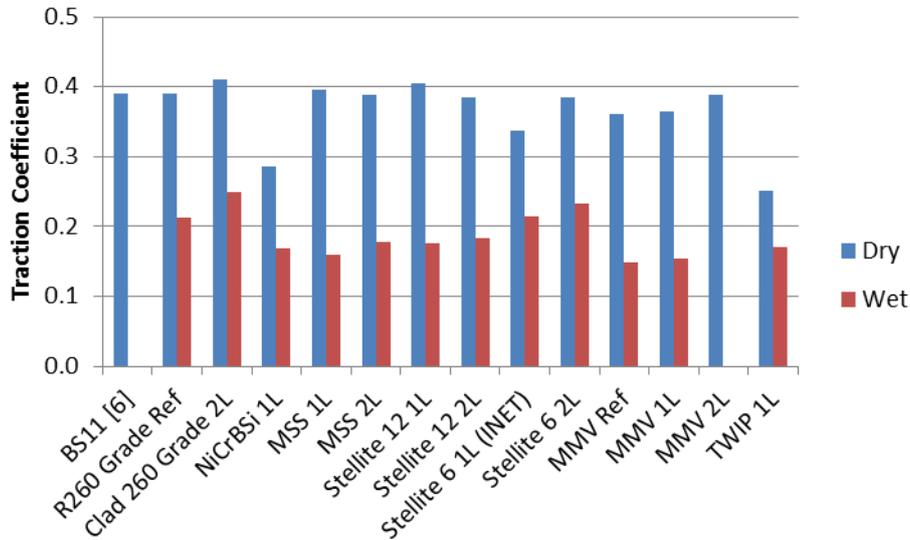
Figure 3. Average traction coefficients for each cladding in both dry and wet conditions. Ref indicates reference, 1L indicates 1 clad layer and 2L indicates 2 clad layers

Figure 3 shows average traction results for each of the different claddings compared to an unclad reference R260 grade rail disc. The dry traction data was taken from the wear tests and the wet data taken from the RCF tests.

In dry conditions the majority of discs showed a traction coefficient above 0.35 with the two exceptions being the 1 layer NiCrBSi and the 1 layer TWIP samples both giving coefficients of 0.29 and 0.25 respectively. In wet conditions all of the discs gave values within a similar range. Apart from the NiCrBSi and TWIP discs none of the traction

coefficients of the clad discs deviated far from the R260 Grade reference sample, indicating that in the field MSS, Stellite 12 and MMV clads would give similar adhesion levels to un-clad R260 Grade rail. Interestingly, in dry conditions, the 2 layer clad R260 and MMV samples show higher traction than their un-clad reference counterparts.

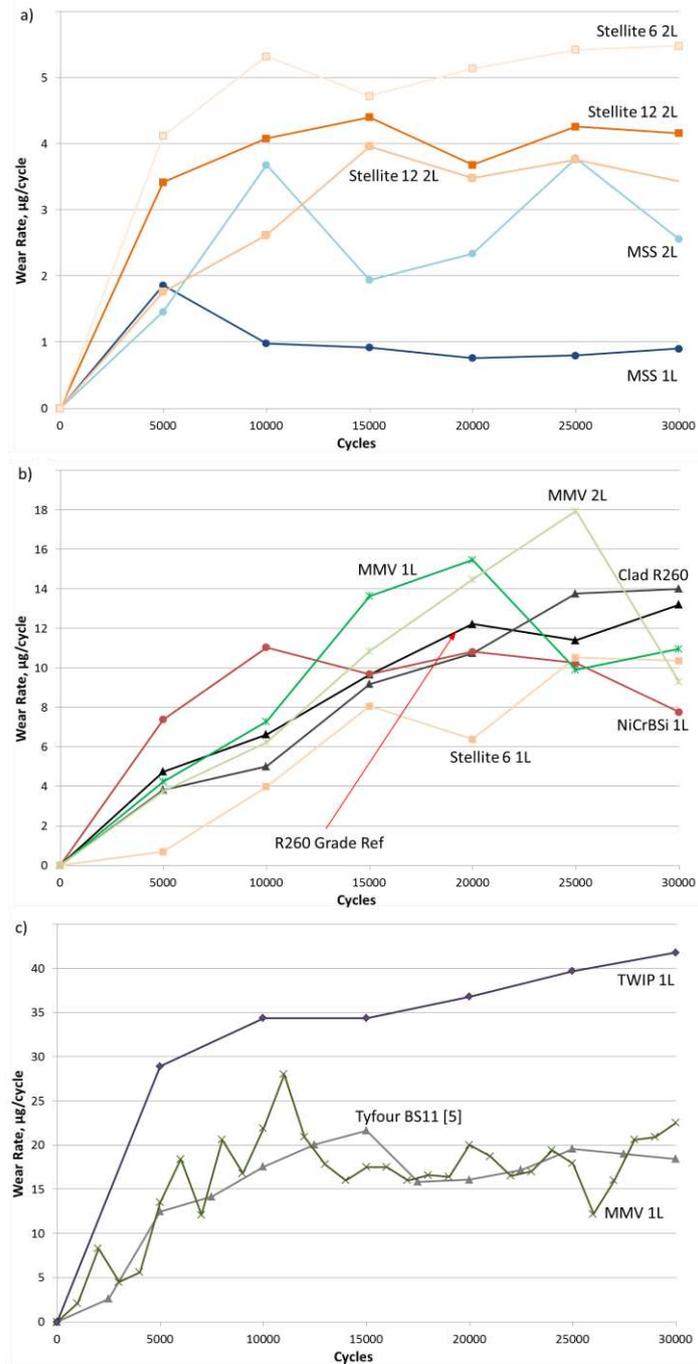
Figure 4 shows the evolution of the wear rate of the rail discs. The results have been compared to tests carried out by Tyfour et al. [6] in which the wear rate evolution of BS11 rail rolling against R8A wheel steel was measured using the same twin-disc machine under the same conditions as used in these tests.

Figure 4 shows that there is a wide variation in the wear behavior of the rail discs. There seems to be 3 distinct groups which the discs can be put into:

- Group 1 (Figure 4a), where the wear rate stays below $5 \mu\text{g}/\text{cycle}$. This group includes both the 1 and 2 layer MSS and Stellite 12 discs and the Stellite 6 2 layer disc.
- Group 2 (Figure 4b), where the wear rate is between 5 and $15 \mu\text{g}/\text{cycle}$. This group includes both the 1 and 2 layer MMV, the Stellite 6 1 layer disc, the R260 grade reference disc, the clad 2 layer R260 grade disc and the NiCrBSi disc.
- Group 3 (Figure 4 c), where the wear rate remains mainly above $15 \mu\text{g}/\text{cycle}$. This group includes the MMV reference disc, the BS11 disc [6] and the TWIP disc

Figure 4. Wear rate evolution of the rail discs under dry conditions. a) Group 1 (Wear < 5 µg/cycle), b) Group 2 (5 > wear < 15 µg/cycle), c) Group 3 (Wear > 15 µg/cycle)

The best performing cladding in this test was 1 layer MSS where the wear rate remained consistently below 1 $\mu\text{g}/\text{cycle}$. The discs in group 1 (see Section 3.2) seemed to reach a steady state of wear relatively quickly (within 5000 cycles) where upon there was little variation in the wear rate after this point. Most of the discs in group 2 reached a maximum wear rate after which a lower cyclical wear rate was seen. However, the R260 Grade reference sample and the clad R260 sample both seemed to show gradually increasing wear rates. The worst performing disc, in terms of wear, was the 1 layer TWIP sample which showed a wear rate far in excess of any other sample tested. The wear rate of the TWIP disc also increased throughout the test. It was observed that there is a large degree of plastic deformation on the surface of the TWIP sample. What is not easy to determine here is whereabouts the wear rate of each sample lies on the curve representing the life of typical tribological components as shown in Figure 16 [8].

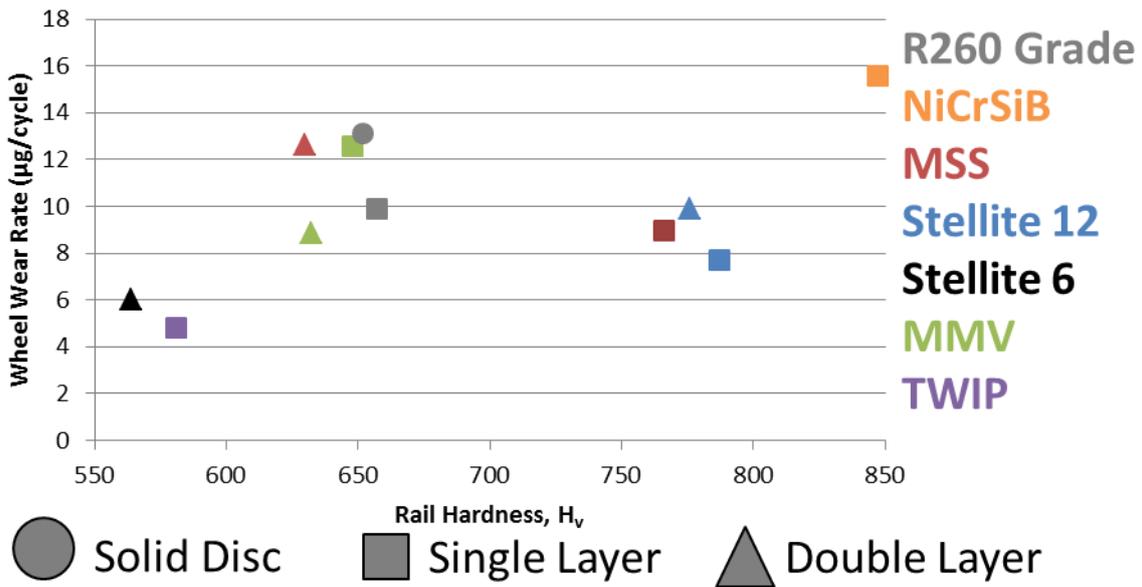
The hardness of each rail disc was compared against the wear rate of the wheel disc that it was tested against as shown in Figure 5. Each disc was sectioned and polished after testing and a Vickers micro-hardness case measurement was taken close to the disc surface. Figure 6 shows the correlation between average rail disc hardness and rail disc wear rate.

Figure 5. Average wear rate of wheel discs in dry conditions plotted against the end-of-test rail disc hardness, colour of data point indicates material/clad type, shape indicates number of layers

In all but one of the cases tested the wheel wear rate was classified as good/superior with Stellite 6 and TWIP, both 1 layer, showing superior wheel wear rates. Figure 5 shows the wear rates of the wheel discs plotted against the measured rail disc hardness. It is difficult to draw a conclusion from this data as the surface disc hardness will have changed throughout the test. What is of more relevance is that the wear rate of the wheels has not increased as a result of running against a harder rail as would be expected. In all but one cases the wear of the wheel is lower than the reference case and in some cases substantially.

Figure 5 shows a comparison between the mean rail disc hardness and the wear rate of the wheel disc which it was tested against. No correlation between rail hardness and wheel wear can be seen in the data. However, only one of the samples showed a higher wheel wear rate than the reference case; that being the NiCrBSi sample. This suggests that in the majority of cases if a premium/harder material were to be clad onto a standard R260 Grade rail this would not adversely affect the wheel wear rate. In all but one of the claddings tested the wheel wear rate was either unaffected or lower than in the baseline R260 Grade case. This is shown in Table 1. This phenomenon of harder rail material yielding lower wheel and rail wear rates has also been seen in [10-12]. It is interesting to note from the hardness change of the rail discs and the indicated hardness change of the wheel discs that both wheel and rail specimens work hardened toward a range of 600 – 800 Hv.

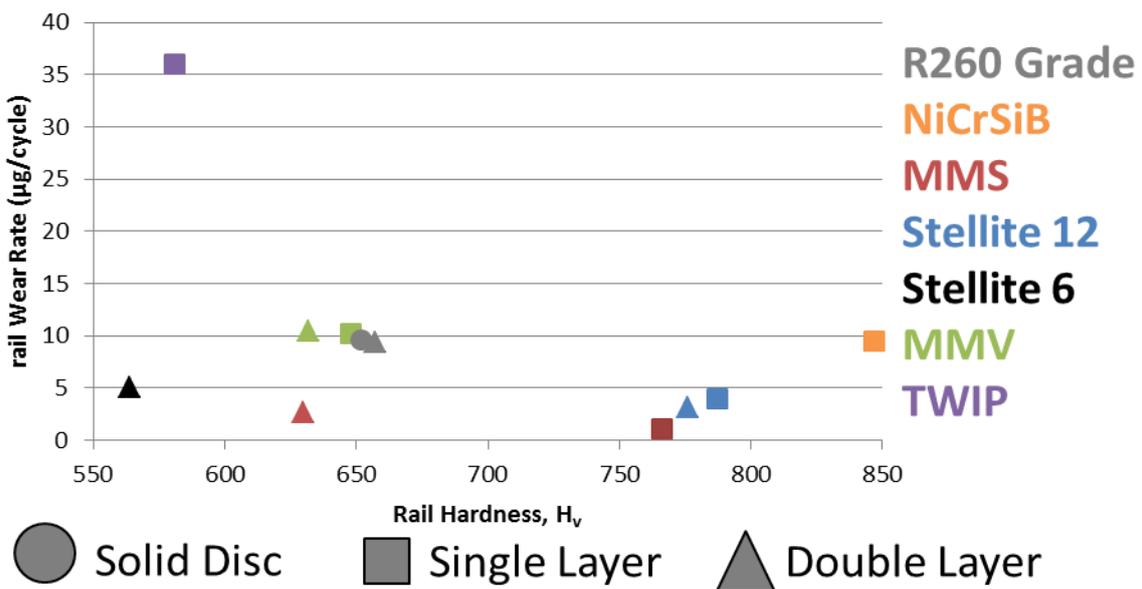
Figure 6. Average wear rate of rail discs in dry conditions plotted against the end-of-test rail disc hardness, colour of data point indicates material/clad type, shape indicates number of layers

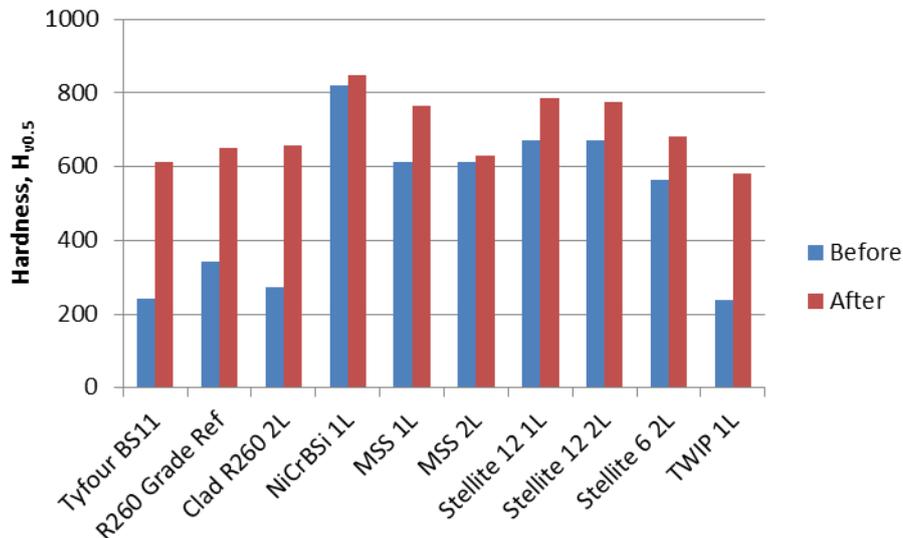
Figure 7 shows the change in hardness of the rail discs before and after the wear tests. Micro-hardness was measured as close to the surface as possible for all of the discs shown in Figure 7 on sectioned specimens with the exception of the R260 Grade reference disc where the hardness was measured on the curved running band before the test. It was decided to leave this specimen in Figure 7 as a reference as the hardness change is still similar to the BS11 and the Clad R260 2L specimens both of which had section micro-hardness measured before and after the test.

Figure 7. Before and after sub-section Vickers micro-hardness of wear test samples. Note the “R260 Grade Ref” sample had macro-hardness taken before but micro-hardness taken after the test but is included for reference purposes.

Figure 7 shows that all of the discs which had Vickers micro-hardness measured near the surface work hardened with the greatest amount of work hardening show by the BS11, R260 and TWIP samples. It is interesting to note that the hardness of all of the discs represented in Figure 7 increase toward the 600 – 800 Hv range during the test regardless of the starting hardness value.

Micro-hardness was measured at the surface of the wheel discs before and after the wear tests. Hardness readings taken on the disc surface are less reliable than section hardness results due to the curved running surface and hence should only be used as a guide. However it is interesting to note that all the wheel discs started at a mean hardness level of approximately 340 Hv and work hardened during the test to an average range of approximately 600 – 800 Hv as is also seen with the rail discs (Figure 7).

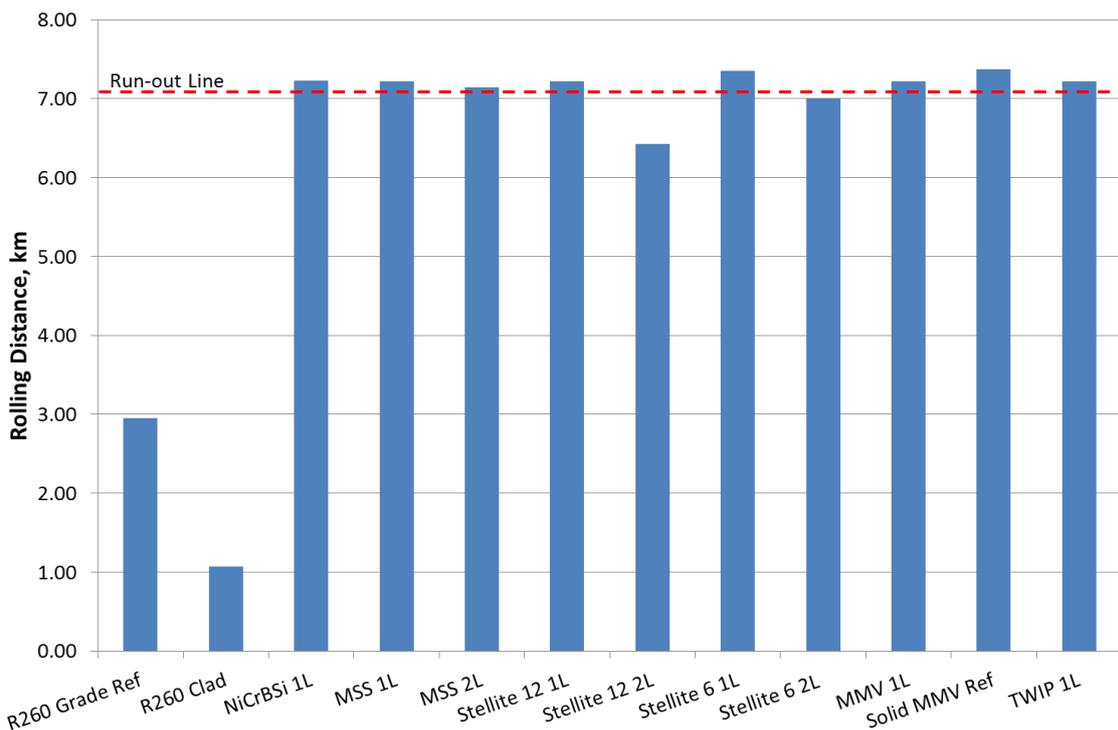
Figure 8. Results of RCF tests. RCF life is expressed in terms of rolling distance.

The RCF initiation life of each disc is quoted in rolling distance and results are shown in Figure 8. Tests were limited to 50,000 cycles (~7 km depending on disc size) for practicality reasons. Tests which ran beyond 7.14 km without failure (as defined by the eddy current method, see section 2) were stopped and recorded as run-out tests. 7.14 km equates to approximately 50,000 cycles for a standard 47 mm diameter disc.

Figure 8 shows that none of the clad samples showed any signs of RCF initiation and all ran out to the 50,000 cycle limit. (Note: the Stellite 12 1 layer sample had a reduced diameter, but still completed 50,000 cycles). The RCF initiation life of the reference sample was 3 km showing that all clad samples show superior RCF initiation resistance compared to standard R260 Grade rail. New, untested specimens of the best performing samples from the wear tests (MSS and Stellite 12 both 1 and 2 layer and Stellite 6 just 2 layer) were tested to 100,000 cycles. However, none showed any signs of crack initiation after being tested to double the original endurance limit.

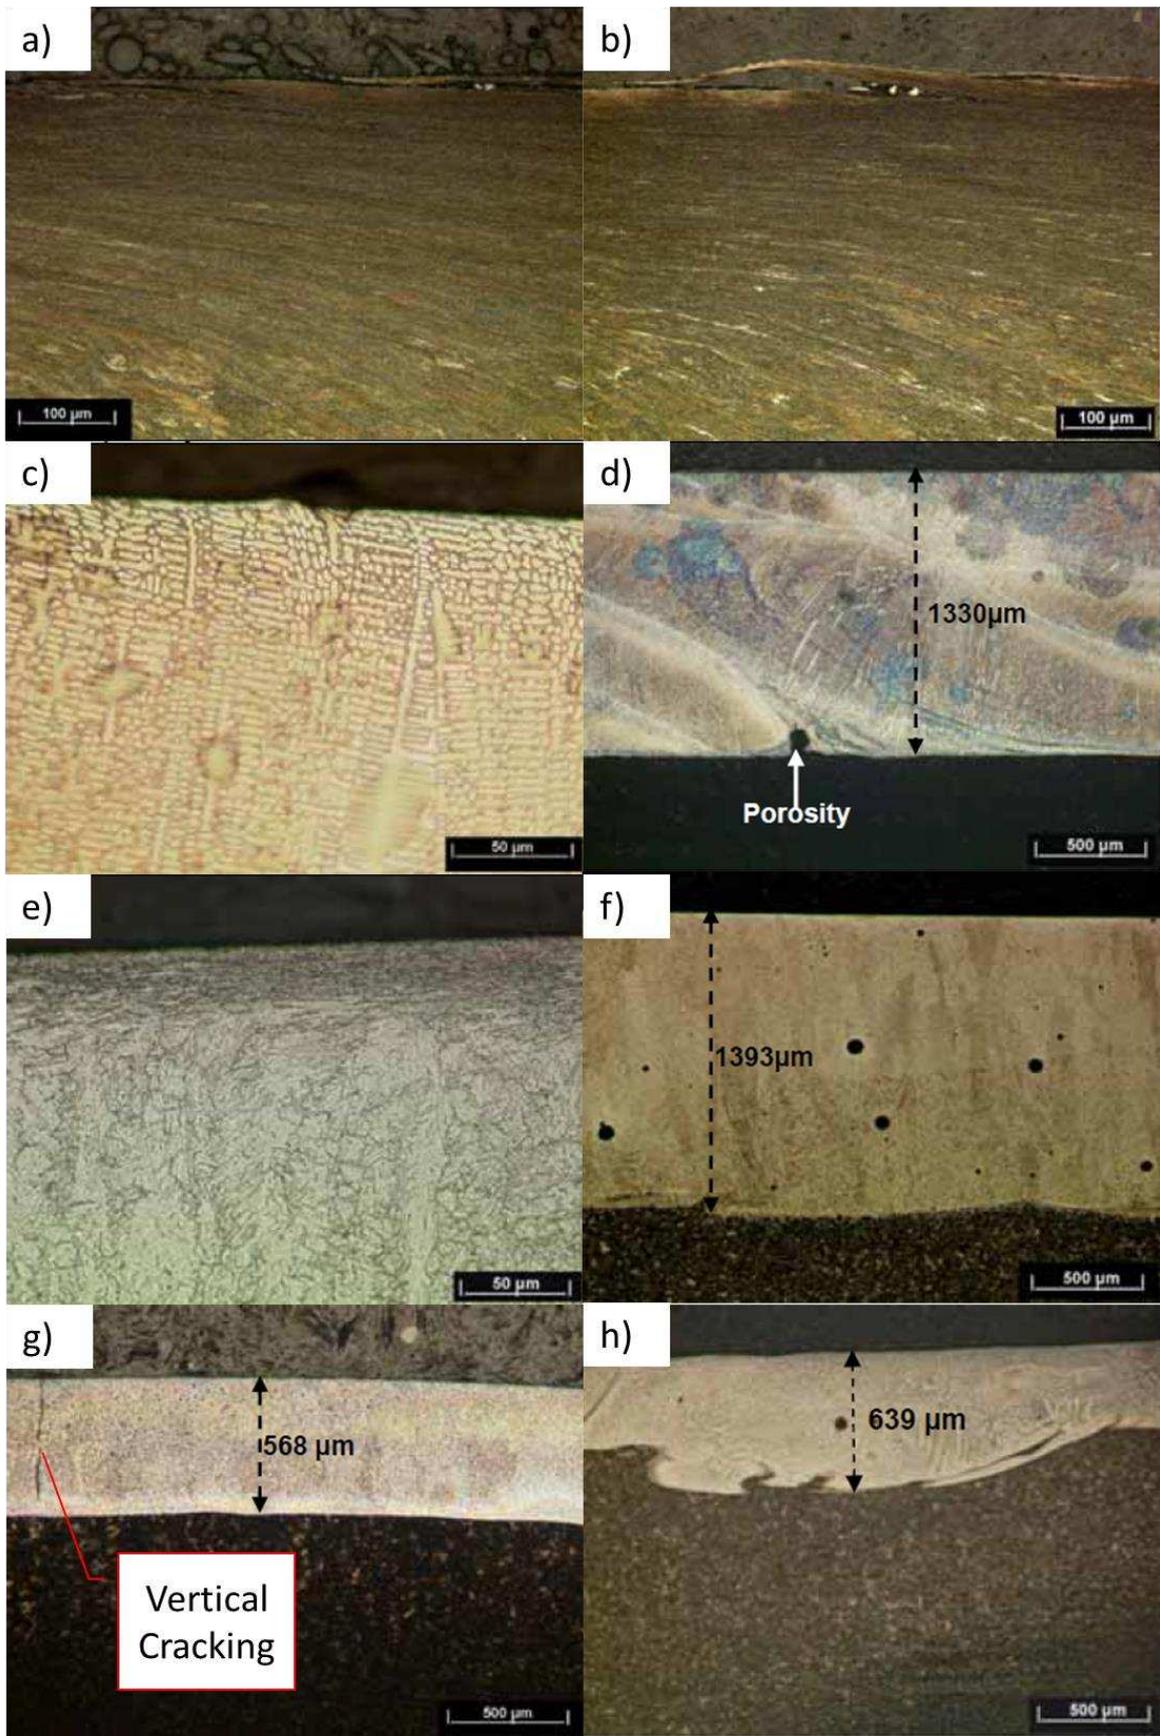
Each of the tested specimens along with an un-tested specimen of the same material were sectioned, polished, mounted and etched and then inspected under a light microscope. The quality of the deposit/interface, depth of deformation and surface damage was assessed. Electron Backscatter Diffraction, EBSD, was performed on some of the sections to gauge the amount of deformation below the surface and more information can be found in [7]. The microstructure of the HAZ of all the samples tested was also checked and found to consist of lamellar pearlite with no embrittling martensite structures seen. Figure 9 shows micrographs of a selection of the wear samples sectioned.

The R260 material clad onto a R260 specimen (Figure 9b) was only clad in two layers and it was found that the microstructure of the deposited layer was actually somewhere between that of R220 and R260 grade rail. This suggested that the carbon content of the deposit was somewhat lower than that of the parent R260 material.

The Stellite 6 specimen (Figure 9c) showed the best deposit quality being virtually porosity free and with excellent fusion at the deposit/substrate interface. This was closely followed by the MSS sample (Figure 9e) which also showed excellent fusion at the interface and only small areas of small porosity in the deposit. It is interesting to note that these two materials exhibited very low wear rates compared to the reference R260 sample.

The Stellite 12 (Figure 9d) sample also exhibited a relatively low wear rate. Sub-surface examination, however, revealed cyclic porosity on the clad/substrate interface. This porosity could potentially be a site for the nucleation of fatigue cracks. It is observed in the field that the failure of track component repair welds arises from inclusions within the weld itself. This porosity could potentially be eliminated with changes to the cladding parameters and despite its presence the Stellite 12 samples were still some of the best performers in terms of wear.

Figure 9. Subsurface micrograph of wear samples: a) Un-Clad R260 after 30,000 cycles, b) Clad R260 after 30,000 cycles, c) Stellite 6 2 Layer after 30,000 cycles, d) Stellite 12 2 Layer after 30,000 cycles, e) MSS 2 Layer after 30,000 cycles, f) MMV 2 Layer after 30,000 cycles, g) NiCrBSi 1 Layer un-tested, h) TWIP 1 Layer after 30,000 cycles

There was a large amount of porosity mostly present within the deposits of the 1 and 2 layer MMV samples (Figure 9f). Some of this porosity was very close to the interface and still had deposit powder trapped within it. The interfaces of both MMV samples was continuous with no lack of fusion.

Only the 1 layer NiCrBSi was assessed in the wear tests. The 1 layer deposit (Figure 9g) showed a small amount of porosity distributed within the sample. However, there was a vertical crack in the untested 2 layer disc which extended through the full thickness of the deposit. It is assumed that similar cracks were also present in the 1 layer sample. The interface of the 1 and 2 layer NiCrBSi discs was continuous with no lack of fusion. However, some porosity can be seen in the deposit close to the interface in the 2 layer sample.

Only the 1 layer TWIP sample (Figure 9h) was tested and was found to contain only minor porosity with some larger pores isolated within the deposit. This was the only sample which did not show an even clad/substrate boundary. The interface of the TWIP sample had a turbulent appearance. Whether this led to the high wear rate of the TWIP sample as seen in Figure 4 cannot be determined. However, it does suggest that the cladding parameters were not fully optimized which may have resulted in changes to the materials wear resistance. This is also supported by the marked increase in the porosity seen in the untested 2 layer sample. The amount of sub-surface deformation was much less than in the R260 reference sample despite the large amount of plastic flow which was seen on the running surface of the disc after testing.

The Stellite 12 (Figure 9d) sample also exhibited a relatively low wear rate. However, cyclic porosity on the clad/substrate interface is a potential site for the nucleation of fatigue cracks. It is observed in the field that the failure of track component repair welds arises from inclusions within the weld itself. This porosity could potentially be eliminated with changes to the cladding parameters and despite its presence the Stellite 12 samples were still some of the best performers in terms of wear.

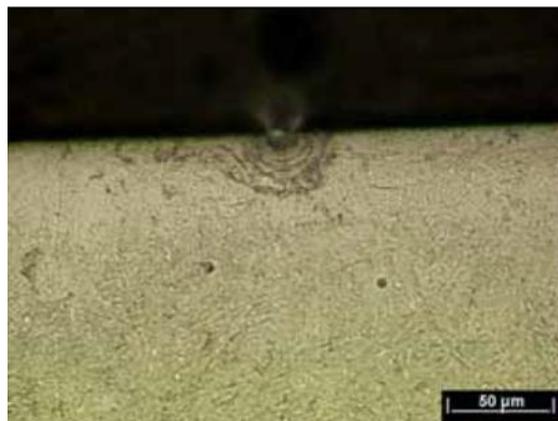
Figure 10. Subsurface micrograph of MMV 2 layer wear sample showing pore at disc surface with associated cracking after 30,000 dry cycles

Figure 10 shows an area of porosity at the surface of the 2 layer MMV sample. It can be seen that the material below the pore deforms to a much greater extent than the surrounding material and cracks have developed around the pore within this deformed region. Thus it can be seen that any porosity within the deposit is likely to be detrimental to the wear performance of the deposit.

The 1 layer MMV disc had extensive porosity throughout the deposit as seen in Figure 14. Cracks seem to have developed from the edges of the pores closest to the specimen surface similar to what was seen in the MMV wear sample as shown in Figure 10.

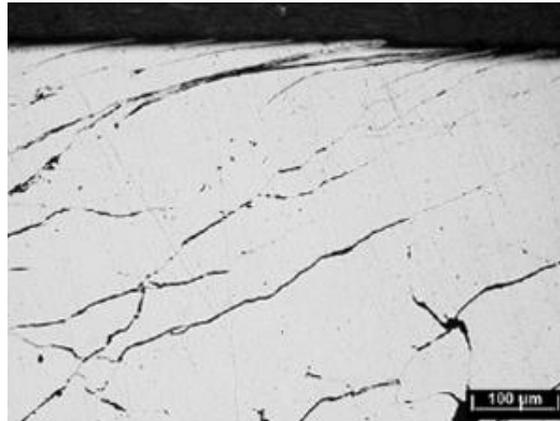
Sectioning of the RCF specimens revealed that the only specimens to show extensive RCF-like cracks were the un-clad R260 reference disc and the clad 2 layer R260 disc. A section of an un-clad R260 RCF specimen which failed after 32,500 cycles is shown in Figure 11. Figure 11 shows there is an extensive network of RCF cracks within the zone of heavy deformation. The depth of deformation in this sample was roughly 630 μm .

Figure 11. Un-etched subsurface micrographs of un-clad R260 sample which failed at 32,500 cycles. Sample is shown in the un-etched condition to aid the visualization of cracks

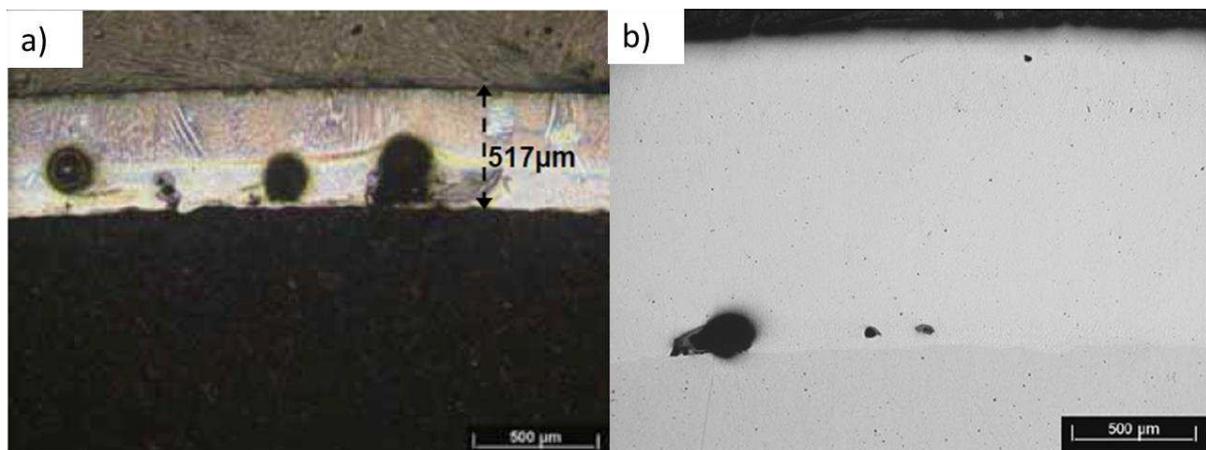
Although one of the best performers in terms of wear and RCF resistance, the Stellite 12 samples had gross porosity present within the deposit as seen in Figure 12. However, despite this the 1 layer sample which was tested to 50,000 cycles contained no RCF cracks and no evidence was seen of any surface damage or sub-surface deformation.

Figure 12. Subsurface micrographs of the Stellite 12 RCF samples: a) 1 layer sample after 50,000 cycles in the etched condition, b) 2 layer sample after 50,000 cycles in the un-etched condition

The 2 layer sample triggered the eddy current crack detector at 45,000 cycles but no evidence of surface damage or embryonic RCF cracks were seen when the samples were sectioned. No deformation in the deposit was seen either. It is likely that the detector was triggered by the gross porosity in the clad layer.

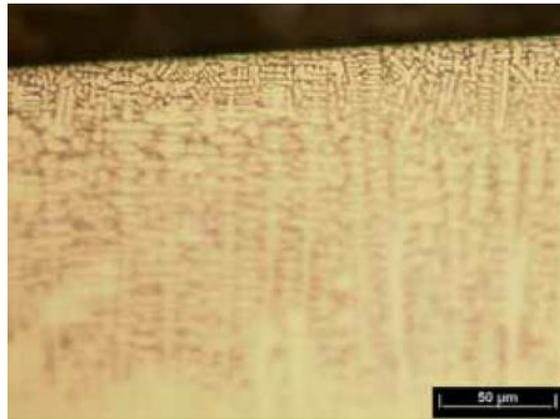
Figure 13. Subsurface micrograph of the 2 layer Stellite 6 RCF sample tested to 100,000 cycles in the etched condition

The 2 layer Stellite 6 RCF sample was internally free of porosity unlike the Stellite 12 samples. Some evidence of surface damage was seen in the 2 layer sample which was tested to 50,000 cycles. However, no subsurface deformation and hence no RCF cracks were seen. Figure 13 shows a second 2 layer sample which was tested to 100,000 cycles with the surface appearing virtually untested. EBSD performed on this sample showed no signs of subsurface damage.

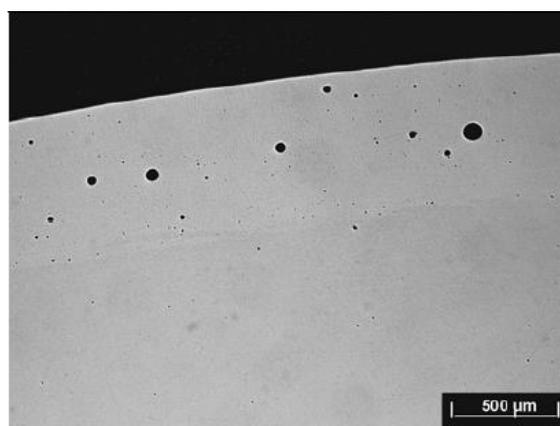
Figure 14. Subsurface micrograph of the 1 layer MMV RCF sample tested to 50,000 cycles in the un-etched condition

The uneven appearance of the MMV sample surface seen in Figure 14 is evidence of surface damage however, no embryonic RCF cracks were seen in the sample.

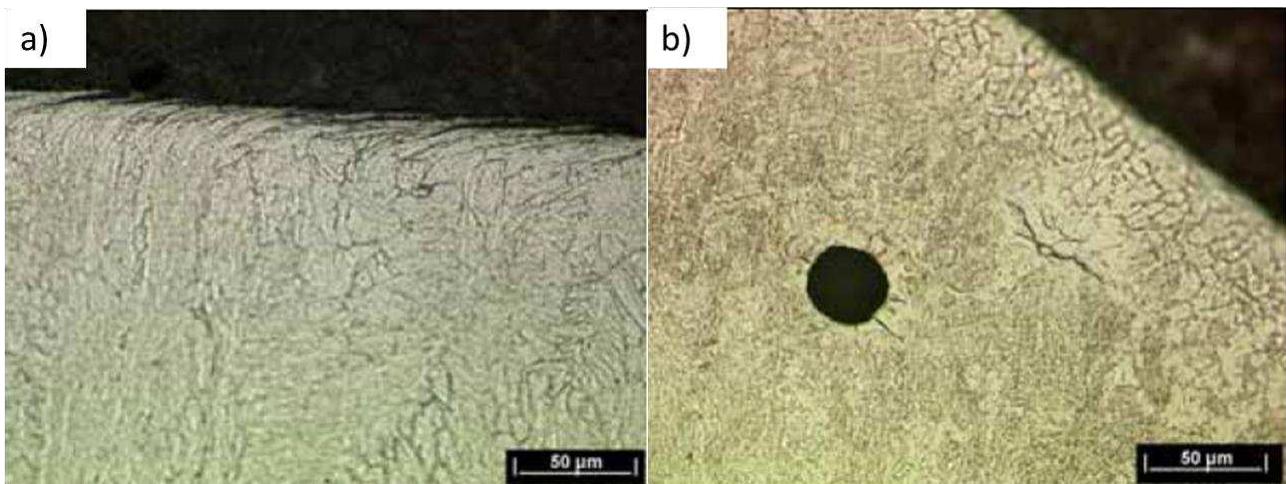
No RCF cracks were observed in the 1 layer MSS sample which was tested to 50,000 cycles. However, there seemed to be a shallow region of deformation between 20 and 50 μm below the surface of the sample. The 2 layer sample on the other hand showed signs of embryonic RCF crack formation at the surface and showed a greater depth of deformation as shown in Figure 15a.

Figure 15. Subsurface micrographs of the MSS RCF samples: a) 2 layer sample after 50,000 cycles in the etched condition, b) 1 layer sample after 100,000 cycles in the etched condition

A separate 1 layer sample was also tested to 100,000 cycles and was seen to exhibit less deformation than the 2 layer sample tested to 50,000 cycles. No typical RCF cracks were seen in this sample, however, cracks were seen around areas of porosity, as shown in Figure 15b; some of which were sub-surface and some exposed at the surface. EBSD showed that the depth of deformation in the 100,000 cycle sample is roughly 50 μm .

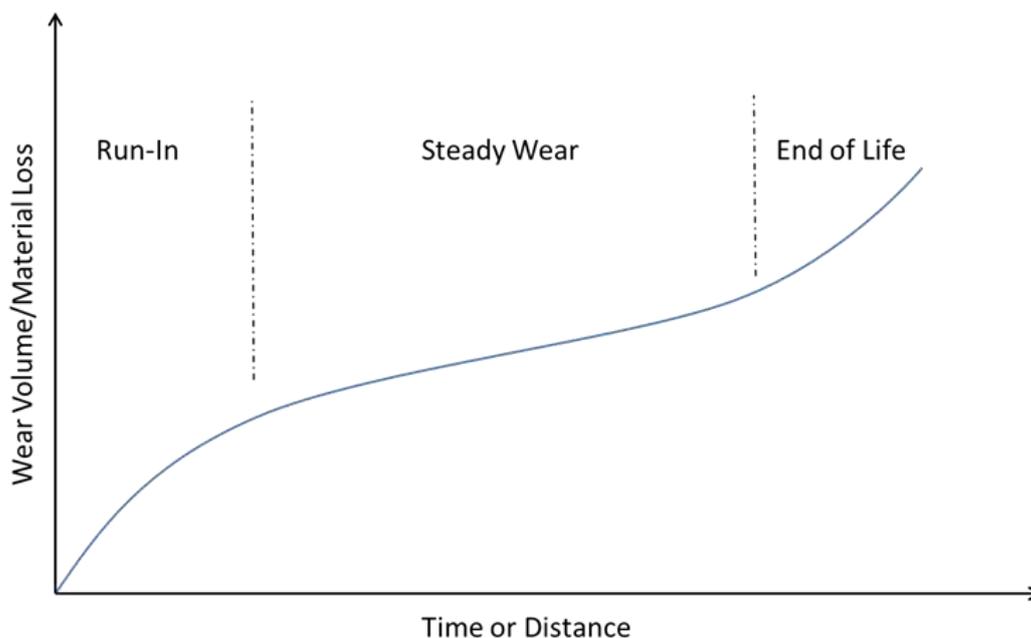
Figure 16. Typical wear behaviour over the lifetime of a component [8]

Due to the scaled nature of the tests and the range of mechanical properties of each of the materials tested it is difficult to say whereabouts 30,000 test cycles places each of the samples on the curve shown in Figure 16. It is possible that the samples in group 1 “Steady wear rate” may be in the “Steady Wear” regime as per Figure 16. It is also possible that those materials in group 1 do not exhibit typical wear behavior and instead transition straight to “Steady Wear”. Thus materials in Groups 2 and 3 which show increasing wear behavior may still be in the “Run-In” phase and may potentially show steady wear if the tests were continued beyond 30,000 cycles.

In this work wear has been expressed as a rate i.e. total mass loss divided by the number of cycles ($\mu\text{g}/\text{cycle}$). For the values of wear rate expressed in Table 1 it is easy to assume a linear amount of material loss over a given time frame. However, as shown in Figure 4, and discussed in great detail in [9], the wear rate is constantly changing as different wear mechanisms come to dominate due to shifts in wear transition. With reference to Figure 4 it seems as if 30,000 cycles was sufficient for most of the samples to transition into the “steady wear” regime as depicted in Figure 16.
