# When is a terrace not a terrace? The importance of understanding landscape evolution in studies of terraced agriculture

Before the invention of modern, large-scale engineering projects, terrace systems were rarely built in single phases of construction, but instead developed gradually, and could even be said to have evolved. Understanding this process of landscape change is therefore important in order to fully appreciate how terrace systems were built and functioned, and is also pivotal to understanding how the communities that farmed these systems responded to changes; whether these are changes to the landscape brought about by the farming practices themselves, or changes to social, economic or climatic conditions. Combining archaeological stratigraphy, soil micromorphology and geochemistry, this paper presents a case-study from the historic and extensive terraced landscape at Konso, southwest Ethiopia, and demonstrates – in one important river valley at least – that the original topsoil and much of the subsoil was lost prior to the construction of hillside terraces. Moreover, the study shows that alluvial sediment traps that were built adjacent to rivers relied on widespread

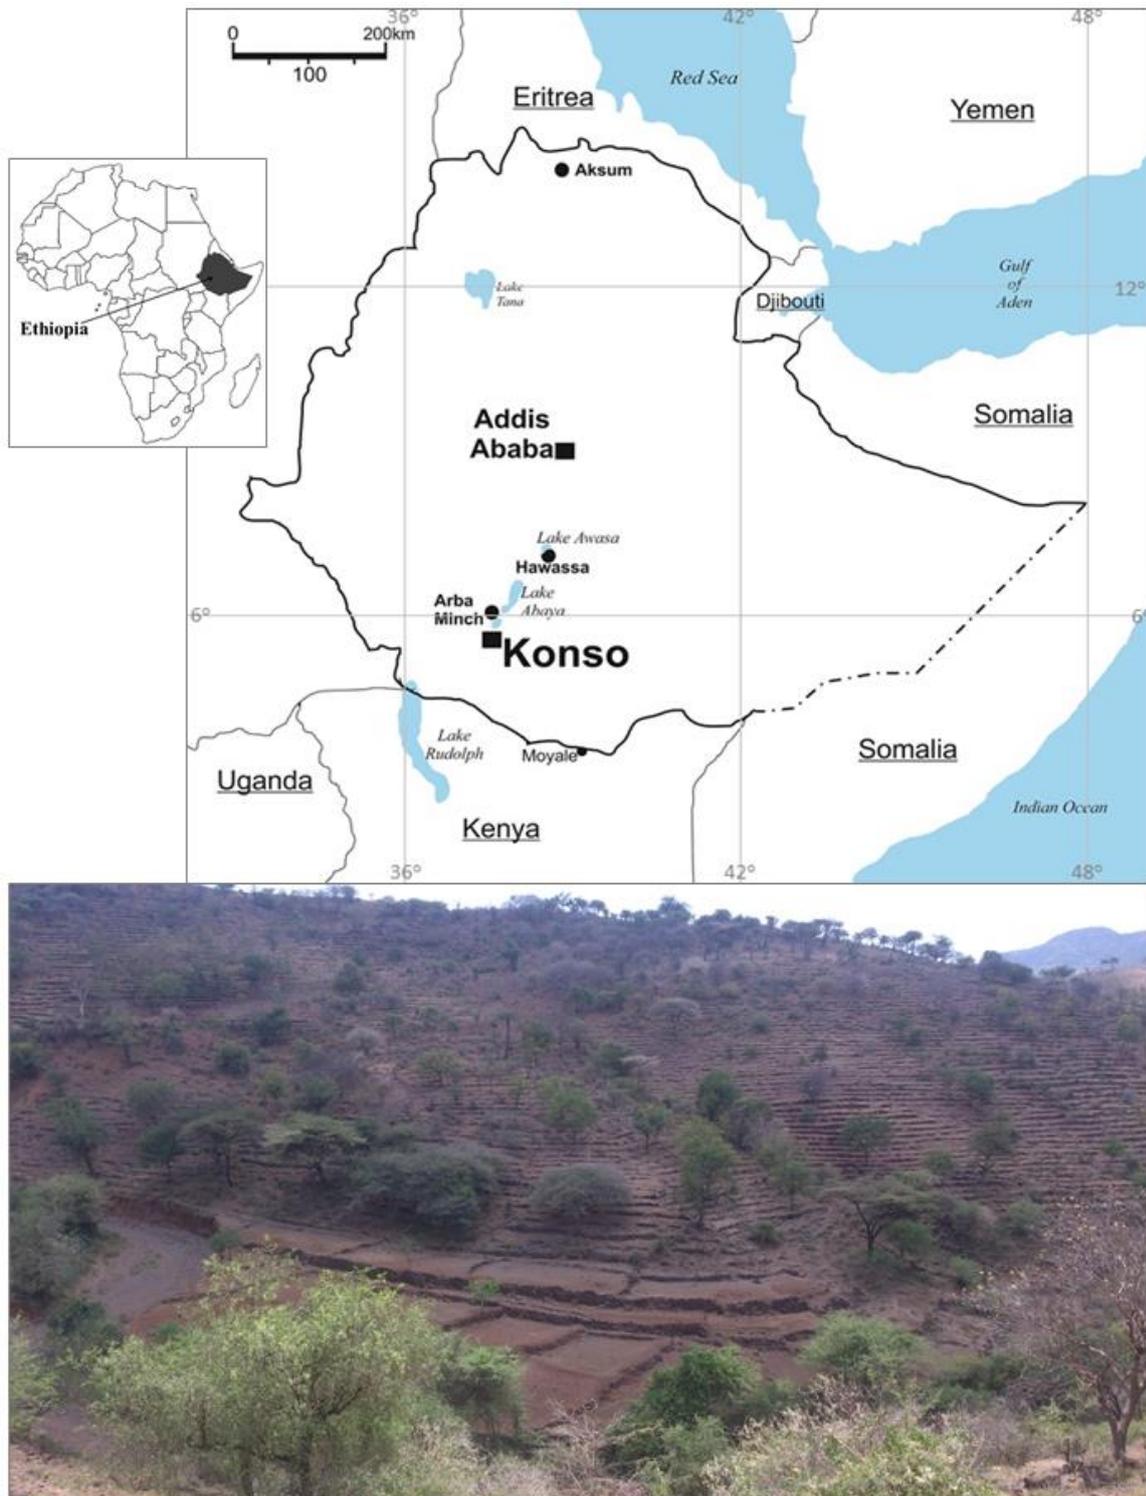
**Figure 1.** Above: location of Konso in relation to the administrative centre for the region (Hawassa). Below: hillside terraces (background) and *yela* sediment traps (foreground) in the Sahayto area, located in the northeast of the Konso highlands.

The work reported upon here focused on terraces located on a west-facing hill slope above the Kilkilo river basin in the Sahayto area (Figure 1), with this area chosen for three reasons. Firstly, because the northeastern corner of Konso contains the highest concentration of historic walled towns, is said by some oral traditions to be the historic heartland of the Konso settlement, and is the area consistently described by visitors from the 1950s onwards as containing the densest and best maintained terraces. Secondly, the area contains both terraces that are currently cultivated and examples that are said to have remained uncultivated for 10 years or more. Finally, the area includes both hillside terraces and riverside sediment traps, in many places with these two types of fields physically abutting one another.

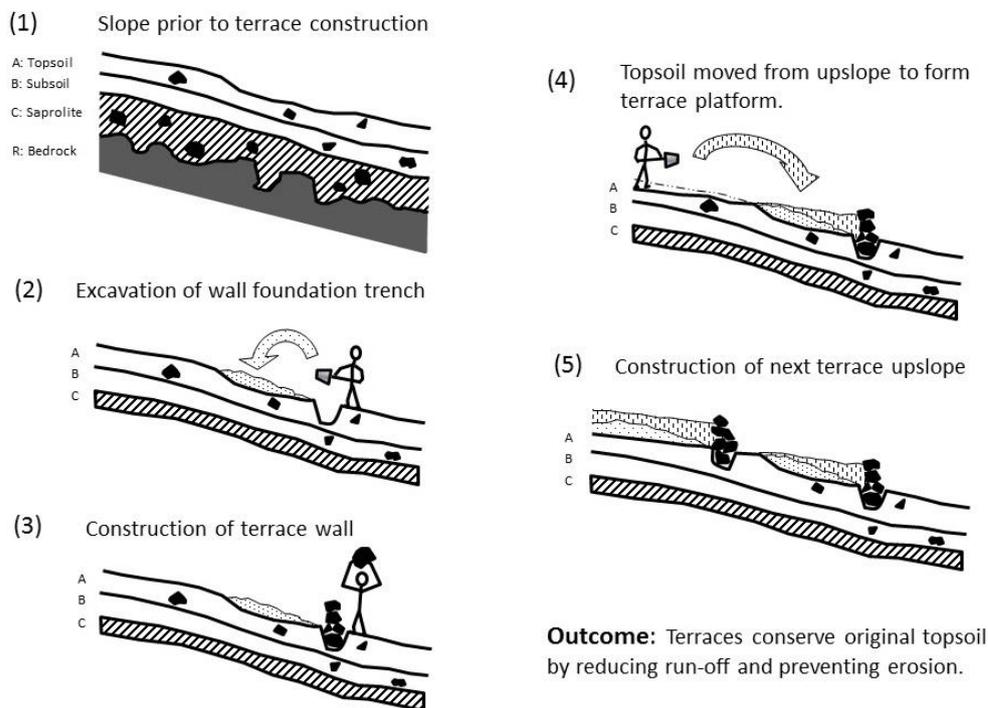
**Figure 2: Schematic representation of the process of hillside terrace construction as described to Beshah (2003). Compare this schematic to that based on excavation, Figure 4.**

landscape is comprised predominately by bench terraces (e.g. Förch, 2003; WOCAT, 2010); a reasonable conclusion given that some sources describe terrace construction as starting with the excavation of a ‘foundation trench’ (Beshah, 2003 uses the term "basement") into which the lower courses of a dry-stone wall are inserted, which is then followed by the dragging of soil from upslope to create a broadly level cultivation platform, with subsequent terraces being built progressively up the slope (cf Amborn, 1989; e.g. Beshah, 2003). Although this does indeed broadly describe one method of building a bench terrace (Figure 2), aspects of this account seemed questionable, particularly the function of the wall foundation cut. It is therefore worth attempting to confirm or refute this characterisation, especially given that Beshah’s informants merely described this process, and noted that although old terraces are still maintained, no members of the community have participated in the building of new terraces.

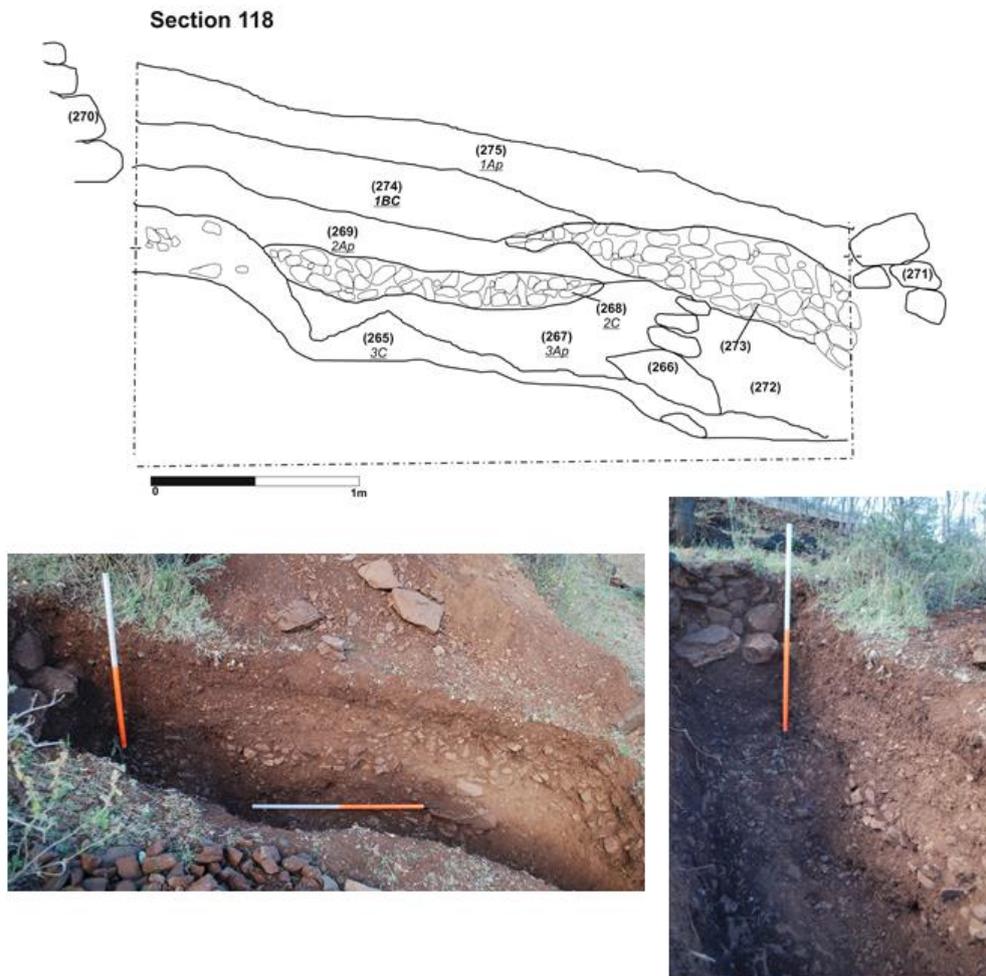
**Figure 3: Scale drawings and photographs of hillside terrace deposits within Section 118. Photographic scales all 1m.**

Section 118 stratigraphy and pedological features has been chosen among all the hillside locations excavated, since this is the most illustrative and is the only location to include unambiguous evidence of earlier terraces buried beneath the terrace walls that are currently visible at ground level. Its stratigraphic sequence (Figure 3) shows a layer of weathered saprolite above the fresh basaltic bedrock, assigned record number (265). This is physically beneath three later deposits: former terrace soils (267) and (272) and former dry-stone terrace wall (266). Stratigraphically, the sequence of deposition of these three deposits is ambiguous, but the most likely sequence is that wall (266) was built to contain terrace soil (267), and that the wall was subsequently buried on its downslope side by the deposition of (272). Importantly, former terrace soils (267) and (272) are distinct in terms of color, the presence of charcoal, and the sharpness of their boundaries to the underlying saprolite (see soil horizons descriptions in online supplementary materials, SM2), demonstrating that they are not

two parts of the same deposit that has been truncated by the excavation of a foundation trench for the construction of wall (266).

These observations have two significant ramifications. First, that wall (266) was built directly on to either exposed bedrock or exposed relic saprolite, meaning that the original topsoil and subsoil had been eroded away prior to the construction of this terrace wall. Second, the lack of a subsoil layer between saprolite (265) and the physically overlying terrace soils (267) and (272) demonstrates that these palaeosols have not developed in situ within the terrace, and instead have been deposited. Taken together this suggests at least two broad phases of erosion and deposition took place, with the first phase removing the topsoil and subsoil to expose the saprolite or bedrock, while a subsequent later phase incorporated material into the terrace formed by wall (266).

Thereafter terrace soil (267) was partially buried by stoney layer (268), which was in turn buried by terrace soil (269); a sequence of deposition that is later repeated by the deposition of stoney layer (273) and the overlying former terrace soil (274). Seen in relation to the downslope terrace riser wall (271) it is clear that the upper of the two stoney deposits is directly associated with the construction of wall (271), and it is therefore surmised that the earlier stoney layer and its overlying palaeosol also represent the remains of a constructed terrace; the (presumed) wall for which may have been removed when (273) and (271) were deposited. Construction of this terrace was then completed by the

deposition of the layer that also forms the modern topsoil (275) which stratigraphically postdates palaeosol (274) and physically buries stoney layer (273), thereby creating a relatively stone-free cultivation layer. Although on the basis of stratigraphic data the upslope terrace wall (270) could have been built immediately after the deposition of former cultivation layer (269) it is equally possible that this wall sits within a trench cut that post-dates current topsoil (275); an interpretation that would fit with observations from other excavation sections, and which could be regarded as receiving support from the descriptions of terrace construction recorded by Amborn (1989) and Beshah (2003 105).

Section 118 thus shows the construction of three and probably four terraces: first the terrace associated with wall (266), then that represented by stoney layer (268) and the subsequent palaeosol (269), followed by the terrace bounded on its downslope side by riser wall (271), and finally by the construction of wall (270). In terms of pedegenic classification the deposits thus form a 1Ap, 1BC, 2Ap, 2C, 3Ap, 3C, R sequence. This is perhaps clearest if illustrated, and a simplified schematic of this sequence is presented in Figure 4.

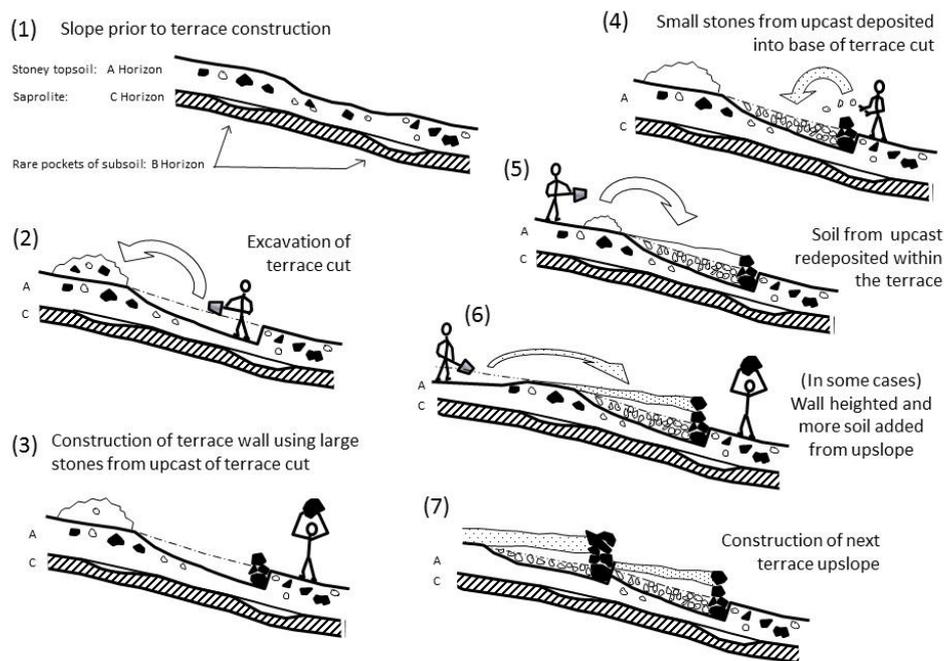
**Figure 4. Sequence of hillside terrace construction as revealed by stratigraphy and soil descriptions, demonstrating loss of original topsoil and most subsoil prior to terrace construction, and suggesting that terracing was undertaken partially to reduce the number of stones in the upper rooting zone. Compare this sequence to that described during interviews shown in Figure 2.**

Since the stratigraphic sequence of the investigated hillside terraces shows that the agricultural landscape expanded up the slopes from the valley bottom (Figures 3, 4 and 6), this suggests the earliest terraces would have been conceived specifically as a means of protecting the agriculturally important and irrigable *yela* fields. Furthermore, the stratigraphy of the excavated locations, illustrated by the sequence of Section 118, shows that most of the terraces surveyed in the catchment have been constructed directly on the saprolite, indicating that the original slope material was already eroded when the terraces were built. This supports the idea that *yelas* were the key agricultural resource in an early stage of the system, as they were constructed and heightened by capturing topsoil that was being eroded from the non-terraced slopes upstream.

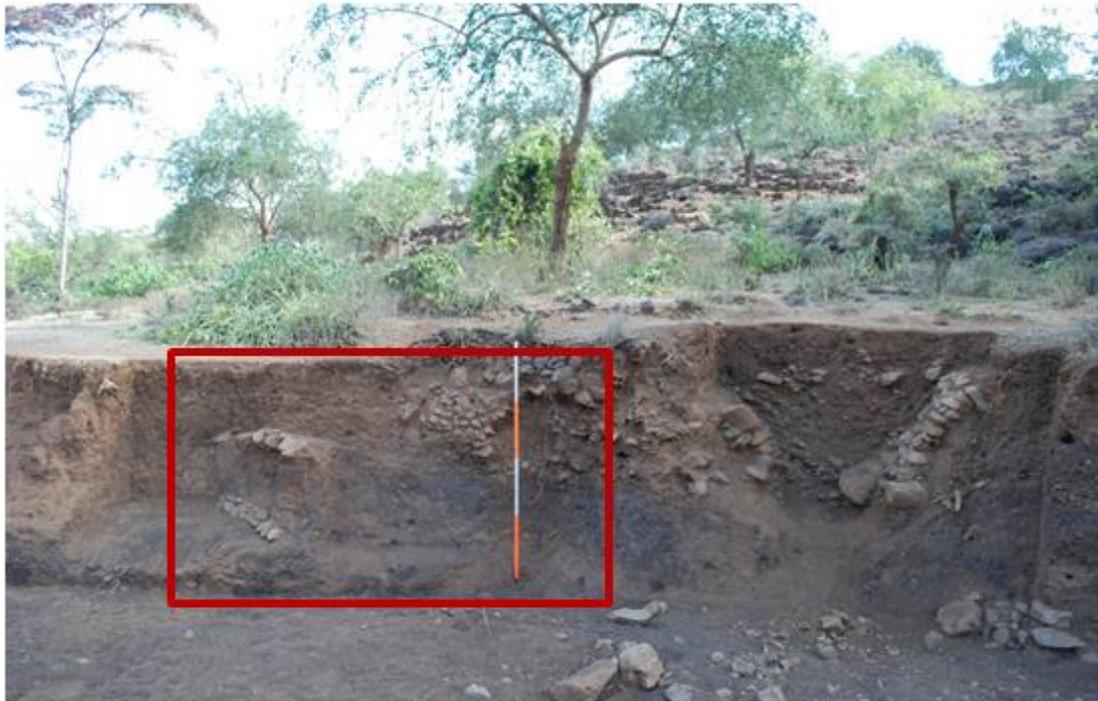
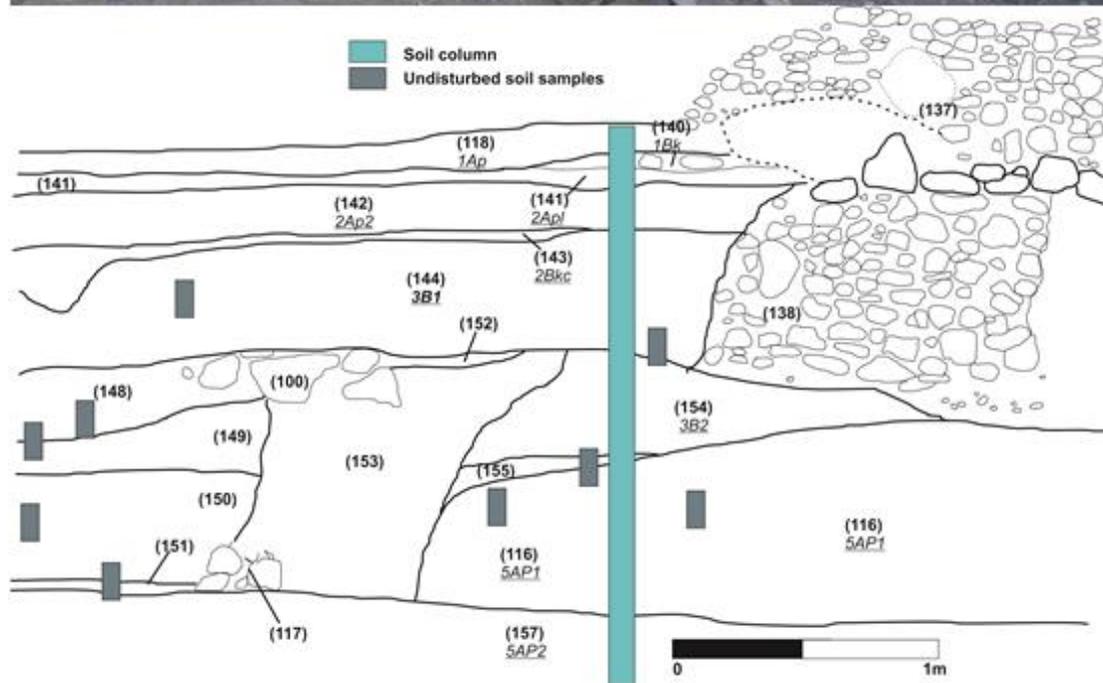
**Figure 5: Photograph and scaled drawing of east-facing Section 102. The blue rectangle indicates the position of the soil sampling column, and the grey boxes mark the undisturbed samples collected for micromorphological analyses. Numbers in brackets indicate the depositional events as described in the field. Note that the drawing shows oblique segments of the drystone walls (137), (138) and (117) and the packing deposit behind wall (100)/(117): (153). The drawing does not show true cross-sections of these walls, therefore. The seasonal river at this location flows from north to south. Photographic scale 2m**

Section 102 (Figure 5) is located immediately adjacent to a seasonal river, the bank of which was cut back to reveal the depositional sequence. Neither bedrock nor saprolite were revealed in this section, with the earliest deposit being a dark brown alluvial (i.e. water deposited) layer (157). Data confirming the alluvial origin of this deposit are presented below, but support for this conclusion is also provided by the stratigraphic relationships between the later walls and sediments within this profile. This is because the drystone walls all consist of a single line of facing stones backed by gravel packing, and are inclined at an angle of between 60 and 75°, meaning that these walls are not self-supporting and rely on the deposits of fine material behind them for their integrity. Each wall is

then subsequently buried by later deposits of fine material, which are themselves contained by inclined walls. The only process that accounts for these observations is if each wall is built incrementally by no more than three courses at a time, since this would seem to be the maximum number of courses that could be supported by the gravels placed behind and beneath the inclined drystone courses; these deposits of gravel typically extending for no more than 60mm behind the wall. Fine sediments entrained within running water are then captured behind the wall, permitting more drystone courses to be added and subsequent alluvial sediments to be captured. Once this manner of sediment accumulation had been identified, questions regarding this construction method were asked of local informants, who noted that this technique was now rarely used but that a field of this type is known as a 'yela'.

The earliest *yela* wall revealed in Section 102 immediately follows the deposition of the earliest sediment in the sequence: (157). This wall, (117), was supported by gravel packing layer (153), with both the drystone face of this wall and its associated packing periodically extended as alluvial layer (116) gradually accumulated. Following the accumulation of (116) a change in the depositional regime deposited the gravelly and pebbly deposit (155), which was followed by fine material (154), the latter very similar to the earlier deposits (116) and (157). These deposits all accumulated behind the earliest wall; the single course of stones marked on the section drawing at (100) being merely the surviving upper course of the wall that started life as (117). Thereafter, this pattern of sediments being deliberately captured behind drystone walls continued with the construction of wall (138) above former *yela* field deposit (154), and the accumulation of predominantly fine material against the face of wall (117)/(100): in chronological order (151), (150), (149) and (148). Following a period in which (148) was presumably farmed, a further batch of alluvial sediments were captured, starting with (144) and ending with (141), after which wall (137) was built along broadly the same orientation as the pre-existing but now almost entirely buried wall (138). Finally, the current topsoil (118) was deposited.

Stratigraphically, then, this one cross-section includes elements of six distinct *yela* fields (i.e. one field each side of the three walls), or seven if it is assumed the lowermost deposit (157) also accumulated in a *yela* for which the associated wall falls outside the limits of the excavation. However, based on the morphological characteristics of the soil core, it is possible to identify two main soil units. The upper one is represented by the reddish clays interspersed with gravel layers that postdate the completion of wall (117)/(100). The six soil horizons postdating the construction of wall (138) thus form the upper soil unit (in pedogenic terms: 1Ap, 1Bk, 2Ap1, 2Ap2, 2BkC, 3B1, 3B2) from 0 to 105 cm depth, differentiated mainly by textural changes and sometimes separated by gravel and stone lines, the most visible one being at 35 cm depth (143; a 2BkC horizon). The deposition of this layer appears to have been an event of sufficient force to scour a channel into the underlying sediment (144). Colour, structure and consistency are quite homogeneous in this upper soil unit.
