# Excavations at Sheffield Manor Lodge 1968-80

Dawn Hadley & Deborah Harlan with a foreword by Pauline Beswick

### **Excavations at Sheffield Manor Lodge 1968-80**

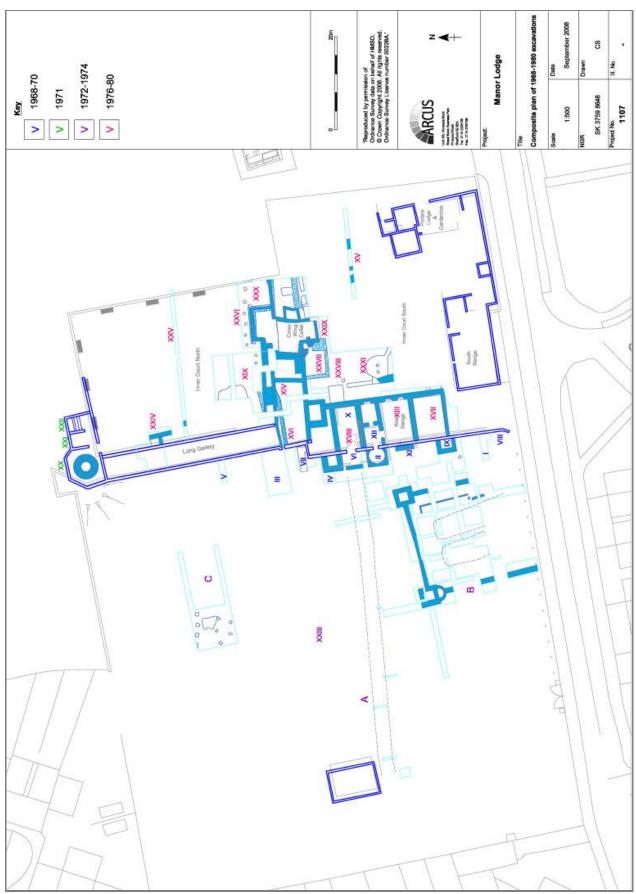
Fig. 4 – Plan of the location of the excavations undertaken between 1968 and 1980 (copyright: University of Sheffield)

The excavations undertaken between 1968 and 1980 were intended to throw important new light on the visible remains at Manor Lodge. Over the course of 12 years the excavations focussed on the western range of buildings of the hunting lodge, the long gallery and the tower at its northern end, and both the inner and outer courtyard (fig. 4). In each season one of these areas was tackled, with a specific set of questions about the development of the site in mind. It was observed at the start of the excavations that each area presented its own problems for interpretation, which it was hoped that archaeological investigation would answer. A phased plan of excavation was devised beginning with a known area and proceeding into areas where little information was available. The excavations were initially directed by Alan Butterworth, and from 1971 by Pauline Beswick.

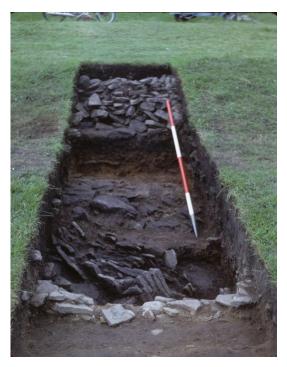
Fig. 24 – The entrance road that ran through the outer courtyard

In Area A, one test trench excavated in 1972 was set directly over an anomaly in line with the entrance to the hunting lodge. The entrance had been excavated in 1969, when part of the road surface across the outer courtyard had been identified (see above; fig. 9). In 1972, more of the original paved road surface, which was 2.5m wide, was located. It had edging stones, making the total width of the causeway 4.5m, with a drainage channel on the south side (fig. 24). Above this was

evidence for possible re-surfacing in the late eighteenth century, using eighteenth-century kiln debris for the foundations. The road, however, does not appear in a survey conducted in 1781 by William Fairbank (fig. 27) and it had presumably gone out of use by this time.

In 1973, excavations in Area A aimed to establish the route of the entrance road. A series of test trenches were laid out to confirm the line of the road (fig. 24; see also upper fig. on back cover). Despite considerable disturbance from eighteenthand nineteenth-century building activity near the Turret House that cut into the road surface, it was established that the road ran alongside the south wall of the house. In the south wall of the Turret House there were slots up to the level of the first string course, which suggested that a gate was formerly positioned across the road here. Historical evidence indicates that the Turret House was constructed in the last quarter of the sixteenth century: an account in a notebook of William Dickenson, the Earl of Shrewsbury's bailiff, dated to 1574, refers to payments for building work 'at the Turrett', and the measurements given equate to the size of the standing remains (Wigfull 1924).

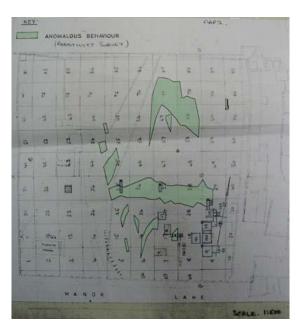
Fig. 26 – Plan of the grid system implemented for excavation in the outer courtyard, with anomalies identified by the resistivity survey highlighted

The outer courtyard was termed 'Site XXIII', following on from the sequence begun in 1971. Three of the areas of anomalies detected by resistivity were investigated, each of which was sub-divided by trenches. It should be noted that in 1973, a new method of excavation was initiated, which saw the switch to a 10m square grid system (figs. 25 and 26).

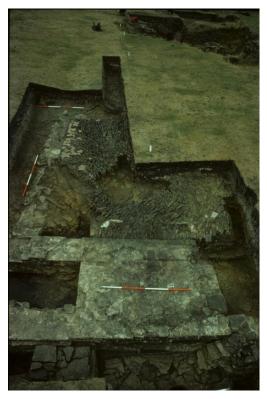
Fig. 35 – Parts of two rooms of the cross-wing excavated near the southern end of the long gallery in Site XIV (looking south). The remnants of an internal wall can be seen on the left-hand side of the photograph, with pitched stonework on the bedrock to form an internal floor surface. The base of the fireplace is beneath the ranging pole

Next to the room with the fireplace excavated in Site XIV in 1976 (fig. 35), was another smaller room with a similar floor make-up. Parallel with the north wall of the cross-wing was a line of four substantial post-holes cut into the bedrock. The fill indicated that they were contemporary with the sixteenth-century building. Because they were
