This is a repository copy of *Repair and reinforcement of timber columns and shear walls – A review*.

White Rose Research Online URL for this paper:
<http://eprints.whiterose.ac.uk/124972/>

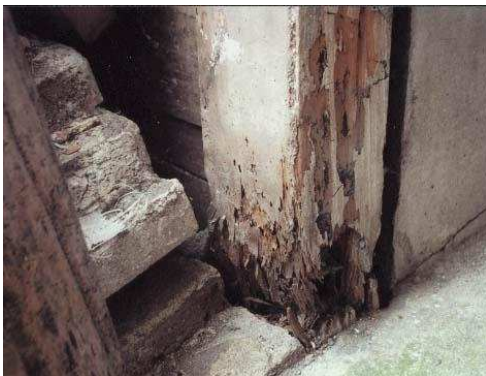
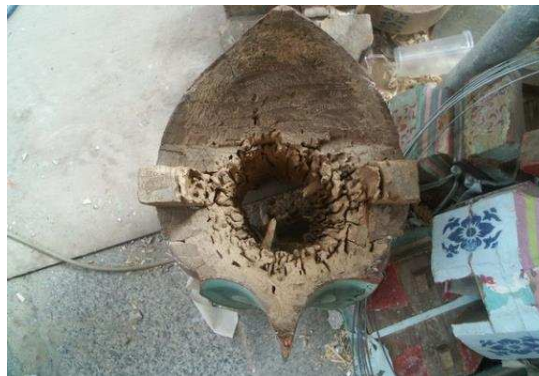
Figure 3 Bio-deterioration in a column that has contact with the ground Figure 4 Timber strut attacked by termites

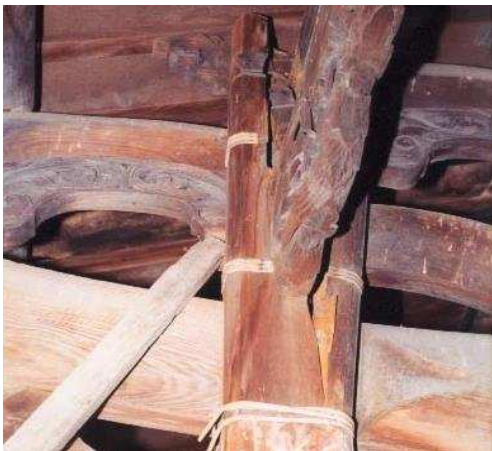
Figure 5 A column damaged due to an earthquake

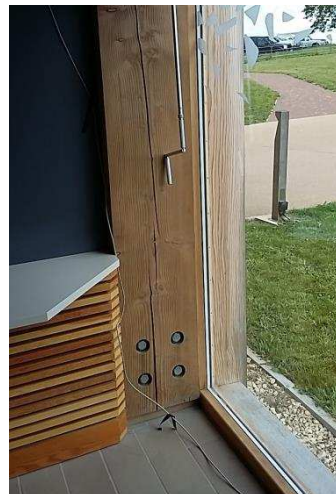
Figure 6 Vertical cracks occur in a column

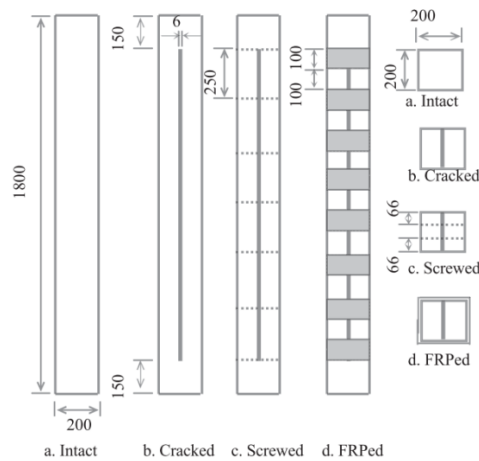
15
 16 Figure 9 Specimen design of repairing cracked timber column by using screws and FRP pads
 17 [5]

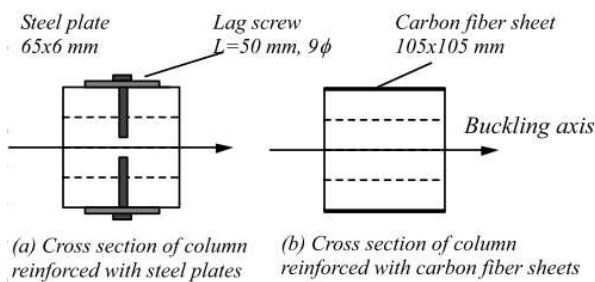
Figure 12 Section of the columns reinforced by steel plates and carbon fibre sheets [6]

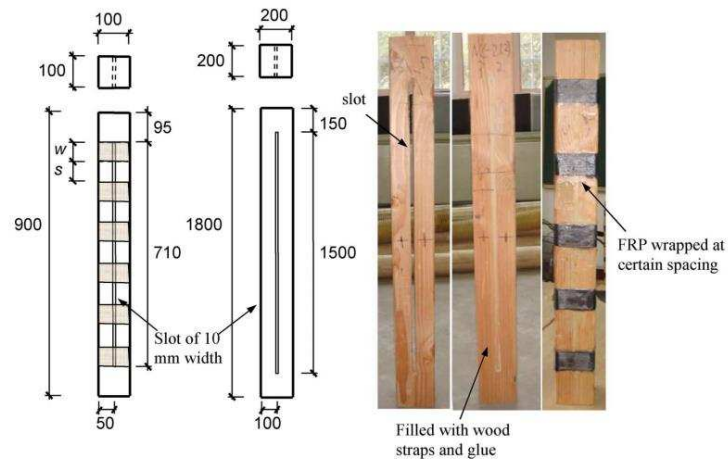
1
2 Figure 14 The specimens and different factors considered in the series of tests carried out by
3 Zhang et al. [12]

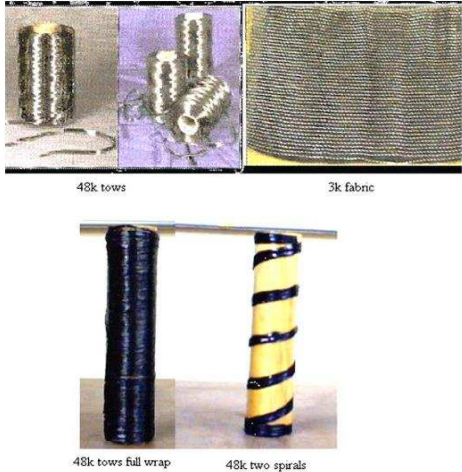
Figure 15 Column specimens and carbon reinforcement used by Najm et al. [16]

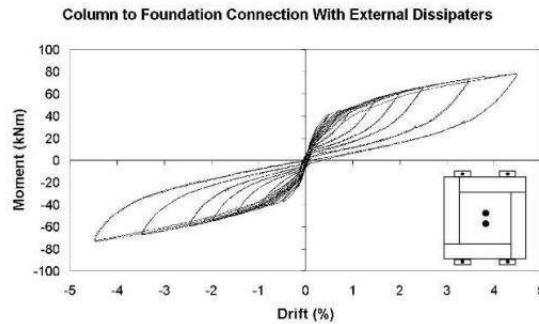
Figure 19 Hysteretic loop of a post-tensioned strengthening LVL column [17]

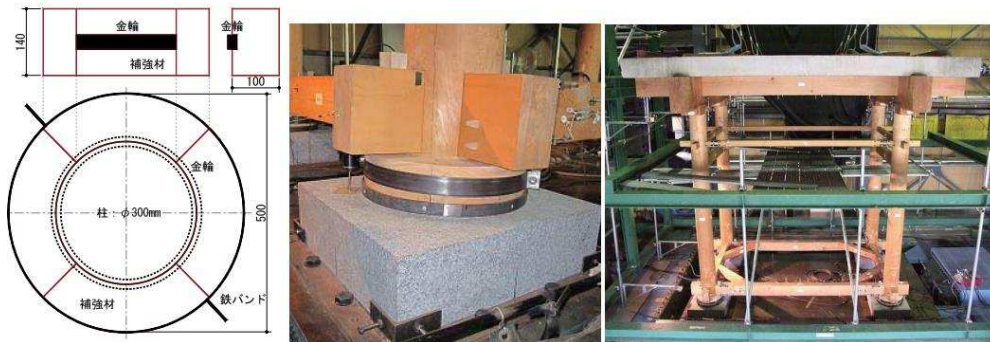
Figure 20 Enlargement of column base proposed by Suda, Tasiro and Suzuki [20]

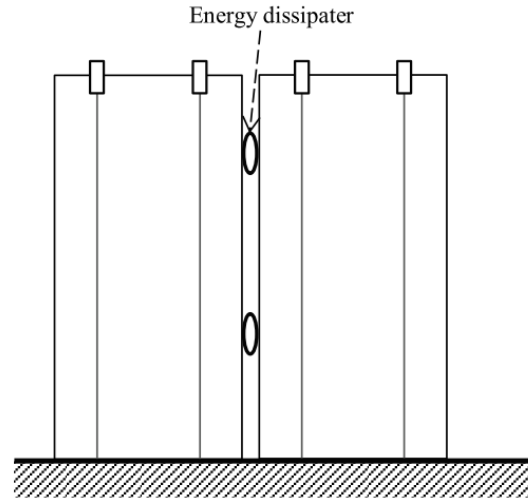
Figure 24 Schematic illustration of coupled post-tensioned timber shear walls

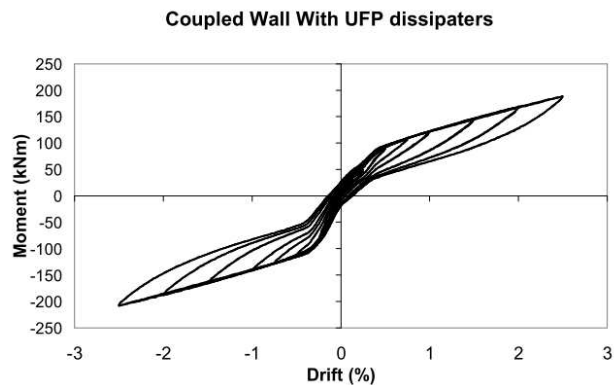
Figure 25 Hysteretic loop of coupled walls [17]
