Gadi, VK, Bordoloi, S, Garg, A et al. (3 more authors) (2018) Effect of shoot parameters on cracking in vegetated soil. *Environmental Geotechnics*, 5 (2). pp. 123-130. ISSN 2051-803X

Effect of shoot parameters on cracking in vegetated soil

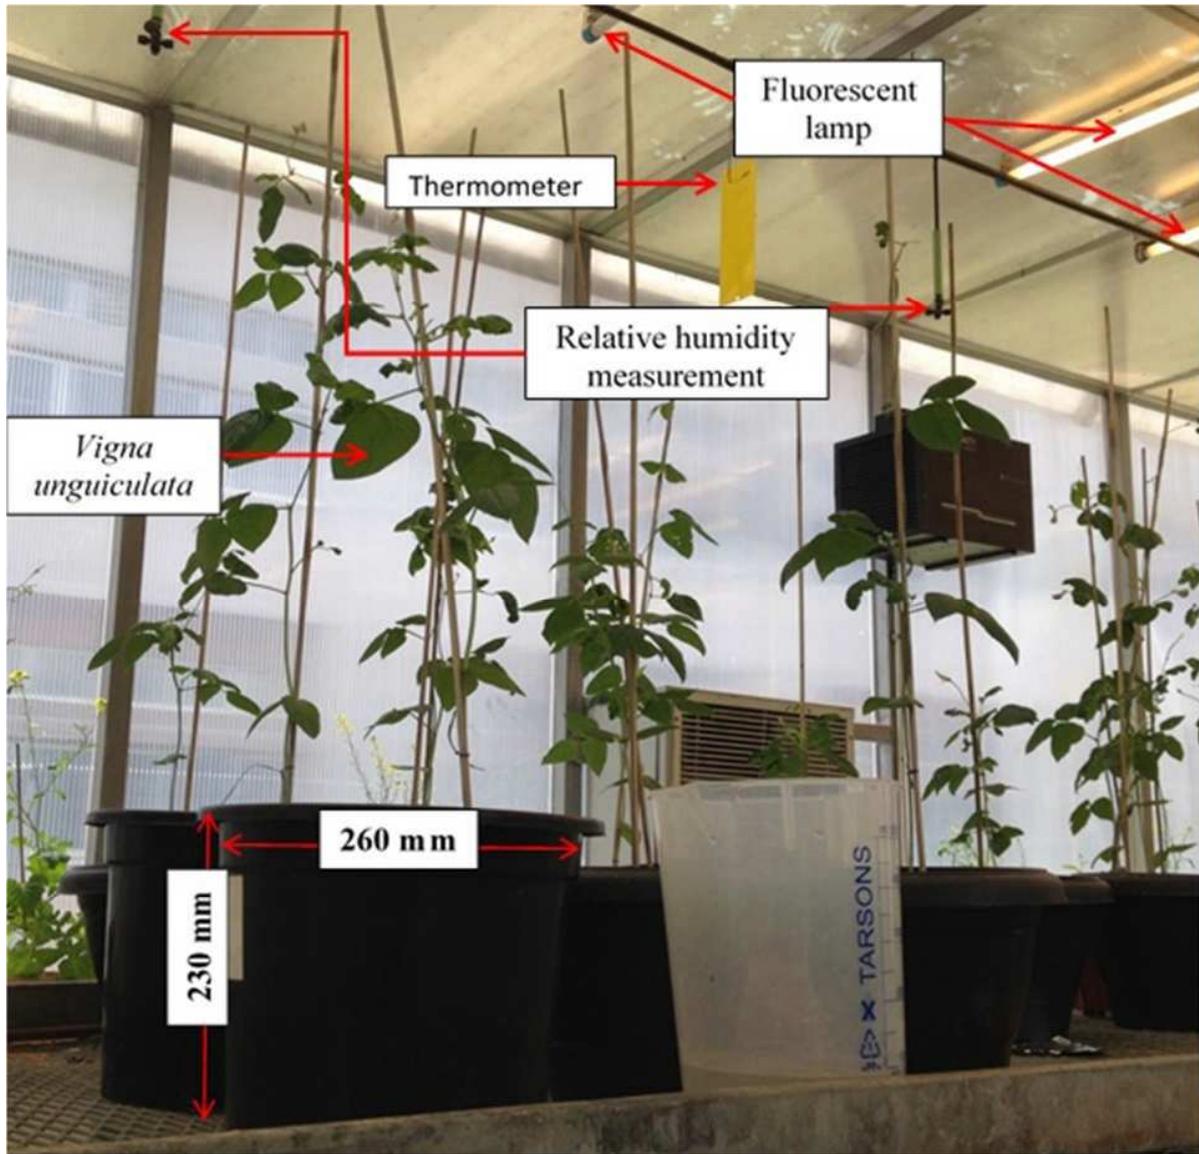
Fig. 1 Overview of experimental setup placed in greenhouse.

The relative humidity and temperature were observed at $52 \pm 8 \%$ and $26 \pm 4 \text{ }^\circ\text{C}$, respectively. To provide radiant energy to the legume seedlings, a provision of white fluorescent lamps capable of emitting light with photosynthetic photon flux density of $50 \mu\text{mol m}^{-2} \text{ s}^{-1}$ was mounted on top (2.5 m from floor base). The cylindrical pots used to conduct experiment were made from PVC plastic in house. Its dimensions are 260 mm diameter and 230 mm depth with perforated base to allow water drainage from the bottom. The soil was compacted in three equal layers to maintain a uniform density of 1.3 g/cc (equivalent to 0.77 maximum dry density of soil) up to 185 mm from bottom. All the 10 pots were irrigated (400 mL per pot using a watering can) regularly after 3 days of interval as shown in **Fig. 2** after transplantation. Evapotranspiration and evaporation rate of the 5 vegetated and 5 bare pots respectively was measured by observing change in weight. **Fig. 2** shows the mean and standard deviation of evaporation/evapotranspiration rate after transplantation (3 day interval). The weight change of vegetated soil pot over a drying cycle was measured using weighing balance. The measured change in weight indicates the loss of water i.e., evapotranspiration. Similar to this, change in weight of bare soil over a drying cycle due to loss of water was reported as evaporation. It is to be noted that the evapotranspiration and evaporation rate noted in the study has been calculated for all 10 different pots individually. SL for all the vegetated pots has been measured using a metric scale at the same 3 day interval after transplantation. The surface crack formation and leaf area photos have been captured regularly after 9 days interval starting from 15th day after transplantation, using image analysis as discussed

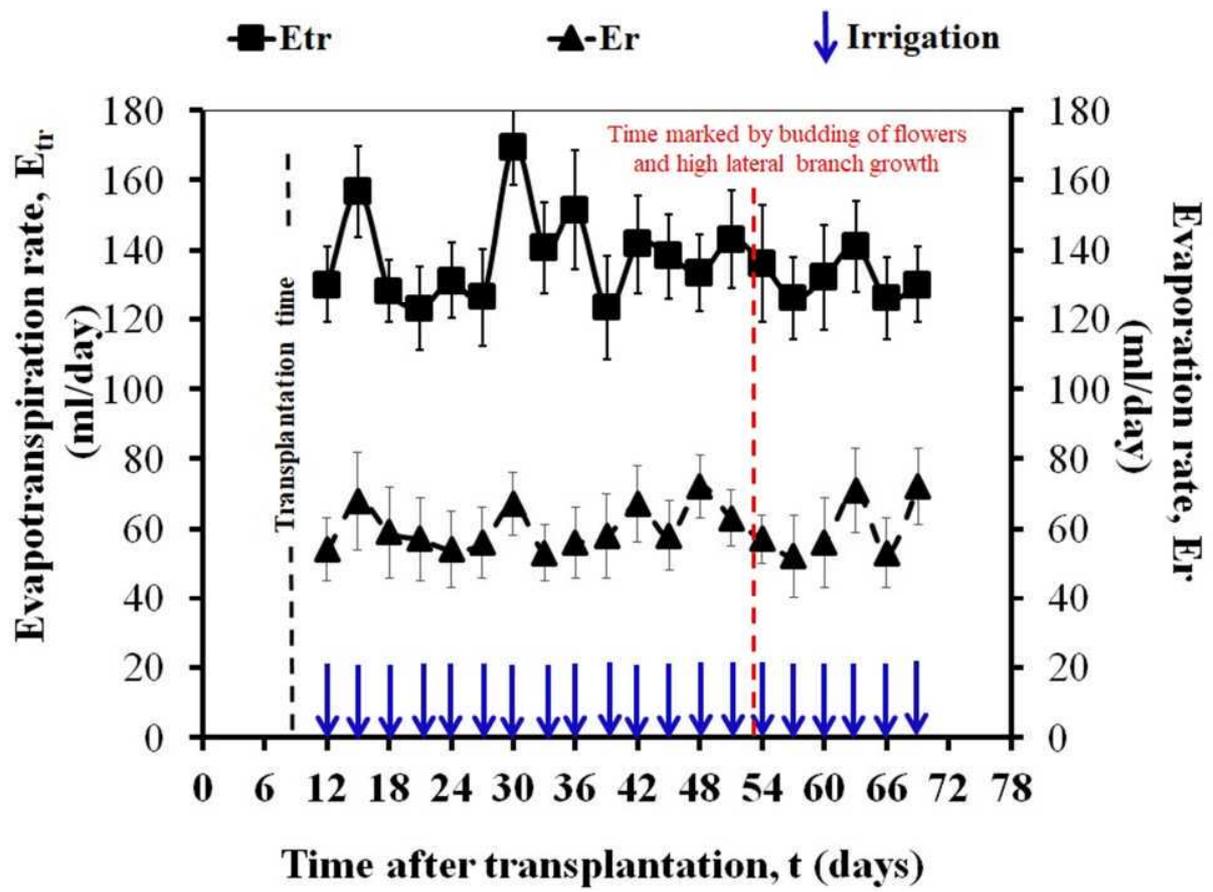
Fig.2 Measured evapotranspiration and evaporation rate of soil along with irrigation schedule during testing period.

A test plan is designed to quantify and compare CIF between bare and vegetated soil in controlled irrigation for a period of 70 days until the plant completes reproductive growth stage. Apart from irrigation, plant parameters were subjected to natural environmental conditions. All the experiments were conducted in a greenhouse (**Fig. 1**). In total, 10 pots (5 vegetated pots, 5 bare pots) were monitored in the test duration. The seedlings of the plant species were germinated and transplanted to the 5 pots. All the 10 pots were irrigated at a regular interval. The evaporation/evapotranspiration rate was measured regularly and reported in later section. The SL

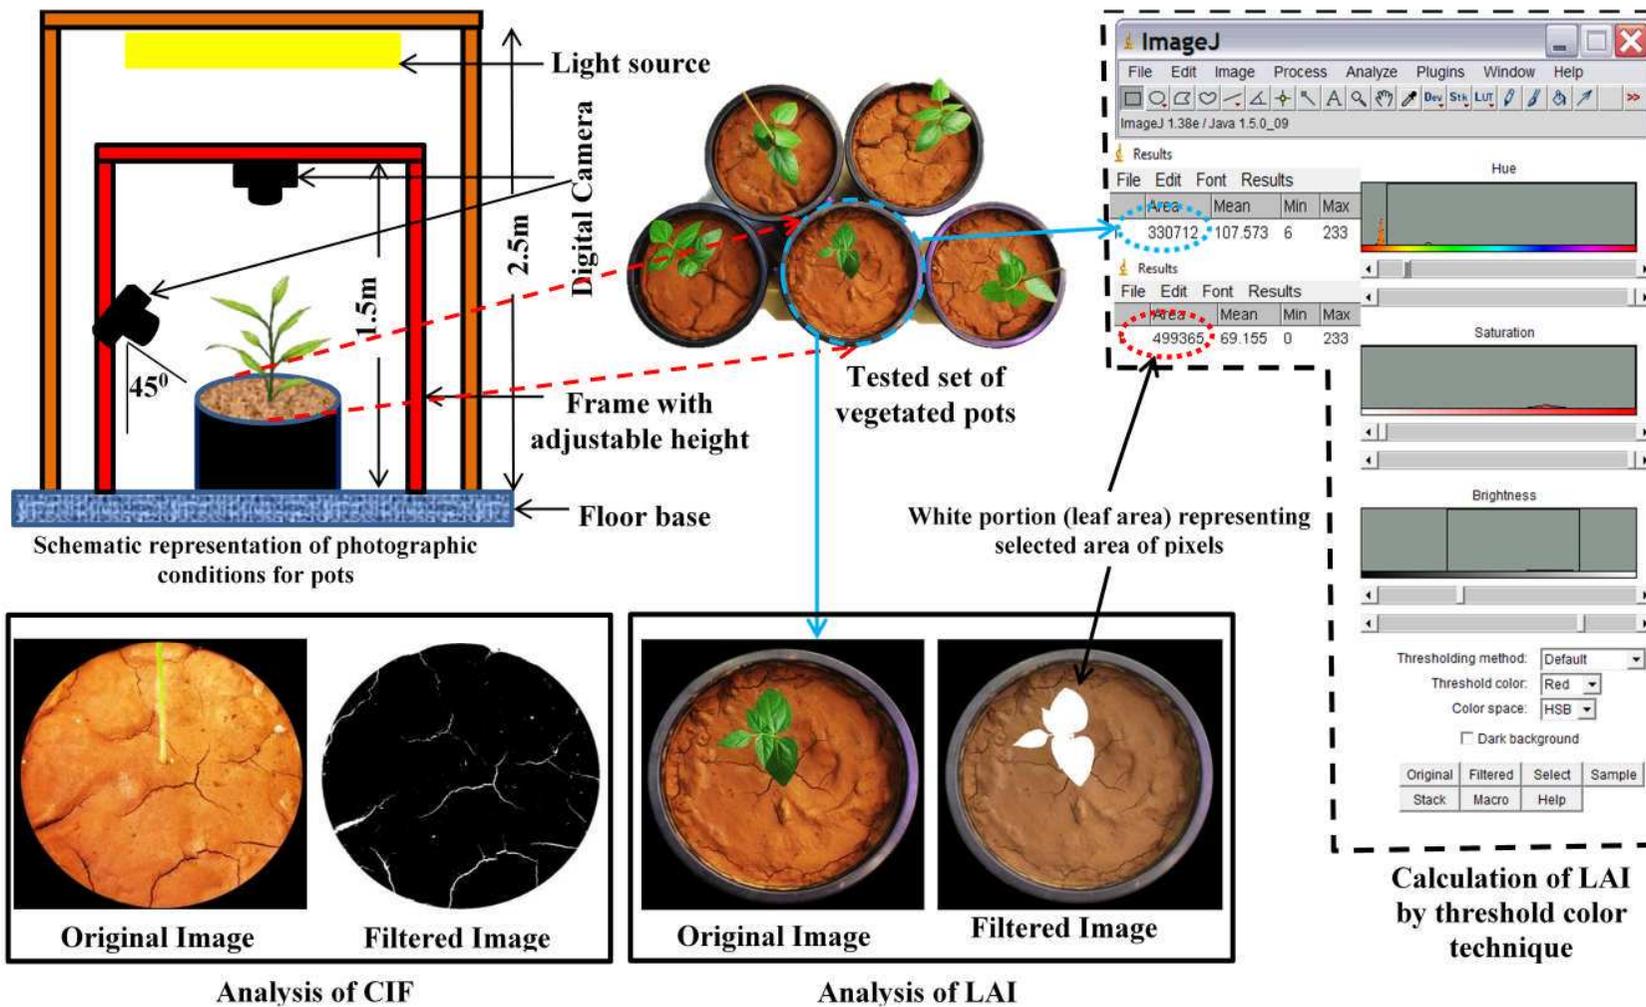
Fig.3 Determination of LAI and CIF respectively by image analysis using threshold color technique.

In order to calculate the areas, the cropped image was transformed into binary image as shown in **Fig. 3**. The pixels that are occupied by the cracks (white portion) and by the total soil surface (both white and black) is calculated to obtain CIF of soil. To ensure equal soil surface area analyzed for all pots, each pot was calibrated to account for equal number of pixel area. This was done by maintaining same height and angle of captured image and it was cross checked by observing the pixel area (accuracy of $\pm 2\%$) for the soil pot. For example in **Fig. 3**, 560 cm² soil area of pot (dia = 26 cm) was calibrated to 7719028 pixels.

The LAI of the vegetated soil is obtained using color threshold technique using ImageJ. As in the case of CIF calculation, the captured image is imported into ImageJ, and the digitized image is cropped to only account for the plant canopy as shown in **Fig. 3**. To calculate the leaf area, the cropped image was adjusted (for hue, saturation and brightness) using (Threshold Color) option in the software (refer **Fig. 3**). Under this option, only those pixels are selected that fall under the leaf color (white portion in **Fig. 3**). These pixels are calculated and taken into account as leaf area. The ratio of the leaf area and total plant canopy area is used to calculate LAI. Any noise (unwanted area) was subtracted in both measurements (CIF and LAI).

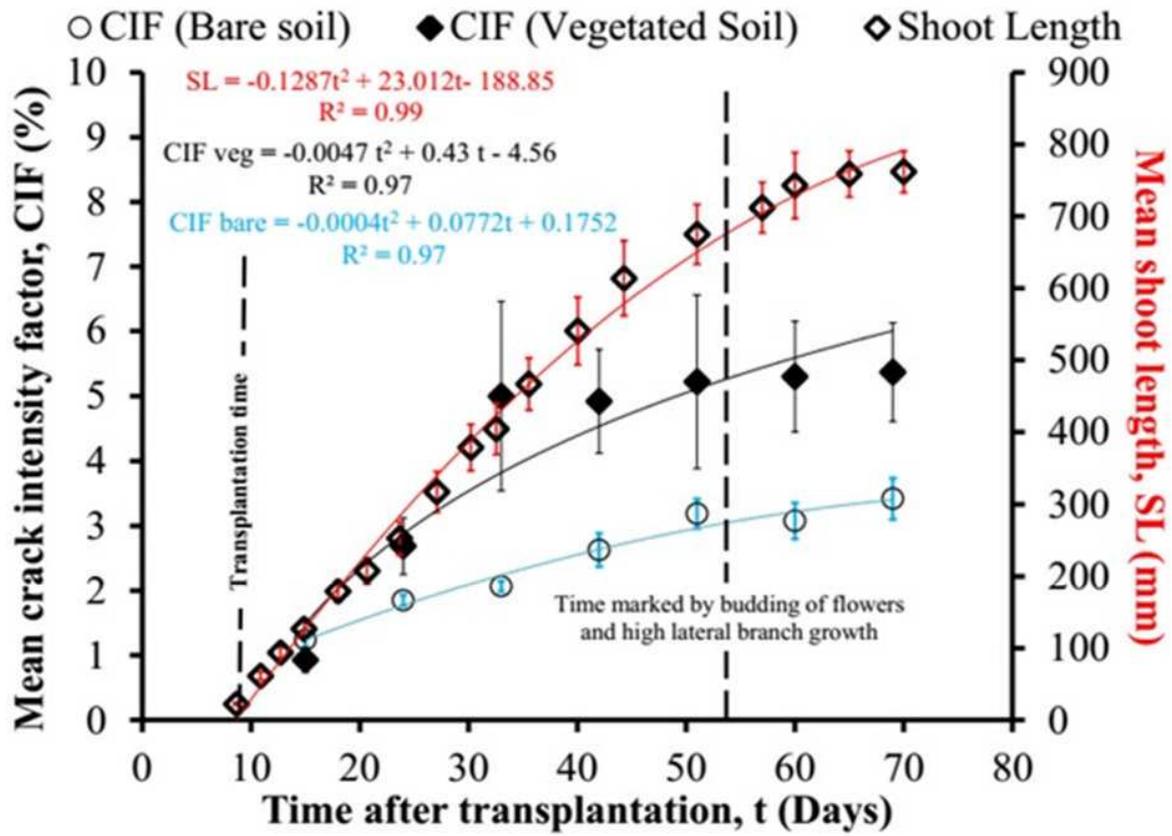
1
 2 **Fig.4** Variation of (a) CIF (bare and vegetated soil) and SL of plant with time (b) Binary image
 3 representation of cracks (white section) with time for a single pot (bare and vegetated soil).

As shown in **Fig. 4(a)**, the mean CIF value for bare soil increased almost from 0.93 to 3.22 up to 51 days. From 51 to 70 days, the CIF value is seen to be relatively constant. This trend has been observed in previous literature (Tang et al., 2012; Li et al., 2016; Wang et al. 2017). The CIF variation for bare soil has been fitted and represented in Equation 1. The R² value of Equation 1 is

On the other hand, for vegetated soil, a similar trend has been observed in variation of CIF for the first 33 days in all 3 vegetated pots. The mean CIF increase from 0.93 to 5 for the initial 33 days and the CIF remained relatively constant thereafter up to 70 days. The CIF values for vegetated soil were observed to be greater than bare soil as shown in **Fig. 4(a)**. This relative increase of CIF values for vegetated soil can be attributed to transpiration induced suction. As observed in **Fig. 2**, the evapotranspiration rate of vegetated soil is much higher than the evaporation rate of bare soil. This results in relatively higher suction (transpiration induced) in vegetated soil and correspondingly induces more cracks as compared to bare soil (Garg et al., 2015a, b, c; Leung et al., 2015b). The CIF variation for vegetated soil has been fitted into a logarithmic equation and represented in Equation 2. The R^2 value of Equation 2 is 0.97.

The SL variation throughout the experiment span has been monitored for all the five vegetated pots up to 70 days. A linear increase in mean SL has been observed initially up to 50 days at the vegetative stage of the plant as shown in **Fig. 4**. After 50 days commencing the reproductive growth stage which is marked by flower budding, the SL growth rate decreases. This slowing down of SL is due to energy of the plant being expended for flower growth. This has been fitted as a second degree polynomial equation in Equation 3. The R^2 value of the equation is 0.99.

The effect of SL on crack formation is proportional up to 33 days. With increase in SL there is a visible increase in CIF as shown in **Fig. 4**. This is due to increase in transpiration due to plant growth throughout this period. This period of plant growth is marked by preliminary growth of lateral branches (with leaves), which take part in enhanced transpiration. After 33 days of shoot growth (i.e. SL = 400 mm), the CIF values showed no visible increase but remain constant thereafter. The relationship between SL and CIF for the plant species has been fitted to give a three degree polynomial equation and represented in Equation 4. The R^2 value in Equation 4 is 0.97.

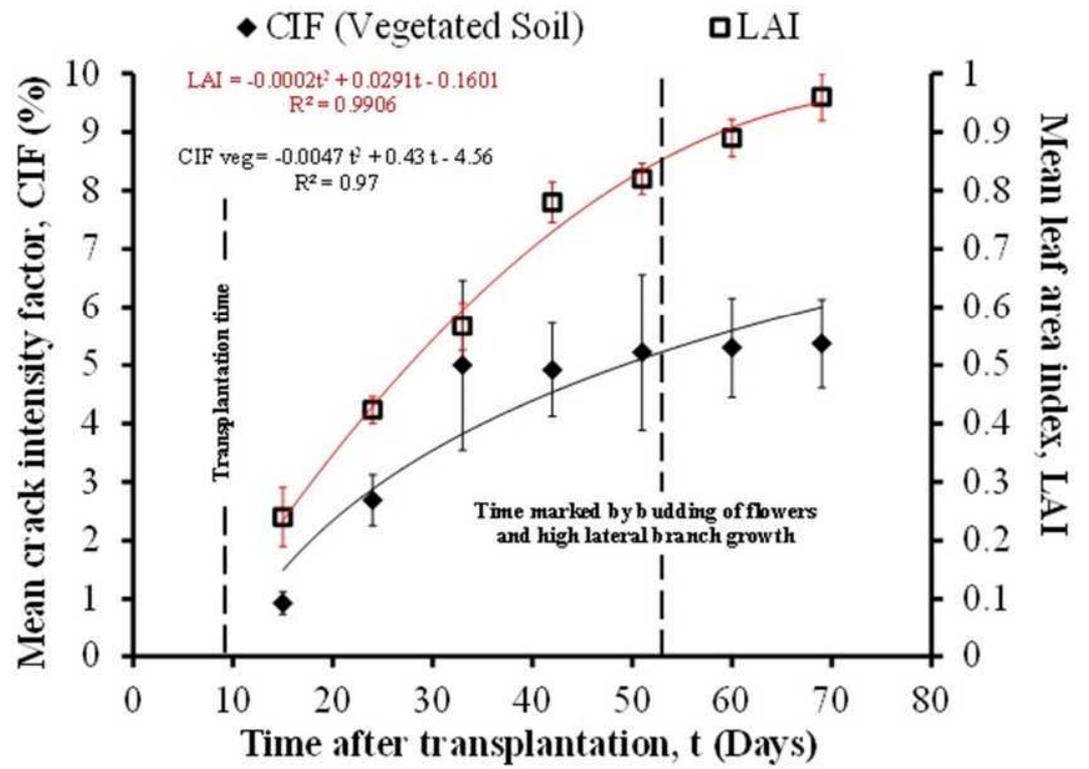
(A)

The LAI variation for the entire testing period has been measured using color threshold analysis using ImageJ. As shown in **Fig. 5(a)**, LAI increased from 0.24 to 0.96 with increase in time. This LAI variation with time has been fitted in Equation 5. The R^2 value is 0.99 for Equation 5.

As in the case of SL, the effect of LAI on crack formation is proportional up to 33 days after which the CIF remains relatively constant. The LAI corresponding to 33 days after transplantation was 0.56. The relationship with LAI and CIF for the entire testing period has been fitted in a two degree polynomial equation as shown in equation 6. The R^2 value of equation 6 is 0.96.

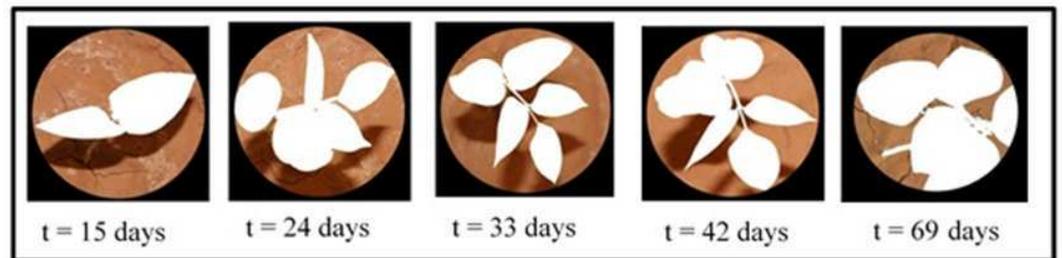
(B)

In this study, LAI values are found to be low for the cow pea plants (less than 1). However, grass species may exhibit relatively higher LAI values (Garg et al., 2015b) and the equation may not be valid for such species with higher LAI. Further studies are needed for other type of species with higher LAI. The LAI variation for a single pot has been shown in **Fig. 5(b)**. It is evident that there is a gradual increase in LAI with time.
