# Threshold Maps for Inclusion-Initiated Micro-Cracks and White Etching Areas in Bearing Steel: The Role of Impact Loading and Surface Sliding

T. Bruce<sup>1</sup> · H. Long<sup>1</sup> · R. S. Dwyer-Joyce<sup>1</sup>

## Abstract

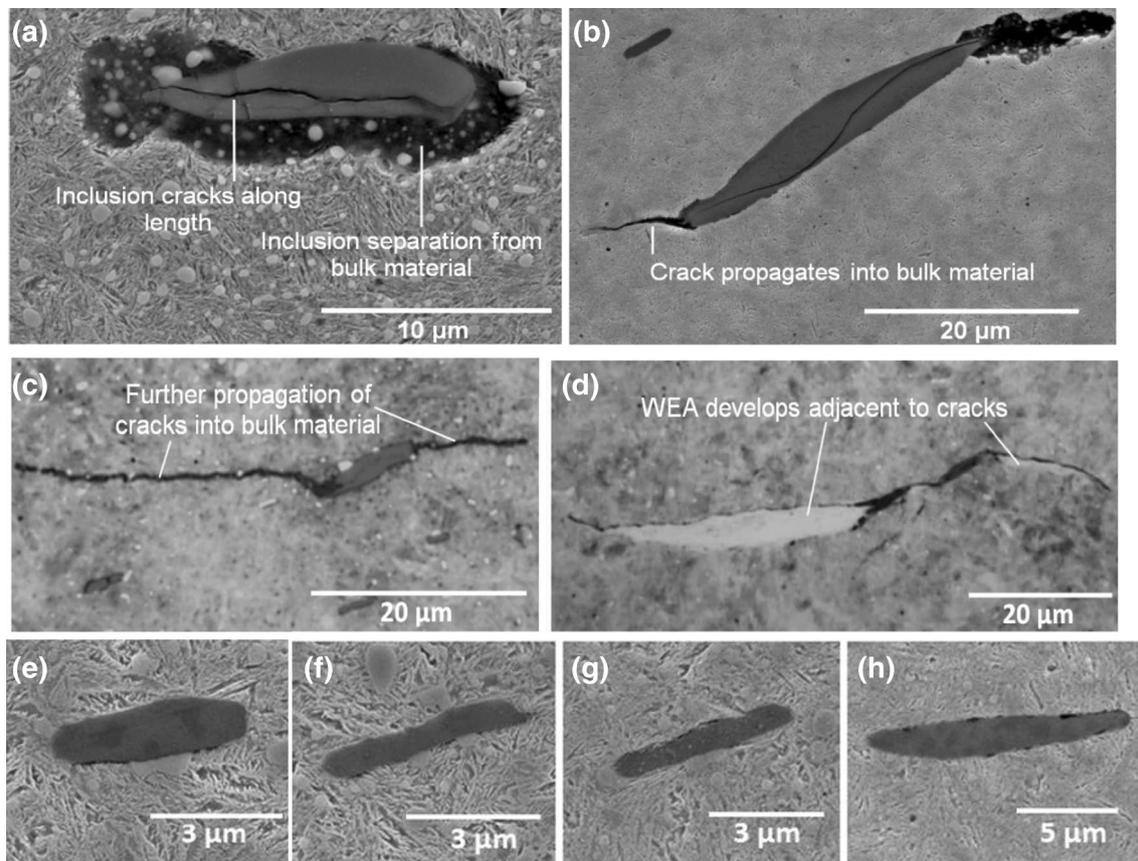
**Fig. 1** Four different forms of subsurface-damaged MnS inclusions from a failed WTG planetary bearing: **a** separation of inclusion from the surrounding steel matrix; **b** internal cracking of inclusion; **c** crack

propagation into surrounding material; **d** WEAs attached to these cracks and/or free surfaces; and **e–h** examples of undamaged inclusions at depths of greater than 5 mm from contact surface

inclusion types, carbide elongation, and possible crack initiation at carbides. Figure 8 shows some examples of damage initiation at alumina and titanium inclusions with their EDX analysis while Fig. 9 shows damage at carbides. In general, the main forms of damage were observed at MnS inclusions, which were similar to those found in both failed WTG bearings [45, 46, 49] as shown in Fig. 1 and tested specimens [51].

The creation of a free surface by separation of inclusions from the surrounding steel matrix (shown in Fig. 1a) has been identified as an initiation mechanism for micro-cracks and WEAs in our previous studies [45, 46, 49]. The testing of twin discs found that separation occurred to varying degrees at a wide range of surface traction and contact pressure levels. Separated inclusions were common at depths, under the impact zone of the specimens, near to the location of  $\tau_{\max}$ . Separation was found at inclusion tips, above and below inclusions as well as completely surrounding inclusions, examples of which are shown in Table 2, Damage I-A. All specimens were carefully washed after etching to prevent

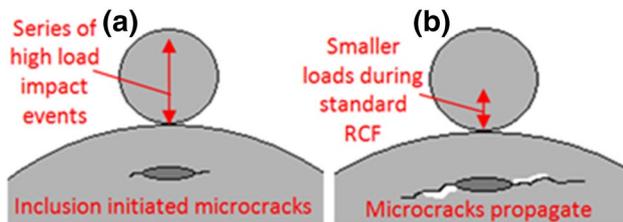
**Fig. 2** Importance of impact loading (not to scale), showing a high-impact load event that initiates subsurface micro-cracking, which is subsequently propagated by standard RCF loading

It has been hypothesized that impact loading is a key factor affecting subsurface damage initiation at inclusions [51]. Figure 2 describes a hypothesis, showing that if a high-impact load event happens prior to a series of lesser loading events, then the damage is more serious than that if these events occur in the reverse order, due to the initiation of fatigue cracking at inclusions (this will be analysed in detail in Sect. 2).

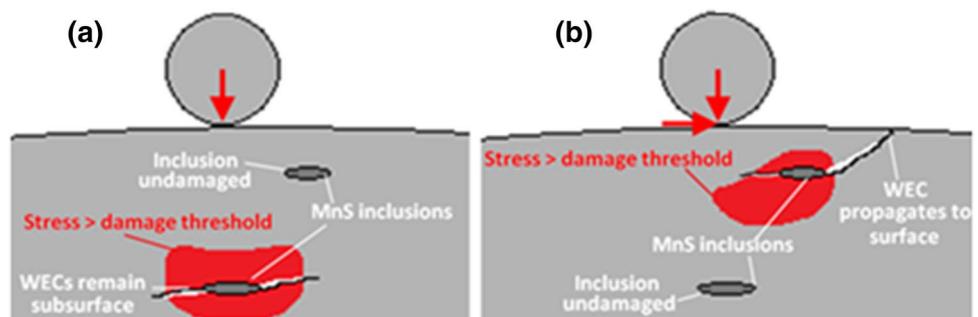
**Fig. 3** Importance of surface traction (not to scale): **a** pure rolling: critical stress threshold exceeded relatively deep—micro-cracking at inclusion may never reach surface and cause failure; **b** rolling and sliding: critical stress field shifted closer to surface—micro-cracking at inclusion propagates to surface, leading to failure

The importance of the surface traction caused by sliding between rolling elements and raceways for general applications has been documented [52, 53]. As discussed early, for WTG bearings, significant sliding due to transient operation conditions has been reported and it has been recognized that the surface sliding has an important effect on initiating micro-cracks at subsurface inclusions leading to surface spalling [31, 32, 41–44]. Since surface traction shifts the subsurface high-level stress field closer to the surface, the locations of maximum shear stresses occur at shallower depths. Since cracks have to propagate a lesser distance from shallower inclusions, those cracks initiated at shallower depths have a higher probability of leading to surface damage. The potential importance of surface traction is illustrated in Fig. 3 and will be analysed in detail in Sect. 2.

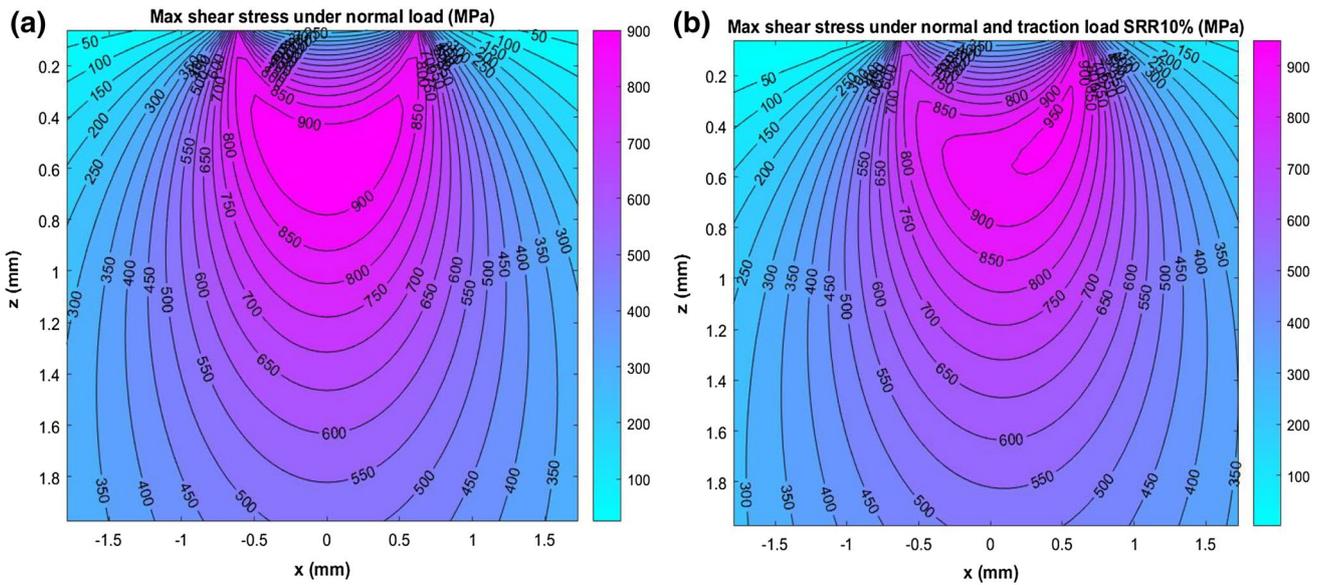
**Fig. 4** Subsurface maximum shear stress distributions: **a** under normal load; **b** under combined normal and tractive load ( $p_0=3030$  MPa,  $a=0.6171$  mm, SRR = 10%)

some previous studies [22, 26, 40, 42, 43]. Considering the maximum loading capability of the twin-disc machine and contact stress levels required to initiate subsurface damage, specimens were designed to induce the maximum values of contact pressure  $p_0$ , as 1.79, 2.42, and 3.03 GPa respectively. Figure 4 shows the maximum shear stress distributions when under a normal load and a combined normal and tractive load, respectively, when the contact pressure  $p_0$  is 3.03 GPa.

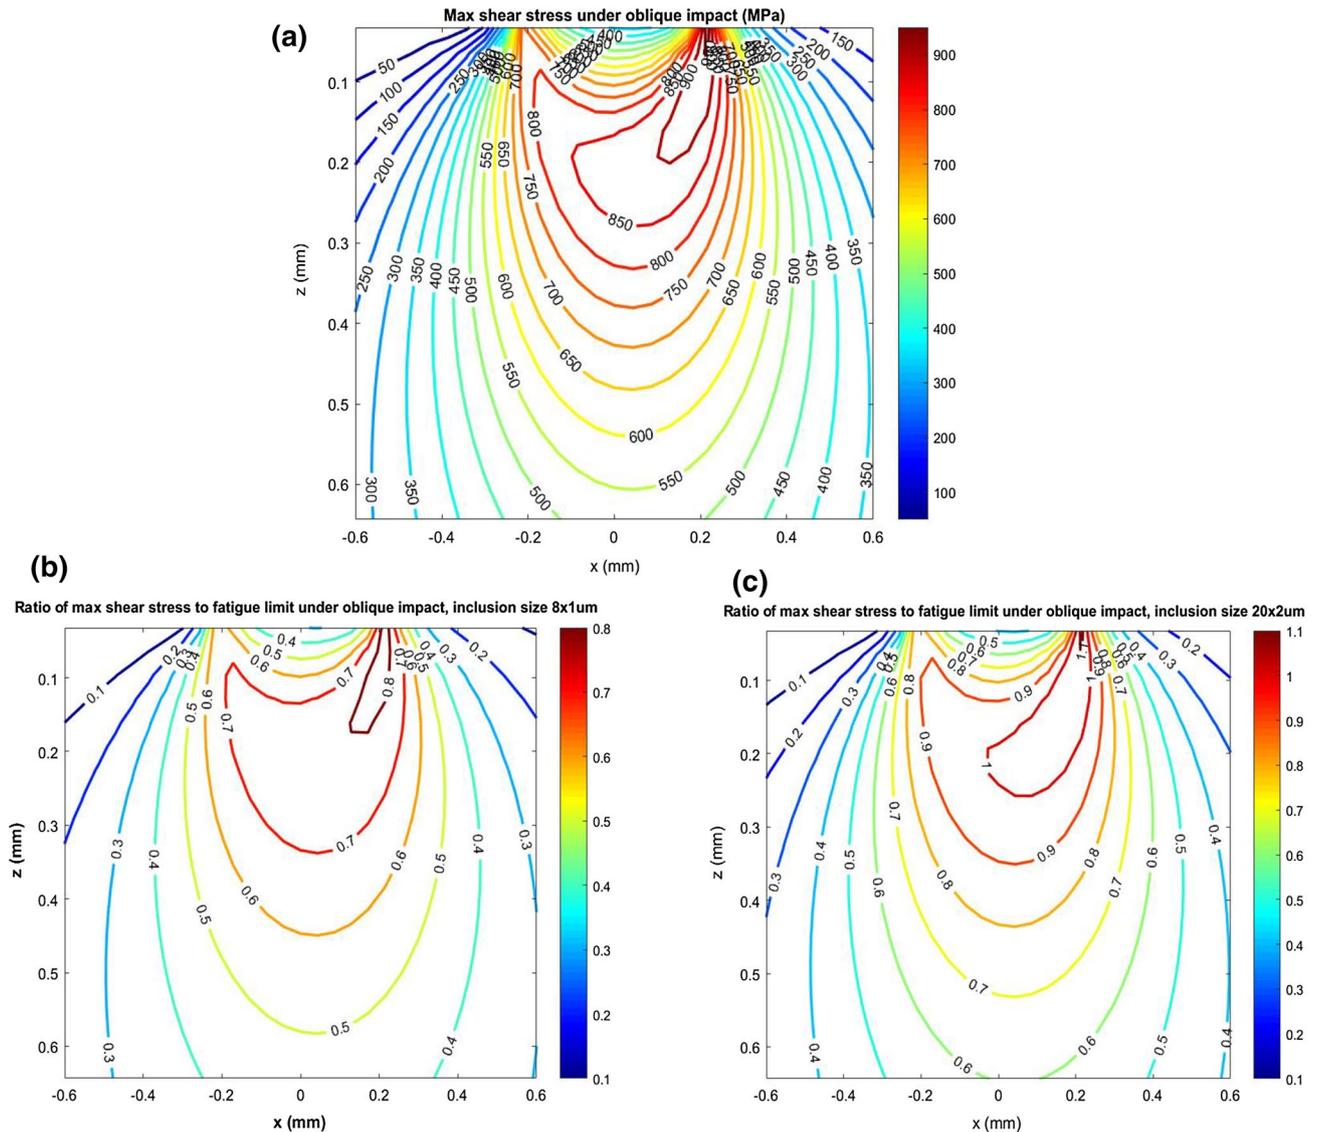
**Fig. 5** Under oblique impact: maximum shear stress  $\tau_{max}$  and ratio of maximum shear stress to fatigue limit  $\tau_{max}/\sigma_w$ : **a** max shear stress  $\tau_{max}$ ; **b** ratio  $\tau_{max}/\sigma_w$  for inclusion size  $8 \mu\text{m} \times 1 \mu\text{m}$ ; **c** ratio  $\tau_{max}/\sigma_w$

for inclusion size  $20 \mu\text{m} \times 2 \mu\text{m}$ . ( $u_0=0.3535 \text{ m/s}$ ,  $p_0=2759 \text{ MPa}$ ,  $r_a=0.2145 \text{ mm}$ , coefficient of friction=0.1, impact angle  $45^\circ$ ; steel hardness  $Hv=760$ )

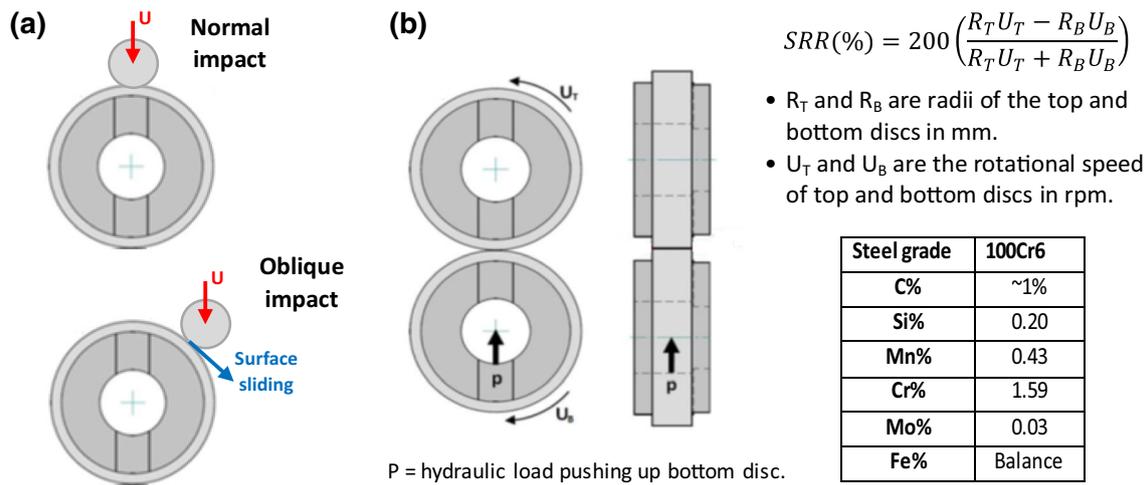
Fig. 6 Illustration of experiments: a impact test; b rolling contact fatigue test of twin discs

The impact test rig described in Ref. [51] was used to seed damage in the test specimens at two opposite locations on the circumference of each disc representing bearing raceways. As illustrated in Fig. 6a, the impact rig can also create oblique impacts, allowing the impacting ball to hit the specimen at an angle of 45° to the tangent, introducing both normal load and surface traction. 50,000 repeated oblique impacts were applied at the impact locations. Any location further than a few millimeters away from the point of impact was assumed to be not directly affected by impact loading and so the effects of subsequent RCF tests without pre-seeded impact damage could be investigated and compared to the pre-damaged impact zone.

The RCF testing using twin discs, illustrated in Fig. 6b, was designed to investigate early stage damage after comparatively few RCF load cycles ( $2 \times 10^5$ ) to that of

SRR from 0.2 to 10% was tested. Specimens representing raceways were positioned on the top shaft that rotated at rotational speed  $U_T$  and those representing the rollers on the bottom shaft rotated at speed  $U_B$ , where  $U_T < U_B$ . The lower disc can be controlled to rotate faster than the upper one in order to introduce sliding, controlled by a computer.

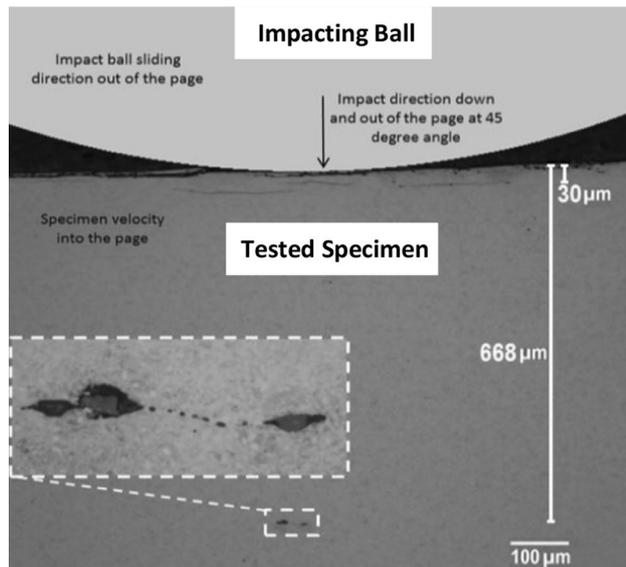
**Fig. 7** Subsurface cracks beneath impact zone of Disc 11 (with approximate position of impacting ball superimposed to illustrate the scale of the ball in comparison to the cracks)

Cracks that were linked to the surface were found in specimens that had been subjected to high surface traction and high contact pressure. Subsurface cracks, which did not appear to have any link to the surface, were found in many of the specimens. Figure 7 shows three subsurface cracks, a few hundred micrometres in length, directly under the impact zone found in Disc 11. Since the cracks were very near to the surface (30  $\mu\text{m}$ ), it seemed likely that surface traction played a role in their initiation or propagation. These cracks were much longer than any found away from the point of impact, the longest of which were of the order of tens of micrometres in length. The figure also displays a damage initiating pair of inclusions at a depth of 668  $\mu\text{m}$  (greater than the depth of

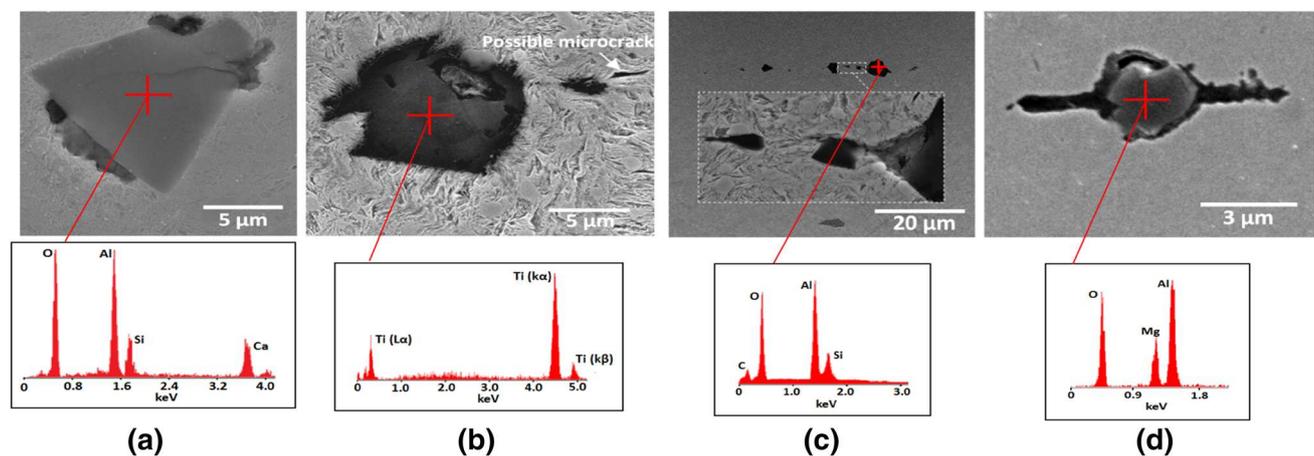
**Fig. 8** Damage at other types of inclusions and EDX analysis: **a** internal cracking of alumina inclusion; **b** micro-crack close to titanium inclusion; **c** possible damage at alumina inclusion; **d** micro-cracks at either side of alumina inclusion

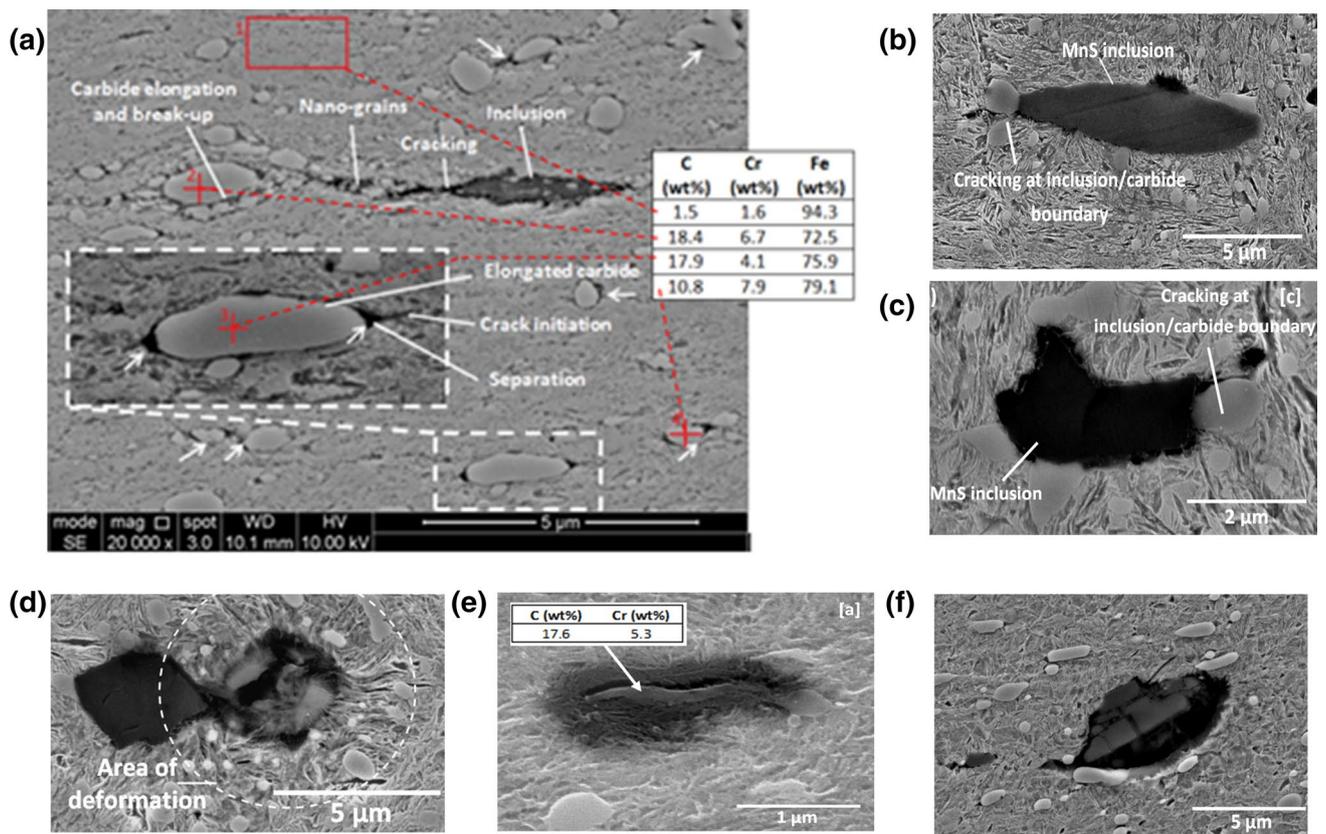
**Fig. 9** Damage at carbides and boundaries with inclusions: **a** EDX analysis of the labelled carbides (Disc 8); **b, c** cracking at MnS inclusion/carbide boundary (Discs 8 and 11); **d** dissolution of carbides in

close vicinity of MnS inclusion (Disc 11); **e** severely elongated separated carbide (under impact zone of Disc 11); **f** elongated carbides around separated/cracked MnS inclusion (Disc 12)

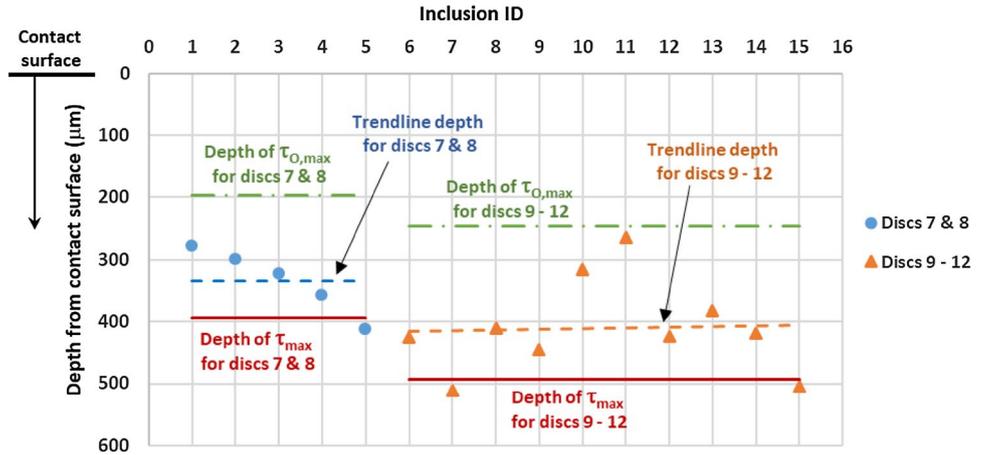
**Fig. 10** Depths of WEA-initiating inclusions in tested discs and comparison with depths of maximum shear stresses

The depth of each of the WEA-initiating inclusions was investigated. Five were found in Discs 7 and 8, which were exposed to the second highest contact pressure (2.42 GPa), and 11 in Discs 9–12, which experienced the highest contact pressure (3.03 GPa). The RCF test parameters and the calculated maximum shear stresses are shown in Table 1. The depths of each of the WEA-initiating inclusions are presented in Fig. 10, together with the depths of the RCF maximum shear stress zones,  $\tau_{max}$  and  $\tau_{0,max}$ . One WEA-initiating inclusion was close to the surface (Table 3, Disc 12—Inclusion 16, depth 37 μm), and was linked to a surface breaking crack. Since it cannot be proved whether the crack was initiated in the subsurface or on the surface, it was decided to ignore it when calculating the trend line depth of WEA inclusions in Discs 9–12. The trend line depths calculated from the

15 WEA-initiating inclusions are plotted in Fig. 10. For both datasets; Discs 7–8 and Discs 9–12, the trend line depth corresponded most closely with the RCF maximum shear stress,  $\tau_{max}$ , however, closer to the contact surface, affected by the surface traction and impact stresses as discussed in Sect. 2 and illustrated in Figs. 4 and 5, respectively. One limitation of these results is that the test sample sizes are fairly small, since only 16 WEA-initiating inclusions were found.

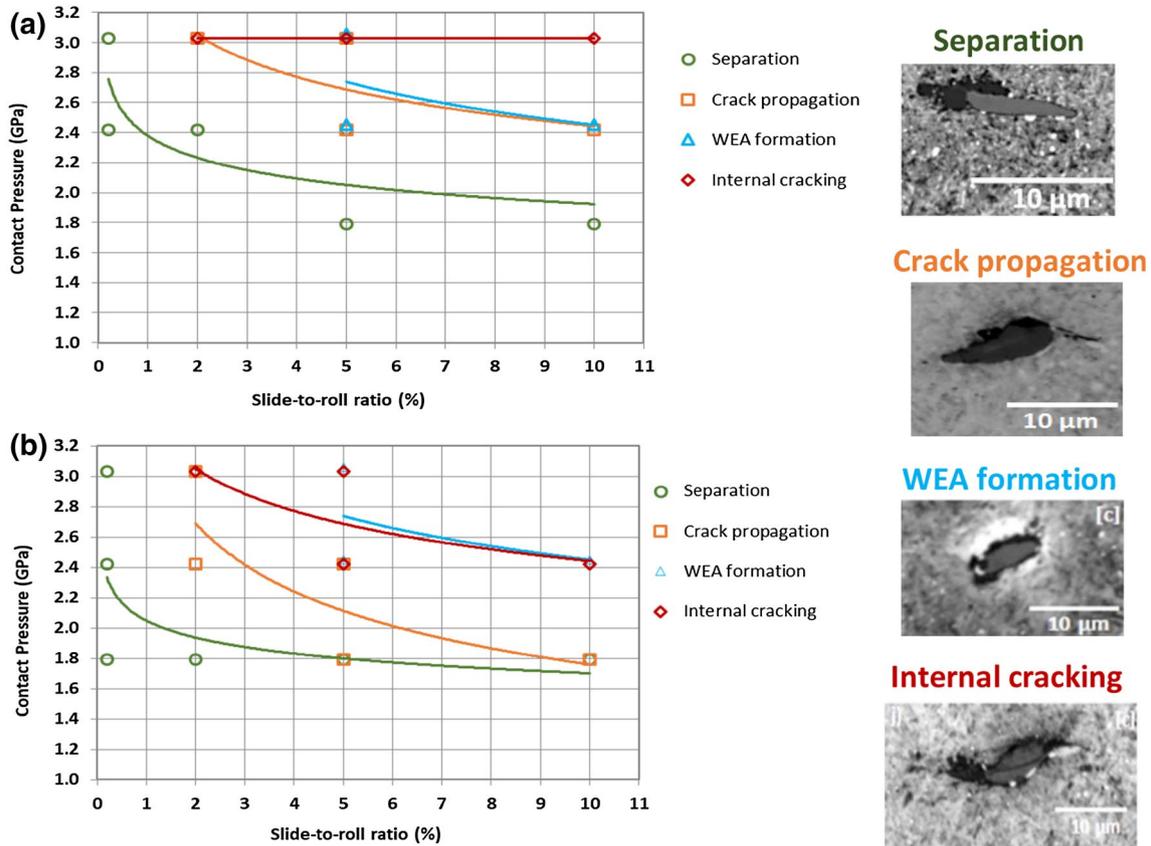
**Fig. 11** Thresholds of contact pressure and SRR for four different forms of inclusion-initiated damage: **a** specimens with no pre-seeded damage; **b** specimens pre-damaged with impact loading

pressures and surface tractions at which the damage was found. Figure 11 presents the thresholds of contact pressures and SRRs while Fig. 12 uses the mean traction coefficients measured during RCF testing. Comparing results in this way allows the minimum required levels of different damage-initiating factors, taking into account their combined effects, to be estimated. Any point above the

plotted trend lines using the obtained data points from the tested specimens is above the threshold required to initiate damage at inclusions. It is clear that increasing contact pressure and sliding within the ranges investigated, caused increasing levels of damage. It is assumed that if a specimen has experienced damage at a lower contact pressure and sliding level, then it will do so at higher levels,

However, increased levels of SRR above certain contact pressure levels were required for the separation to spread away from inclusion tips into the steel matrix (Damage I-B). This occurred in Disc 4 at the lowest contact pressure of 1.79 GPa (damage image is shown in Table 2, Disc 4), when SRR was 10%, as shown in Fig. 11.

no internally cracked inclusions were found. As shown in Figs. 11a, b and 12a, b, the thresholds of contact pressure for specimens with pre-impact damage were lowered in comparison with the trend lines for those without impact damage, indicating that the inclusion internal cracking could occur at much lower contact pressures when under higher SRRs, if the specimens were pre-damaged with impact loading.

As shown in Figs. 11 and 12, crack propagation from inclusion tips occurred at lower contact pressures and SRRs than that for inclusion internal cracking, which offers further evidence that the latter is not required to initiate the former [45]. It was clear that the pre-damaged specimens had lower contact pressure and surface traction thresholds for this damage mechanism to occur, further backing up the hypothesis that impact loading may accelerate damage of WTG bearings.

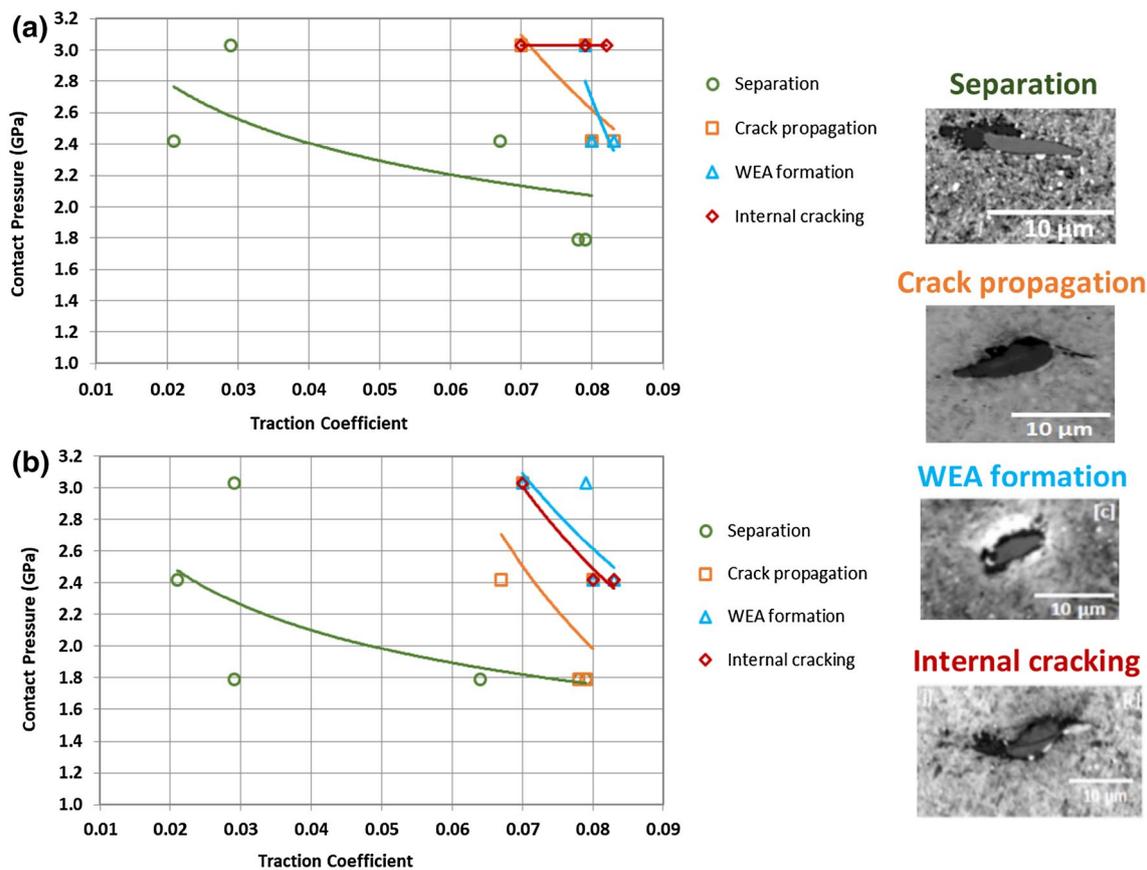
**Fig. 12** Thresholds of contact pressure and traction coefficient for four different forms of inclusion-initiated damage: **a** specimens with no pre-seeded damage, **b** specimens pre-damaged with impact loading
