The influence of malalignment and ageing following sterilisation by gamma irradiation in an inert atmosphere on the wear of ultra-high-molecular-weight polyethylene in patellofemoral replacements

Proc IMechE Part H:
J Engineering in Medicine
2017, Vol. 231(7) 634–642
© IMechE 2017

Raman Maiti, Raelene M Cowie, John Fisher and Louise M Jennings

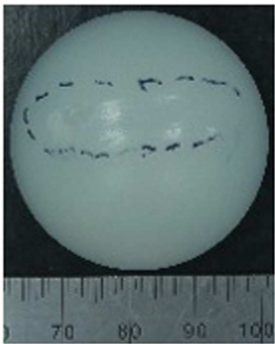
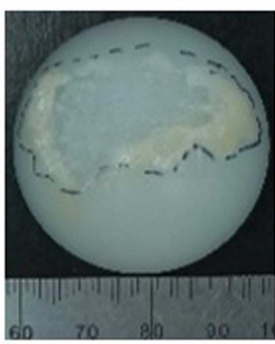
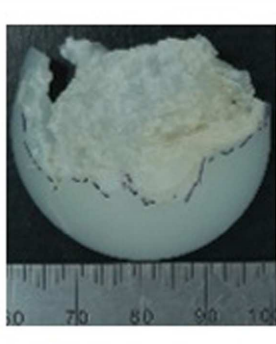
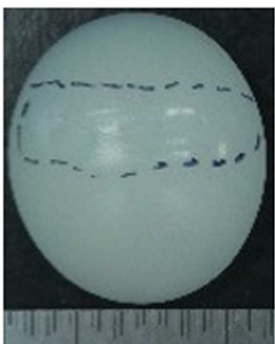
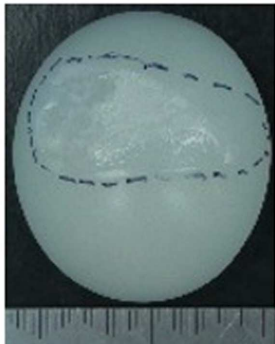
Group 1 – Unworn, aged 4 years	Group 2 – Worn, aged 4 years	Group 3 – Unworn aged 8-10 years
Round Dome

Mean area of wear scar (%)	27.2	60.4±24.6	Not measurable
Oval Dome

Not tested
Mean area of wear scar (%)	30.8±43.3	41.7±11.6

Figure 5. Images representative of the patella buttons after wear simulation under malaligned conditions; the wear scar is shown by the dashed lines and mean area of wear scar expressed as a percentage of the whole patella \pm 95% confidence limits.

Figure 5 shows the mean percentage area of the wear scar, which was larger in the Group 2 implants than the Group 1 implants for both round and oval dome patellae. It was not possible to assess the size of the wear scar on the Group 3 implants due to their failure and the shortened duration of the study.

This novel method for experimental wear simulation of the PFJ under malaligned conditions was developed by moving the centre of rotation in the IE axis to the surface of the patella button, imparting a 5° external rotation on the sample throughout the gait cycle. When patella tilt occurs in vivo, the degree of tilt varies with the flexion angle of the knee,³⁹ and the constant tilt of the patella in this study created a worst case test by continually applying a high contact stress within a small contact area on the patellae. The constant external rotation shifted the position of the wear scar visible on the

patellae from the previously reported symmetrical bow-tie-shaped wear scar¹⁶ to a more medially positioned wear scar where the patella came into contact with the edge of the femoral groove. A loss of symmetry in the wear scar on the patella button has also been observed by Vanbiervliet et al.¹⁴ who created an adverse wear test condition by internally rotating the femoral component. In an optimally positioned implant, the patella follows the profile of the trochlear groove and tracks centrally in the groove. However, this is only seen in approximately 55% of patients,⁴⁰ so, suboptimal tracking and patella tilt are common. Rotation of the femoral component, tissue tension around the implant or the depth and angle of the resected bone can cause malalignment of the patella¹⁹ highlighting the need for the development of enhanced test protocols for the patella.
