Tang, N., Soltani, P., Pinna, C. orcid.org/0000-0002-9079-1381 et al. (2 more authors)
(2018) Ageing of a polymeric engine mount investigated using digital image correlation.
Polymer Testing, 71. pp. 137-144. ISSN 0142-9418

Ageing of a polymeric engine mount investigated using digital image correlation

Ning Tang^{a,*}, Payam Soltani^b, Christophe Pinna^a, David Wagg^a, Roly Whear^c

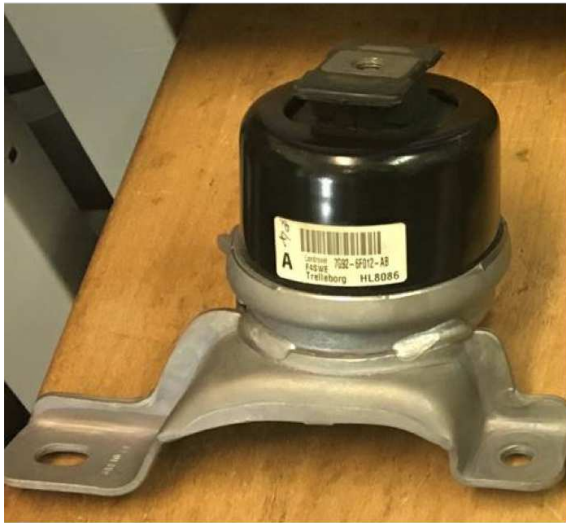
(a) hydraulic engine mount

(b) cross-sectional view

Figure 1: Hydraulic engine mount and its components.

The engine mounts studied in this research were commercial products fitted to a particular Land Rover model. A representative sample is shown in Figure 1. For the purpose of the ageing studies undertaken, some samples were removed from vehicles which had been used in high temperature environments.

The engine mount studied in this paper is made from four components: the main spring, the inertia track and decoupler, the viscous liquid chamber and a steel case. The main spring contributes to the elasticity of the entire mount. This spring is divided into three components: the tip, the rib and the elastomeric element. The main load-carrying region of an engine mount is located between the tip and the rib, as shown in Figure 1(b). Since the load-carrying region is axisymmetric, test results on half of the cross-section are assumed to represent the overall performance in the following analysis. The axisymmetric axis here is defined as the central axis of the engine mount.
