Dais, D orcid.org/0000-0002-0533-5171, Sarhosis, V orcid.org/0000-0002-5748-7679, Smyrou, E et al. (7 more authors) (2019) *Investigations On The Restoration And Seismic Enhancement Options For The Jaisedewal Temple After The Gorkha Earthquake In Nepal*. In: *Proceedings of SECED 2019*. SECED 2019, 09-10 Sep 2019, London, UK. Society for Earthquake and Civil Engineering Dynamics .

INVESTIGATIONS ON THE RESTORATION AND SEISMIC ENHANCEMENT OPTIONS FOR THE JAISEDEWAL TEMPLE AFTER THE GORKHA EARTHQUAKE IN NEPAL

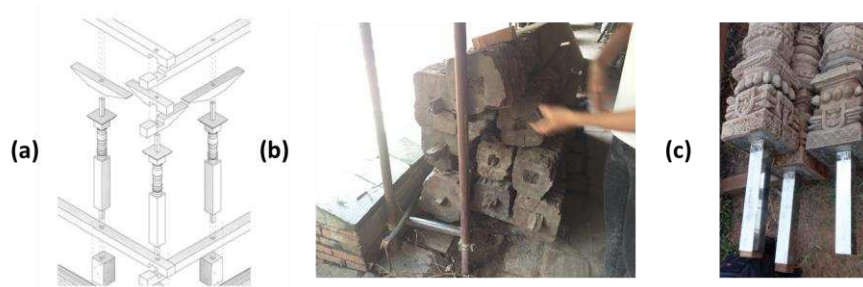
Figure 1: (a) Detail of the connection of the wooden pillars with the rest structural elements (Arce *et al.*, 2018), (b) typical failure of the vertical timber elements supporting the peripheral walls, and (c) strengthening of timber pins with stainless steel warping (Arce *et al.*, 2018).

loading. The pillars at both edges end up to a pretty thin cross-section called pin (Figure 1a). The rupture of the pin of the main wooden columns was a common observation during the Gorkha Earthquake, which confirms its vulnerability (Figure 1b). Such local failure led to the loss of support of the overlying peripheral wall which could be the main reason of collapse of some temples.

For the “retrofitted” model interventions of low interference were implemented: the wooden slabs were stiffened in order to provide a diaphragmatic action, wooden planks were added to connect the internal core with the peripheral wall with the aim to exclude the concentration of stresses around the connections of the existing timber pegs, and the wooden poles at the end of the timber columns were wrapped with stainless steel to improve their connection with the foundation (Figure 1c).

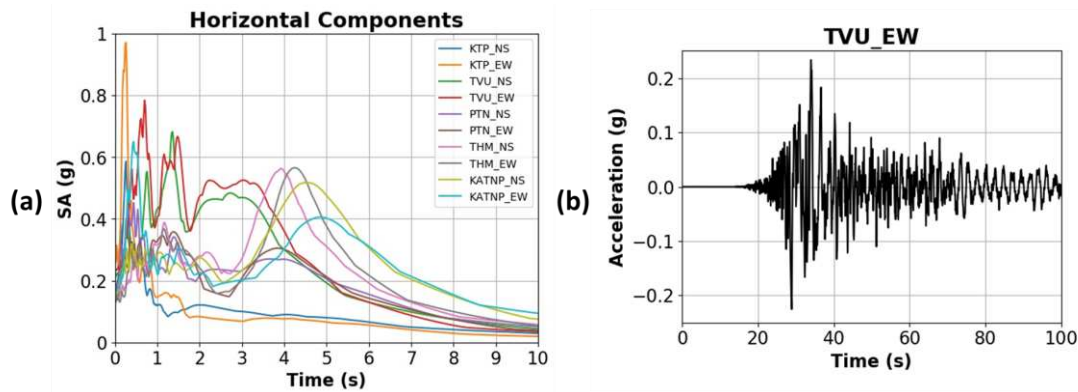
Figure 4: (a) The response spectra corresponding to the horizontal components of the main records of the Gorkha earthquake Nepal (April 25, 2015), and (b) the record used for the time-history analysis.

On April 25, 2015, the Gorkha earthquake (7.8-magnitude) hit the Kathmandu Valley. This tremendous ground motion was followed by a 7.3-magnitude earthquake on May 12, 2015. The epicentre was near the Gorkha region, 80 km from the Kathmandu Valley. Seismic records came from the rock site (KTP station) as well as from the sedimentary sites TVU, PTN, THM, and KATNP (Takai et al., 2016). The recorded waveforms produced significant spectral accelerations in the range of short periods (up to 1 s) but also for longer periods (i.e. up to 6 s). The largest maximum peak ground acceleration (PGA=0.25g) was recorded at the EW component of the KTP station. The response spectra of the main records of the Gorkha Earthquake are presented in Figure 4a.

Another destructive characteristic of the earthquake was its long duration containing multiple pulses (Figure 4b). As will be shown below, many vulnerable Nepalese Pagodas reached their capacity in the very first pulses of the excitation, while the next pulses pushed the structure even further making the total collapse inevitable.

The record coming from the EW component of the TVU station (Takai et al., 2016) was chosen for the time-history analyses performed in this work (Figure 4b). The distance between the TVU station and the Jasidewal temple is 3km. The chosen record has a PGA of 0.23 g and more importantly, it produces spectral accelerations of up to about 0.8 g at the period of 0.7 s, which coincides with the fundamental period of the case-study structure.

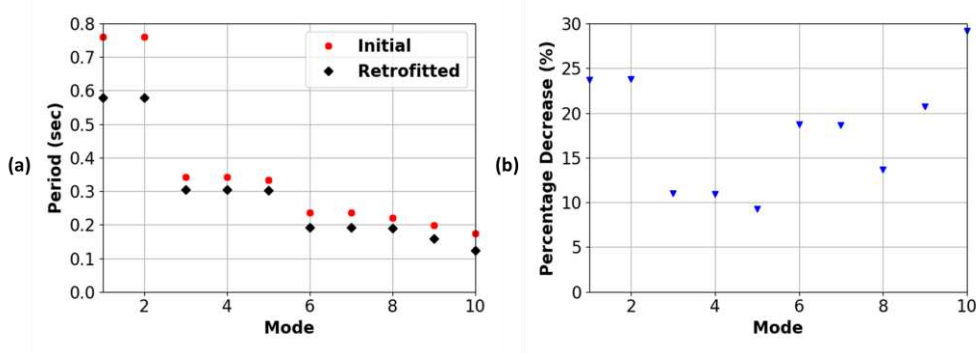
Figure 6: (a) The first ten periods of the structure, as calculated from the numerical model for the initial and retrofitted structure, and (b) the percentage decrease of the periods after the implementation of the retrofitting interventions.

First the dynamic characteristics of the temple were derived by performing modal analysis. Figure 6a presents the first ten periods of the temple. The first two modes were translational in the two horizontal directions corresponding to a period of 0.76 s. The third and fourth modes were translational too, while the fifth mode was rotational, all of a period of 0.34 s. The rest of the modes were local (Figure 6a). Figure 7a shows the first mode of the initial structure. It is evident that the peripheral walls tend to deform out-of-plane (OOP) probably due to the limited capacity of the wooden beams that tie the peripheral walls to the main masonry core. Consequently, this connection is reckoned to be flexible. The periods of the first ten modes for the retrofitted structure are given in Figure 6a. The direction and the type (translational, rotational or local) of the modes were similar to the “original” structure. However, in Figure 6b it is evident that the strengthening options implemented herein reduce the periods of the structure by up to 30%. The first two periods of the retrofitted structure were calculated as 0.58 s signifying a 24% reduction. The beneficial impact of the interventions can be noticed in the first mode shape of the retrofitted structure (Figure 7b). The peripheral wall moves along with the main core of the structure and the tendency for OOP deformations observed in the initial structure has now been diminished.

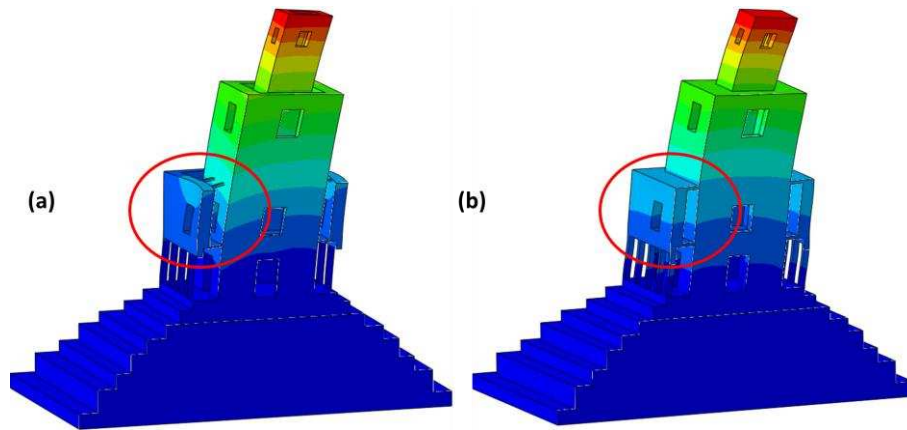
Figure 7: Cross-sections of the structure presenting the first mode shape at the (a) initial and (b) retrofitted state.

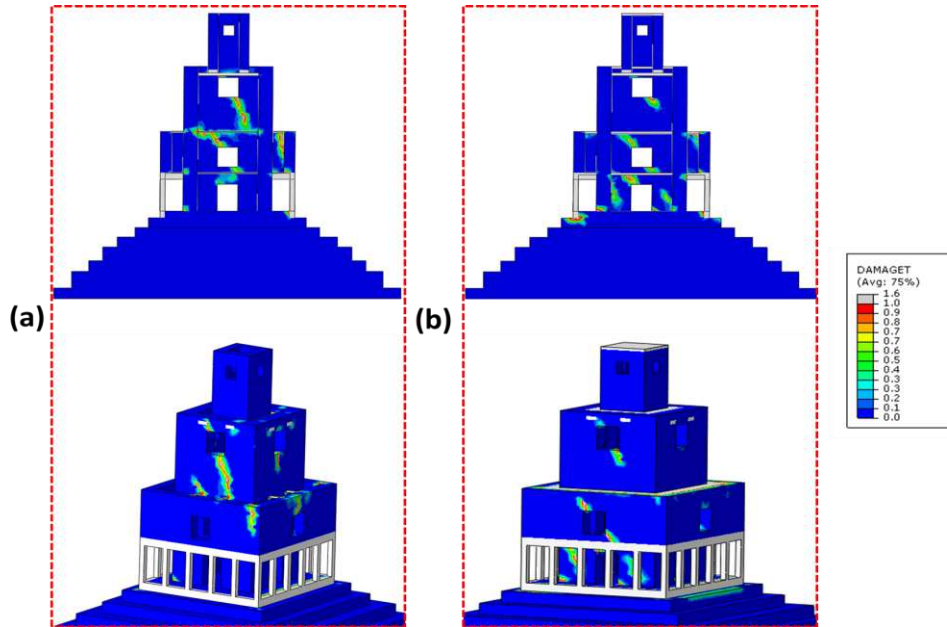
Figure 8: The distribution of tensile damage for cross-section (top) and perspective view (bottom) of the deformed structure when drift 0.5% is attained during the pushover analysis for (a) the initial, and (b) the retrofitted structure.

Figure 8 shows the failure patterns for the initial and the retrofitted structure as obtained from the pushover analysis. The results are presented for drift 0.5%. This value of drift corresponds to the yield limit for URM structures as defined in EN-1998-1 (2005). For the case of the initial structure (Figure 8a) concentration of damages occurs around the timber pegs which connect the main core to the peripheral wall. Due to the lack of diaphragmatic action at the level of the timber floors, the structure experiences extensive damage at the corners of the peripheral walls. Furthermore, the failure of the timber joist connections lead to OOP deformations in the middle of the peripheral wall, responsible for the development of cracks at these areas. Consequently, it can be inferred that the damages on the initial structure originate from local effects.

For the case of the retrofitted structure (Figure 8b) the main damages manifest as diagonal cracks on the main core. The tendency of the peripheral wall for OOP deformations has been eliminated and the cracks at the corners of the peripheral walls are limited. A drawback appearing at the retrofitted structure is that the wooden pillars participate more in carrying horizontal loads, thus higher stresses are transmitted to their foundation causing the formation of cracks. After the retrofit of the temple, the core of the structure is the main structural element that attracts the horizontal loads and local failure modes are limited. However, any possible strengthening of the wooden pillars needs to be done in combination with interventions on their foundation.

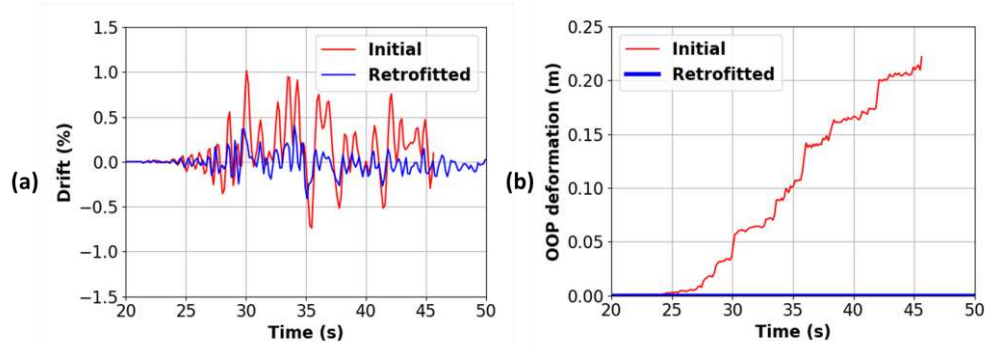
Figure 10: From the time-history analysis (a) the drift values of the main core, and (b) the OOP deformation of the peripheral wall are given for the for the strong part of the record, that is from 20 to 50 s.

Figure 10a presents the drift values of the main core for the initial and the retrofitted structure. The results are given for the strong part of the record, that is from 20 to 50 s. Note that the analysis with the initial structure is terminated for $t=46$ s due to excessive damage inflicted on the damage bringing the structure close to collapse. Until that point the maximum recorded drift on the main core for the initial structures reaches the value of 1%, while the corresponding value for the retrofitted system is limited to 0.4%. Another point that the retrofitted structure outperforms the initial one is the OOP deformation of the peripheral wall. In particular, the relative deformation between the main core and the peripheral wall at the level3 of the structure (Figure 3a) is given in Figure 10b. While for the retrofitted case the OOP deformation is zero, for the initial structure accumulation of OOP displacement is noticed. Therefore, toppling of the peripheral for the temple at its initial state is extremely likely.
