— DRIVE Project V1031

An Intelligent Traffic System for Vulnerable Road Users

**TRIALS WITH MICROWAVE DETECTION OF VULNERABLE ROAD USERS
AND PRELIMINARY EMPIRICAL MODEL TEST**

Deliverable No. 11

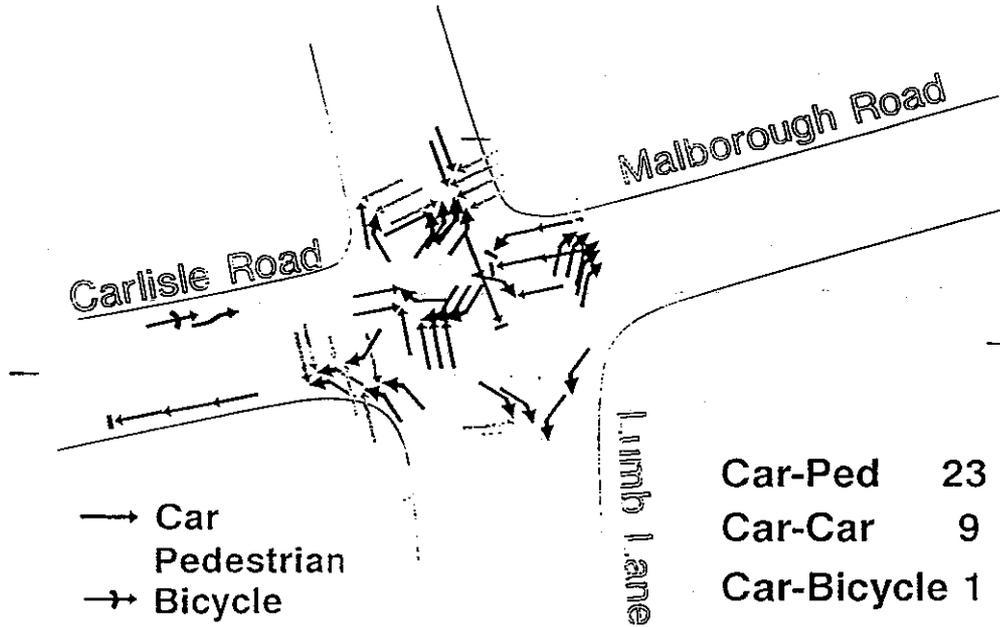
Figure 5: Conflicts at Signalized Junction (First Before Study)

BRADFORD 1989-10-16--20
 CONFLICTS *Before*

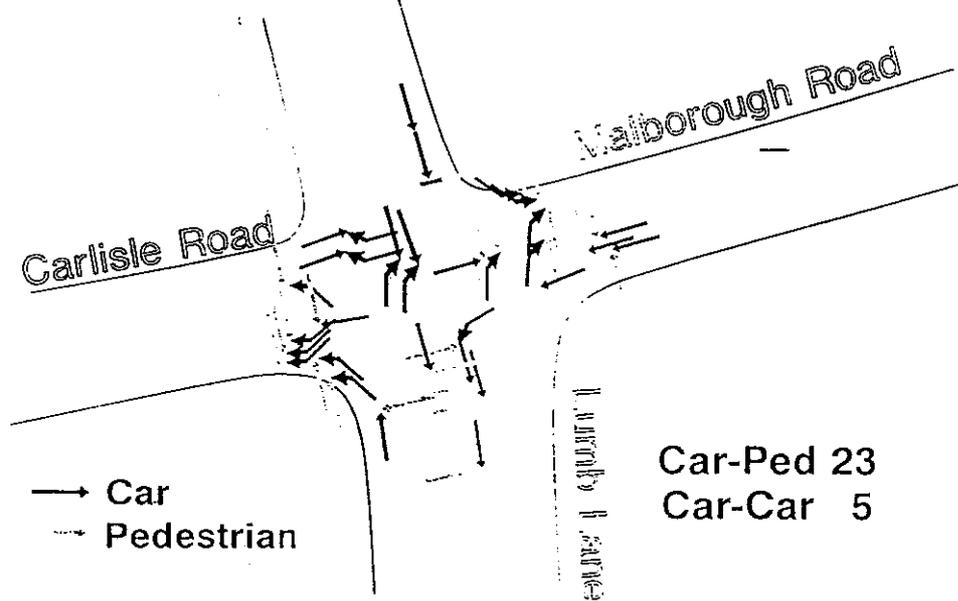
Figure 6: Conflicts at Signalized Junction (Second Before Study)

BRADFORD 1990-07-03 -- 06
 CONFLICTS *Before II*

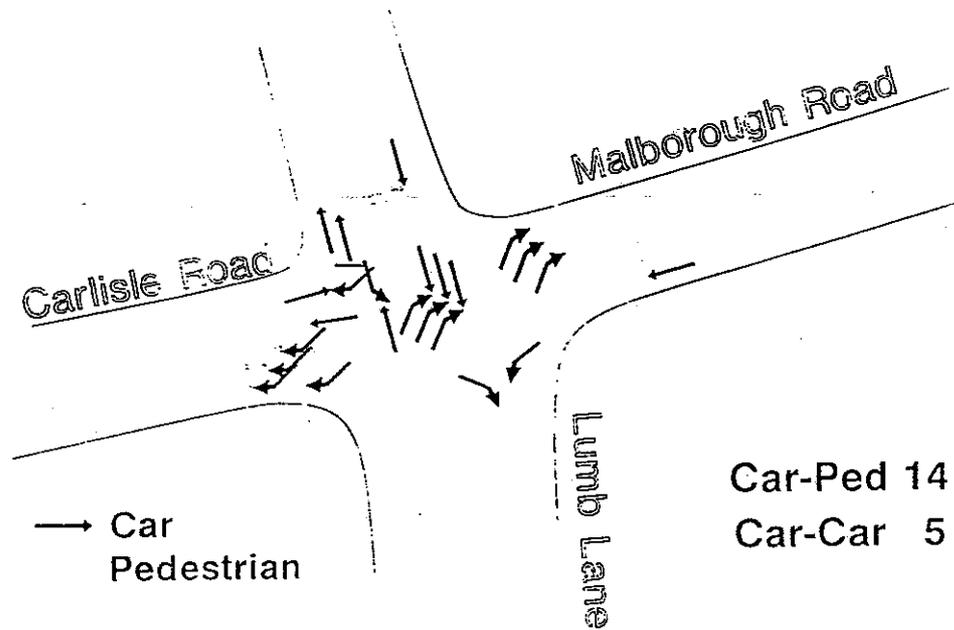
BRADFORD 1990-09-10 -- 14
CONFLICTS *After*

Figure 7: Conflicts at Signalized Junction (First After Study)
BRADFORD 1991-05-07 -- 09
CONFLICTS *After II*

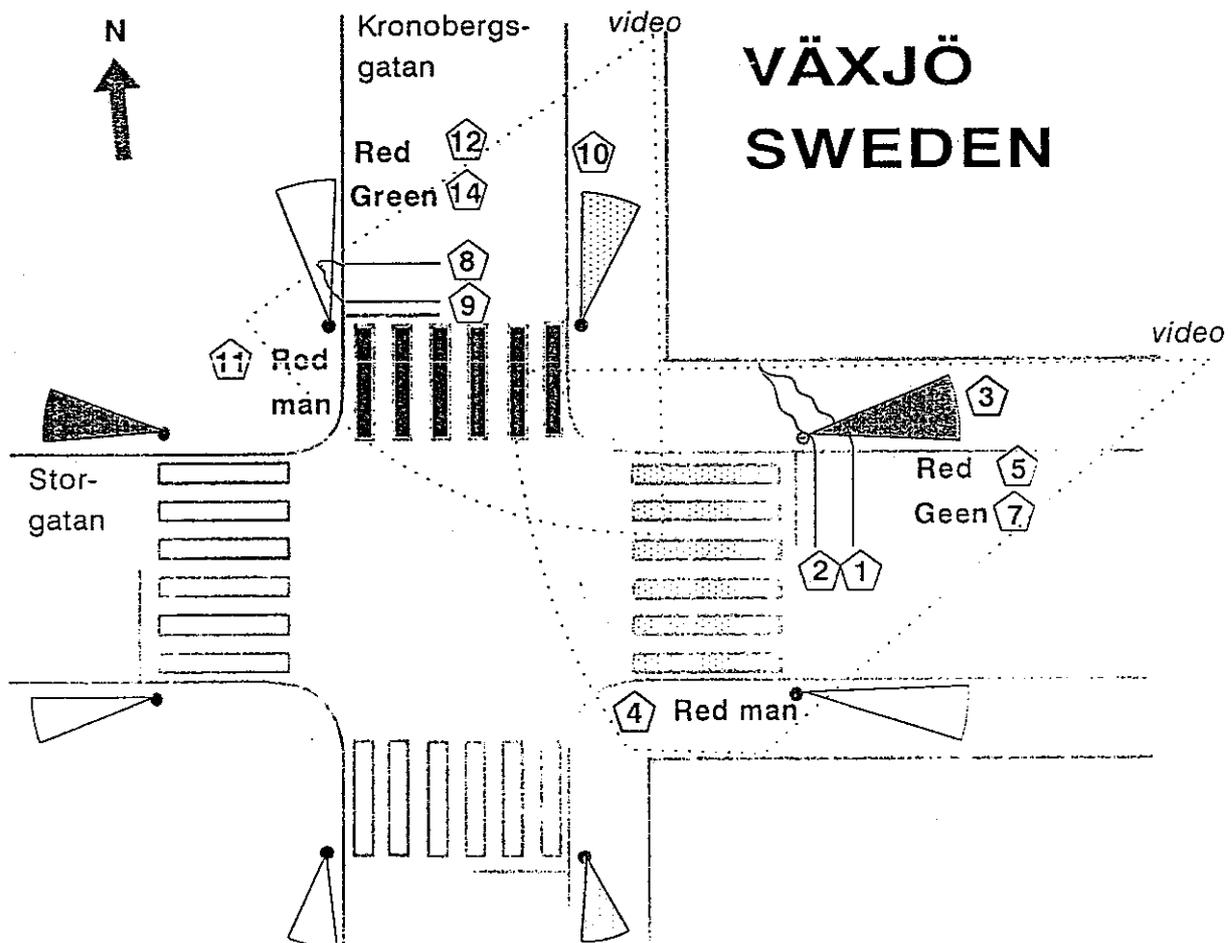
Figure 9: The Experimental Site in Växjö

Detection of a pedestrian was announced to the signals of both of the pedestrian crossings that might be used by the detected person. The normal push button could still be used by the pedestrian if the detection had failed. Figure 9 shows the setup. The dark grey arcs in the figure represents the areas covered by the detectors detecting pedestrians approaching the signal and presumably intending to cross the minor road (Kronobergsgatan). The light grey arcs represents the coverage of pedestrians presumably aiming to cross the major road. The numbers (1 to 14) represent the different events (signal phase, passing vehicle) that were directly recorded by the datalogger in the field.

The evaluation area which was covered by video cameras was two of the pedestrian crossings (the eastern one at Storgatan and the northern one at Kronobergsgatan) of the intersection. The characteristics that were measured were as follows:

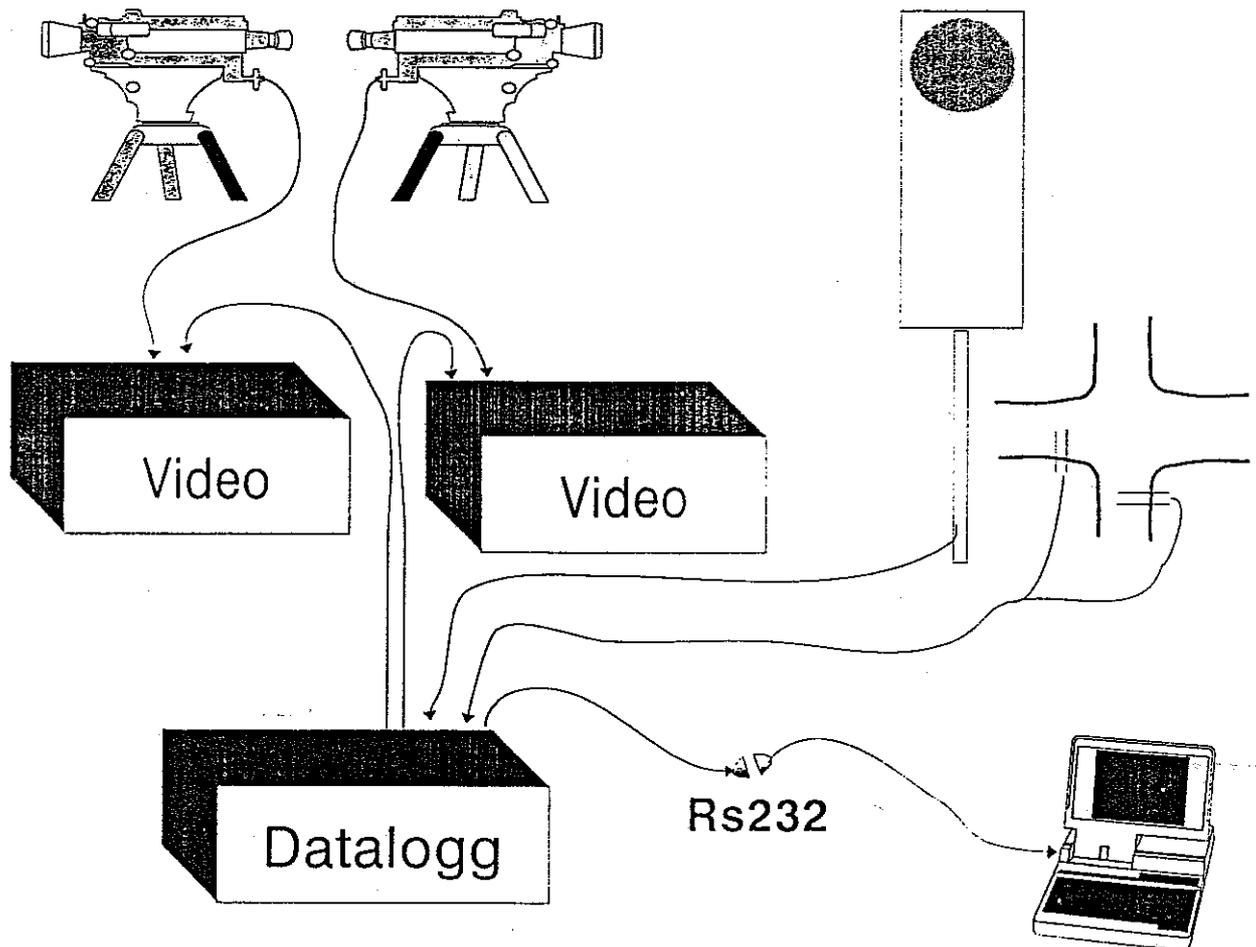
Figure 10: Data Collection Procedure (Outdoor)

A semi-automatic data collection procedure was designed for data collection in the field. Information about events such as changes in signal phase and vehicle detection (by rubber tubes) were recorded directly into the datalogger. The datalogger used was a computer that records events with a precision of one millisecond.

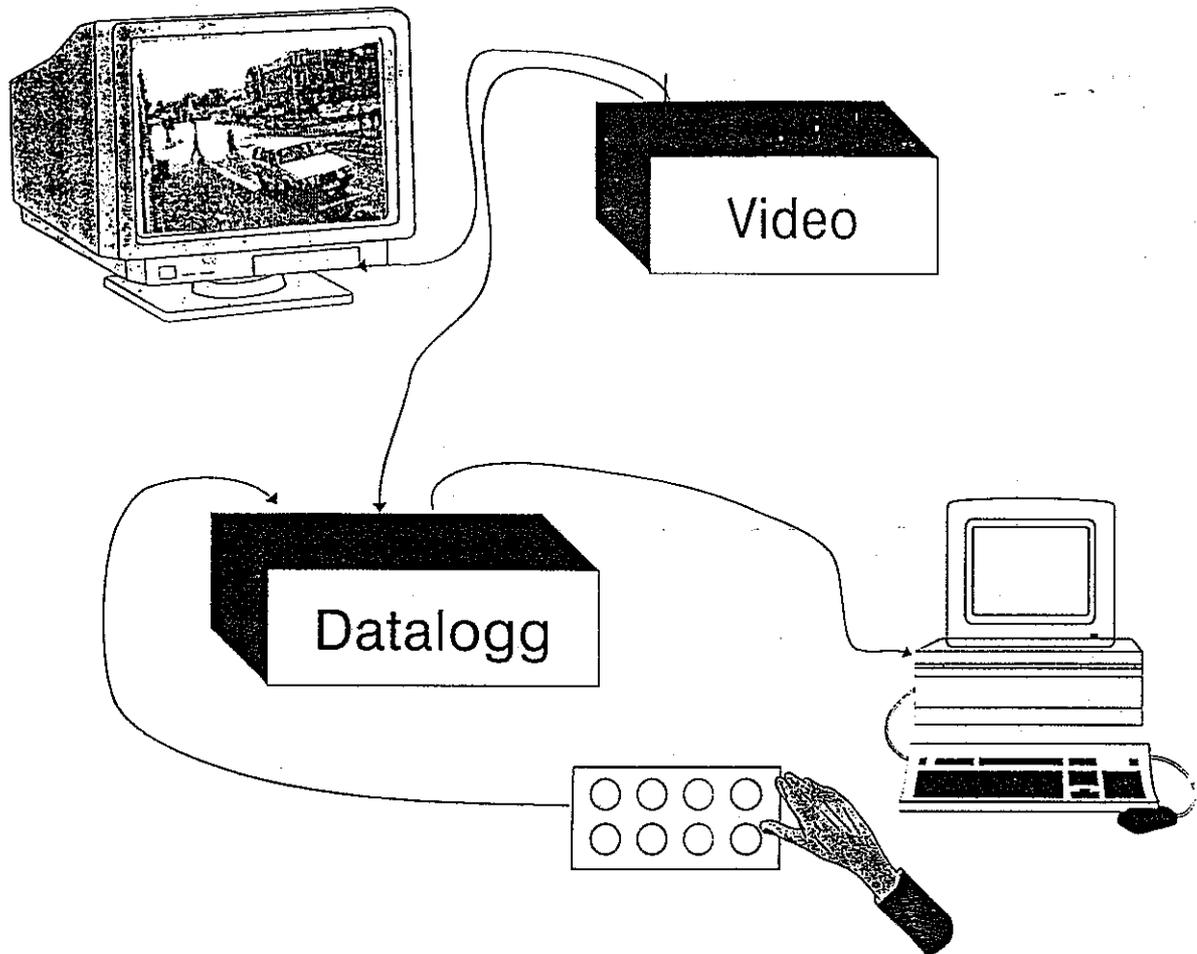
Figure 11: Data Collection Procedure (Indoor)

Most of the behavioural data were obtained from the video recordings carried out indoors. The datalogger was connected to the video recorders during recording in such a way that a time code was recorded on one of the audio channels (see Figure 10). The time code was calibrated with the clock in the datalogger every ten seconds, enabling those viewing the video to enter data subsequently to the datalogger which were synchronized with the data collected in the field (see Figure 11). Pedestrian arrival and stepping out on the road were recorded this way.

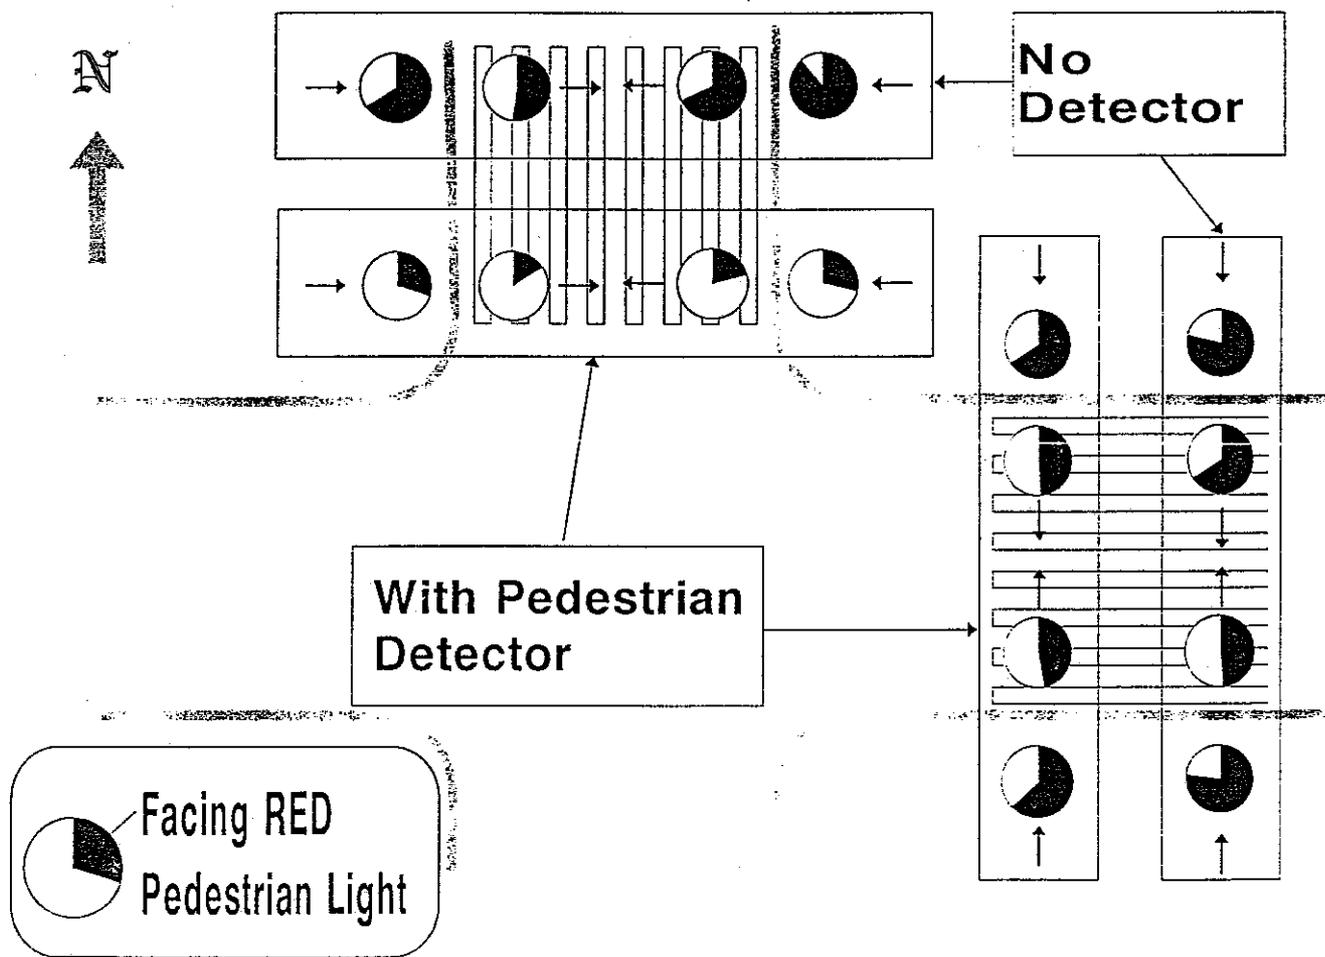
The most important expected safety effect was reduced red walking. Without detection, especially in periods of low traffic, the majority of pedestrians walked against red. Detecting approaching pedestrians reduced red light violation significantly. The reduction was especially large for pedestrians crossing the minor road. This is due to the fact that the controller programme gave high priority to the vehicular traffic on the major road and therefore provided green for pedestrians crossing the minor road. The effect can be seen in Figure 12, where the diagrams located on the pavement show the proportion of pedestrians arriving at red or green, while the diagrams on the zebra crossings show the proportion of pedestrians crossing on red or green by direction for each pedestrian crossing.

Figure 12: Proportion of Red Arriving and Red Walking Pedestrians with and without Pedestrian Detection

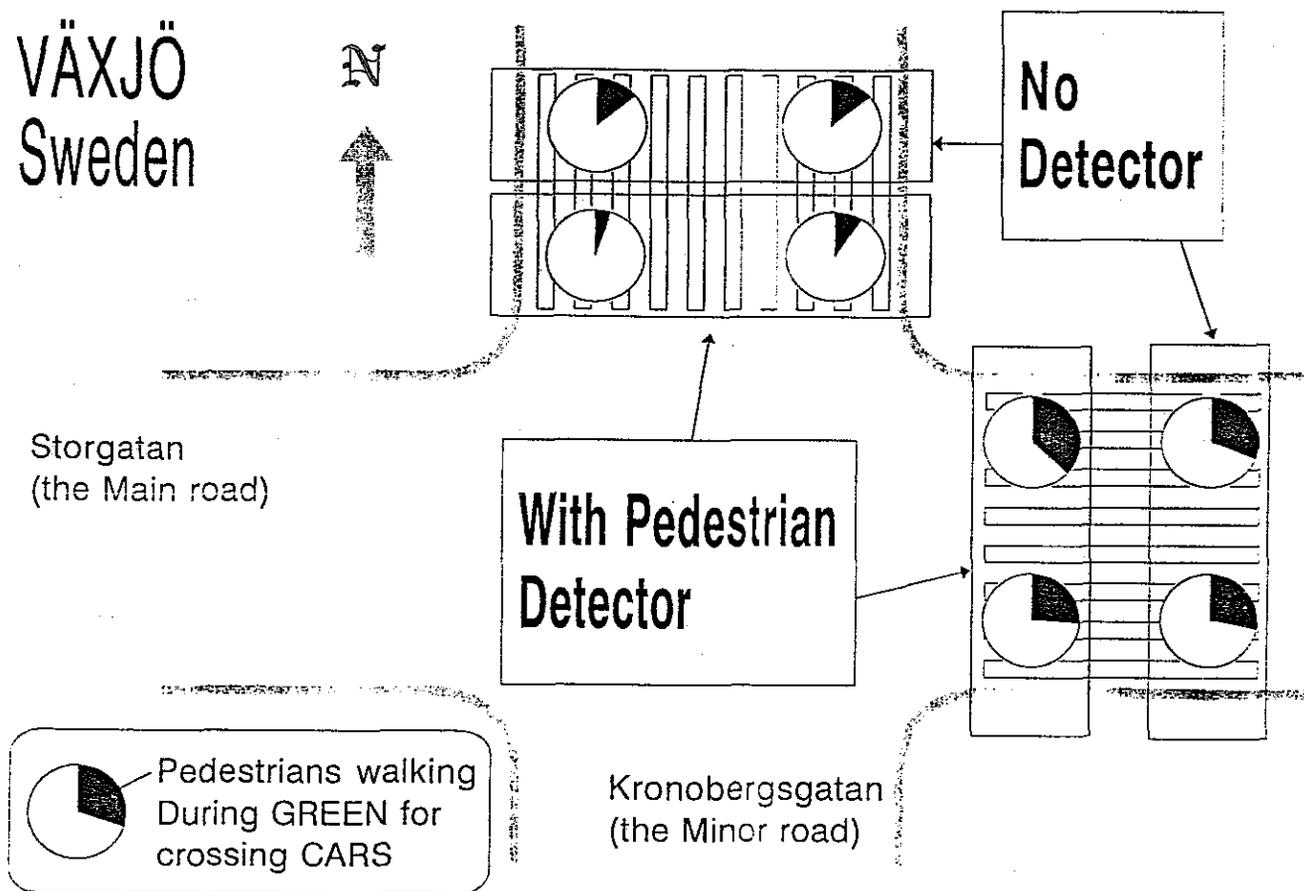
From a safety point of view it is important not only to look at pedestrians walking against red but also to look at pedestrians crossing the road when conflicting cars have a green light. The results indicate a reduction in the frequency of this dangerous situation, but the reduction is of course smaller. The observations revealed that about half of the pedestrians who walked on red did so when the vehicles had green and the other half walked when the vehicle light was changing (see Figure 13).

Figure 13: Proportion of Pedestrians who Walk on Red when the Conflicting Traffic has Green with and without Pedestrian Detection

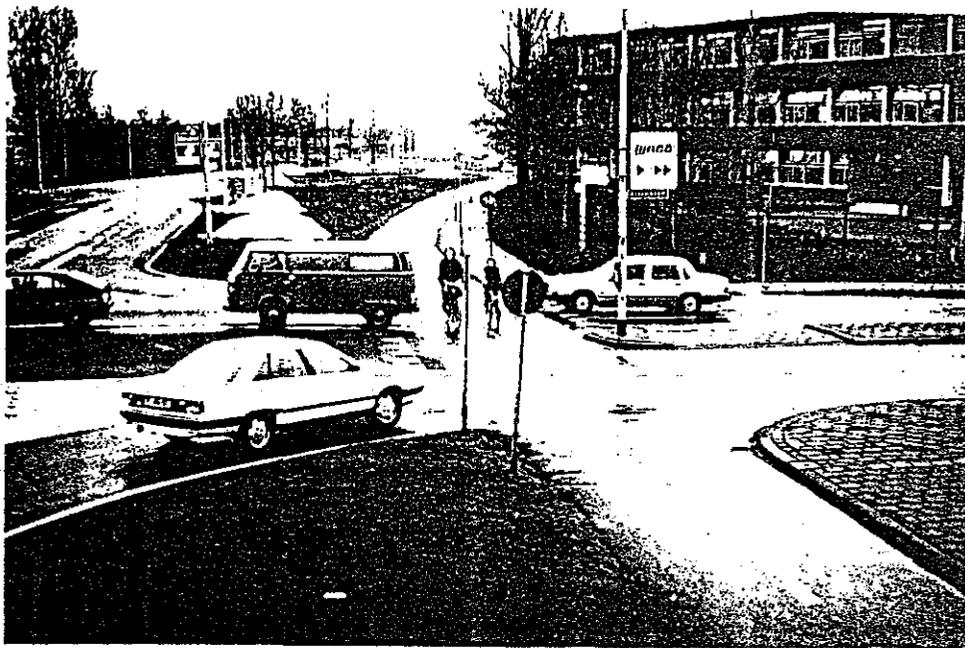
Figure 22: The Observation Site

The observation site is located near the outer ring road, west of the city of Groningen. It is a four armed junction. A picture of this location is shown in Figure 22.

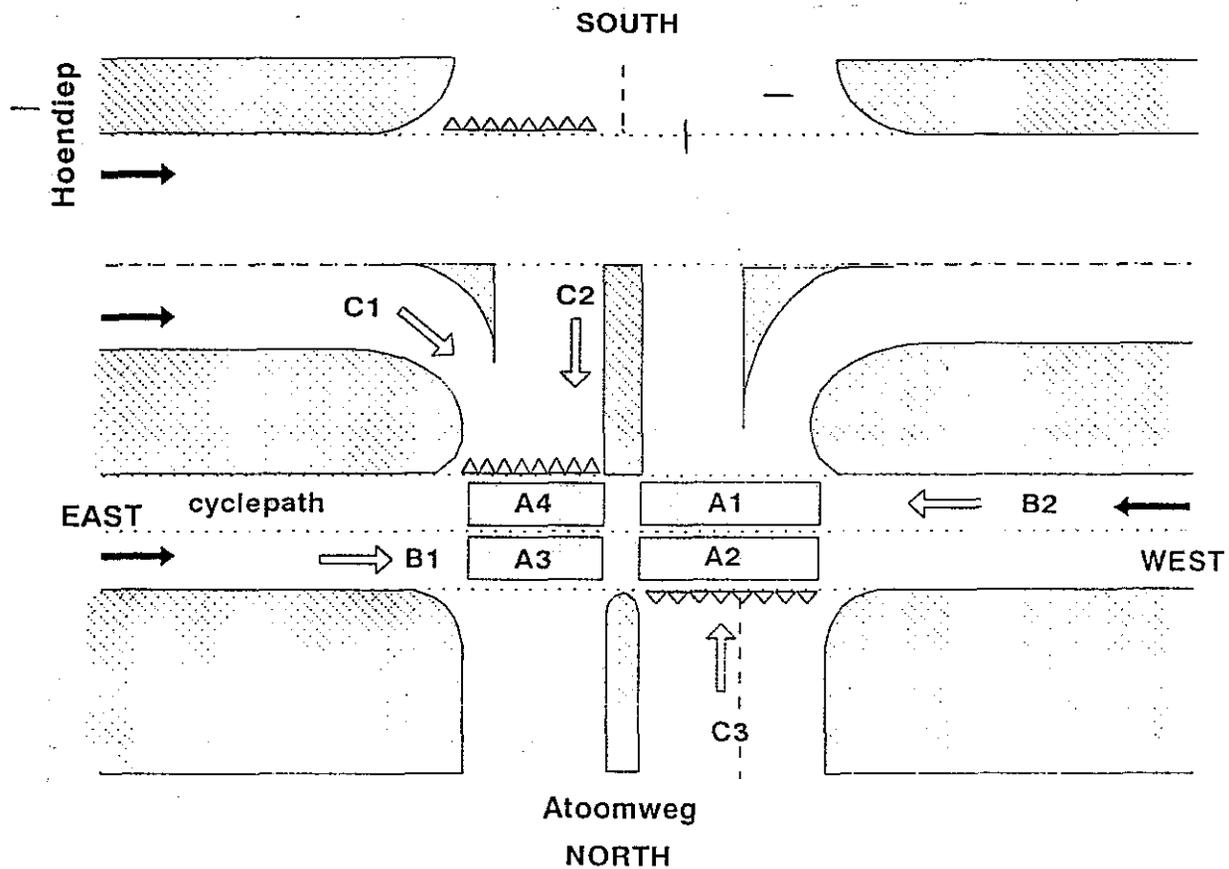
Figure 23: Schematic Drawing of the Observation Site Showing Approach and Encounter Areas

The observations were limited to the northern half of the intersection (see Figure 23). This part of the intersection was split into 9 smaller sections to distinguish between the different type of interactions. Sections A1 to A4 represent the bicycle/car encounter areas. Section B1 is the approach area of cyclists and moped riders travelling from east to west;

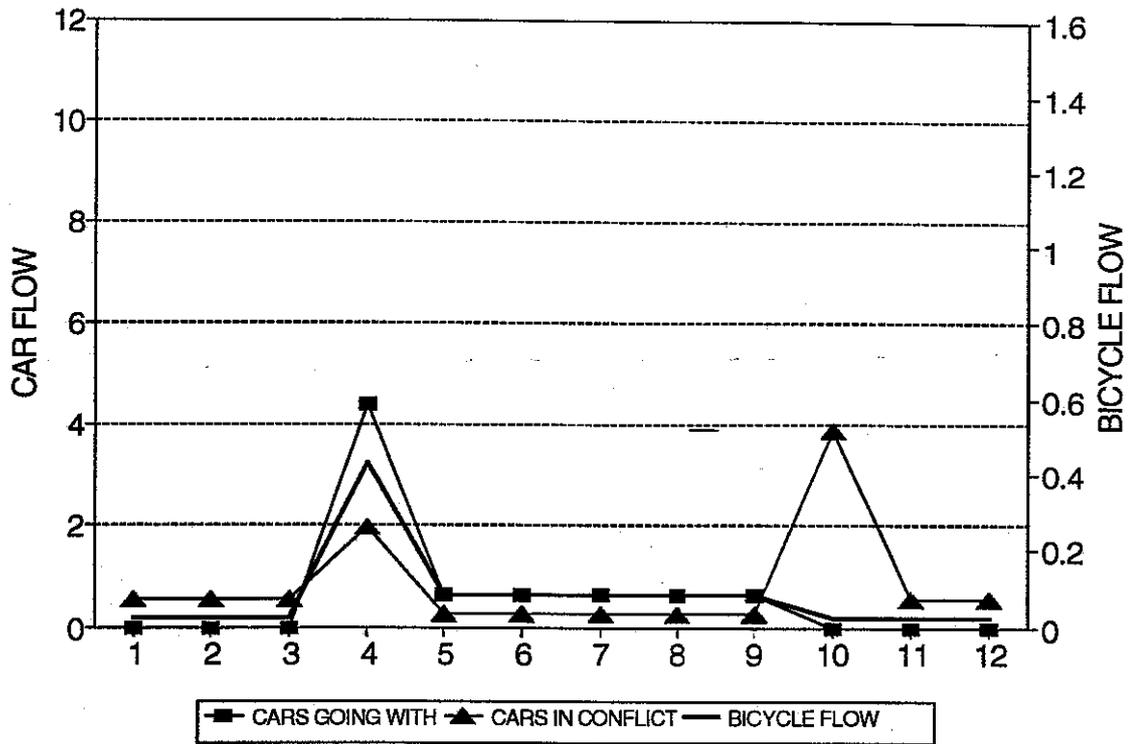
Figure 26: Flows of Right-Turning Bicycles and Relevant Cars

Figures 26–28 show the output from the simulation in graphical form. The x axis indicates the twelve segments of the signal cycle, while the two y axes show the flow of cars and bicycles. The distributions first of all indicate that the programme produces reasonable results in that the highest flow for each movement is at the beginning of the stage, with lower flows occurring subsequently. In terms of safety, they show that, as might be expected, the greatest problems are for left-turning cyclists.
