This is a repository copy of *Ergonomic Standards for Pedestrian Areas for Disabled People: Results from Observation Work*.

Berrett, B., Leake, G., May, A.D. et al. (2 more authors) (1988) Ergonomic Standards for Pedestrian Areas for Disabled People: Results from Observation Work. Working Paper. Institute of Transport Studies, University of Leeds, Leeds, UK.

Working Paper 255

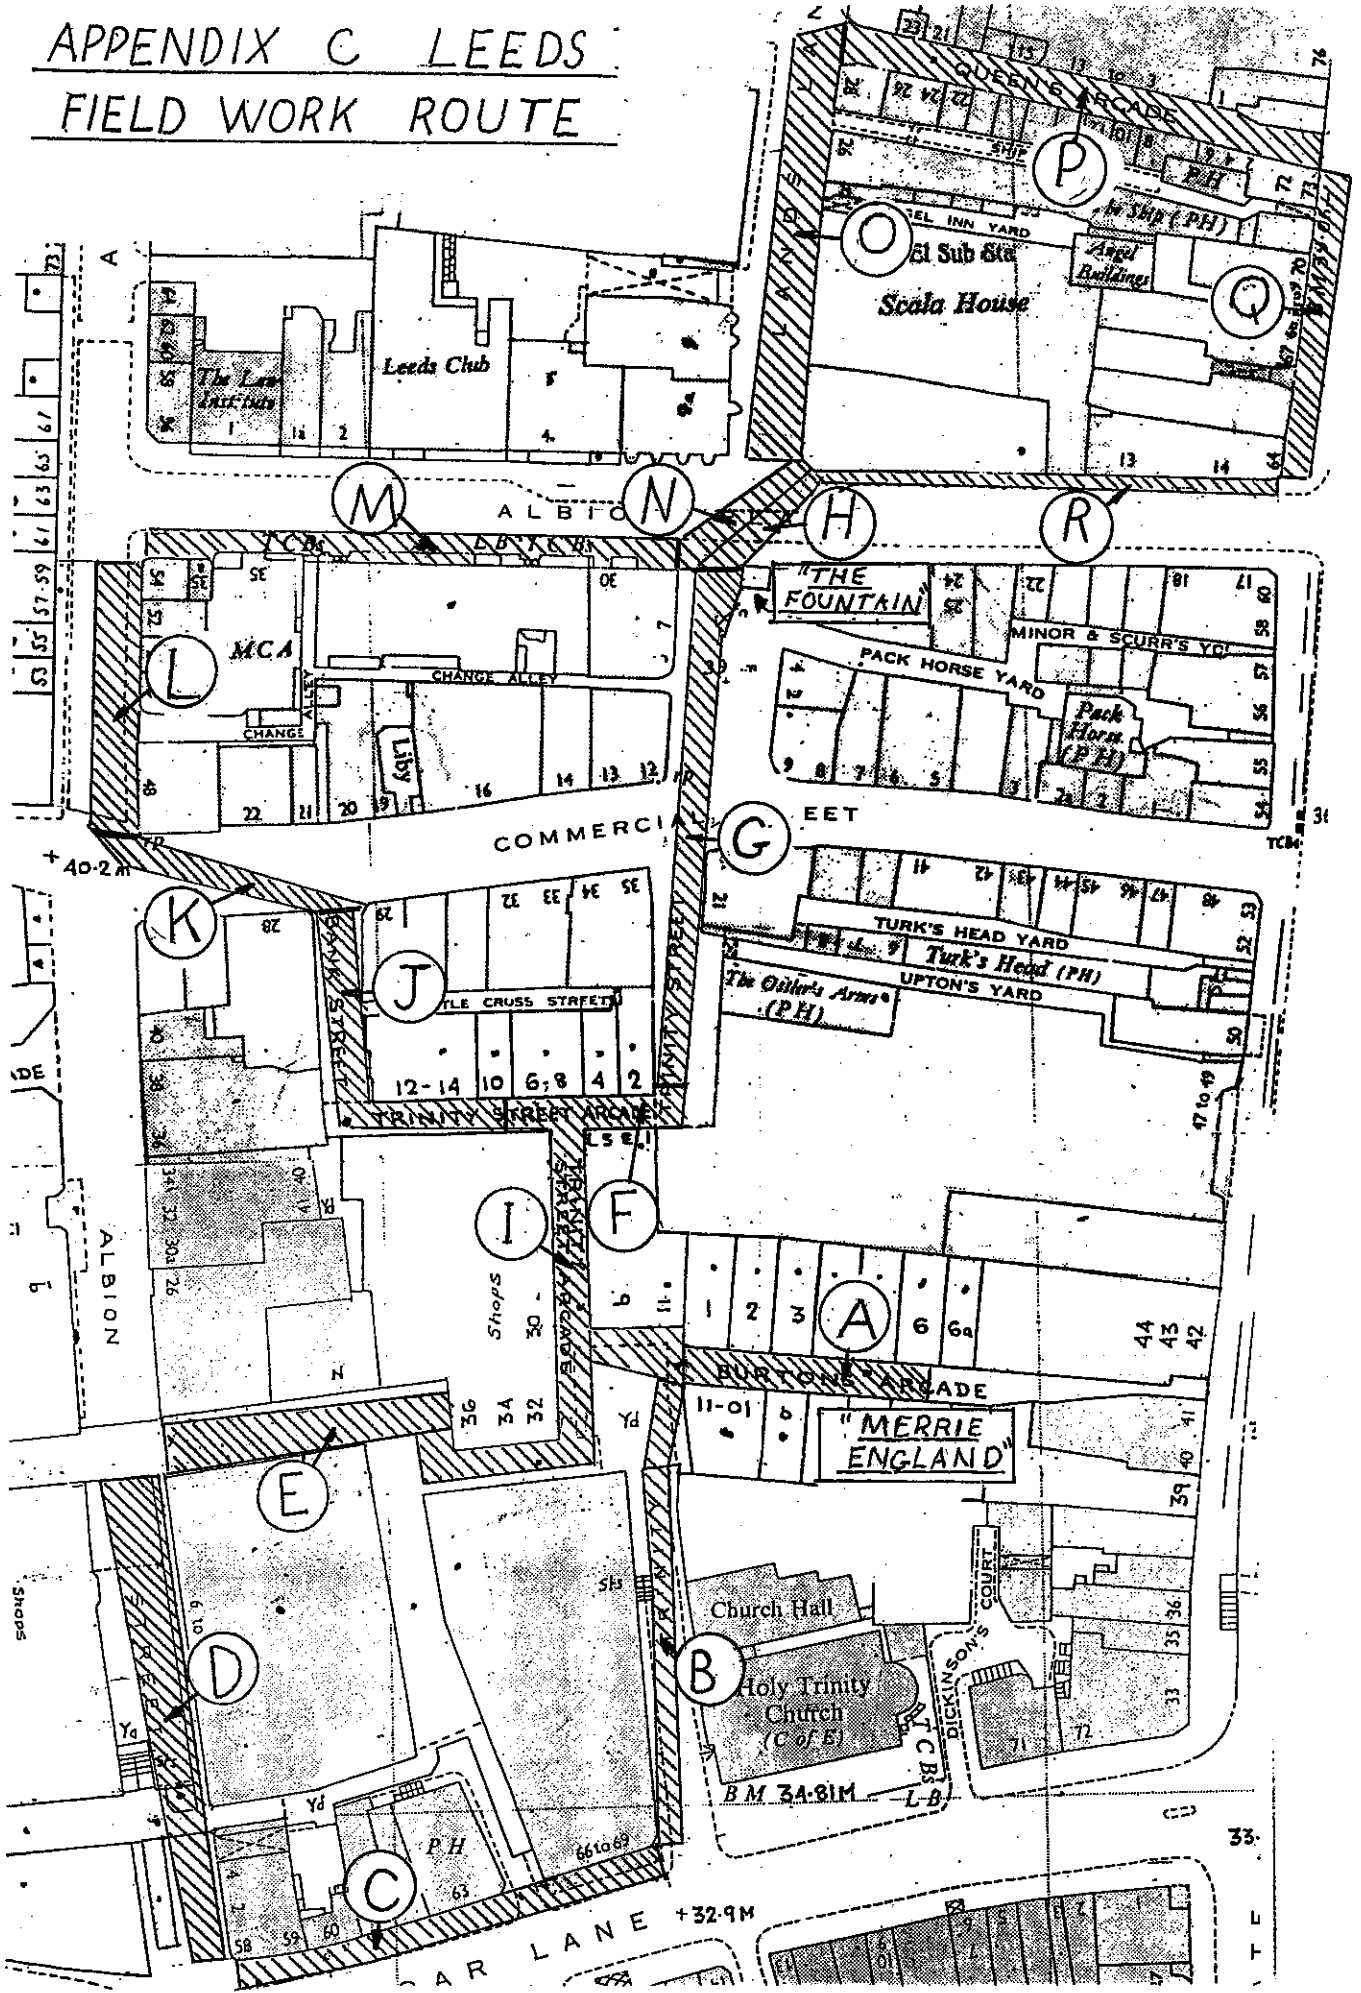
APPENDIX C LEEDS  
FIELD WORK ROUTE

A - end of first route section      H - end of long route      N - end of short route
