# Restoration of seventeenth century water gardens at Bramham Park

**Joseph Holden** reports on his research into discovering how the original water features at Bramham Park worked and to suggest how they might be restored to their former glory.

**Joseph Holden**  
University of Leeds

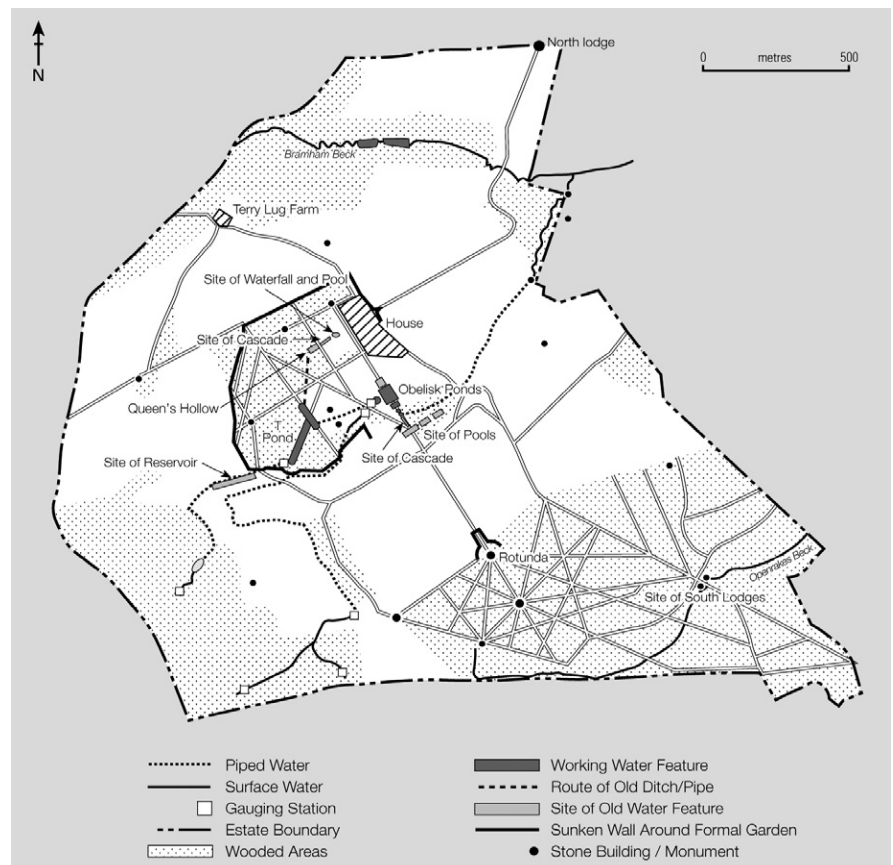
**Figure 1. Map of main water features at Bramham**

Figure 1 is a map of Bramham Park showing named working and defunct water features. In order to establish how water was supplied to the now dry Queen's Hollow and associated cascades and how other features were originally connected, ground penetrating radar

Since gravity was the only feasible mechanism for transporting water at the time this obstacle had to be overcome by contouring the water along an elaborate series of ditches and pipes for over 2 km around the valley edge (Figure 1) with a gradient of only 1:250.

linking water level to discharge. The discharge was also automatically recorded at four other sites (Figure 1) to allow determination of where there were leaks or inputs.

there are some losses between its supply springs and the ponds, repairing these leaks would still not be enough to feasibly allow restoration of the Obelisk cascades. This is because each of the two major cascade systems (Obelisk Pond and Queen's Hollow – see Figure 1) would need around 8-10 litres s<sup>-1</sup> to operate in a satisfactory way. For most of the year this would not be possible.

While the research discussed above has concentrated on water features in the formal gardens at Bramham, one of the best assets of Bramham is the landscape of the Park as a whole. Forming this landscape there is a range of plantations, rides, walks, buildings and stone monuments which are supplemented by water features such as fish ponds and stone arch bridges along Bramham Beck and Openrakes Beck (Figure 1).

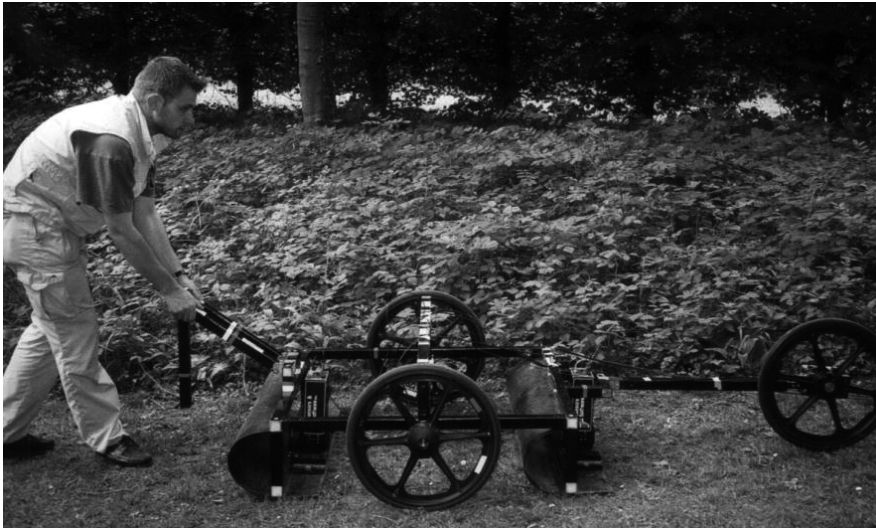
**Figure 2. Surveying the old water features at Bramham using GPR**

(GPR) was used (Figure 2).

This technique has been established at Leeds University for detecting underground pipes and water leaks for the water industry without the need for disturbing the ground.

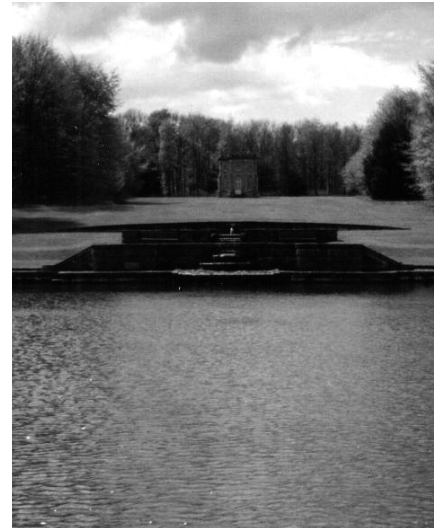
**Figure 5. The main Obelisk Pond**

This system no longer works and maps suggest that it had ceased operation by the early nineteenth century. Cascades leading from the large Obelisk Pond system (Figures 5 and 6) are now covered with turf too and also probably stopped functioning during the nineteenth century.

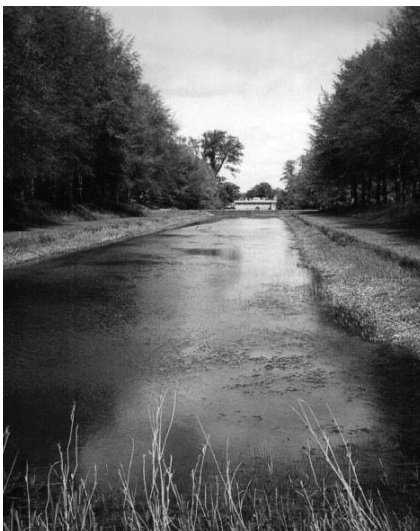
**Figure 3. The T Pond**

Water enters the T Pond via pipes leading from one of the springs. The GPR survey showed that the T Pond (Figure 3) originally overflowed into a pipe and ditch that sent water to the Queen's Hollow which it then delivered via a 30-step cascade to the mouth of a mythical beast. From here water poured down a further waterfall to a pool in a Parterre (Figure 4).

Many of the ponds (just like the great Yorkshire canals) were lined traditionally with puddled clay. However, some ponds, such as the T Pond, are leaking or are completely dry. Puddled clay requires relining every few decades and this will be the first step necessary at Bramham before any of the other restoration work can take place.

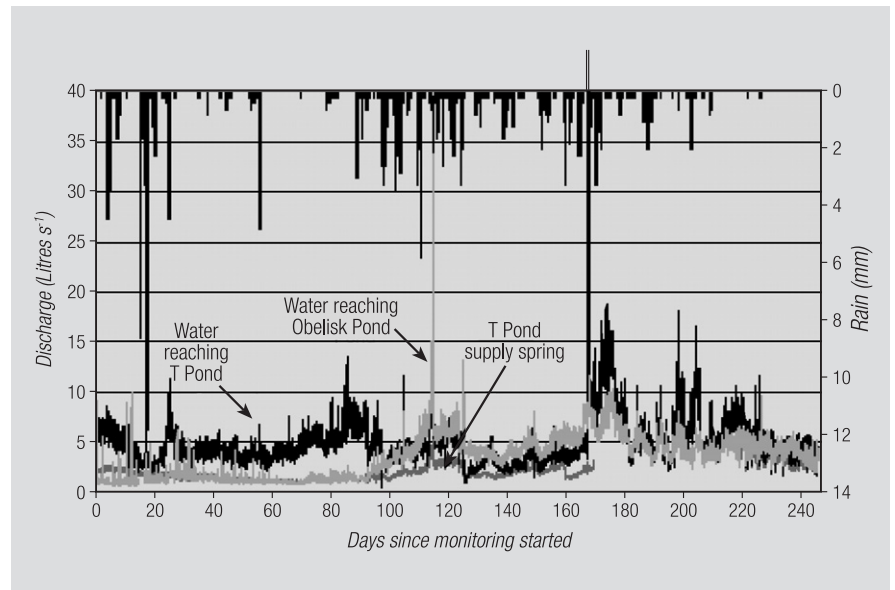
**Figure 7. 15-minute discharge and precipitation (vertical bars) for three sites at Bramham since July 15th 2002**

Figure 7 shows the discharge for the spring supplying water to the T Pond and the amount of water received at the T Pond. It is evident that there are large gains between the two sites. Because water is piped for most of the distance between the two sites, the extra inputs of water are restricted to hillslope runoff running down into the open stream

immediately downslope of the spring.

This shows that while piping the whole course of the system might seem useful in order to prevent sedimentation and remove the need for ditch maintenance, it would result in a large reduction in available water supply. This is because the spring water alone is not the main source of water.

Figure 7 also plots the amount of water reaching the Obelisk Pond system. While

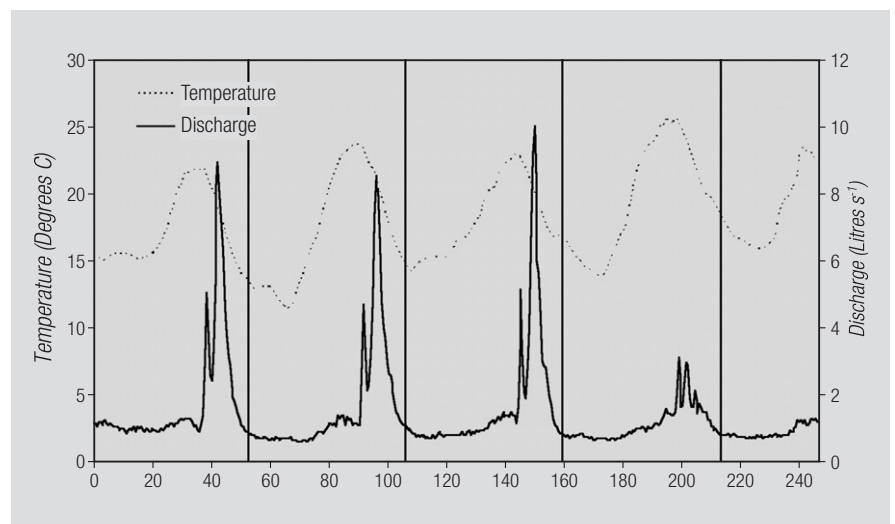
**Figure 8. Daily discharge cycles for a spring at Bramham for a 4.5 day period during August 2002**

from the springs.

This feature could be caused by instrument readings affected by temperature, groundwater tides resulting from lunar cycles, daily evaporation or groundwater abstraction.

The first three of these factors can be discounted since temperature and tidal cycles are not coincident with discharge fluctuations and the instruments have been carefully calibrated for temperature effects. It is likely that some form of abstraction is taking place which may be affecting supply to Bramham Park.

Figure 8 may provide some clues as to why there is insufficient water supplying the water features. This plot shows that there are daily fluctuations in discharge
