Published conference paper

Garrity, SW, Ashour, AF and Chen, Y (2010) *An experimental investigation of retro-reinforced clay brick arches*. International Masonry Society Proceedings 11, Volume 1. 733 - 742 (10). ISSN 0950-9615

An experimental investigation of retro-reinforced clay brick arches

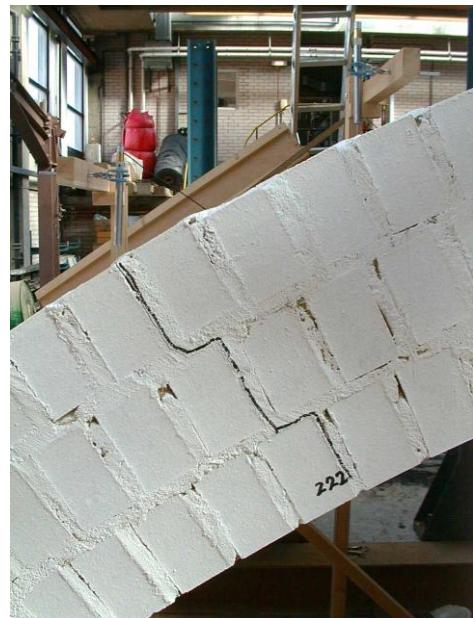
a). 1st hinge forming beneath the applied line load

b). 2nd hinge forming in the arch extrados

Figure 4. 1st and 2nd hinges forming in the brickwork arch

This section provides a summary of the test results; a more detailed description has been provided by Chen [9]. The test results for the phase I tests (arches 1 to 4, inclusive) are summarised in Table 2. Those for the phase II tests (arches 5 to 8, inclusive) are summarised in Table 3. All eight arches failed as a result of the formation of a 4-hinge collapse mechanism. In each case, a hinge initially formed directly beneath the applied load with a crack (or series of cracks) forming in the arch intrados (soffit) and a centre of rotation forming in the shallow compression zone in the brickwork close to the upper surface of the arch. A typical example of this is shown in Figure 4a. Soon afterwards, a second hinge was observed to form in the arch between $\frac{1}{2}$ and $\frac{3}{4}$ span. In this case cracking occurred in the arch extrados (upper surface) with the centre of rotation forming in the shallow compression zone in the brickwork close to the intrados, as shown in Figure 4b. As the applied test load was increased, a third hinge formed at or close to the springing of the abutment adjacent to the applied load, with the crack forming on the upper surface of the brickwork and the centre of rotation occurring in the

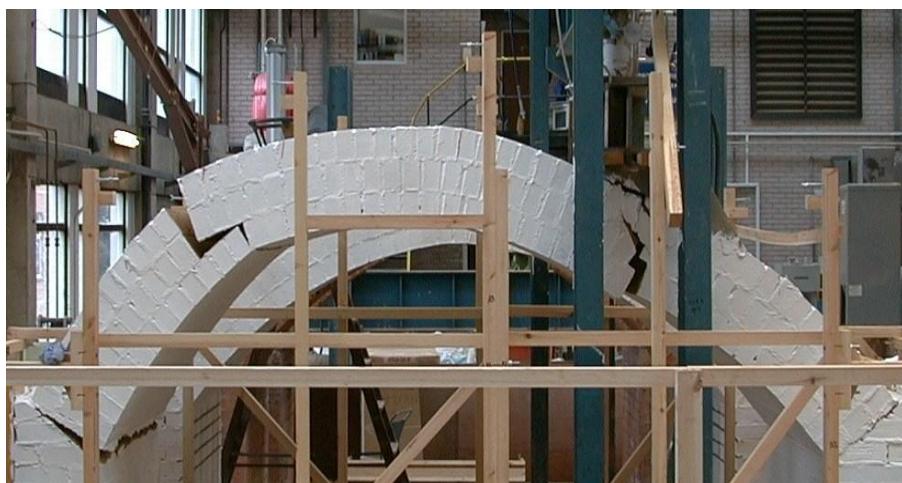
Figure 5. Arch 1 (unreinforced control) showing the 4-hinge collapse mechanism

brickwork close to the intrados. Finally, at or close to the collapse condition, a fourth hinge formed in the springing of the other abutment. The 4 hinge collapse mechanism for arch 1 is shown in Figure 5. Some of the reinforced arches failed prematurely as a result of partial ring separation. Typically, this occurred as a result of a longitudinal crack propagating between the bottom two rings of brickwork from the second hinge towards the first hinge. This was followed by the rapid formation of the third and fourth hinges and collapse, as shown in Figure 6 (for arch 2). It should be noted that the cracking shown in Figure 6 has been deliberately accentuated by the continued loading of the arch after it sustained its maximum load.

ARCH 1 (Unreinforced Control)	
Longitudinal Reinforcement: None	
Compressive strength of mortar:	5.5 MPa
Compressive strength of brickwork prisms:	39.9 MPa
Applied load at first visual signs of cracking:	45.0 kN
Maximum load sustained by the arch:	246.0 kN
Sudden 4-hinge collapse mechanism; little warning of collapse. See Figure 5.	
ARCH 2 (Reinforced)	
Longitudinal Reinforcement: Twelve 6mm dia. bars; 2 bars per groove. 6 grooves @ 225 mm centres (transverse spacing) Effective depth of steel = 286 mm	
Cross sectional area of longitudinal reinforcement:	340mm ²
Compressive strength of mortar:	3.6 MPa
Compressive strength of brickwork prisms:	39.7 MPa
Compressive strength of grout (average):	58.8 MPa
Applied load at first visual signs of cracking:	170 kN
Maximum load sustained by the arch:	351 kN
Gradual failure exhibited. Formation of hinges at $\frac{1}{4}$ and $\frac{1}{2}$ span followed by premature failure caused by the partial separation of the lower ring from the upper 2 rings of the arch barrel. At collapse, hinges formed at both springings. See Figure 6.

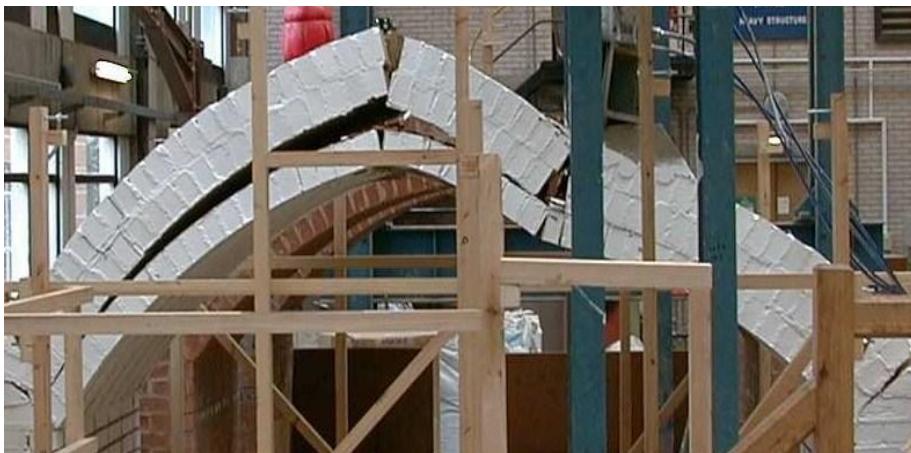
Figure 6. A reinforced arch (arch 2) without shear reinforcement showing premature partial ring separation and a 4-hinge collapse mechanism.
