# COMBATING AUTOMOTIVE ENGINE VALVE RECESSION: A CASE STUDY

R. Lewis\* and R.S. Dwyer-Joyce

Department of Mechanical Engineering, The University of Sheffield, Mappin Street,  
Sheffield, S1 3JD, UK.

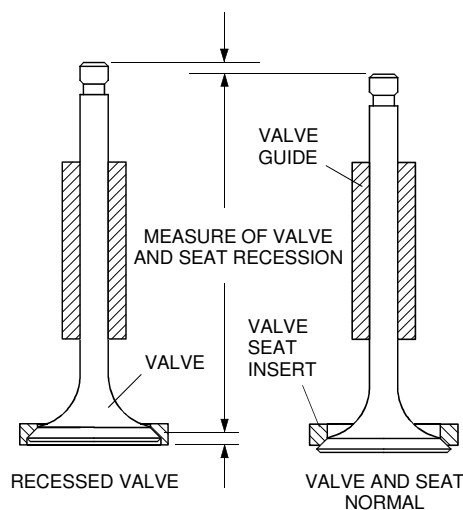
Figure 1. Valve Recession

Valve recession occurs when wear of the valve or seat inserts in an automotive engine has caused the valve to *sink* or recede into the seat insert (as shown in Figure 1).

Excessive recession leads to valves not seating correctly and cylinder pressure loss. Leaking hot combustion gases can also cause valve guttering or torching, which will accelerate valve failure.

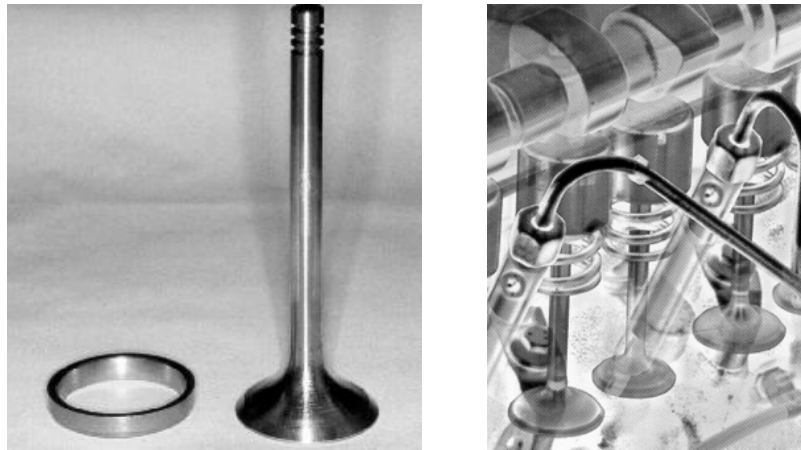
Figure 2. Valve, Seat Insert and Valve Operating System

The failures that initiated the investigation involved an eight valve, 1.8 litre, direct injection diesel engine, with direct acting cams. The engine was undergoing design upgrades, one of which was the change from indirect to direct injection. This meant the inclusion of holes in the cylinder-head between the inlet and exhaust ports to accept the fuel injector. A new seat insert material was also being trialed in the tests. The material had solid lubricants incorporated, which were thought to help improve machinability and reduce sliding wear problems at the valve/seat interface. The valve, seat insert and operating system are shown in Figure 2.

A number of problems occurred during pre-production dyno-testing. The new seat insert material exhibited excessive wear (0.3mm of recession in 100 hours). Further analysis also revealed that uneven wear of the seat inserts was occurring. This was found to be a result of thermal distortion of the seat inserts thought to be due to enforced changes in cooling channels to incorporate the fuel injectors. On cooling the seat inserts returned to their original shape, which meant on restarting the valves were unable to seat properly and cylinder pressure loss resulted.

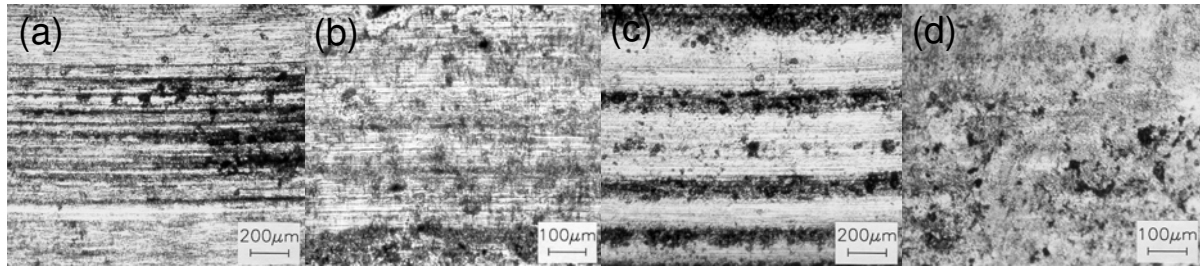
Figure 3. Laboratory Tested Valve (a) and Seat Insert (b) Compared with Engine Tested Valve (c) and Seat Insert (d)

Impact on valve closure causes plastic deformation of the seating face surface and the formation of a series of circumferential ridges and valleys. It also led to surface cracking and subsequent material loss from seat inserts at high closing velocities. Sliding caused the formation of radial scratches on the seat insert seating faces.

Figure 3 illustrates some of these features and compares wear surfaces on valves and seats run in the test apparatus (Figure 3a and b) with those examined during failure analysis of valves and seats from engine tests (Figure 3c and d).

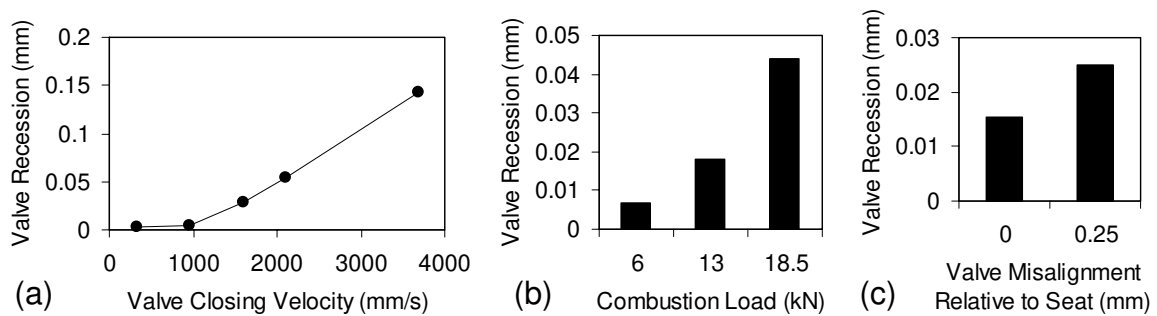
Figure 4. Valve Recession with Cast Tool Steel Seat Inserts for Increasing (a) Valve Closing Velocity (after 100 000 cycles); (b) Combustion Load (after 25000 cycles) and (c) Valve Misalignment (after 25000 cycles)

The test work showed that recession was strongly dependent on valve closing velocity, combustion load and valve/seat insert misalignment, as shown in Figure 4 [3].

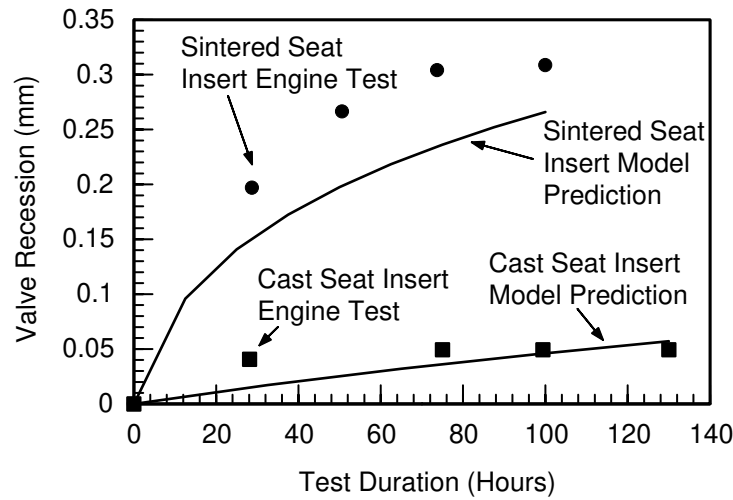
Figure 5. Model Predictions versus Engine Test Data

To provide a tool for running the wear modelling code software called RECESS has been developed. Figure 5 shows RECESS predictions against measured data for engine dyno-tests run using cast and sintered tool steel inserts. As can be seen, the model produces a good prediction of valve recession.

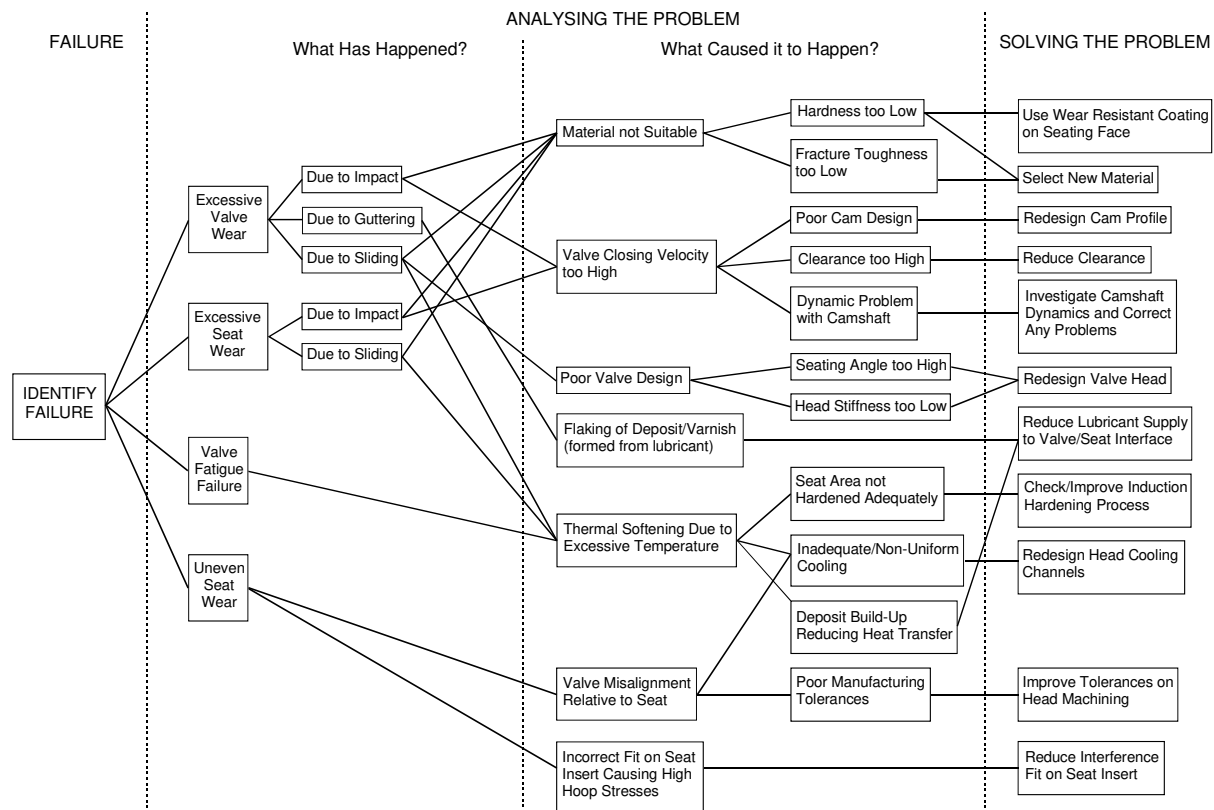
Figure 6. Solving Valve/Seat Failure Problems

Knowledge built-up during failure analysis, bench testing and modelling has been combined to develop a flow chart for use in solving valve recession problems that do occur, more quickly, as shown in Figure 6.
