Case Study of Barrette Retaining Wall, Kent, UK

ABSTRACT This paper presents a case history of a retaining wall designed by Arup and constructed in Kent, UK, between 1996 and 1998, as part of a highway cutting. The design methodology which was applied for this novel wall type is introduced, and measured horizontal displacements are presented and discussed. The design requirements specified that the wall had to be capable of supporting up to 8.8 m of retained height and was not to be propped or anchored. To attain sufficient bending stiffness, Arup introduced a series of discrete barrettes perpendicular to the excavation. Arches of sprayed concrete retain the soil between the barrettes above dredge level. The barrettes were designed applying the general design principles for embedded retaining walls. Pore water pressures on the wall were reduced and controlled by installing a back of wall drainage system. Inclinometers in one of the instrumented wall sections were recently re-read. These data are shown and compared to the original predictions. Overall the wall showed only minor movements and satisfies the stated design requirements.

2 THANET WAY RETAINING WALL

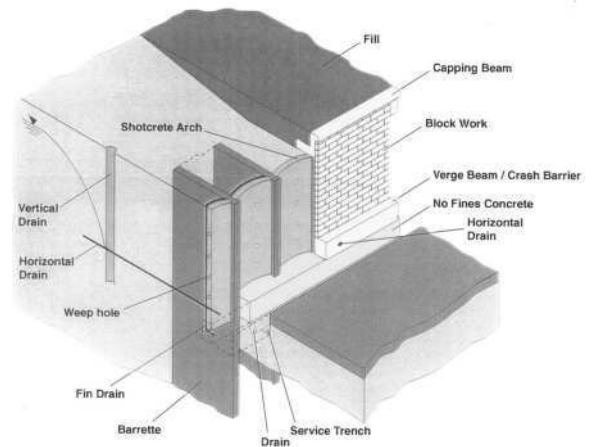
Figure 1. Isometric view of the wall and the drainage system.

Maximum allowable wall deflections of 20mm horizontal movement at verge level and 1:200 tilt above verge level, following construction of a non-structural facing wall, were specified by KCC in order to minimize the risk of future damage to the block work. In order to ensure that these limits were not exceeded, a permanent drainage system was provided, consisting of fin drains behind the sprayed concrete arches and vertical drains located 6m behind the wall facing, at the end of the barrettes. The water level behind the shotcrete is controlled with intersecting horizontal drains which discharge through the verge beam into the highway drainage system. The general arrangement and the back of wall drainage system is shown in Figure 1.

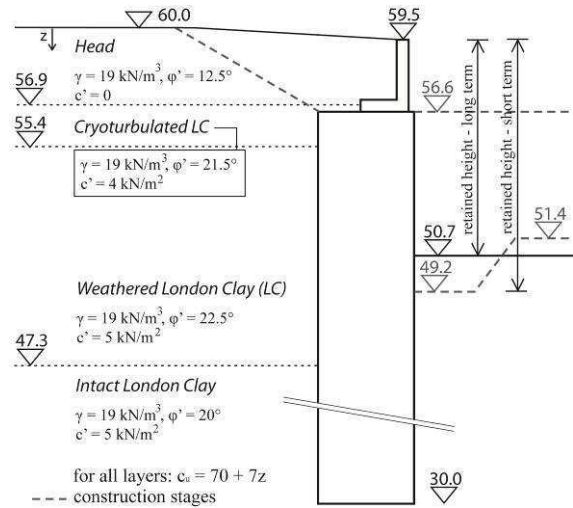
Figure 2. Wall section of maximum retained height: cross section and geology

The section considered in this paper, including the geology and basic design parameters is shown in Figure 2. The wall in this section is fully embedded in London Clay (LC).

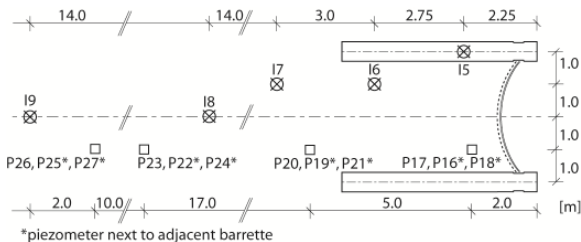
Figure 3. Installed instrumentation at critical wall section.

both behind and in front of the wall using vibrating wire pressure transducers which were installed in standpipes. Figure 3 shows the location of inclinometers and piezometers installed at the wall section in plan. Magnetic extensometers were installed in conjunction with the inclinometer tubes.

It can be seen from comparison of the deflected profiles of the wall at the end of construction and some 15 years later that only minor movements of the wall have occurred in the interim. At the top of the wall, increases in deformation of 2mm in I5, in the barrette, and 3mm in I6, between the barrettes (see Figure 3), have been recorded.

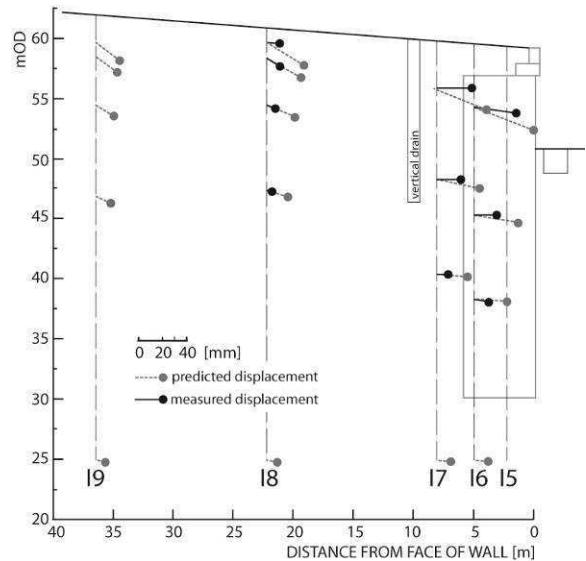
Figure 4. Predicted and measured displacements at end of construction (April 1998).

In Figure 4, observed movements after completion of construction are compared to movements predicted from the original undrained model. The analyses conducted in SAFE showed movement of the inclinometer toes which, for the inclinometer readings, are assumed to be fixed. As there was no independent monitoring of the top of the inclinometers, it cannot be verified if toe movement actually occurred.

Even though the displacements had been over-predicted in the original analysis for the short as well as in the long-term (Figures 4, 6), horizontal strain in the soil behind the wall, calculated as $(d_{16}-d_{18})/17\text{m}$, with d_{16} : deformation at inclinometer I6, level +55 mOD, was similar for predicted and measured values (short-term measured: 0.14%, short-term predicted: 0.12%, long-term measured: 0.14%, long-term predicted: 0.15%). It must be noted that taking into account the system accuracy of inclinometers there is some uncertainty in these values and they

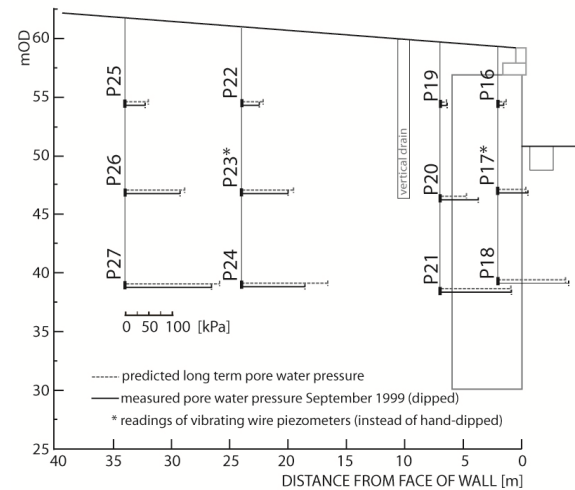
Figure 5. Long term prediction of pore water pressures and measured values 1 year after completion of construction (April 1999).

Water levels one year after completion of construction in the serviceable piezometer were found to be close to the expected long-term levels, indicating that the installed drainage system was operating efficiently (Figure 5). Compared to the plotted values, until 2003 an increase in P20 and a decrease in P21 were recorded, with all other piezometers being stable.

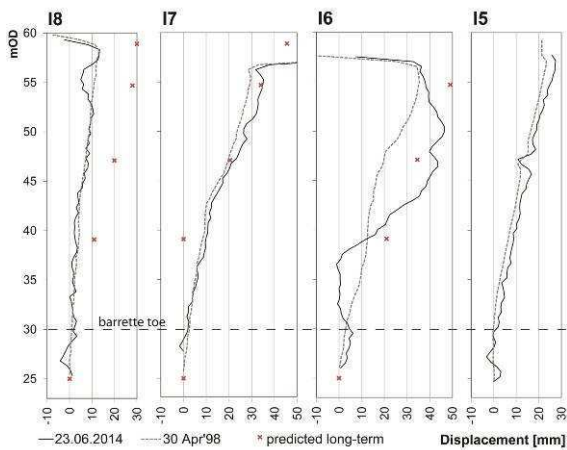
Figure 6. Horizontal displacements at end of construction, recent readings and long-term prediction.

In June 2014, inclinometers I5-I8 were read again. Deformations of these inclinometers at end of construction as well as the new readings are shown in Figure 6. It has to be noted that I5, in the barrette, was commissioned about 6 months later than I6-I8 and consequently did not record all movements during construction.

Horizontal long-term deformations as predicted in the original analysis are plotted alongside the new readings in Figure 6. The plotted displacements are reduced by the predicted toe movements which were 20mm for I6 and 16mm for I7 as well as I8.

Inclinometer I5, in the barrette, shows a kink at around +47 mOD. This is probably due to an inconsistency in the inclinometer tube as it appears in the prior readings and also is apparent in the checksums of the recent measurements, suggesting false readings around this level. Between +25 and +28 mOD, deformation of the inclinometer tube possibly indicates squeezing of the ground below the barrette. Both features are apparent in the B-axis as well, which is not plotted here. However, the recorded movements are very small ($\pm 3\text{mm}$) and further evidence would be required to verify this conclusion.

Inclinometer I6 which is located 5m behind the wall face, adjacent to a barrette, shows backwards movement between +32 and +37 mOD compared to the reading in 1998. This could possibly be due to a bias shift. However, shifting the data to match the prior reading at this level would increase the post construction movement at the top of the wall to 12 mm, which does not seem plausible given the negligible displacement of I5 and I7 in the same period. Between +37 and +57 mOD I6 bulges in the direction of the wall face. Both, the bulge and the backward movement at lower levels seem to show local effects between the barrettes, as they don't appear 3m further back, in I7. In I8, 16m behind the wall face, no additional movements have occurred since construction was completed.

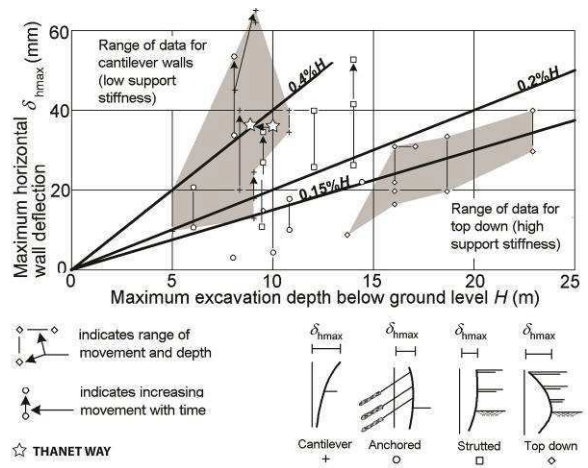
Figure 7. Comparison of barrette wall with case studies after CIRIA C580 Figure A2.1.

In order to demonstrate the performance of this barrette wall in the context of other case studies, the maximum horizontal wall deflection vs maximum excavated depth below ground level has been plotted against case history data given in Ciria C580 (Figure 7). The Thanet Way wall performance is within the range of data for other cantilever walls and is close to the line where deflection is equal to 0.4% of excavated height. It is important to note that unlike other cantilever walls this wall remained as an unpropped cantilever wall after construction and has no long-term propping from the final structure.
