# Surface damage effects caused by debris in rolling bearing lubricants, with an emphasis on friable materials

R S DWYER-JOYCE, J C HAMER, and R S SAYLES  
Imperial College Tribology Section, London, UK  
E IOANNIDES  
SKF ERC BV (Visiting Professor at Imperial College)

## SUMMARY

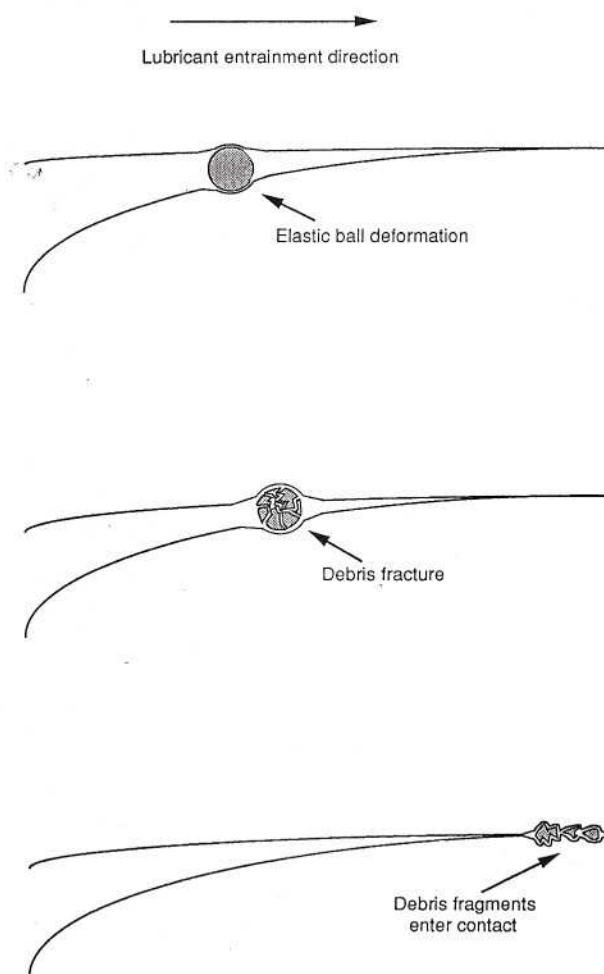
Fig 4 Fracture mechanism of brittle debris particles in a rolling element contact

It was found that the very brittle materials fracture early in the entry zone, almost as soon as they are compressed (see figure 4). The fragments then enter the contact and can be embedded in the ball surface. The photograph included, as figure 5, shows the breakdown of 30 micrometre glass micro-spheres, in the entry zone and the fragments entering the contact.

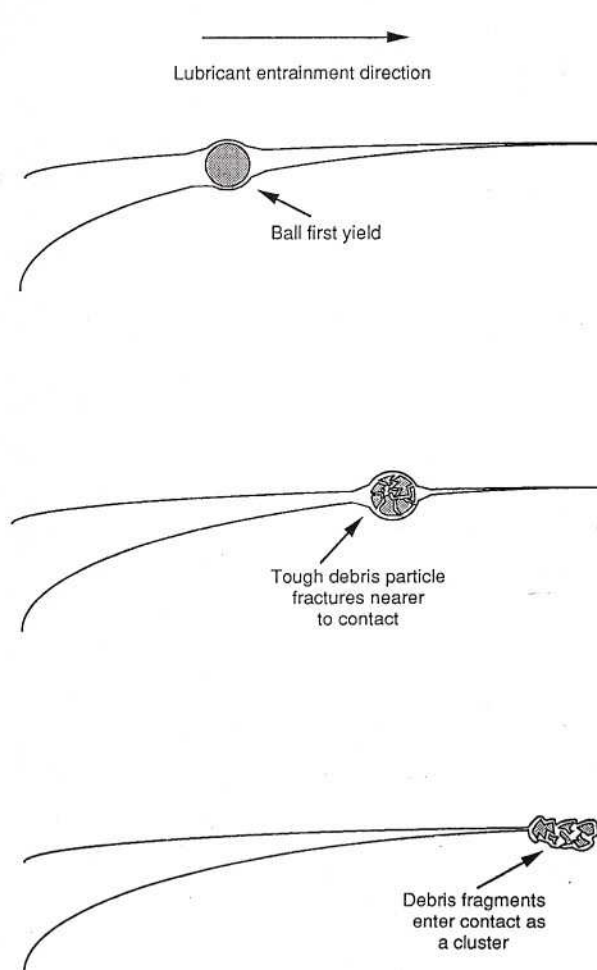
Fig 6 Deformation mechanism of high toughness ceramic debris in a rolling element contact

The harder ceramic particles breakdown further into the entry zone or in the contact itself (see figure 6). The particle fragments then tend to enter the contact in a mass and damage the ball surface.

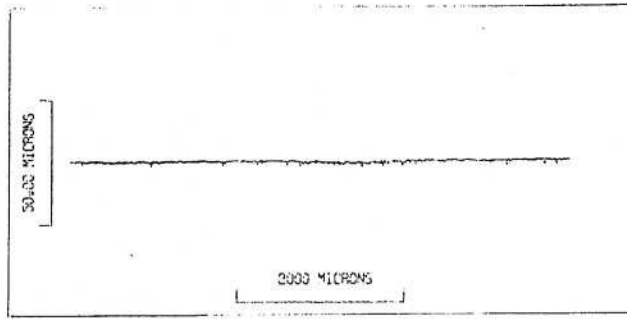
Fig 7 Dents caused by squashing 1.5mm cylindrical particles between hard steel anvils: (a) quartz, (b) silica, (c) alumina

Again, the experiments using hard steel anvils to compress particles were carried out to study the nature of the surface damage caused by brittle particles. 1.5mm diameter cylindrical quartz, silica, and alumina particles were crushed between the anvils and the surface damage measured. Figure 7 shows surface maps of the resulting damage. In addition the specimens from the optical EHD studies were examined for surface damage.

The damage to a rolling element surface can be caused at two stages of the particle fracture process. If the debris material is tough the ball surface will yield before fracture of the particle occurs. When particle fracture has occurred, it is the surviving fragments which embed in the rolling element surface causing the second stage of surface damage. The silica particles appear to have caused this first

yield before fracture. The quartz particles, however, have caused little or no yield before fracture; the surface damage is a result of the fragment indentation process.

It should be noted that the strength of the friable particles need not be entirely dependent to the material hardness. The test results for figure 7 show that silica causes more surface damage than quartz; however its hardness is approximately half that of quartz. Other factors such as the shape and crystal structure have an effect on the particle strength and resulting surface damage.

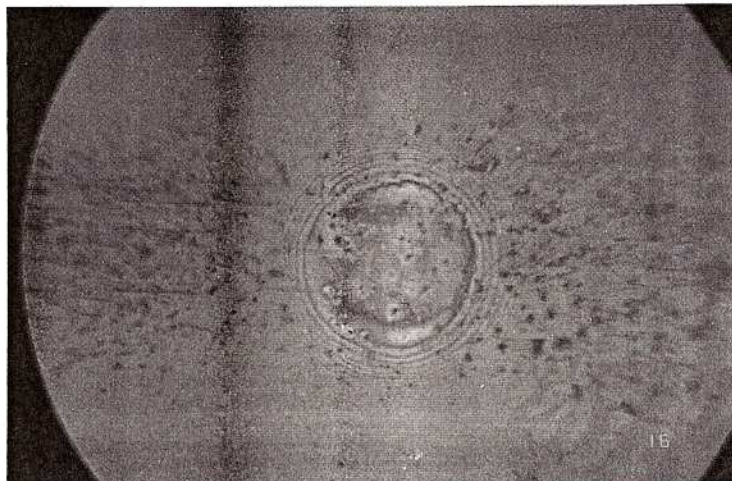
Fig 8 Optical EHD photo of 5 micron silicon carbide particles entering the contact (photograph magnification  $\times 60$ , photographically reduced to 55 percent)

For low fracture toughness materials the critical crack size will be lower, hence the surviving fragment size is small. In the optical EHD rig, glass fragments of one micrometre are typical, whilst silicon carbide fragments of 5 micrometres appear to survive (see figure 8).

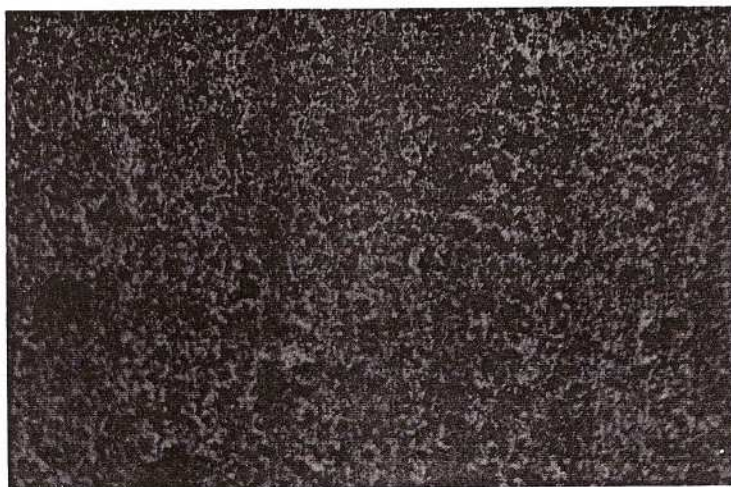
Fig 10(a) Photomicrograph of raceways tested with ACTFD lubricant contaminants (photograph magnification  $\times 300$ , photographically reduced to 55 percent)

The nature of the surface damage is clear; the silicon carbide particles have left deep sharp dents with embedded material projecting out; the ACFTD particles have left very fine shallow surface dents. Figures 10a & b show photographs of the surface damage on these tested raceways.

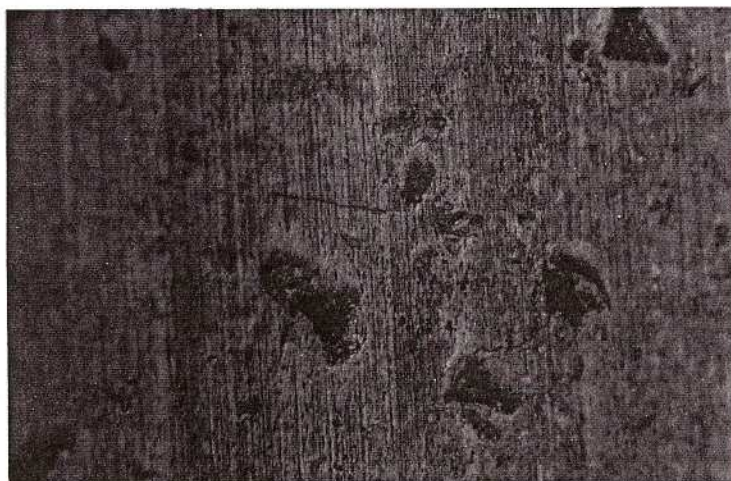
Fig 10(b) Photomicrograph of raceways tested with SiC contaminated lubricants (photograph magnification  $\times 300$ , photographically reduced to 55 percent)
