# Strain evolution measurement at the microscale of a Dual Phase steel using Digital Image Correlation

**Abstract.** Digital Image Correlation (DIC) together with in-situ tensile testing has been used to measure in DP1000 steel the evolution of plastic strains at the microstructure scale. Interrupted tensile tests were performed on specially designed samples and scanning-electron micrographs were taken at regular applied strain intervals. Patterns defined by the microstructural features of the material have been used for the correlation carried out using LAVision software. The full field strain maps produced by DIC show a progressive localisation of deformation into bands at about 45° with respect to the loading direction. Plastic strains as high as 130% have been measured within the ferrite phase.

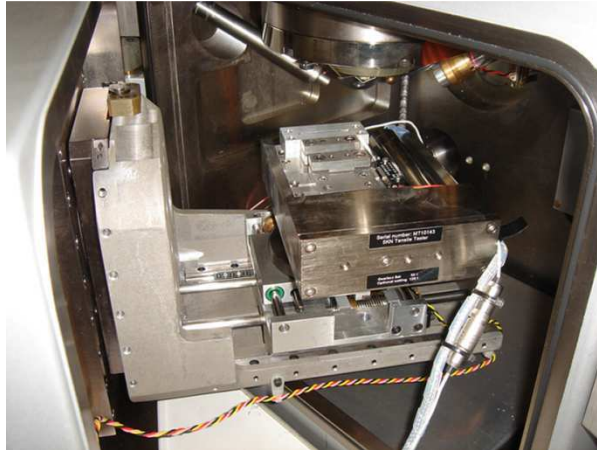
Fig. 2: Tensile test stage loaded in the SEM chamber

A Deben MICROTTEST tensile stage with a capacity of 5 kN was used to carry out the tests. The machine was loaded in a CAMSCAN SEM, Fig. 2. The test was interrupted regularly under loading to take images of a pre-selected area of the microstructure. This area was located as close as possible to the centre of the gauge length where necking was likely to take place. A very slow strain rate ( $\dot{\epsilon} \approx 0.001s^{-1}$ ) was selected to give sufficient time to follow the deformation of the microstructure. The test was stopped after the start of necking. The specimen was then removed from the stage and polished until a flat surface was obtained to remove the surface roughening due to the out of plane deformation. The microstructure was then revealed following the same procedure described. Fig. 3 shows the various steps of this procedure with the specimen loaded again in the microscope at the end. Micrographs were taken again regularly until the final fracture of the sample.
