Lewis, S.R., Fretwell-Smith, S., Goodwin, P.S. et al. (2016) Improving rail wear and RCF performance using laser cladding. *Wear*, 366. pp. 268-278. ISSN: 0043-1648

# Improving Rail Wear and RCF Performance using Laser Cladding

Laser cladding has been considered as a method for improving the wear and RCF performance of standard grade rail. This paper presents results of small scale tests carried out to assess the wear and RCF performance of rail which had been laser clad. Using the Laser Cladding process premium metals can be deposited on to the working surface of standard rail with the aim of enhancing the wear and RCF life of the rail. Various laser clad samples were tested using a twin-disc method. The candidate metals were clad on to standard R260 grade rail discs and were tested against a disc of standard wheel material. During the tests, wear rates and RCF initiation were monitored and compared to those of a standard rail disc. Six candidate cladding materials were chosen for this test: A multi-phase Manganese Steel Variant (MMV), Martensitic Stainless Steel (MSS), TWIP Steel, NiCrBSi, Stellite 12 and Stellite 6. The MSS, Stellite 6, and Stellite 12 samples showed reduced w

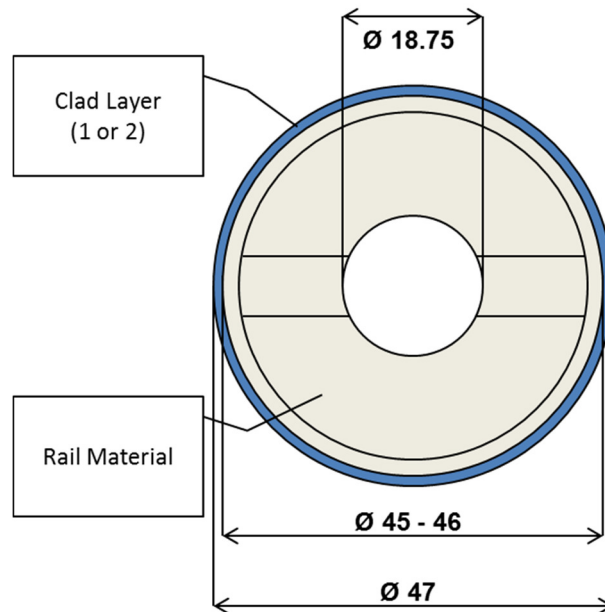
Figure 1. Schematic of a twin-disc specimen

proven/expected wear and RCF resistance. Materials were deposited in nominally 1 mm thick layers. 1 or 2 layers were applied, as shown in Figure 1. The width of a deposited bead is typically 4mm and several beads are required to cover the 10 mm wide running band of a twin-disc specimen. Once the surface of a specimen is covered and the deposit cooled the surface has a “ploughed field appearance due to the adjacent beads of deposit. After the required number of layers are applied the discs then need to be ground to achieve the final test surface finish.

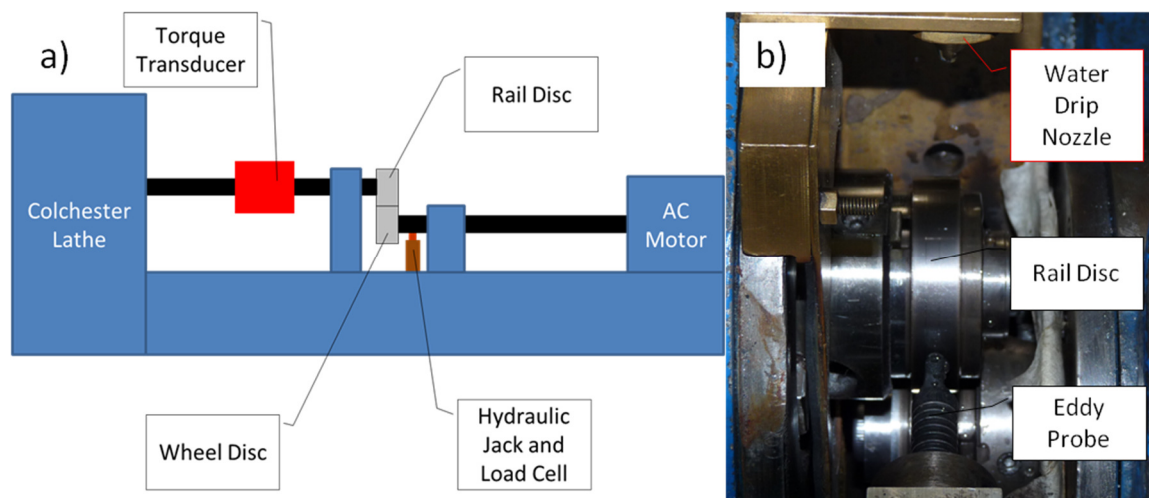
Figure 2. a) Schematic of twin-disc machine b) Eddy current probe secured close to rail disc

Two types of tests were carried out; one to look at wear and the other RCF. Before each test, the samples were cleaned in an ultrasonic bath with acetone. In the wear tests the discs were run for a total of 30,000 cycles in 5,000 cycle intervals. Wear was periodically measured by weighing the discs before the test start and after each subsequent 5000 cycles. The tests were intermittently stopped in order to monitor the evolution of the wear rates of the discs over time. The wear tests were designed to characterize the traction and wear properties of the laser clad samples under dry conditions. Some of the candidate cladding materials were known to work-harden, hence will not show a stable wear rate. Therefore monitoring the evolution of the wear rate allowed a better understanding of the wear characteristics of each material. Micro-hardness of the discs was also measured before and after each test. The RCF test samples were run for 500 cycles under dry conditions to build up plastic flow at the disc surface and initiate cracks. The discs were then run for 50,000 wet cycles [5]. The contact between the discs was wetted by dripping water at a rate of 1 drop per second onto the discs. The contact was wetted to accelerate the rolling contact fatigue process. Both types of test were performed at a slip of 1% and a maximum Hertzian contact pressure of 1500 MPa. An Ellotest B1 Eddy Current Crack Detector was used to show the presence of any fatigue cracks in the specimens during the RCF tests. A differential eddy current probe was offset 0.3 mm from the surface of the rail disc, see Figure 2b. This induces an eddy current in the surface of the disc. Any crack or fissure in the disc surface will disturb this eddy current and these

disturbances are sent back to the detector unit. The unit is calibrated with a reference disc which has a 5mm long wire eroded crack in its surface parallel to the discs axis of rotation.

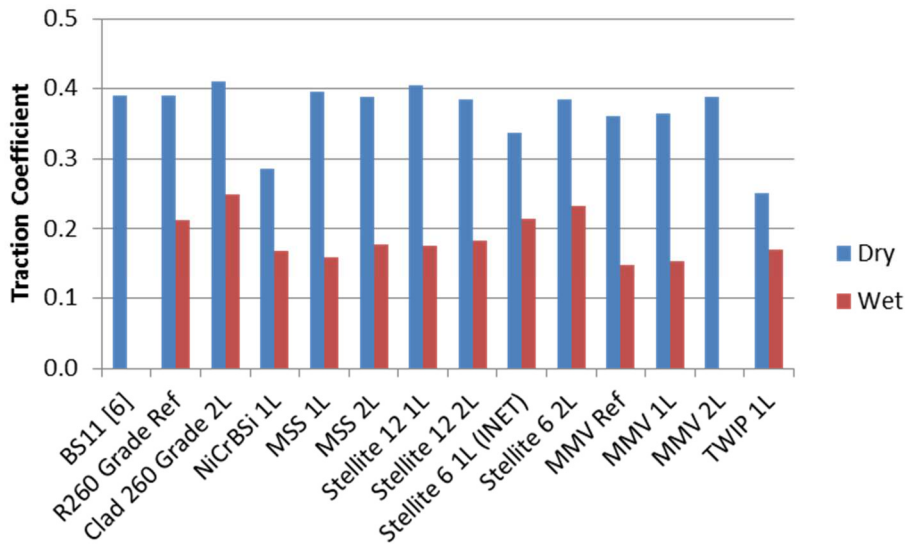
Figure 3. Average traction coefficients for each cladding in both dry and wet conditions. Ref indicates reference, 1L indicates 1 clad layer and 2L indicates 2 clad layers

Figure 3 shows average traction results for each of the different claddings compared to an unclad reference R260 grade rail disc. The dry traction data was taken from the wear tests and the wet data taken from the RCF tests.

In dry conditions the majority of discs showed a traction coefficient above 0.35 with the two exceptions being the 1 layer NiCrBSi and the 1 layer TWIP samples both giving coefficients of 0.29 and 0.25 respectively. In wet conditions all of the discs gave values within a similar range. Apart from the NiCrBSi and TWIP discs none of the traction

coefficients of the clad discs deviated far from the R260 Grade reference sample, indicating that in the field MSS, Stellite 12 and MMV clads would give similar adhesion levels to un-clad R260 Grade rail. Interestingly, in dry conditions, the 2 layer clad R260 and MMV samples show higher traction than their un-clad reference counterparts.

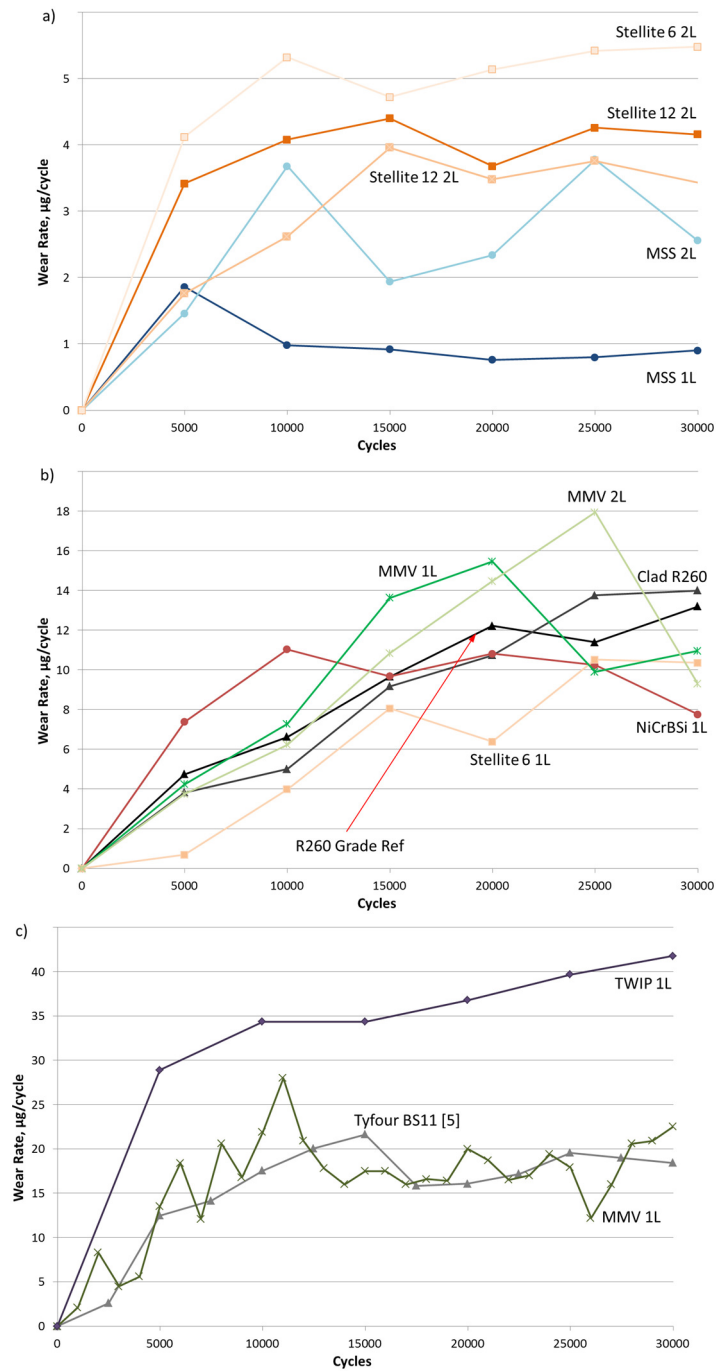
Figure 4. Wear rate evolution of the rail discs under dry conditions. a) Group 1 (Wear < 5 µg/cycle), b) Group 2 (5 > wear < 15 µg/cycle), c) Group 3 (Wear > 15 µg/cycle)

Figure 4 shows the evolution of the wear rate of the rail discs. The results have been compared to tests carried out by Tyfour et al. [6] in which the wear rate evolution of BS11 rail rolling against R8A wheel steel was measured using the same twin-disc machine under the same conditions as used in these tests.

Figure 4 shows that there is a wide variation in the wear behavior of the rail discs. There seems to be 3 distinct groups which the discs can be put into:

- Group 1 (Figure 4a), where the wear rate stays below 5  $\mu\text{g}/\text{cycle}$ . This group includes both the 1 and 2 layer MSS and Stellite 12 discs and the Stellite 6 2 layer disc.
- Group 2 (Figure 4b), where the wear rate is between 5 and 15  $\mu\text{g}/\text{cycle}$ . This group includes both the 1 and 2 layer MMV, the Stellite 6 1 layer disc, the R260 grade reference disc, the clad 2 layer R260 grade disc and the NiCrBSi disc.
- Group 3 (Figure 4 c), where the wear rate remains mainly above 15  $\mu\text{g}/\text{cycle}$ . This group includes the MMV reference disc, the BS11 disc [6] and the TWIP disc

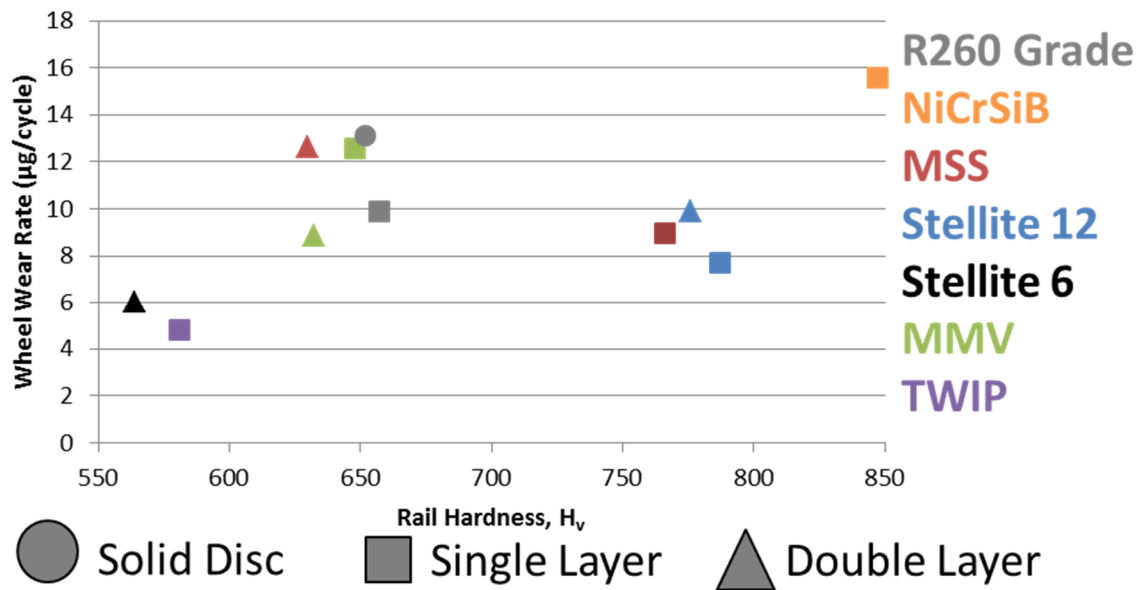
Figure 5. Average wear rate of wheel discs in dry conditions plotted against the end-of-test rail disc hardness, colour of data point indicates material/clad type, shape indicates number of layers

The hardness of each rail disc was compared against the wear rate of the wheel disc that it was tested against as shown in Figure 5. Each disc was sectioned and polished after testing and a Vickers micro-hardness case measurement was taken close to the disc surface. Figure 6 shows the correlation between average rail disc hardness and rail disc wear rate.

In all but one of the cases tested the wheel wear rate was classified as good/superior with Stellite 6 and TWIP, both 1 layer, showing superior wheel wear rates. Figure 5 shows the wear rates of the wheel discs plotted against the measured rail disc hardness. It is difficult to draw a conclusion from this data as the surface disc hardness will have changed throughout the test. What is of more relevance is that the wear rate of the wheels has not increased as a result of running against a harder rail as would be expected. In all but one cases the wear of the wheel is lower than the reference case and in some cases substantially.

Figure 5 shows a comparison between the mean rail disc hardness and the wear rate of the wheel disc which it was tested against. No correlation between rail hardness and wheel wear can be seen in the data. However, only one of the samples showed a higher wheel wear rate than the reference case; that being the NiCrBSi sample. This suggests that in the majority of cases if a premium/harder material were to be clad onto a standard R260 Grade rail this would not adversely affect the wheel wear rate. In all but one of the claddings tested the wheel wear rate was either unaffected or lower than in the baseline R260 Grade case. This is shown in Table 1. This phenomenon of harder rail material yielding lower wheel and rail wear rates has also been seen in [10-12]. It is interesting to note from the hardness change of the rail discs and the indicated hardness change of the wheel discs that both wheel and rail specimens work hardened toward a range of 600 – 800 Hv.

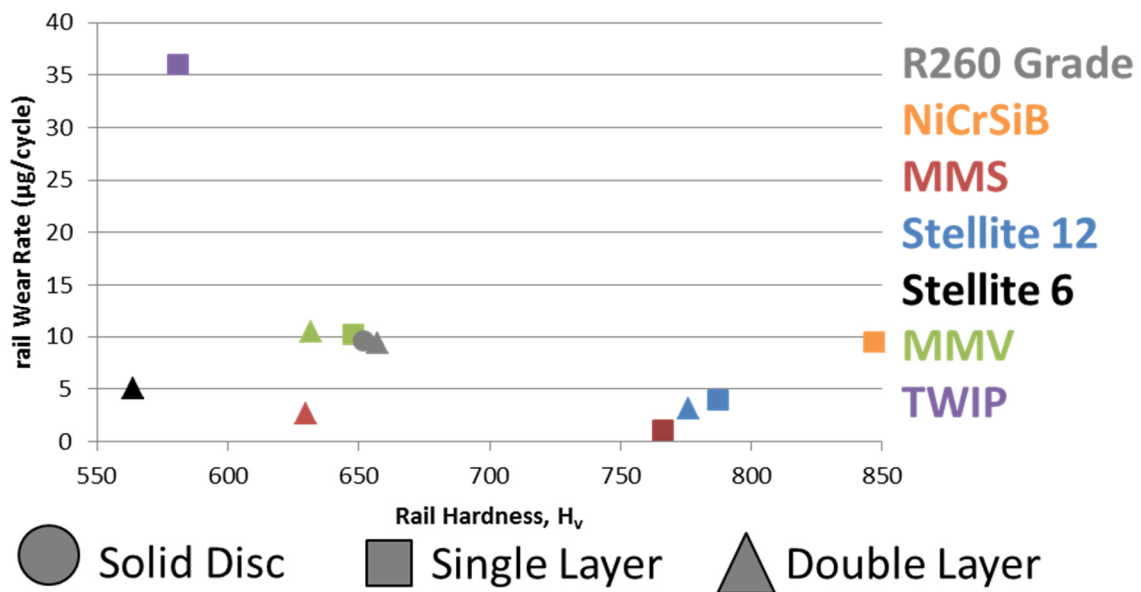
Figure 6. Average wear rate of rail discs in dry conditions plotted against the end-of-test rail disc hardness, colour of data point indicates material/clad type, shape indicates number of layers

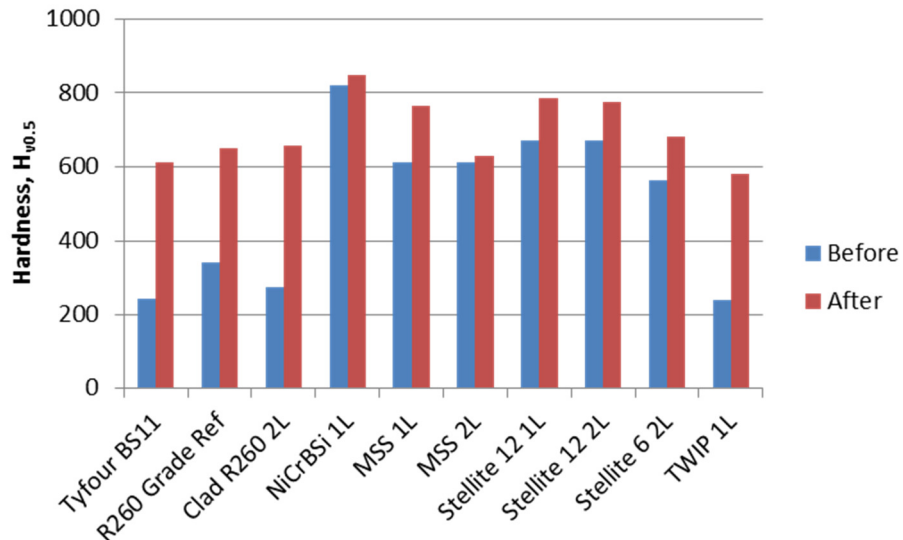
Figure 7. Before and after sub-section Vickers micro-hardness of wear test samples. Note the “R260 Grade Ref” sample had macro-hardness taken before but micro-hardness taken after the test but is included for reference purposes.

Figure 7 shows the change in hardness of the rail discs before and after the wear tests. Micro-hardness was measured as close to the surface as possible for all of the discs shown in Figure 7 on sectioned specimens with the exception of the R260 Grade reference disc where the hardness was measured on the curved running band before the test. It was decided to leave this specimen in Figure 7 as a reference as the hardness change is still similar to the BS11 and the Clad R260 2L specimens both of which had section micro-hardness measured before and after the test.

Figure 7 shows that all of the discs which had Vickers micro-hardness measured near the surface work hardened with the greatest amount of work hardening show by the BS11, R260 and TWIP samples. It is interesting to note that the hardness of all of the discs represented in Figure 7 increase toward the 600 – 800 Hv range during the test regardless of the starting hardness value.

Micro-hardness was measured at the surface of the wheel discs before and after the wear tests. Hardness readings taken on the disc surface are less reliable than section hardness results due to the curved running surface and hence should only be used as a guide. However it is interesting to note that all the wheel discs started at a mean hardness level of approximately 340 Hv and work hardened during the test to an average range of approximately 600 – 800 Hv as is also seen with the rail discs (Figure 7).

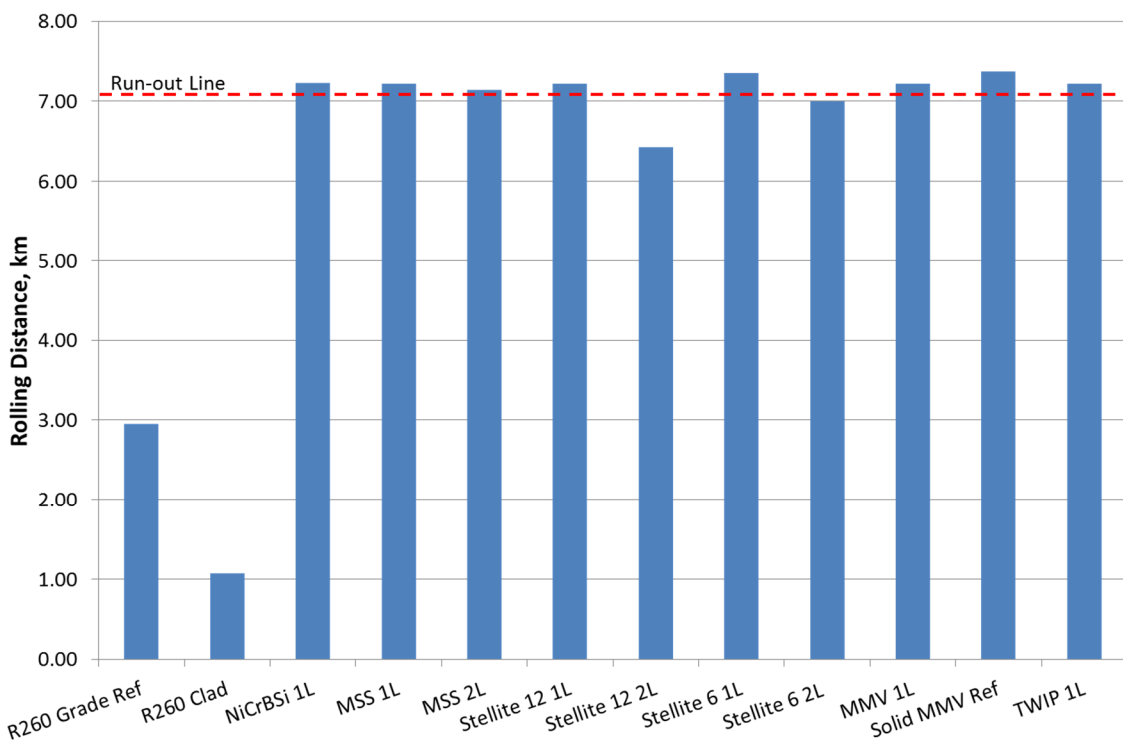
Figure 8. Results of RCF tests. RCF life is expressed in terms of rolling distance

The RCF initiation life of each disc is quoted in rolling distance and results are shown in Figure 8. Tests were limited to 50,000 cycles (~7 km depending on disc size) for practicality reasons. Tests which ran beyond 7.14 km without failure (as defined by the eddy current method, see section 2) were stopped and recorded as run-out tests. 7.14 km equates to approximately 50,000 cycles for a standard 47 mm diameter disc.

Figure 8 shows that none of the clad samples showed any signs of RCF initiation and all ran out to the 50,000 cycle limit. (Note: the Stellite 12 1 layer sample had a reduced diameter, but still completed 50,000 cycles). The RCF initiation life of the reference sample was 3 km showing that all clad samples show superior RCF initiation resistance compared to standard R260 Grade rail. New, untested specimens of the best performing samples from the wear tests (MSS and Stellite 12 both 1 and 2 layer and Stellite 6 just 2 layer) were tested to 100,000 cycles. However, none showed any signs of crack initiation after being tested to double the original endurance limit.

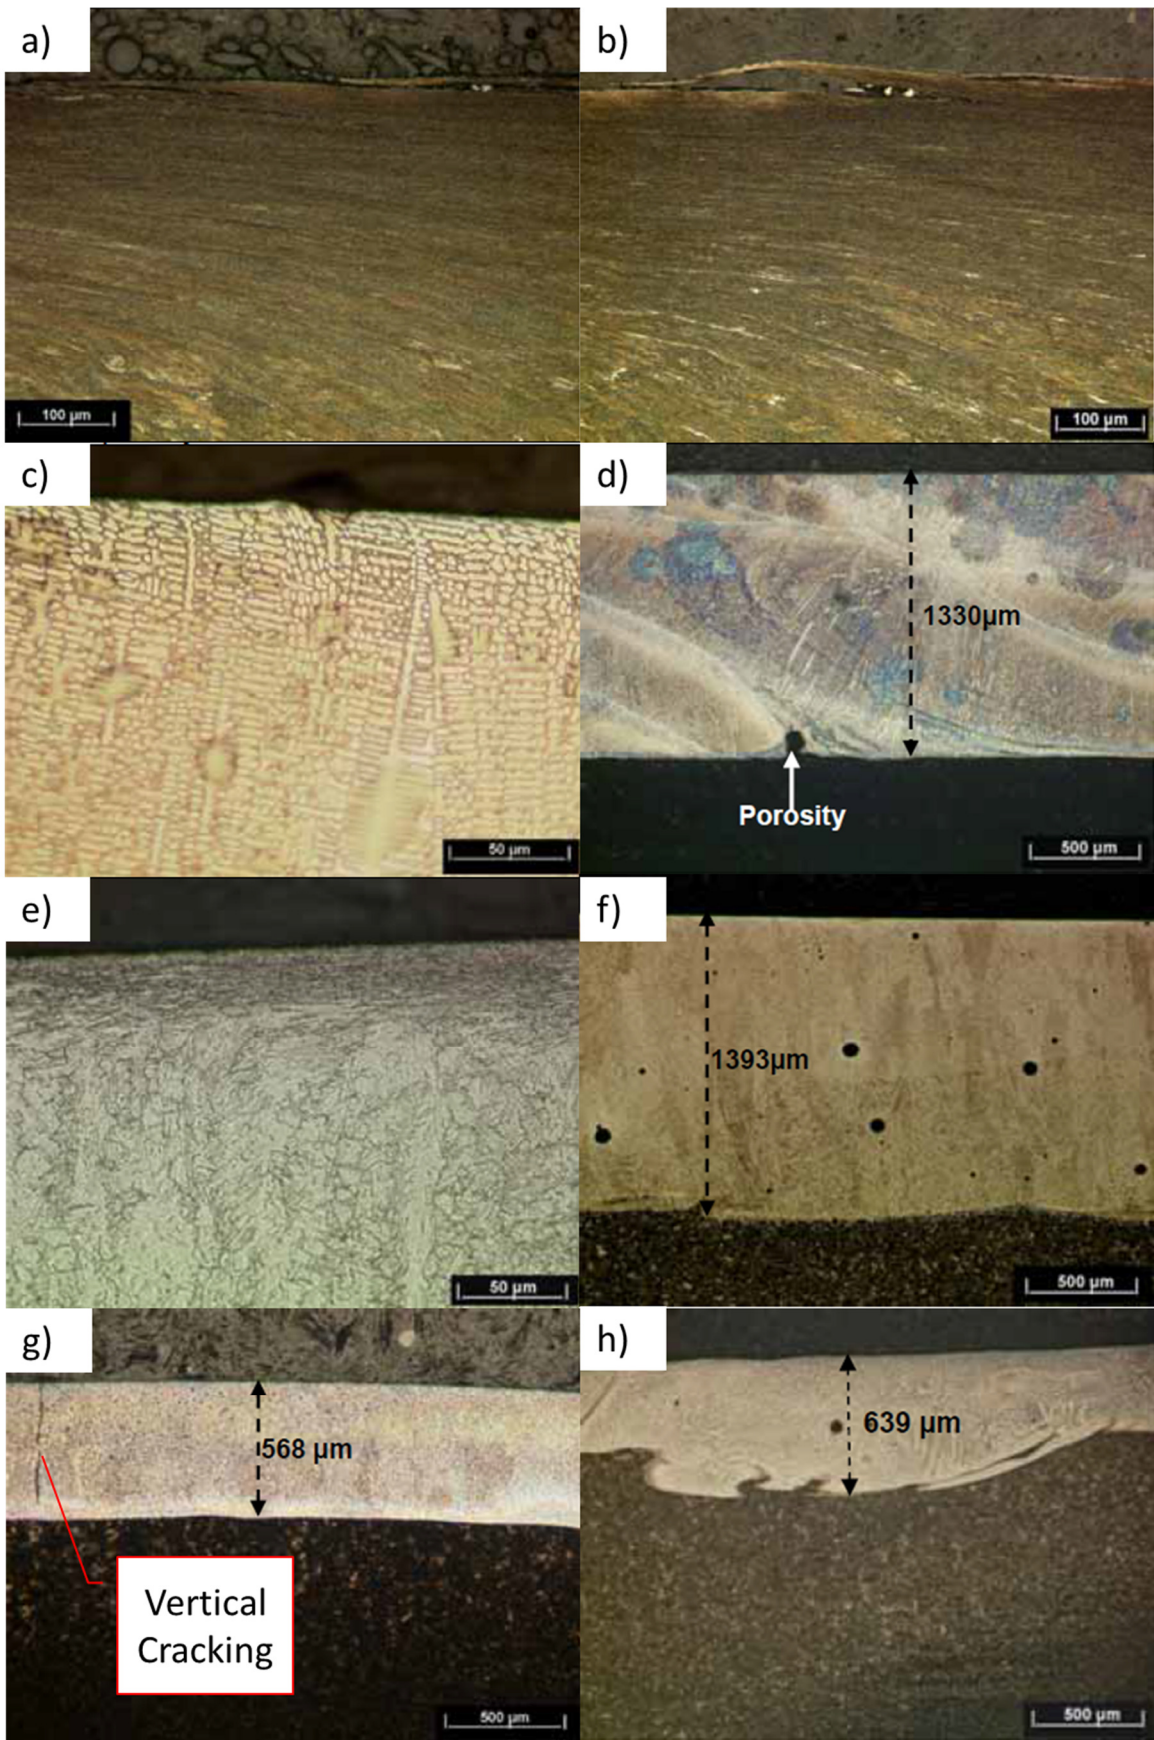
Figure 9. Subsurface micrograph of wear samples: a) Un-Clad R260 after 30,000 cycles, b) Clad R260 after 30,000 cycles, c) Stellite 6 2 Layer after 30,000 cycles, d) Stellite 12 2 Layer after 30,000 cycles, e) MSS 2 Layer after 30,000 cycles, f) MMV 2 Layer after 30,000 cycles, g) NiCrBSi 1 Layer un-tested, h) TWIP 1 Layer after 30,000 cycles

Each of the tested specimens along with an un-tested specimen of the same material were sectioned, polished, mounted and etched and then inspected under a light microscope. The quality of the deposit/interface, depth of deformation and surface damage was assessed. Electron Backscatter Diffraction, EBSD, was performed on some of the sections to gauge the amount of deformation below the surface and more information can be found in [7]. The microstructure of the HAZ of all the samples tested was also checked and found to consist of lamellar pearlite with no embrittling martensite structures seen. Figure 9 shows micrographs of a selection of the wear samples sectioned.

The R260 material clad onto a R260 specimen (Figure 9b) was only clad in two layers and it was found that the microstructure of the deposited layer was actually somewhere between that of R220 and R260 grade rail. This suggested that the carbon content of the deposit was somewhat lower than that of the parent R260 material.

The Stellite 6 specimen (Figure 9c) showed the best deposit quality being virtually porosity free and with excellent fusion at the deposit/substrate interface. This was closely followed by the MSS sample (Figure 9e) which also showed excellent fusion at the interface and only small areas of small porosity in the deposit. It is interesting to note that these two materials exhibited very low wear rates compared to the reference R260 sample.

The Stellite 12 (Figure 9d) sample also exhibited a relatively low wear rate. Sub-surface examination, however, revealed cyclic porosity on the clad/substrate interface. This porosity could potentially be a site for the nucleation of fatigue cracks. It is observed in the field that the failure of track component repair welds arises from inclusions within the weld itself. This porosity could potentially be eliminated with changes to the cladding parameters and despite its presence the Stellite 12 samples were still some of the best performers in terms of wear.

Only the 1 layer NiCrBSi was assessed in the wear tests. The 1 layer deposit (Figure 9g) showed a small amount of porosity distributed within the sample. However, there was a vertical crack in the untested 2 layer disc which extended through the full thickness of the deposit. It is assumed that similar cracks were also present in the 1 layer sample. The interface of the 1 and 2 layer NiCrBSi discs was continuous with no lack of fusion. However, some porosity can be seen in the deposit close to the interface in the 2 layer sample.

Only the 1 layer TWIP sample (Figure 9h) was tested and was found to contain only minor porosity with some larger pores isolated within the deposit. This was the only sample which did not show an even clad/substrate boundary. The interface of the TWIP sample had a turbulent appearance. Whether this led to the high wear rate of the TWIP sample as seen in Figure 4 cannot be determined. However, it does suggest that the cladding parameters were not fully optimized which may have resulted in changes to the materials wear resistance. This is also supported by the marked increase in the porosity seen in the untested 2 layer sample. The amount of sub-surface deformation was much less than in the R260 reference sample despite the large amount of plastic flow which was seen on the running surface of the disc after testing.

The Stellite 12 (Figure 9d) sample also exhibited a relatively low wear rate. However, cyclic porosity on the clad/substrate interface is a potential site for the nucleation of fatigue cracks. It is observed in the field that the failure of track component repair welds arises from inclusions within the weld itself. This porosity could potentially be eliminated with changes to the cladding parameters and despite its presence the Stellite 12 samples were still some of the best performers in terms of wear.

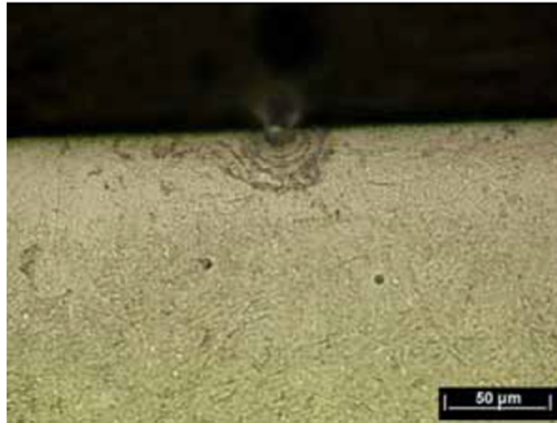
Figure 10. Subsurface micrograph of MMV 2 layer wear sample showing pore at disc surface with associated cracking after 30,000 dry cycles

Figure 10 shows an area of porosity at the surface of the 2 layer MMV sample. It can be seen that the material below the pore deforms to a much greater extent than the surrounding material and cracks have developed around the pore within this deformed region. Thus it can be seen that any porosity within the deposit is likely to be detrimental to the wear performance of the deposit.

The 1 layer MMV disc had extensive porosity throughout the deposit as seen in Figure 14. Cracks seem to have developed from the edges of the pores closest to the specimen surface similar to what was seen in the MMV wear sample as shown in Figure 10.

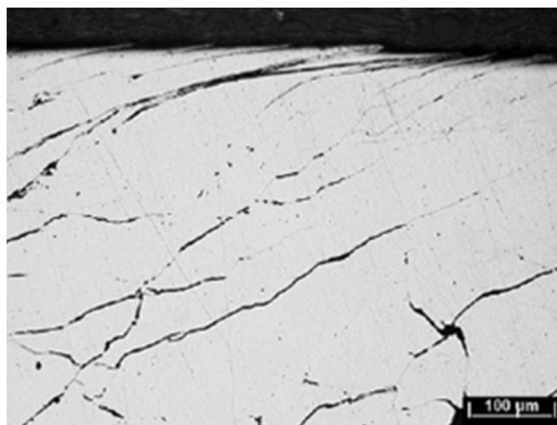
Figure 11. Un-etched subsurface micrographs of un-clad R260 sample which failed at 32,500 cycles. Sample is shown in the un-etched condition to aid the visualization of cracks

Sectioning of the RCF specimens revealed that the only specimens to show extensive RCF-like cracks were the un-clad R260 reference disc and the clad 2 layer R260 disc. A section of an un-clad R260 RCF specimen which failed after 32,500 cycles is shown in Figure 11. Figure 11 shows there is an extensive network of RCF cracks within the zone of heavy deformation. The depth of deformation in this sample was roughly 630 μm.

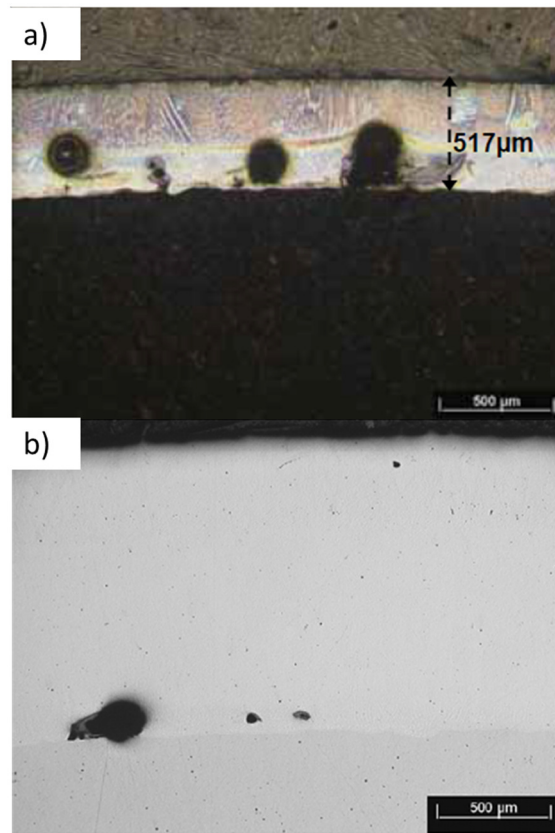
Figure 12. Subsurface micrographs of the Stellite 12 RCF samples: a) 1 layer sample after 50,000 cycles in the etched condition, b) 2 layer sample after 50,000 cycles in the un-etched condition

Although one of the best performers in terms of wear and RCF resistance, the Stellite 12 samples had gross porosity present within the deposit as seen in Figure 12. However, despite this the 1 layer sample which was tested to 50,000 cycles contained no RCF cracks and no evidence was seen of any surface damage or sub-surface deformation.

The 2 layer sample triggered the eddy current crack detector at 45,000 cycles but no evidence of surface damage or embryonic RCF cracks were seen when the samples were sectioned. No deformation in the deposit was seen either. It is likely that the detector was triggered by the gross porosity in the clad layer.

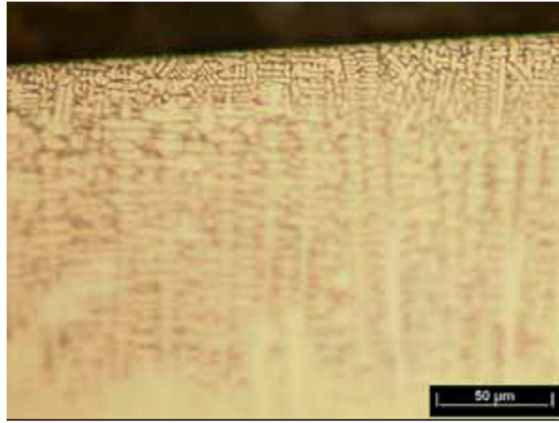
Figure 13. Subsurface micrograph of the 2 layer Stellite 6 RCF sample tested to 100,000 cycles in the etched condition

The 2 layer Stellite 6 RCF sample was internally free of porosity unlike the Stellite 12 samples. Some evidence of surface damage was seen in the 2 layer sample which was tested to 50,000 cycles. However, no subsurface deformation and hence no RCF cracks were seen. Figure 13 shows a second 2 layer sample which was tested to 100,000 cycles with the surface appearing virtually untested. EBSD performed on this sample showed no signs of subsurface damage.

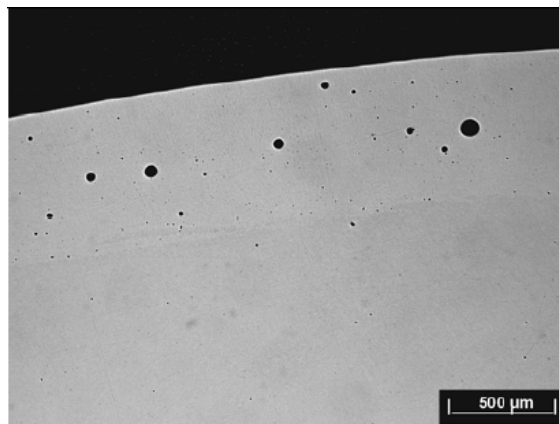
Figure 14. Subsurface micrograph of the 1 layer MMV RCF sample tested to 50,000 cycles in the un-etched condition

The uneven appearance of the MMV sample surface seen in Figure 14 is evidence of surface damage however, no embryonic RCF cracks were seen in the sample.

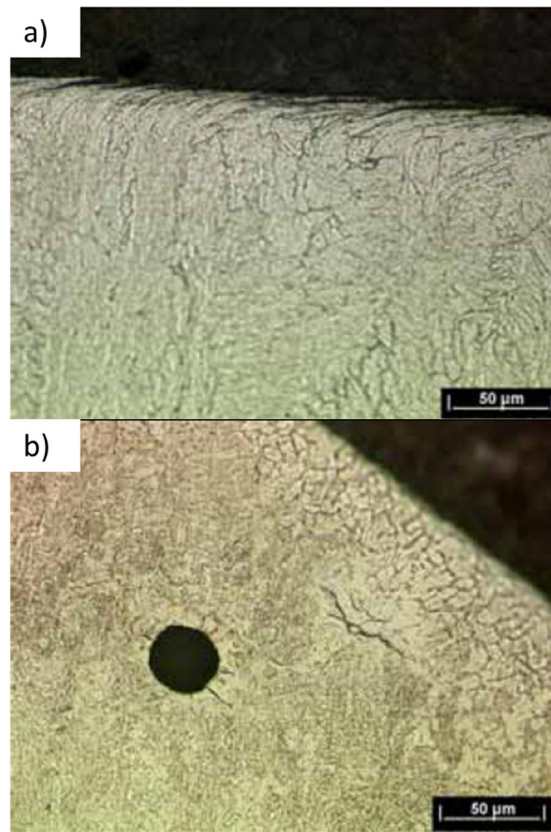
Figure 15. Subsurface micrographs of the MSS RCF samples: a) 2 layer sample after 50,000 cycles in the etched condition, b) 1 layer sample after 100,000 cycles in the etched condition

No RCF cracks were observed in the 1 layer MSS sample which was tested to 50,000 cycles. However, there seemed to be a shallow region of deformation between 20 and 50  $\mu\text{m}$  below the surface of the sample. The 2 layer sample on the other hand showed signs of embryonic RCF crack formation at the surface and showed a greater depth of deformation as shown in Figure 15a.

A separate 1 layer sample was also tested to 100,000 cycles and was seen to exhibit less deformation than the 2 layer sample tested to 50,000 cycles. No typical RCF cracks were seen in this sample, however, cracks were seen around areas of porosity, as shown in Figure 15b; some of which were sub-surface and some exposed at the surface. EBSD showed that the depth of deformation in the 100,000 cycle sample is roughly 50 $\mu\text{m}$ .

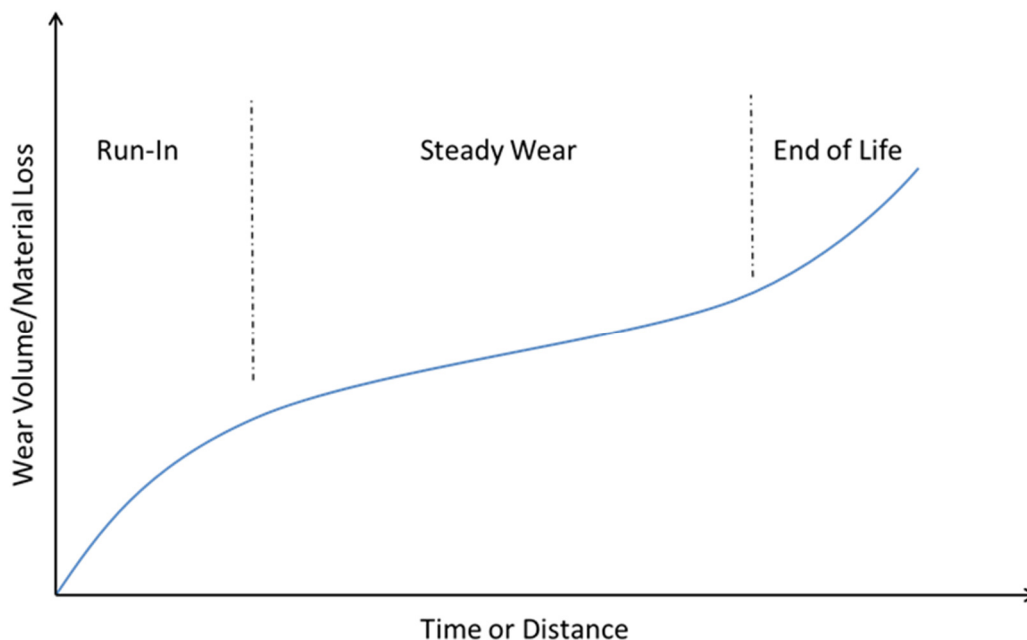
Figure 16. Typical wear behaviour over the lifetime of a component [8]

The best performing cladding in this test was 1 layer MSS where the wear rate remained consistently below 1  $\mu\text{g}/\text{cycle}$ . The discs in group 1 (see Section 3.2) seemed to reach a steady state of wear relatively quickly (within 5000 cycles) where upon there was little variation in the wear rate after this point. Most of the discs in group 2 reached a maximum wear rate after which a lower cyclical wear rate was seen. However, the R260 Grade reference sample and the clad R260 sample both seemed to show gradually increasing wear rates. The worst performing disc, in terms of wear, was the 1 layer TWIP sample which showed a wear rate far in excess of any other sample tested. The wear rate of the TWIP disc also increased throughout the test. It was observed that there is a large degree of plastic deformation on the surface of the TWIP sample. What is not easy to determine here is whereabouts the wear rate of each sample lies on the curve representing the life of typical tribological components as shown in Figure 16 [8].

Due to the scaled nature of the tests and the range of mechanical properties of each of the materials tested it is difficult to say whereabouts 30,000 test cycles places each of the samples on the curve shown in Figure 16. It is possible that the samples in group 1 “Steady wear rate” may be in the “Steady Wear” regime as per Figure 16. It is also possible that those materials in group 1 do not exhibit typical wear behavior and instead transition straight to “Steady Wear”. Thus materials in Groups 2 and 3 which show increasing wear behavior may still be in the “Run-In” phase and may potentially show steady wear if the tests were continued beyond 30,000 cycles.

In this work wear has been expressed as a rate i.e. total mass loss divided by the number of cycles ( $\mu\text{g}/\text{cycle}$ ). For the values of wear rate expressed in Table 1 it is easy to assume a linear amount of material loss over a given time frame. However, as shown in Figure 4, and discussed in great detail in [9], the wear rate is constantly changing as different wear mechanisms come to dominate due to shifts in wear transition. With reference to Figure 4 it seems as if 30,000 cycles was sufficient for most of the samples to transition into the “steady wear” regime as depicted in Figure 16.
