Effects of extreme natural events on the provision of ecosystem services in a mountain environment: the importance of trail design in delivering system resilience and ecosystem service co-benefits

Aleksandra M. Tomczyk^{a,b,*}, Piran C.L. White^a, Marek W. Ewertowski^{b,c}

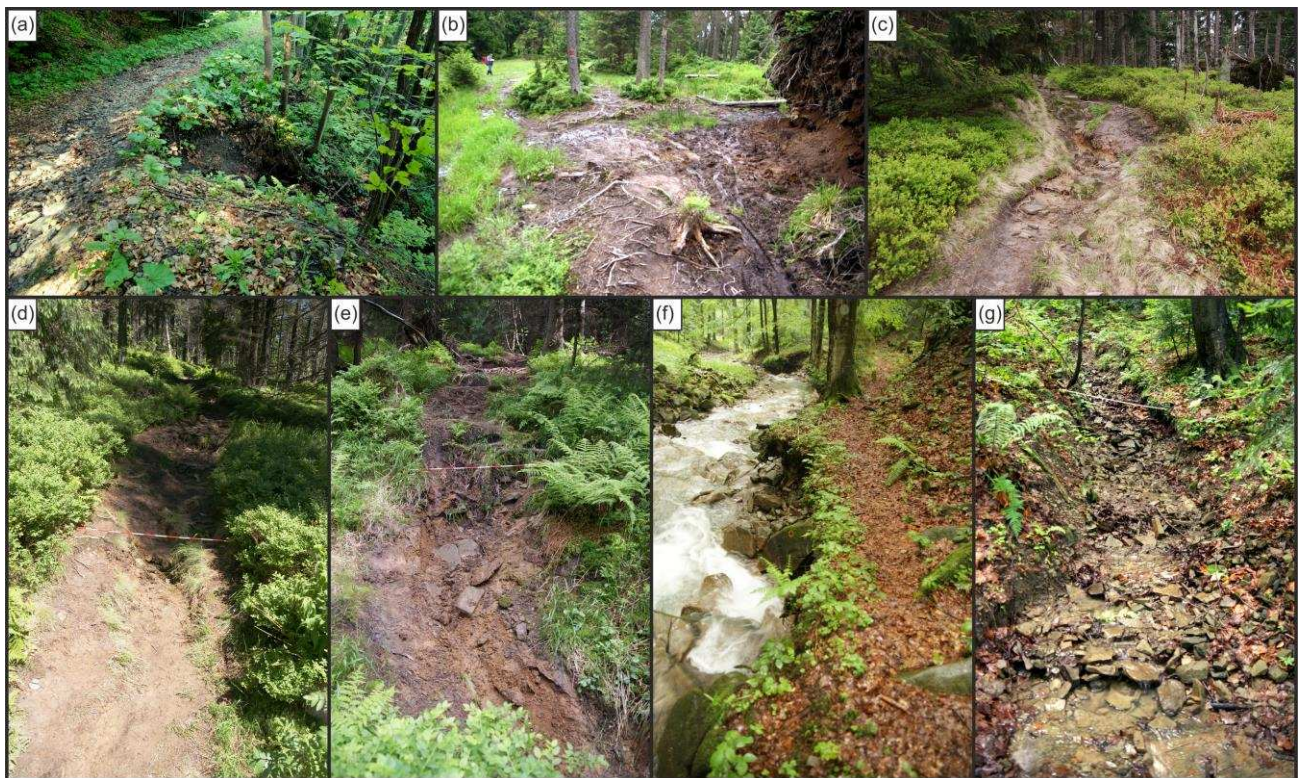
Figure 2. Examples of impacts in Gorce National Park related to the extreme rainfall event in May 2010: (a) damage to trail tread due to small landslide; (b) creation of muddy sections; (c), (d), (e) development of erosional rills destroying trail tread; (f) undercutting of trail treads by a stream; (g) increase in delivery of sediments due to soil erosion.

The intense rainfall in May 2010 caused a variety of damage within the Park area. The most important effects were the following (Fig. 2): (1) development of erosional rills on trail treads; (2) damage or destruction of bridges, culverts and water bars; (3) creation of extensive muddy sections; and (4) overall increase in soil erosion. These degradation problems created difficult and unsafe travel conditions. Visitors, trying to avoid these difficulties, started to trample trailside vegetation, leading to the additional widening of the trail tread. Moreover, in several places, alternative (informal) sections of trails were developed by users. Among other consequences of the intense rainfall were a rise in delivery of sediments into streams and retention ponds following soil erosion, and an increase in flood risk, which affected not only the Park area, but also areas downstream.

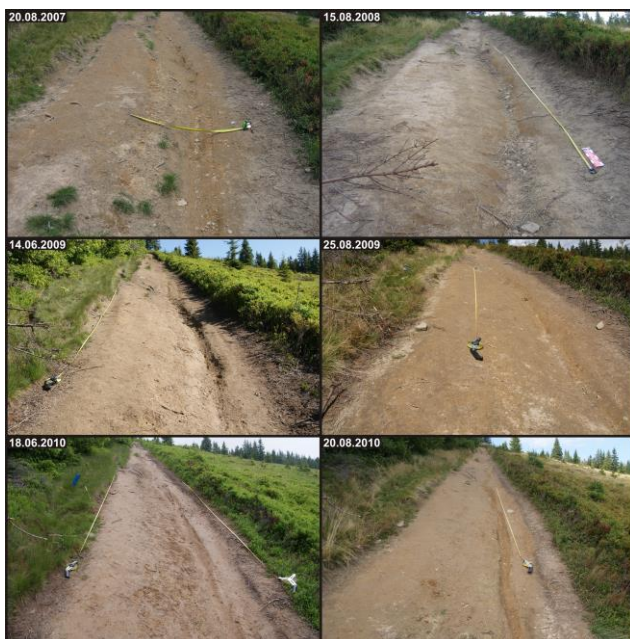
Figure 6. Case study E – an example of trail which had already been degraded before the intense rainfall event. Trail tread was uneven and wide. The extreme rainfall event caused an increase in soil erosion and the rill was deepened.

Case study E was another example of scenario 3. The analysed section was steep (16°) and routed along the edge of the glade. Trail tread was natural and directed obliquely to the prevailing slope. Prior to May 2010, it was 2.65 m wide and a small erosional rill (up to 0.1 m deep) was developed along the trail (Fig. 6). As a consequence of water runoff during the intense rainfall event, the rill was deepened.

Mean soil loss in the period of normal functioning (prior to the extreme event) was 43.4 mm (Table 1). It increased during the intense rainfall event to 52.3 mm. The trail became rougher and more prone to erosion. Hence, no natural restoration was observed. On the contrary, at this site, soil loss increased (up to 71.32 mm), and the trail section widened 0.20 m in the period 2010-2014 (Table 1).
