Effects of extreme natural events on the provision of ecosystem services in a mountain environment: the importance of trail design in delivering system resilience and ecosystem service co-benefits

Aleksandra M. Tomczyk^{a,b,*}, Piran C.L. White^a, Marek W. Ewertowski^{b,c}

Keywords: erosion, recreation, trail impact, intense rainfall, trail restoration, Gorce National Park

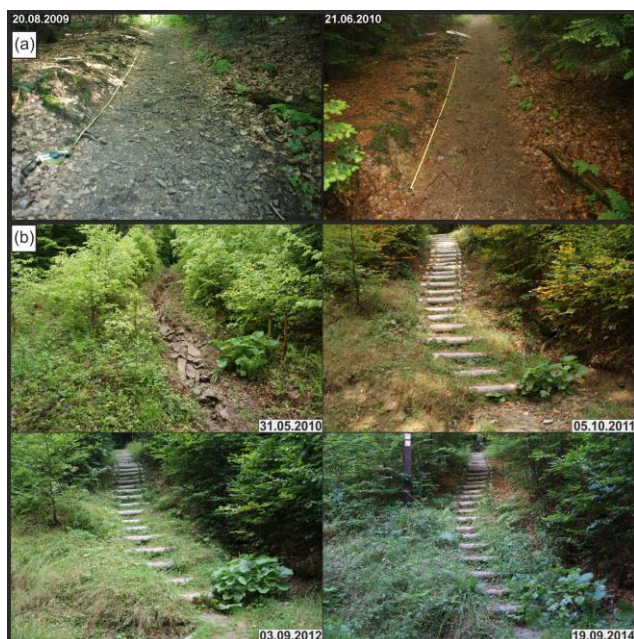
Figure 4. (a) Case study A – an example of a trail which was not damaged during the intense rainfall event which occurred in May 2010. (b) Case study B – an example of trail damage (development of an erosional rill) and the appearance of the trail after repair (scenario 2).

Scenario 1 represented the situation in which trails were properly constructed and maintained, and therefore, no significant damages occurred after the heavy rainfall in May 2010 (Fig. 4a). Moreover, trails returned to normal function almost immediately after the event (Table 1, Fig. 3). Case study A exemplified scenario 1. It was located on a ridge, in a forest. Trail slope was moderate (10°). The tread was even with natural stone pavement. The studied section had side-hill trail alignments (at 50° and more), that allowed natural tread drainage and minimised trail erosion. However, case study A had a low slope alignment (25°), that potentially could be difficult to drain. In case study A, proper tread drainage features such as water bars existed downslope, which helped to intercept and drain surface runoff from the tread. The trail was able to accommodate 177 users per day. As the trail was not damaged during the extreme rainfall event, the trail

Case study B illustrated scenario 2. The analysed section of trail was very steep (22°) and routed parallel to the main slope. Before the extreme rainfall, the trail was narrow, with a natural surface and no incision. The intense rainfall and subsequent surface water runoff eroded a rill, up to 0.85 m deep and up to 1.1 m wide (Fig. 4b), which created difficult and unsafe travel conditions, and forced the park managers to repair this section. In summer 2010 the rill was filled and wooden steps were installed, and visitors could use this section again safely. Shortly after the management action, as the trail was still steep and there was no trailside vegetation, surface water runoff and erosion occurred along the

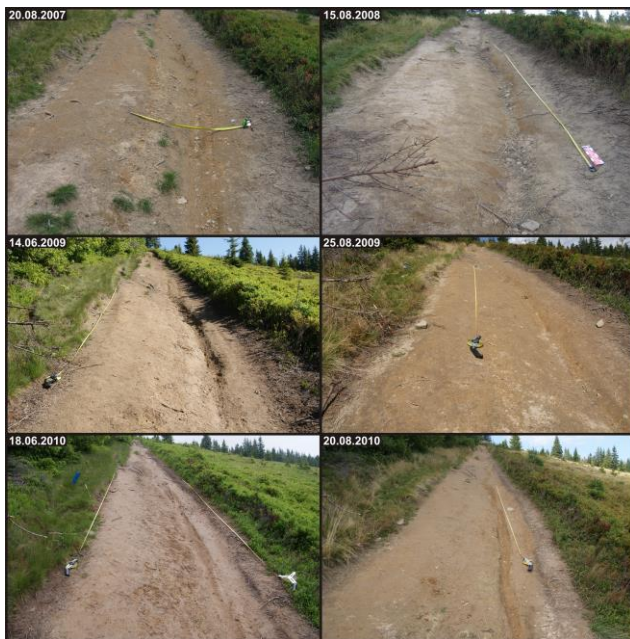
Figure 6. Case study E – an example of trail which had already been degraded before the intense rainfall event. Trail tread was uneven and wide. The extreme rainfall event caused an increase in soil erosion and the rill was deepened.

Case study E was another example of scenario 3. The analysed section was steep (16°) and routed along the edge of the glade. Trail tread was natural and directed obliquely to the prevailing slope. Prior to May 2010, it was 2.65 m wide and a small erosional rill (up to 0.1 m deep) was developed along the trail (Fig. 6). As a consequence of water runoff during the intense rainfall event, the rill was deepened.

Mean soil loss in the period of normal functioning (prior to the extreme event) was 43.4 mm (Table 1). It increased during the intense rainfall event to 52.3 mm. The trail became rougher and more prone to erosion. Hence, no natural restoration was observed. On the contrary, at this site, soil loss increased (up to 71.32 mm), and the trail section widened 0.20 m in the period 2010-2014 (Table 1).
